## Case History 14: Buncefield Incident

## Buncefield: Why did it happen?

The underlying causes of the explosion and fire at the Buncefield oil storage depot, Hemel Hempstead, Hertfordshire on 11 December 2005

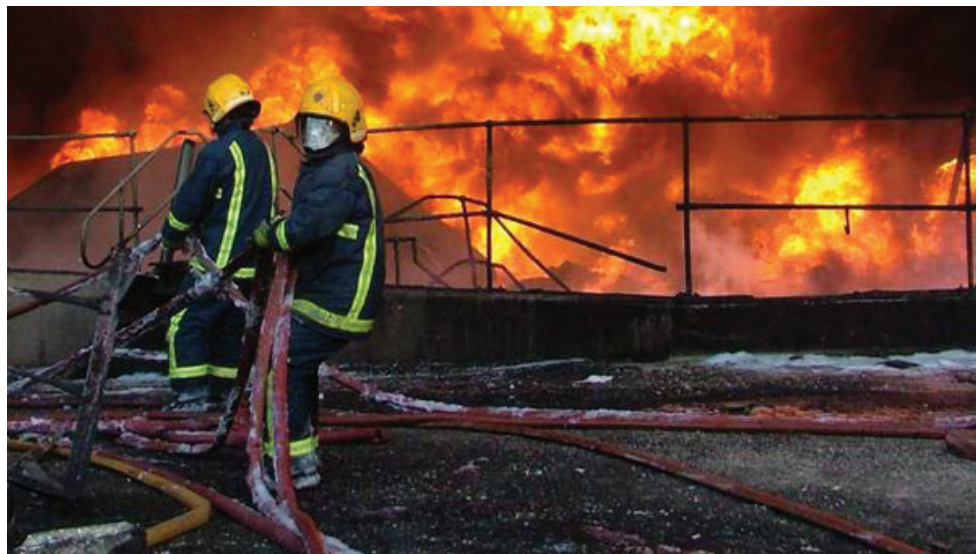
**Figure 4** Firefighters tackle a blazing tank at Buncefield © Hertfordshire County Council

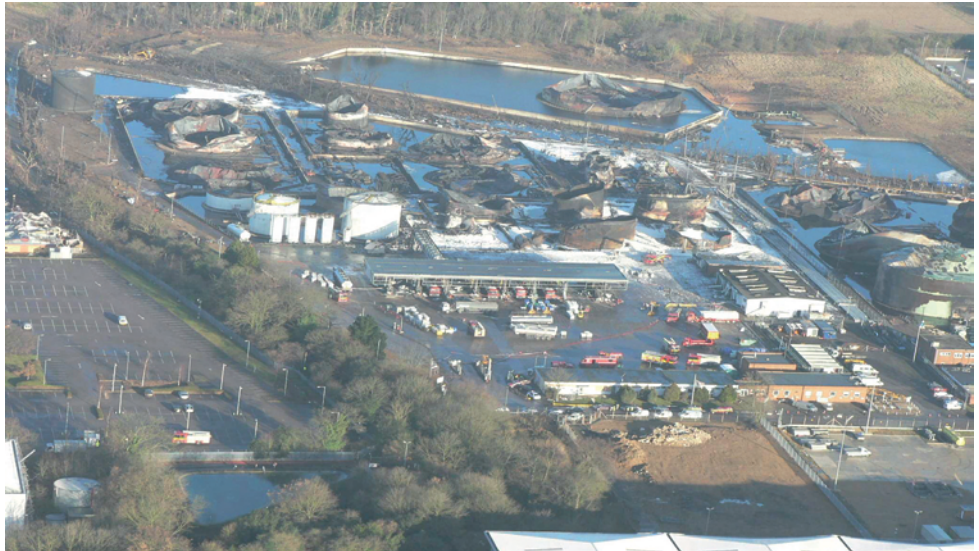
**Figure 5** Part of the Buncefield depot after the incident © Chiltern Air Support

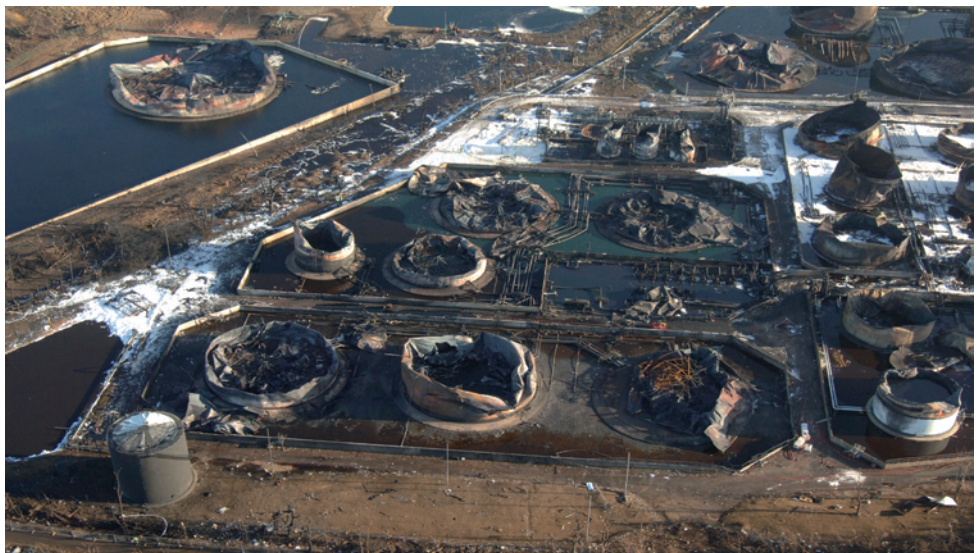
**Figure 6** Buncefield after the incident: Tank 912 is in the centre foreground and Tank 12 is in the top left of the picture © Chiltern Air Support

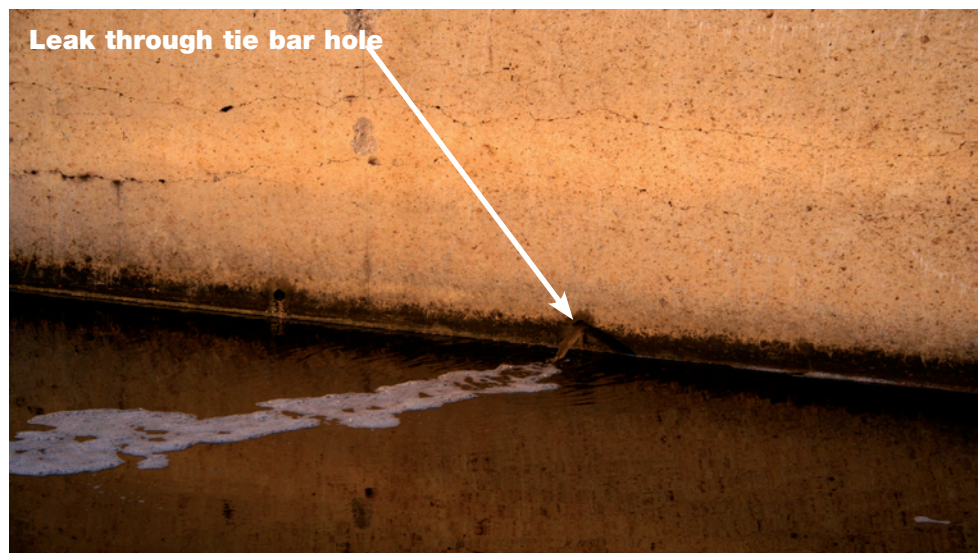
69 Another failure mode of the BPA bund was introduced at the construction phase. The shuttering (or formwork) used to hold the concrete in place before it set was held in place using tie bars (or tie bolts). Good practice requires either use of formwork techniques avoiding tie bolts or use of ‘tie bar waterstops’. The BPA bund was constructed with tie bars penetrating through the bund and, although they were plugged and grouted, they were unable to resist the impact of the fire. Holes opened up, which were further pathways for leakage of fuel, foam and firewater from the bund.

**Figure 7** Tank 12 after the incident showing liquid leaking through tie bar hole

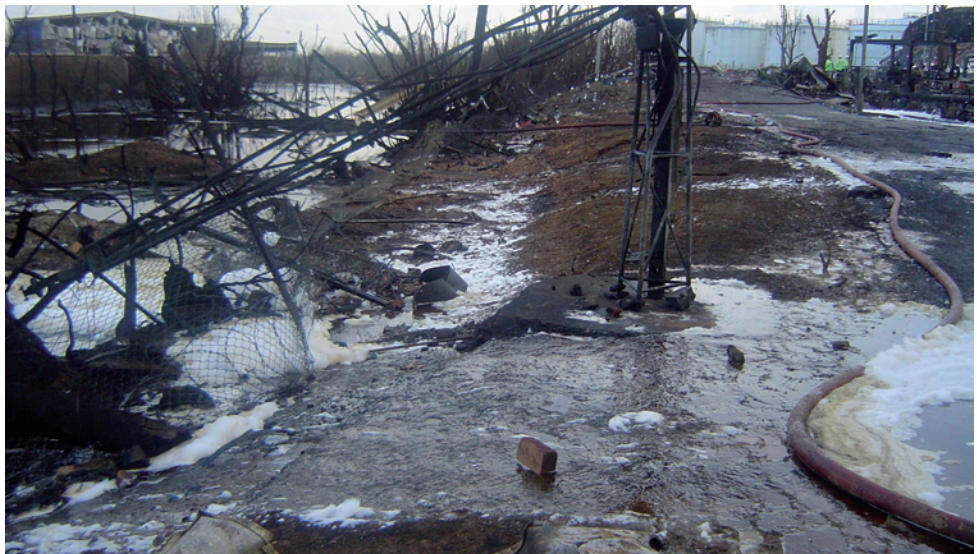
- There was no kerbing or boundary wall/mound to keep liquids on site and direct them into drainage systems. Once released, liquids could flow anywhere.

**Figure 10** Fuel and firefighting liquids flowed off site

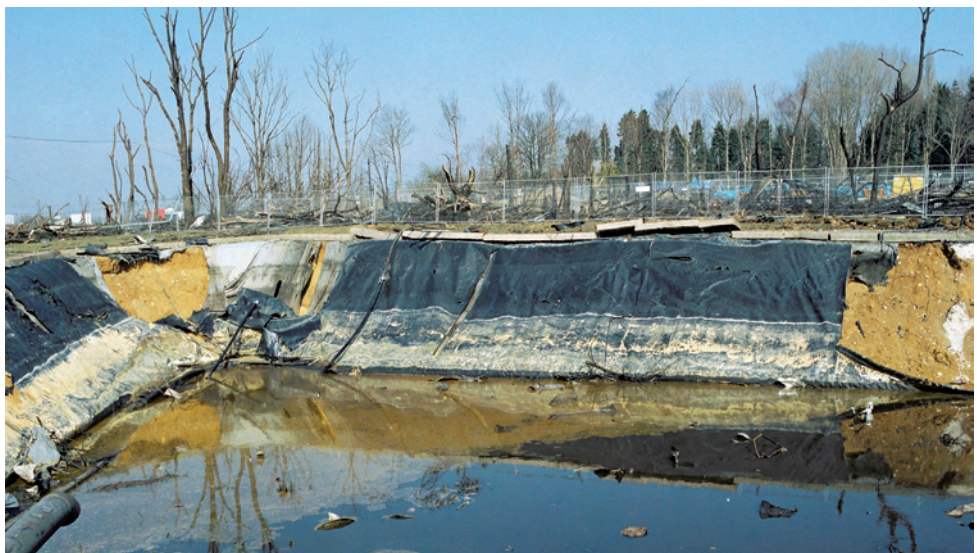
- The capacity of the drains and the lagoon was too small.
- Some of the drains were 'perforated' so that a 'back up' of liquids would cause their release through underground perforations.
- The liner of the firewater lagoon was susceptible to fire damage and to damage from debris from the explosion.

**Figure 11** The firewater lagoon on the HOSL site after the incident

- The HOSL West lagoon was intended as a firewater supply, but was rendered useless as it received fuel draining from the site. It flooded the fire system pump house when it overflowed.
- There was a dependence on pumping liquids, which as a process is vulnerable to, for example:
  - inadequate pumping capacity;
  - failure of pumps on loss of power; and
  - inability to use pumps following release of flammable vapour.
- Some areas of unmade ground were not protected from liquids and one such area of the site included a soakaway.
- The effluent treatment plant included soakaways that were not identified in the safety reports or emergency plans.
