## **Case History 016:**

### **Heat exchanger rupture and ammonia release in Houston, Texas**

## Heat exchanger rupture and ammonia release in Houston, Texas (One Killed, Six Injured)

2008-06-I-TX  
January 2011

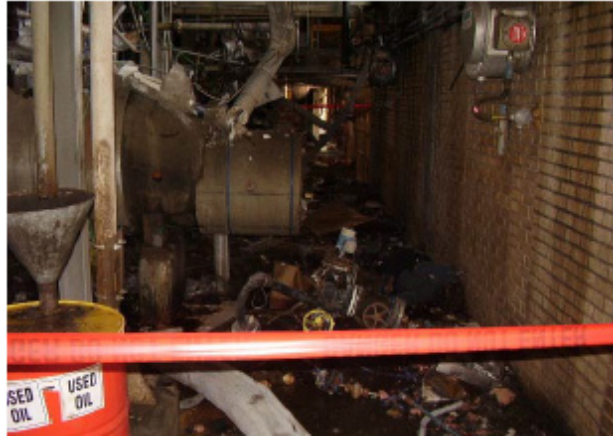
The catastrophic rupture threw debris that stuck and killed a Goodyear employee walking through the area. The rupture also released ammonia, exposing five nearby workers to the chemical. One additional worker was injured while exiting the area. The six injured workers were immediately transferred to a hospital, but Goodyear erroneously declared an end to the emergency after that. Hours later, workers discovered the body of the Goodyear employee, buried in the rubble near the ruptured vessel.

Area of fatality

- The absence of the victim was not noted, due to the lack of training and drills on worker headcounts. Thus, companies' procedures must account for breakdowns in automated worker tracking systems to ensure that all workers inside a facility can be quickly accounted for in an emergency.

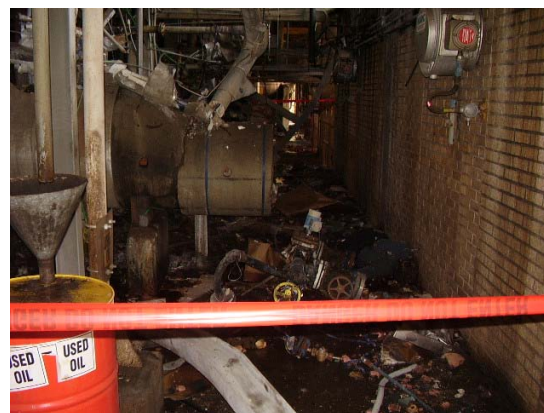
Figure 1. Area of fatality

Several hours later, after plant operations had resumed, a supervisor assessing damage in the immediate incident area discovered the body of a Goodyear employee located under debris in a dimly lit area (Figure 1).

At about 1:20 p.m., an operations supervisor assessing the damage to the incident area discovered the victim buried in rubble in a dimly lit area and contacted City of Houston medical responders.

*Companies should conduct worker headcount drills that implement their emergency response plans on a facility-wide basis. Company procedures must account for breakdowns in automated worker tracking systems to ensure that all workers inside a facility can be quickly accounted for in an emergency. Drills that simulate such malfunctions should be conducted to verify that all lines of responsibility and alternate verification techniques will account for workers in a real situation.*

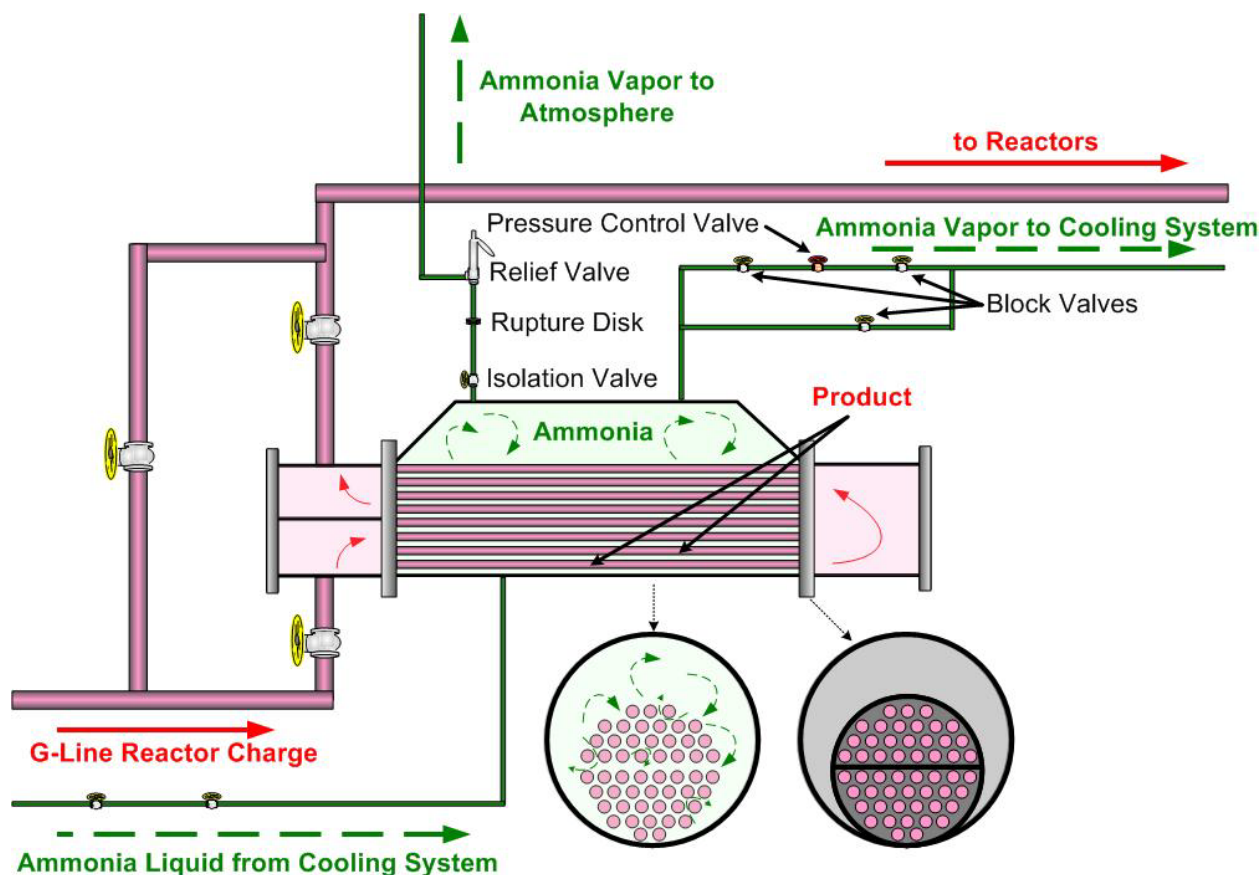
Figure 2. Ammonia heat exchanger

The process chemicals exiting the heat exchanger flow to the process reactors. Each heat exchanger is equipped with a rupture disk in series with a pressure relief valve (both set at 300 psig) to protect the heat exchanger from excessive pressure. The relief system vented ammonia vapor through the roof to the atmosphere.

As Figure 2 shows, a rupture disk and a pressure relief valve in series protected the ammonia heat exchanger from over-pressure. An isolation valve installed between the rupture disk and the heat exchanger isolated the rupture disk and relief valve for maintenance. However, when the valve was in the closed position, the heat exchanger was still protected from an over-pressure condition by the automatic pressure control valve.

the heat exchanger and the automatic pressure control valve. This isolated the ammonia side of the heat exchanger from all means of over-pressure protection. Steam flowing through the heat exchanger increased the ammonia temperature and the pressure in the isolated heat exchanger. Because the over-pressure protection remained isolated, the internal pressure increased until the heat exchanger suddenly and catastrophically ruptured.

*In accordance with the ASME Boiler and Pressure Vessel Code, over-pressure protection shall be continuously provided on pressure vessels installed in process systems whenever there is a possibility that the vessel can be over-pressurized by any pressure source, including external mechanical pressurization, external heating, chemical reaction, and liquid-to-vapor expansion. Workers should continuously monitor an isolated pressure relief system throughout the course of a repair and reopen blocked valves immediately after the work is completed.*

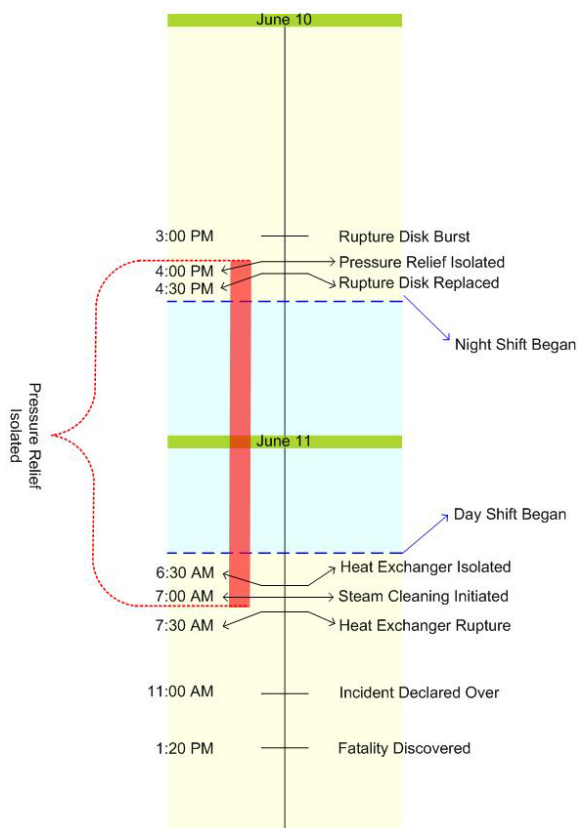
Figure 3. Event timeline

Although maintenance workers had replaced the rupture disk by about 4:30 p.m. on June 10, the valve isolating the rupture disk was not reopened. No further activities involving the rupture disk or relief line occurred on the nightshift or the dayshift on June 11 and the valve remained closed. Figure 3 shows the timeline of these events.

*Communicating plant conditions between maintenance and operations personnel is critical to the safe operation of a process plant. Good practice includes formal written turnover documents that inform maintenance personnel when a process is ready for maintenance and operations personnel when maintenance is completed and the process can be safely restored to operation.*
