## Case Study 17: Metal Dust Flash Fires and Hydrogen Explosion

## Hoeganaes Corporation: Gallatin, TN Metal Dust Flash Fires and Hydrogen Explosion

5 Killed, 3 Injured

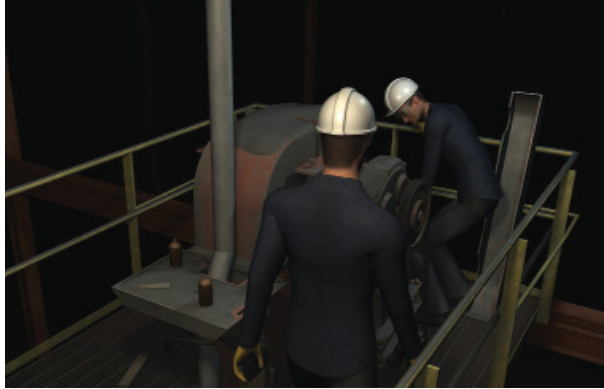
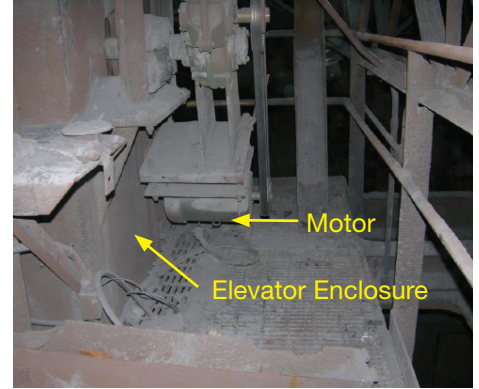
**FIGURE 4 (RIGHT)**

Scene of January 31, 2011, incident area.

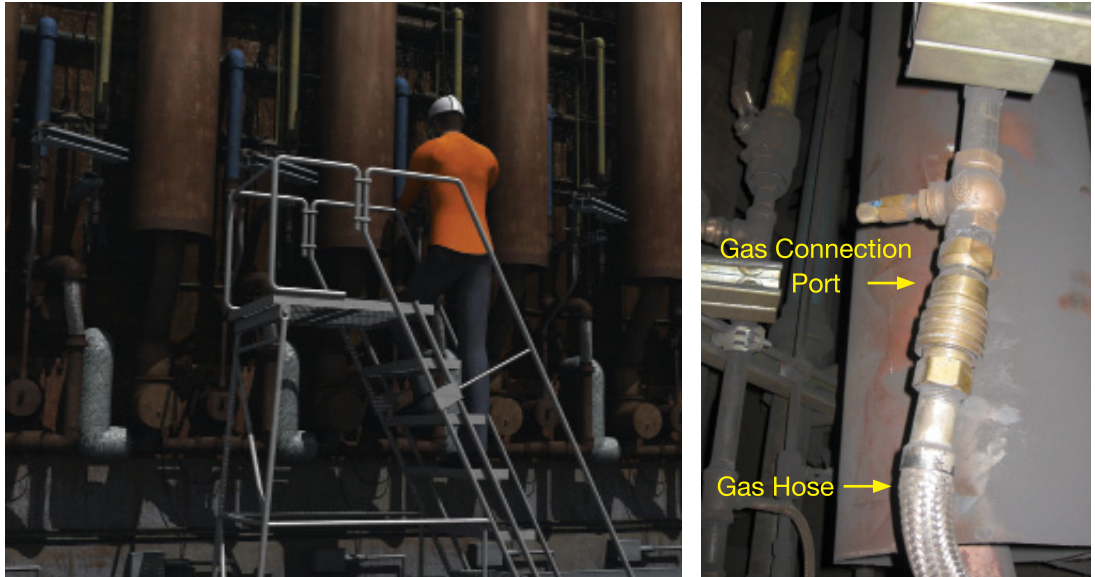
**FIGURE 7 (RIGHT)**

The gas line connection involved in March 29, 2011, incident.

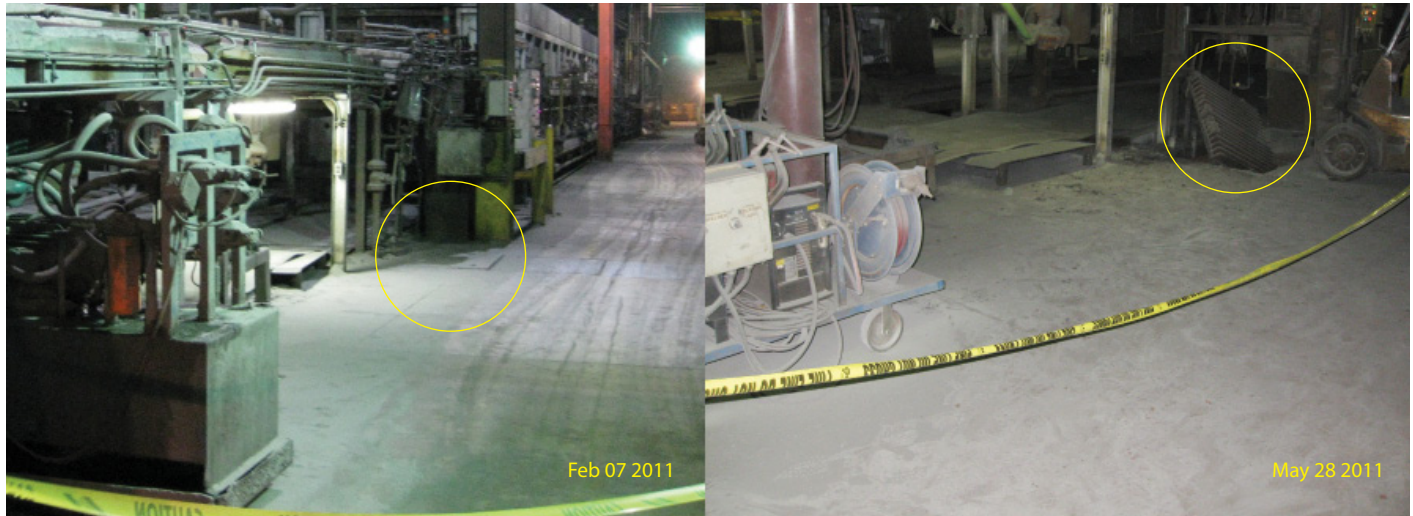
**FIGURE 9 (TOP)**

Scene of the May 27 incident before (left, taken during the CSB's January 31 incident investigation) and after (right). Note visible accumulations of iron powder on surfaces. Circled areas show trench cover location.

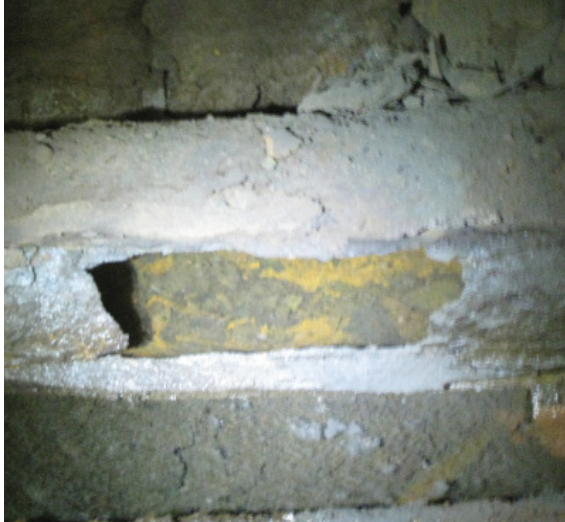
**FIGURE 11 (TOP LEFT)**

Interviews with eyewitnesses indicate that just as the first trench cover was wrenched from its position by the forklift, friction created sparks, followed by a powerful explosion. Several days after the explosion, CSB investigators observed a large hole (approximately 3 x 7 inches) in a corroded section of piping that carried hydrogen and ran through the trench (Figure 11).

Hole in 4-inch piping after the May 27, 2011, incident.

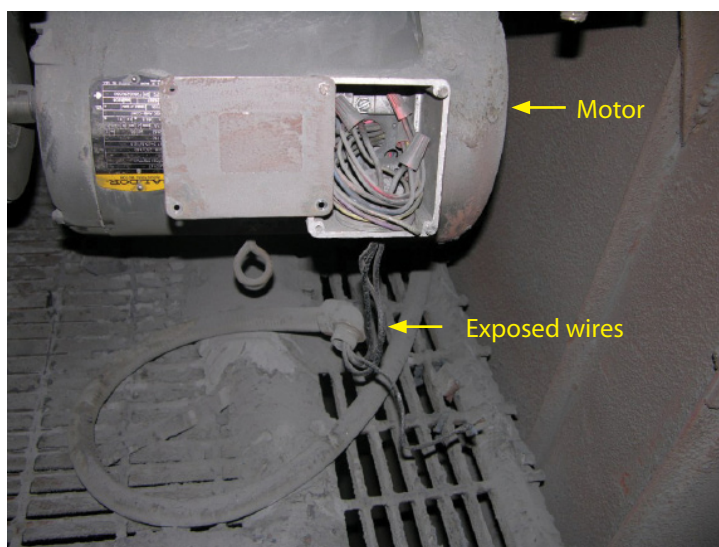
FIGURE 15

Exposed electrical wiring on elevator motor near January 2011 incident site (motor panel cover was rotated post incident by fire department).

The testing contracted by Hoeganaes in 2010 determined that the minimum ignition energy for representative iron dust samples was greater than 500 mJ, and that a continuous arc would ignite the samples. One witness at ground level reported hearing an “electric sound” at the time of the incident. The motor operating bucket elevator #12 was a likely source of ignition since it had exposed wiring, was not properly grounded, and was within a few feet of the dust cloud source. The wiring was exposed because the electrical conduit supplying power to this motor was not securely connected to the motor’s junction box.

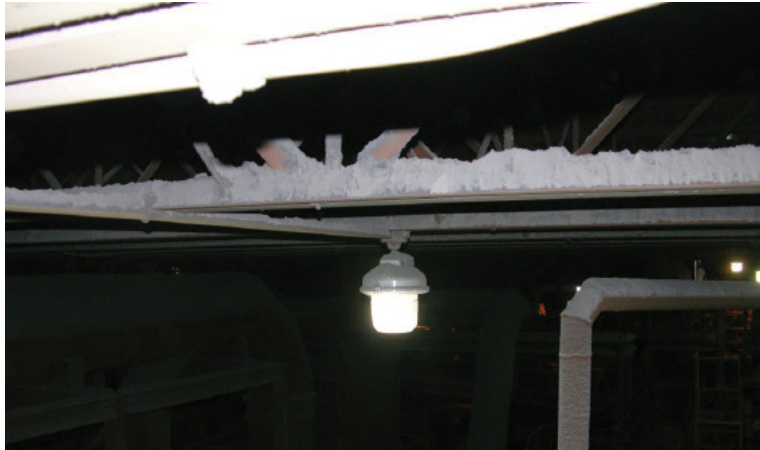
FIGURE 16

Mounds of iron dust along elevated surfaces at the Gallatin plant, February 3, 2011.

The Building Construction section of the code states, “Avoid beams, ledges or other places where dust may settle, particularly overhead.” The Gallatin facility, built in the 1980s, was not designed to avoid significant overhead accumulations of dust. The code calls for designing and maintaining dust-tight equipment to avoid leaks and, where this is not possible, to enforce good housekeeping procedures.

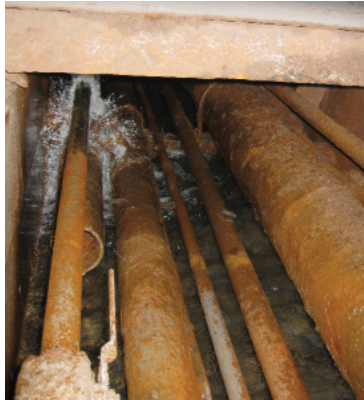
**FIGURE 17**

Water flow (upper left of photo) and externally corroded pipes in the trench involved in the May 27, 2011, incident.

According to ASME B31.3, design concerns about ambient conditions around process pipes focus on environments and changes that can create physical stresses in the piping. Section 10.5.3 of NFPA 55 requires annual maintenance including inspection for physical damage and leak tightness. CGA G-5.4 similarly requires regular inspection for physical damage and leak tightness. However, Hoeganaes did not regularly inspect the pipes in the trench. The design and maintenance of this trench, should have addressed the issue of slow corrosion over time caused by the hot water runoff and solids accumulation.

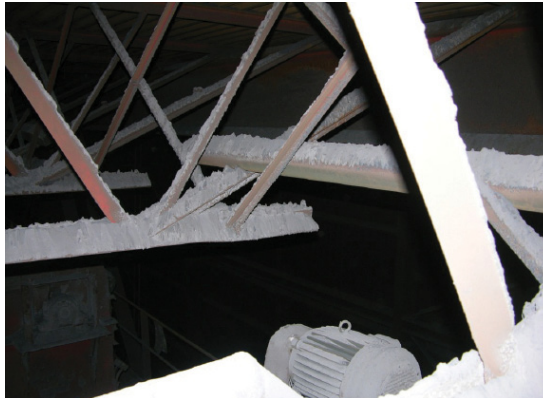
**FIGURE 18 (LEFT)**

Iron dust on rafters,  
February 3, 2011.

surface up to 4 inches deep and was visible in the air. Mitigation of the combustible dust hazard by Hoeganaes was limited to a less-than-adequate vacuuming service, sparsely enclosed conveyance equipment, and an inadequate baghouse filtration system.

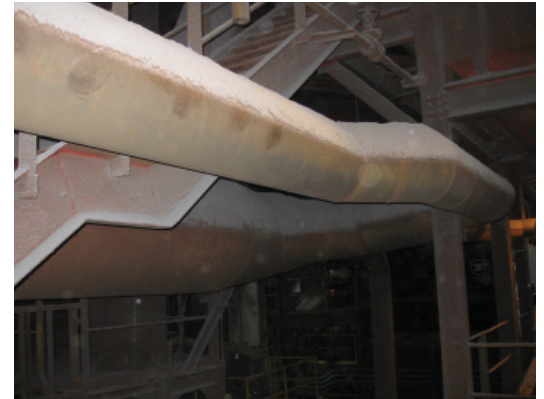
**FIGURE 19 (RIGHT)**

Iron dust on overhead  
surfaces, February 3, 2011.

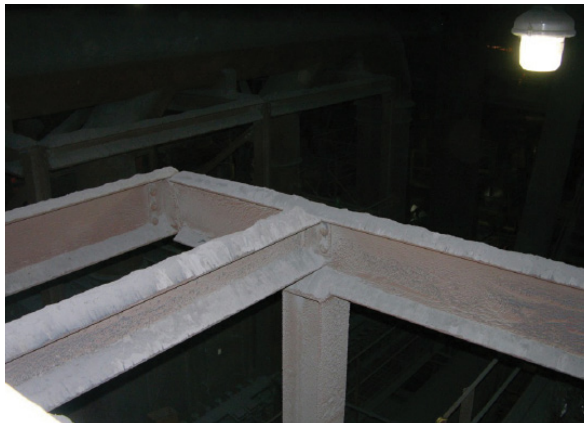
**FIGURE 20**

Iron dust on structural  
supports, February 3, 2011.

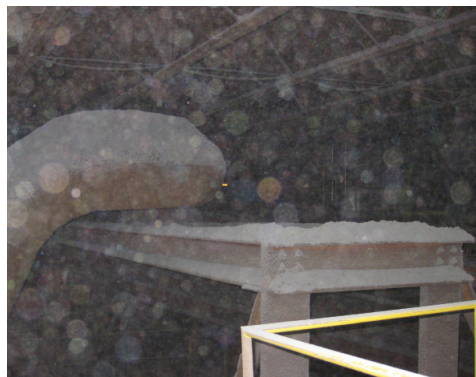
FIGURE 21

Photo of equipment obscured by airborne dust, taken by CSB investigators, February 7, 2011.
