## **Case History 02 : « Distillation »**

# The fire at **HICKSON & WELCH LTD**

A report of the investigation by the  
Health and Safety Executive into the fatal  
fire at Hickson & Welch Ltd, Castleford  
on 21 September 1992

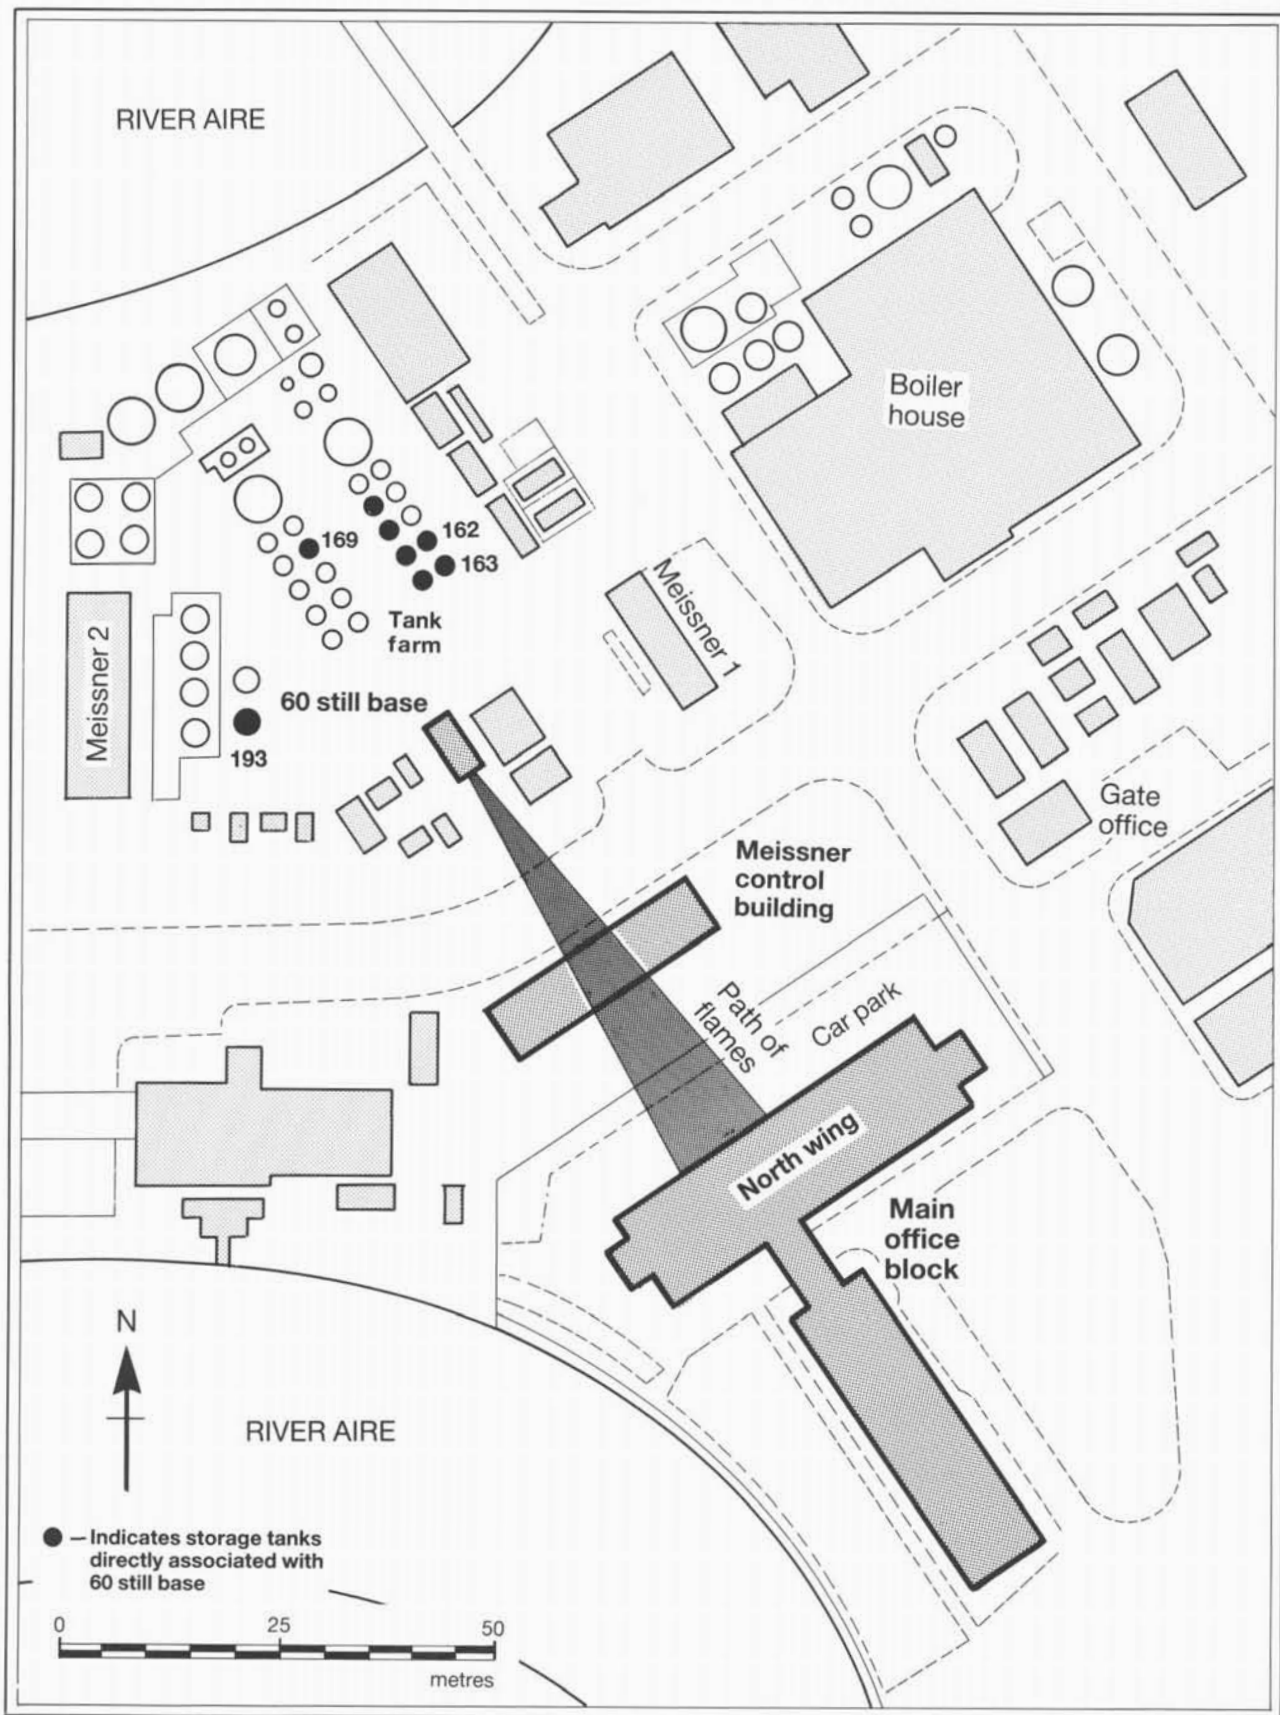
**Figure 1** Plan of area around 60 still base showing path of the jet of flame

- 44 Most of the main fire damage was roughly in a V-shape emanating from the still base to an area where the flame hit the main office block 55 m away (Figure 1). However, there was some damage to scaffolding on the adjacent vertical still, caused by the jet which came out of the rear vent. The panel room beside the still base was scorched and windows were broken (Figure 8).

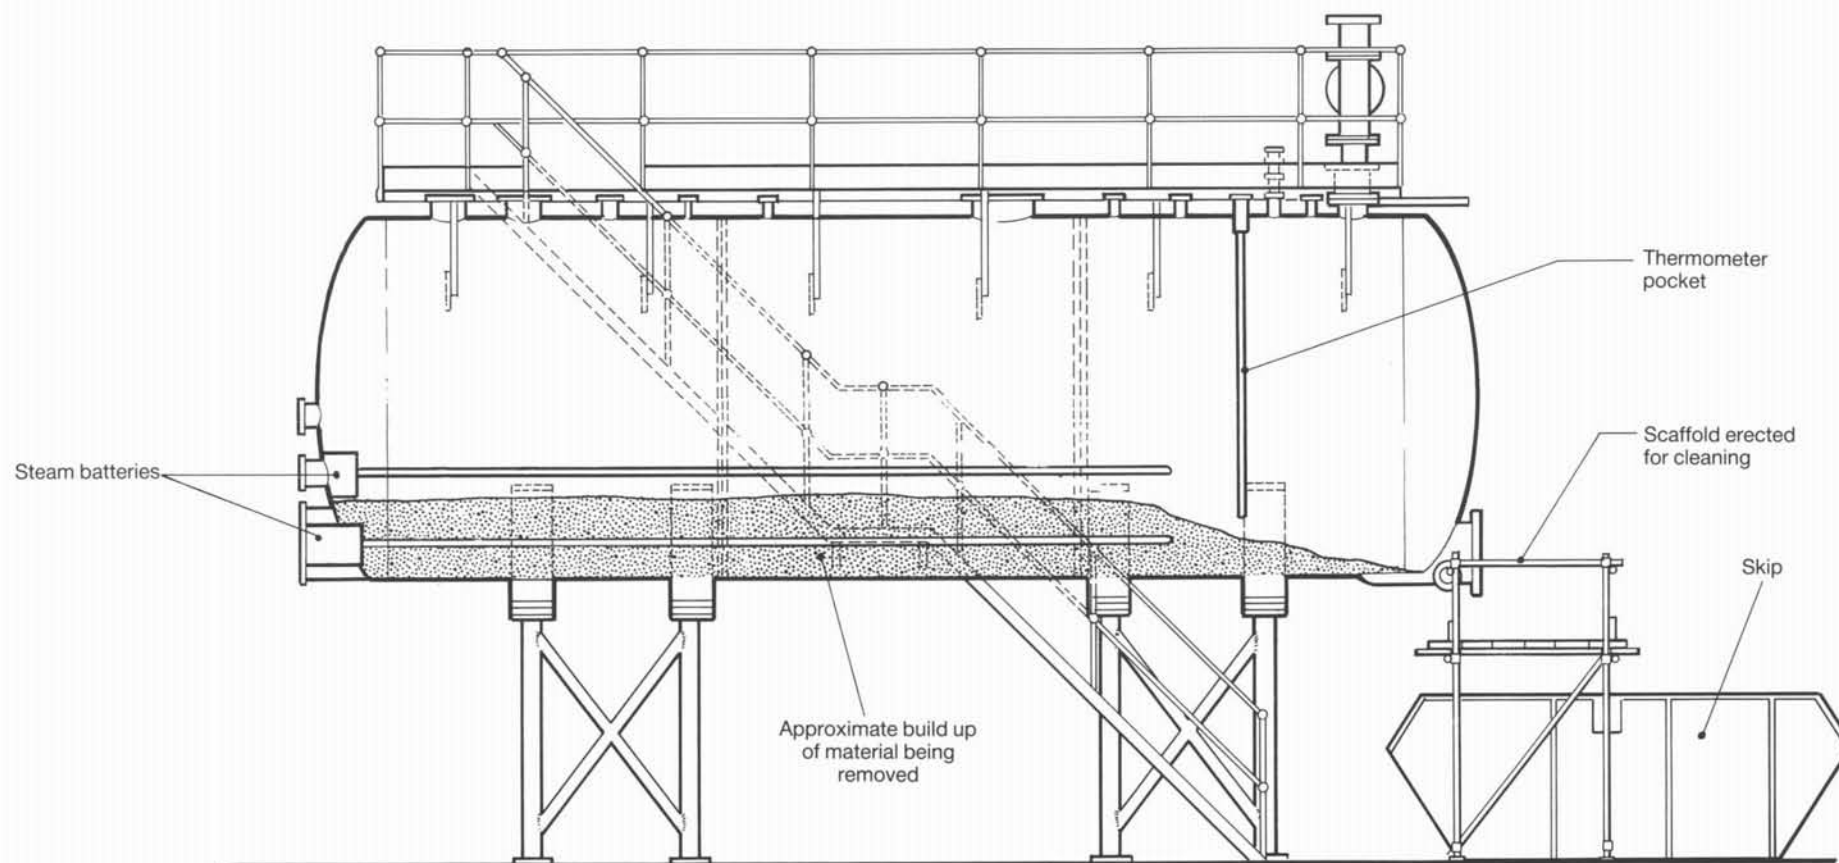
**Figure 5** Longitudinal section of 60 still base showing estimated sludge accumulation and position of the thermometer pocket

- 26 Since it was first installed in the nitrotoluenes area, in 1961, 60 still base had never been opened for cleaning. Following the process change in 1988, manufacturing problems affecting quality and production were experienced in the nitrotoluenes area. The continuous stills were stripped and cleaned to remove residues and operators working on 60 still base began to notice and reported a build up of sludge in this vessel which was slowing the rate of distillation. Various estimates were made about the depth of sludge but the general consensus was that there was as much as 1820 litres equivalent to a uniform depth of about 10 cm (4 in). A senior employee had reported a depth of 29 cm (12 in) several months before the incident and on 21 September 1992, the day of the accident, the same employee dipped the still base on the instructions of his area manager. He used a metal dipping rod and estimated that the sludge was approximately 34 cm (14 in) deep.

- 30 At 9.45 am the AM instructed that steam should be applied to the bottom battery to soften the sludge. Advice was given that the temperature inside the still base should not exceed 90°C. This was recorded by an employee on a piece of paper which was found in the Meissner panel room after the incident. However the thermometer probe was above the level in the sludge and was, in fact, recording the temperature of the atmosphere just inside the manway (Figure 5). Even if it had been in the sludge it would not have adequately monitored the temperature variation across the vessel, but might have given warning that the temperature was much higher than anticipated.

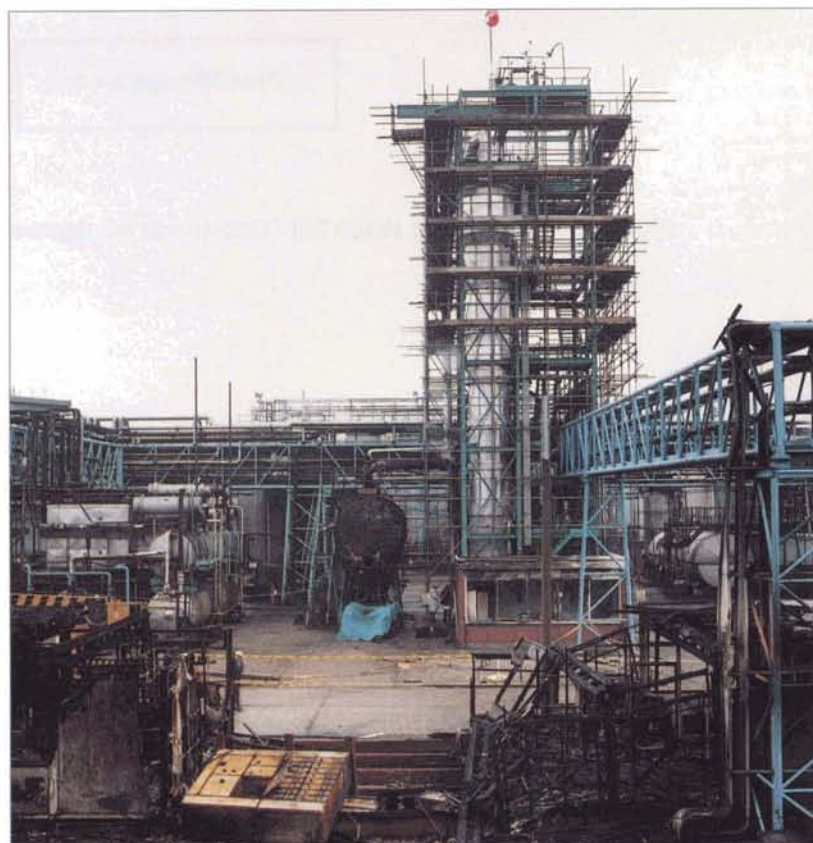
**Figure 9** Photograph of roadway and buildings showing direction of the flame and scorch marks on roadway and main office block

- 45 The central section of the lightly constructed Meissner control building took the initial impact. An area approximately 6 m wide was consumed and to either side there was extensive fire damage (Figure 9 and Appendix 2). At the rear of the centre section a metal control panel weighing 1040 kg was found on its side.

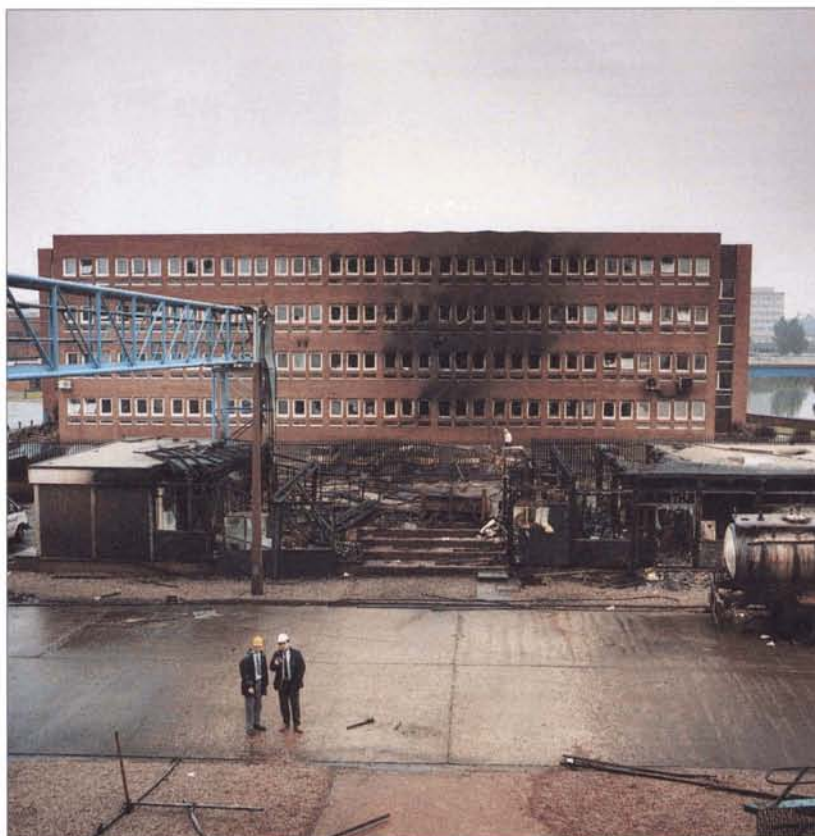
**Figure 10** Photograph of the north wing of the main office building and adjoining car park

- 46 Behind the control building a section of palisade fence was demolished and a number of vehicles in the adjoining car park were gutted.
- 47 The exterior of the north wing of the four-storey main office building was scorched (see Figure 10). Brickwork in the centre of the fire damage zone was spalled, windows shattered and their frames melted. The most severe damage extended upwards to the second floor, immediately outside the big sales office, where employees were congregating after lunch. Flame and fire spread horizontally through the north facing offices but did not penetrate to the middle corridors which linked the means of escape (Appendix 3).

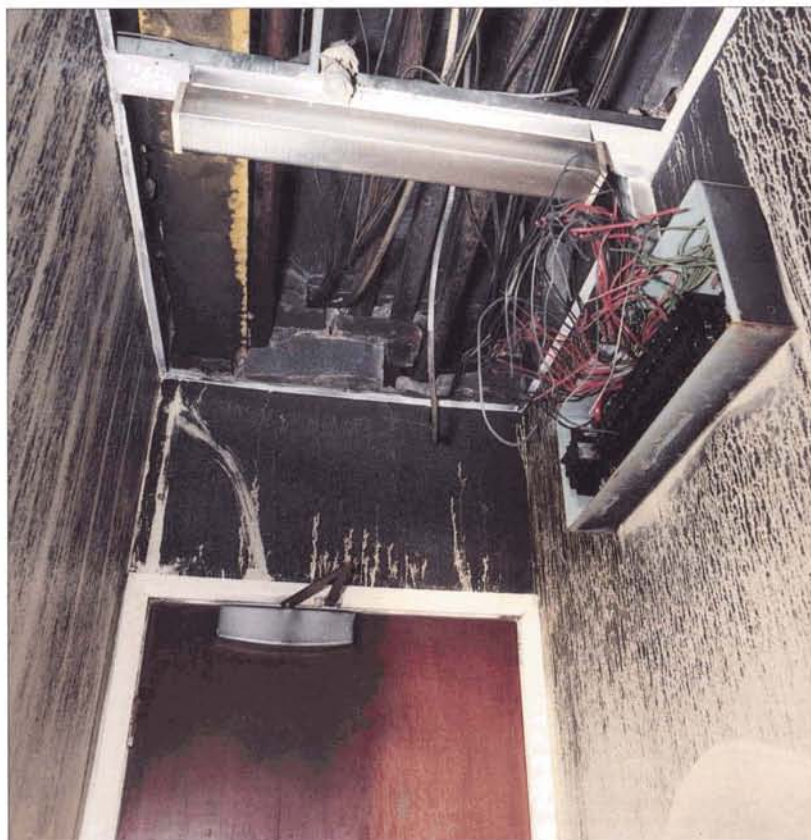
**Figure 12** Photograph showing breaches in the fire-resisting enclosure around pipework and cables

jet flame had impacted, through protected route C into the toilet accommodation. These breaches and the false ceiling provided a direct path for smoke into the women's toilet. Smoke damage in the women's toilet is shown in Figure 11 and it was here that an office worker was found. The probable direction of smoke travel is illustrated in Figure 12 and Appendix 4.

- 106 With regard to the main office building reference has previously been made to breaches in the fire-resisting enclosure defined in the relevant section of the fire certificate as protected route C (paragraph 48). Investigation failed to reveal when these holes, which are illustrated in Appendix 4 and Figures 11 and 12, were made. They may have resulted from internal alterations and could have been left following installation of a new fire alarm system in 1990. It was concluded that if the required level of integrity of the protected route had been maintained rapid ingress of smoke into this and particularly the toilet accommodation might not have occurred.
