## Case History 09: Ink dust explosion

## Ink Dust Explosion and Flash Fires in East Rutherford, New Jersey

2013-01-I-NJ

### **US Ink/Sun Chemical Corporation**

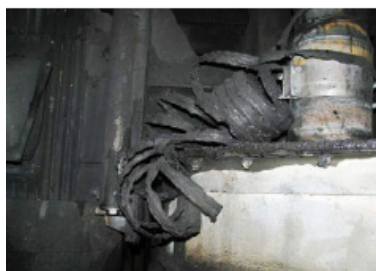
The dust collection system was not designed to handle liquids, however, vapors were drawn out of the mixers and condensed in the dust collection system. This led to the formation of sludge material which self-heated and ignited the dust clouds of Gilsonite, carbon black, and clay in the ductwork above T-306.

Burned ductwork over T-306

- Necessity to develop better system controls (such as temperature and pressure indicators) as they were not installed for operators to monitor the mixing tanks and dust collection system during start up.
- Install automatic fire alarm systems
- Develop and implement a management of organizational change protocol to allow for the transfer of knowledge and information to new personnel, at a minimum including initial or refresher training in the following: safety and health procedure, lessons learned from previous incidents, technical information for equipment and routine plant operations.
- The design of the dust collection system did not match the needs for which it was implemented.

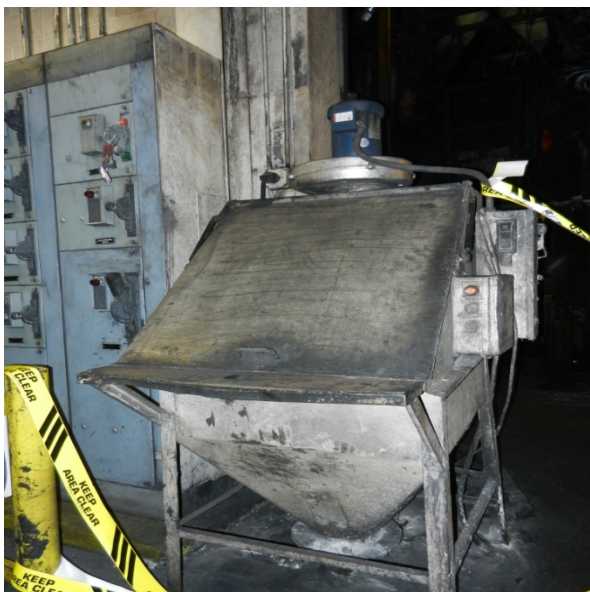
<sup>4</sup> The bag dump station was positioned in the doorway of the pre-mix room. An overhead rollup service door was installed for access to the pre-mix room. At the time of the incident, the CSB found that the rollup service door was chained into a fixed rolled-up position to provide easier entry into the room. Witness accounts from plant employees and contractors indicated that Gilsonite dust generated from the bag dumping operation often accumulated around the facility but particularly on flat surfaces. US Ink did not provide an effective means of containing fugitive dust at the bag dumping station because emptied bags were often stacked alongside the bag dump, which in turn lofted dust into the air.

**Figure 2. Bag dump station**

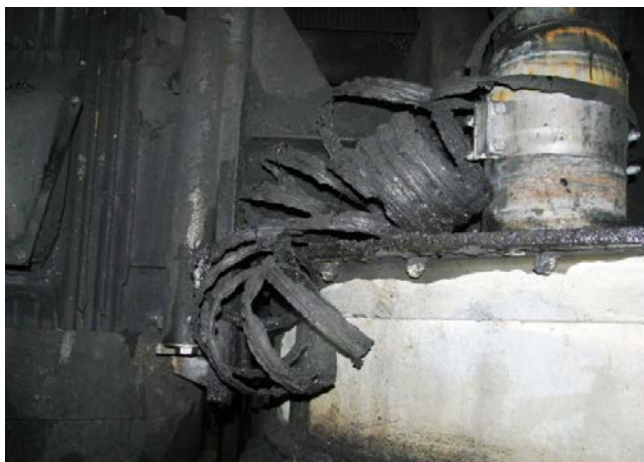
In response to the flash from the bag dump station and the subsequent loud thump, workers congregated at the entrance to the pre-mix room. Employees stated that the rubberized spiral-wound duct hose material that connected T-306 to the dust collection riser appeared to be melting and dripping onto the tank (Figure 6).

**Figure 6. Burned ductwork over T-306**

deformation, heat charring of the ductwork directly above T-306, and corroborated witness testimony all indicated that the fire originated within the ductwork of the dust collection system.

On the basis of all the test results, the CSB concluded that the incident probably started with the self-heating and spontaneous ignition of the accumulated sludge (mostly Gilsonite and carbon black mixed with hydrocarbon oils) in the ductwork of the dust collection system. Transport of the burning sludge to the dust collector caused the dust collection explosion. The explosibility of the accumulated sludge and powder deposits in various sections of the duct combined with the flame propagation back from the dust collector explosion to cause more extensive residual burning in the various duct sections. Dust deposits in and around the ducting, including deposits produced from the dust collector explosion, dispersed as the US Ink employee climbed the stairs,<sup>51</sup> intending to suppress the visible flame in the detached flexible duct above Tank 306. The residual flame ignited the dispersed dust, and the subsequent fireball dislodged and lifted more dust so that an expanding fireball vented through the doorway into the corridor. This expanding fireball (or flash fire) was responsible for the multiple burn injuries.

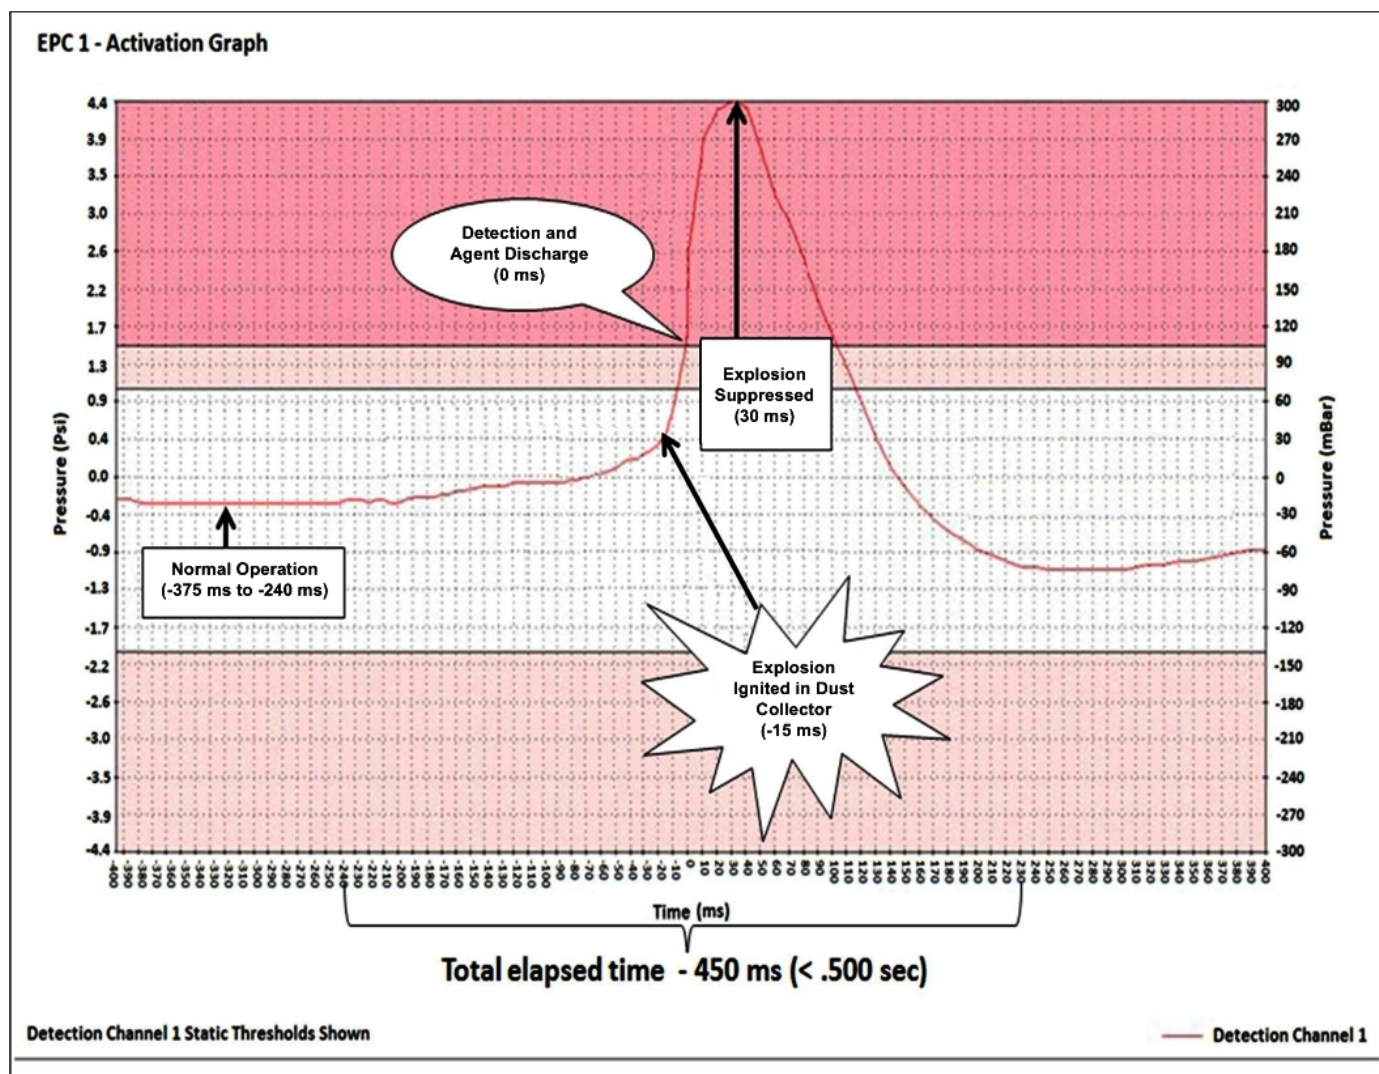
Although the ignition led to a dust explosion within the dust collector, the pressure rise activated the Fike explosion suppression system, which prevented the structural failure of the dust collector.<sup>36</sup> The pressurized discharge of the explosion suppression canister caused the thumping sound that employees heard coming from outside the building. At the same time, the ignition at the dust collector and discharge of the 5-liter suppression and 9-liter isolation canisters created a pressure spike of 4.4 pounds per square inch gauge (psig) in the dust collector and caused the flame front to propagate counter-current toward the mixing tanks. This rapid pressure rise (and the associated rapid flame propagation back through the ducting) triggered an initial flash fire at the bag dump station and within the rubberized ducts above T-306 (where the second and more volatile flash fire occurred). After the incident, the CSB learned that the design total suppression pressure (maximum design pressure for suppressed explosion) predicted for the dust collector was 3.8 psig. The increase in the total suppression pressure occurred because of the higher rate of pressure rise of the dust mixture compared to the expected design  $K_{ST}$  of 165 bar-meters per second (bar-m/sec).<sup>37</sup>

Figure 7. Annotated Fike system pressure plot<sup>39</sup>

but the  $K_{ST}$  values for the two Gilsonite dust samples were more than 165 bar-m/sec (Table 3). The low MIE and higher  $K_{ST}$  values indicate that Gilsonite is a faster-burning dust that represents both a greater susceptibility to deflagration and a more demanding explosion protection system challenge than the specified  $K_{ST}$  value of 165 bar-m/s.

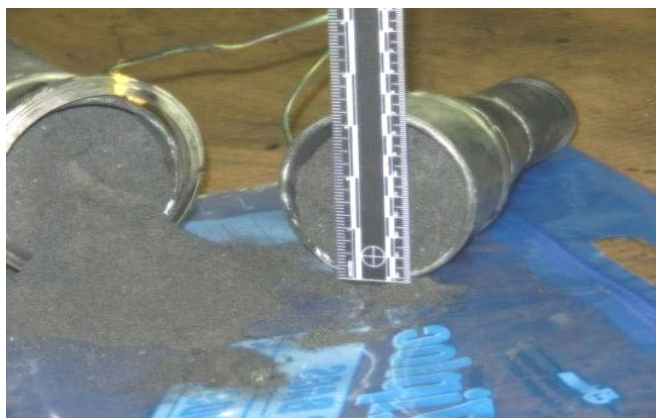
The 3-inch ducts were disassembled during the investigation; they were plugged with free-flowing dust, a sign of insufficient conveying velocity (as illustrated in Figure 9). The connection of housekeeping hoses to a dust collection system is not a good practice because the pressure drop required to move air at 4,000 feet per minute (ft/min) in the 1.5-inch hose (1.5 to 2.0 inches of mercury or 20 to 27 inches of water column) is much greater than the available system static pressure of 17 inches of water column. In addition, doubling the duct diameter reduced the air velocity to less than 25 percent of that available in the hose, plugging the 3-inch duct in less than 2 days of operation.

**Figure 9. Vacuum cleaning ducts, plugged after less than 2 days of operation**
