## Case History 13: BP America Refinery explosion

U.S. CHEMICAL SAFETY AND HAZARD INVESTIGATION BOARD

(15 Killed, 180 Injured)

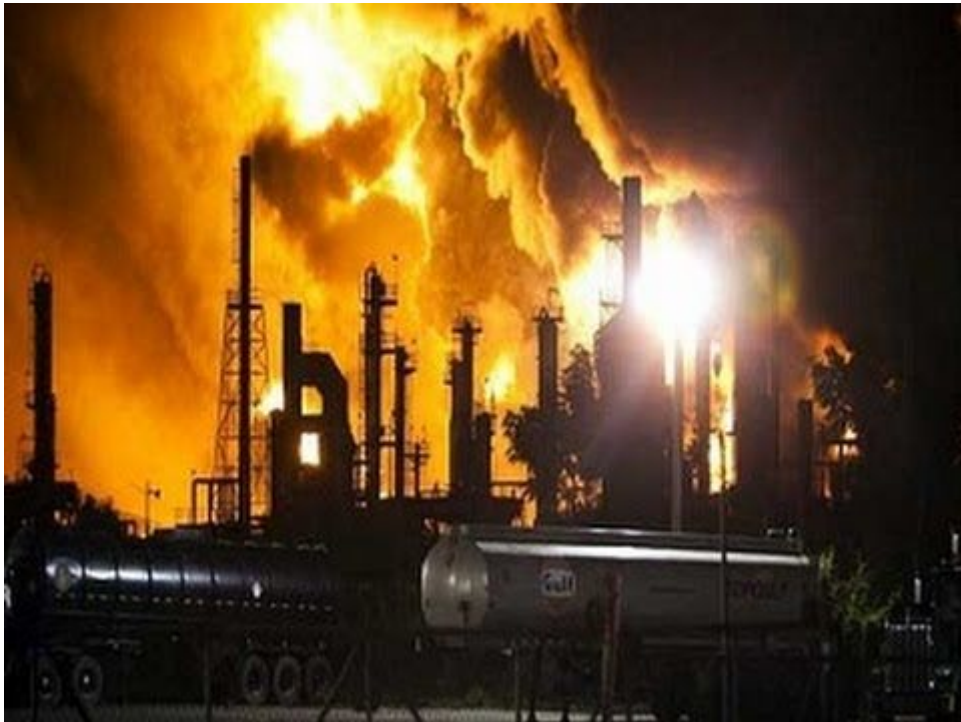
BP Texas refinery after the explosion

1. Evaluate the refinery process units to ensure critical process equipment is safely designed.
2. Ensure that process startup procedures are updated and reflect the actual process conditions.
3. Have knowledgeable supervisors or technically trained personnel to be present during especially hazardous operation.
4. Develop a fatigue prevention guideline for the refining and petrochemical industries by limiting hours and days of work and proper shift work.
5. Establish and implement an integrated and comprehensive process safety management system that systematically and continuously identifies, reduces, and manages process safety risks.

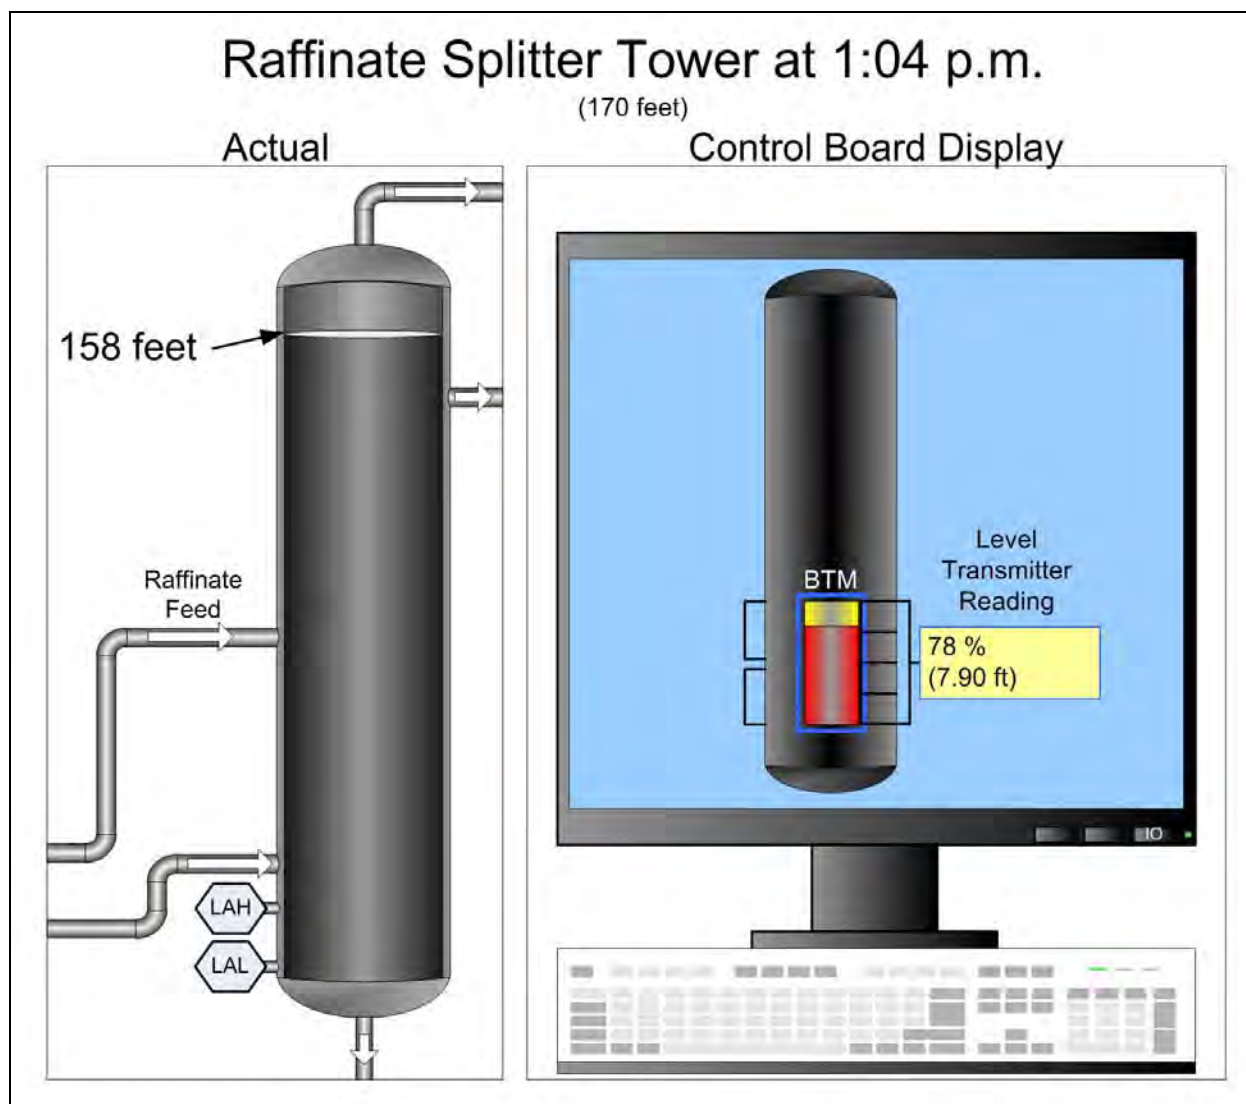
Figure 6. At 1:04 p.m. the liquid level in the tower was 158 feet (48 m), but the computerized control system indicated to operators that the level was at 78 percent of the level transmitter (7.9 feet, or 2.4 m, of liquid in the tower).

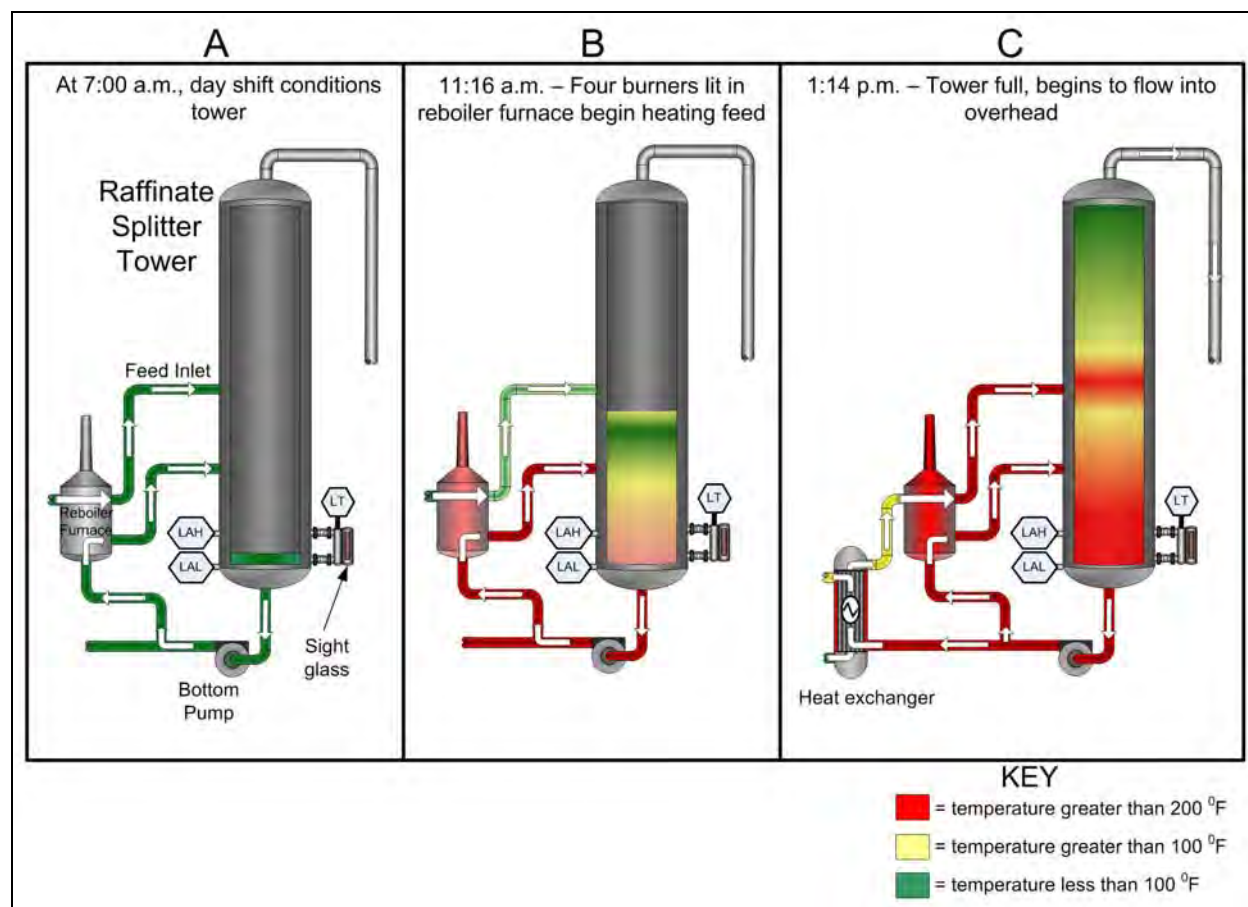
Figure 7. Heating of feed in the splitter tower

At 1:14 p.m., sub-cooled<sup>43</sup> hydrocarbon liquid flowed out of the top of the raffinate splitter tower and into the vertical overhead vapor line, due to overfilling and rapid heating of the column (Figure 7).

Heating from the furnace had created a temperature profile in the raffinate splitter column, such that cold liquid was on top and hot liquid was in the lower section (Figure 7B). Bubbles of hot vapor rising through the column contacted the overlying cold liquid, rapidly condensing the vapor and heating the liquid. At the time of the incident, the resulting hot liquid reached nearly to the level of the feed inlet. Hot liquid

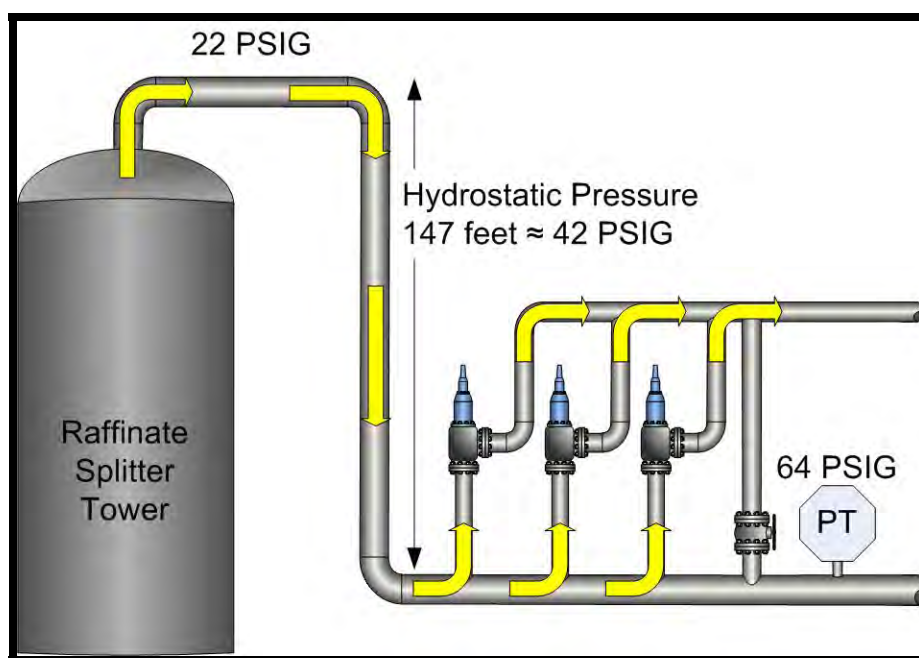
Figure 8. Hydrostatic head of liquid in overhead piping leads to the three relief valves opening

The minimum closing (blowdown) pressure for the three safety relief valves to stop flowing was 37.2 psig (256.5 kPa). Computerized control system data indicate that all three safety relief valves were fully open and flowing at capacity for slightly longer than six minutes. An average pressure of 61 psig (421 kPa) at

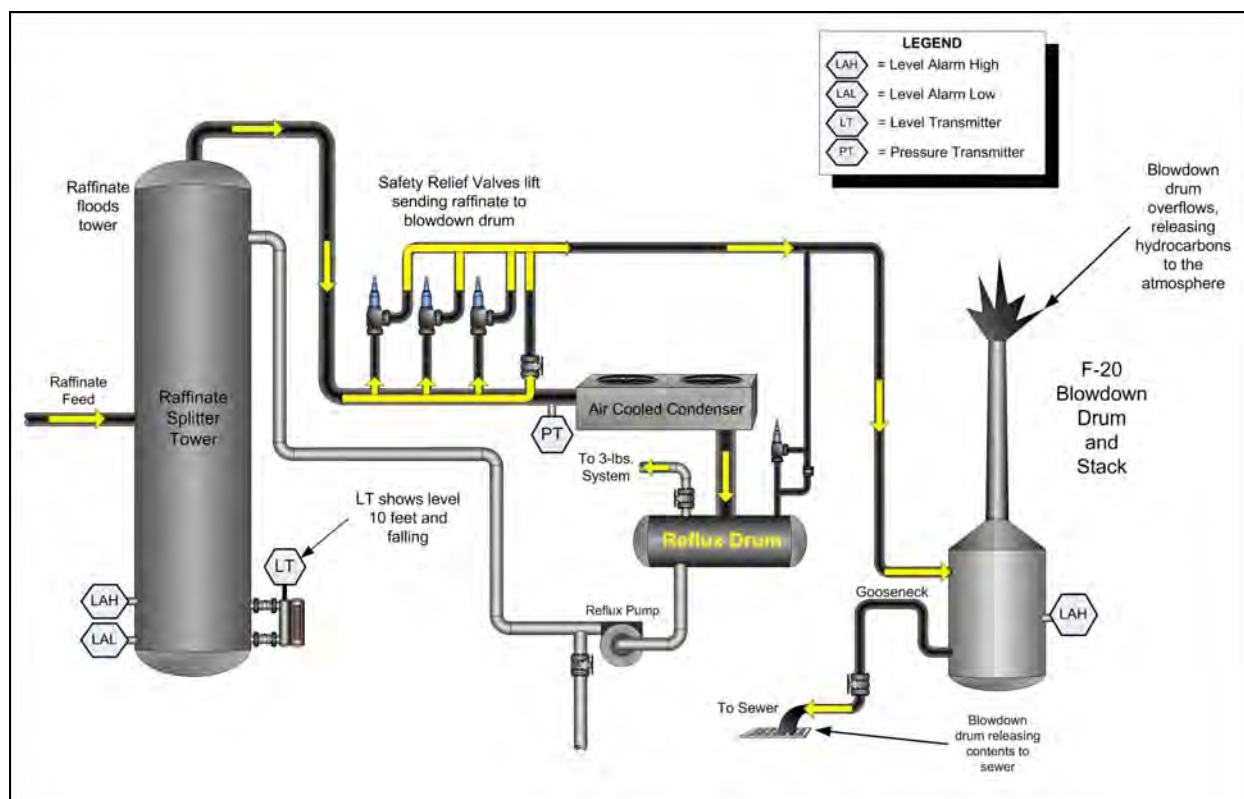
Figure 9. Tower overfills and blowdown drum releases hydrocarbons

Once the blowdown system filled, flammable liquid discharged to the atmosphere from its stack as a geyser and fell to the ground (Figure 9). Shortly after the ISOM operators began troubleshooting the pressure spike, they received, via radio, the first notification that the blowdown drum was overflowing. In response to the radio message, the Board Operator and Lead Operator used the computerized control system to shut the flow of fuel to the heater, while the other operators left the satellite control room and ran toward an adjacent road, Avenue F, to re-direct traffic away from the blowdown drum, as required by BP's "Emergency Response Procedure A-7."

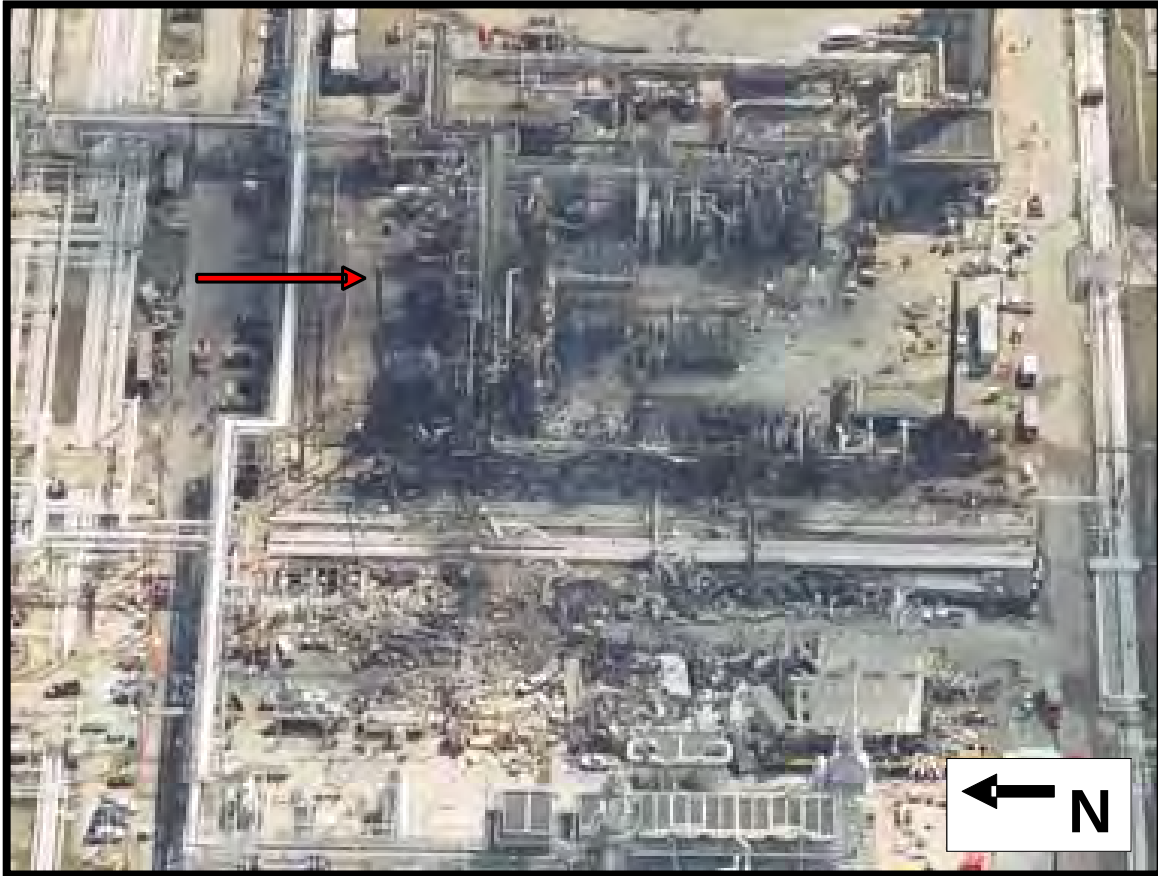
Figure 10. The darkened areas in and around the ISOM unit had the heaviest fire damage; the red arrow points to the top of the blowdown stack

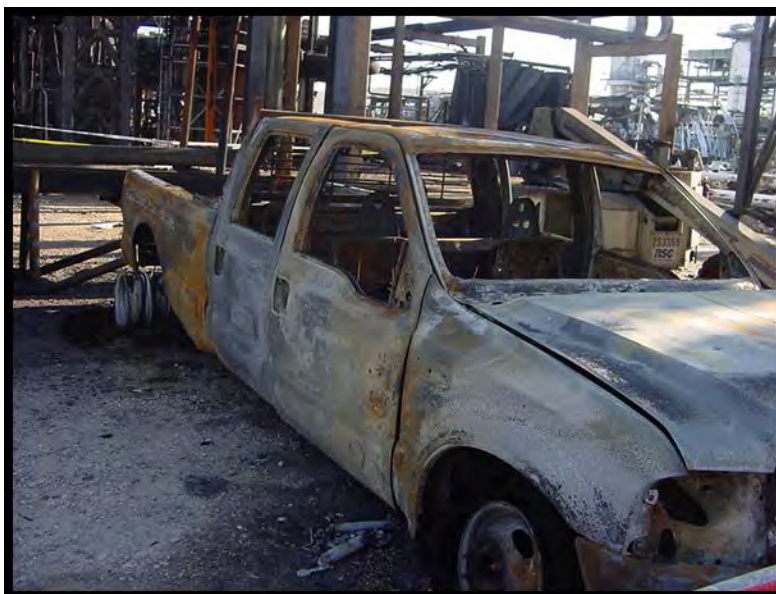
Although several potential ignition sources (Appendix H.16) were identified, the most likely ignition point was an idling diesel pickup truck (Figure 11). This truck was parked about 25 feet (7.6 m) from the blowdown drum, and several eyewitnesses reported seeing or hearing the truck's engine over-revving when the vapor cloud reached it.

Figure 11. Idling diesel pickup truck at north end of ISOM unit

Two eyewitnesses saw the truck catch fire, followed shortly by the vapor cloud explosion. One eyewitness saw sparks leaving the truck after a backfire and igniting the vapor cloud. While the diesel pickup has been positively identified by witnesses as an ignition point, this does not preclude the potential that the cloud was additionally ignited by other sources.

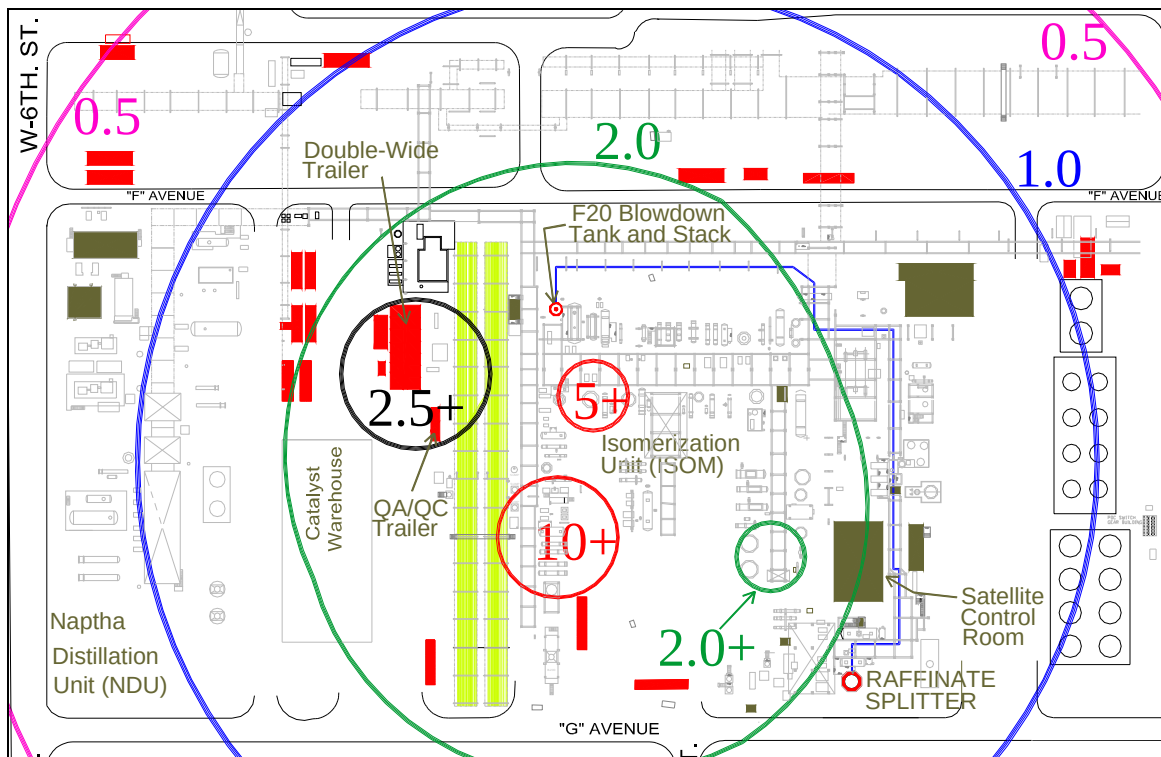
congestion/confinement and flammable mix allowed, greatly intensifying the blast pressure in certain areas. These intense pressure regions, or sub-explosions, produced heavy structural damage locally and left a pattern of structural deformation away from the blast center in all directions. A computer simulation<sup>49</sup> and a blast overpressure map (Figure 12) were developed based on site observations, structural analysis, and blast modeling (Appendix H).

Figure 12. Blast overpressure map depicting the areas of highest blast pressure (10+, 5+, and 2.5+ psi)

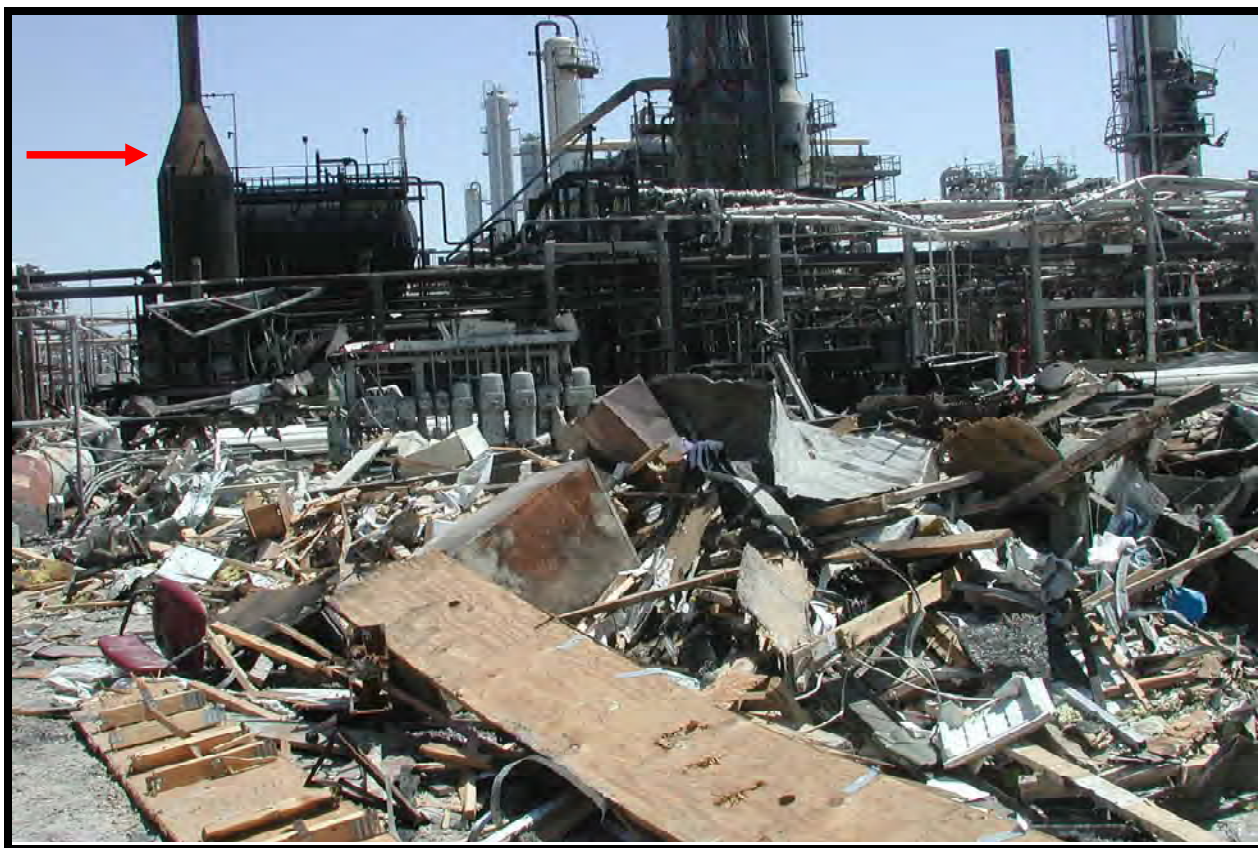
Many of the approximately 70 vehicles in the vicinity of the ISOM unit were damaged and a number were destroyed. More than 40 trailers were damaged; 13 were destroyed. On June 30, 2006, the CSB released a detailed analysis of the trailer damage, which can be viewed or downloaded from the CSB website, [www.csb.gov](http://www.csb.gov).

Figure 13. Destroyed trailers west of the blowdown drum (red arrow in upper left of the figure)

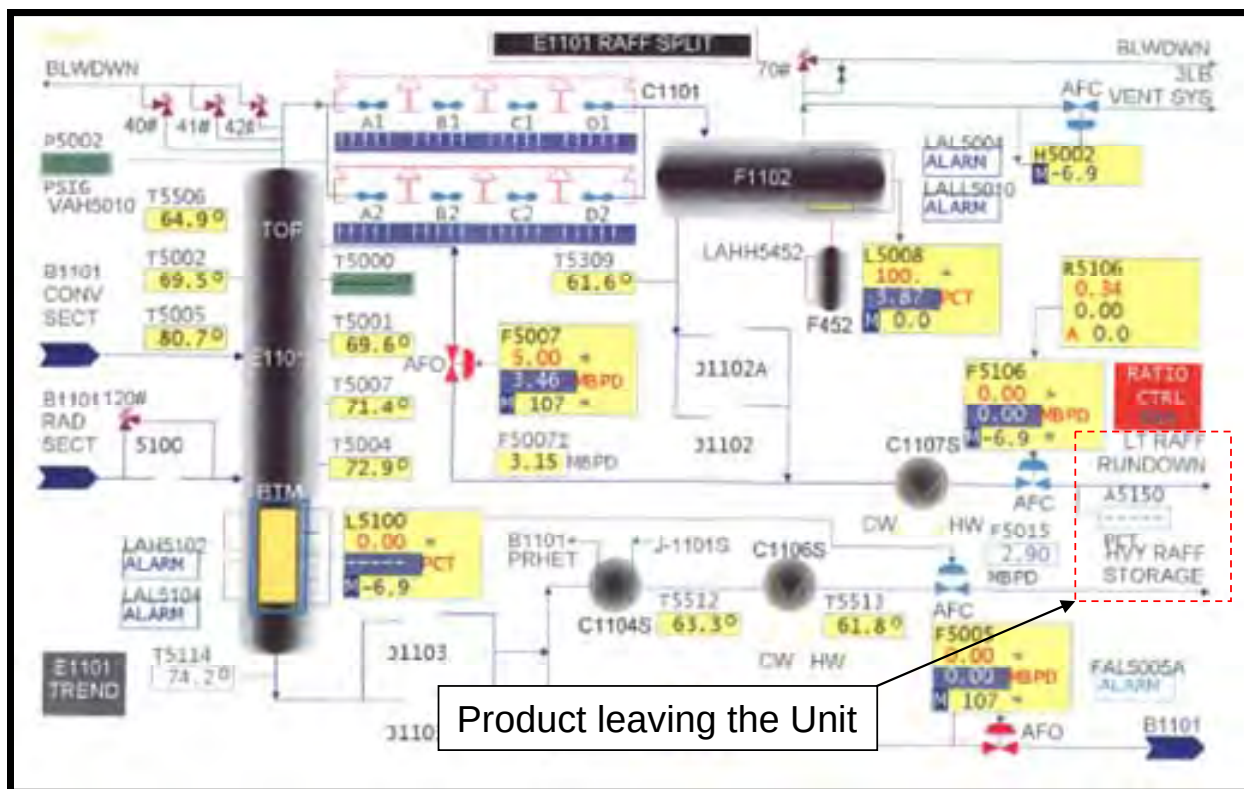
Figure 14. The Board Operator viewed this screen, which provides information on raffinate product leaving the unit but not the liquid being added to the unit.

A poorly designed computerized control system display was found to be a cause in another major incident, the 1994 [explosions and fire at a Texaco plant in Milford Haven](#), in the United Kingdom. The control system did not calculate the material balance of the system and the operators did not know how to make such calculations. The computerized control system was also configured to display only portions of the unit in discrete detailed sections, and did not allow for a complete overview of the process, just like the control system screens for the Texas City ISOM unit. The U.K. Health and Safety Executive<sup>83</sup> recommended that computerized control systems include a process overview and, as appropriate, material balance summaries to ensure full process oversight by operators (HSE, 1997).

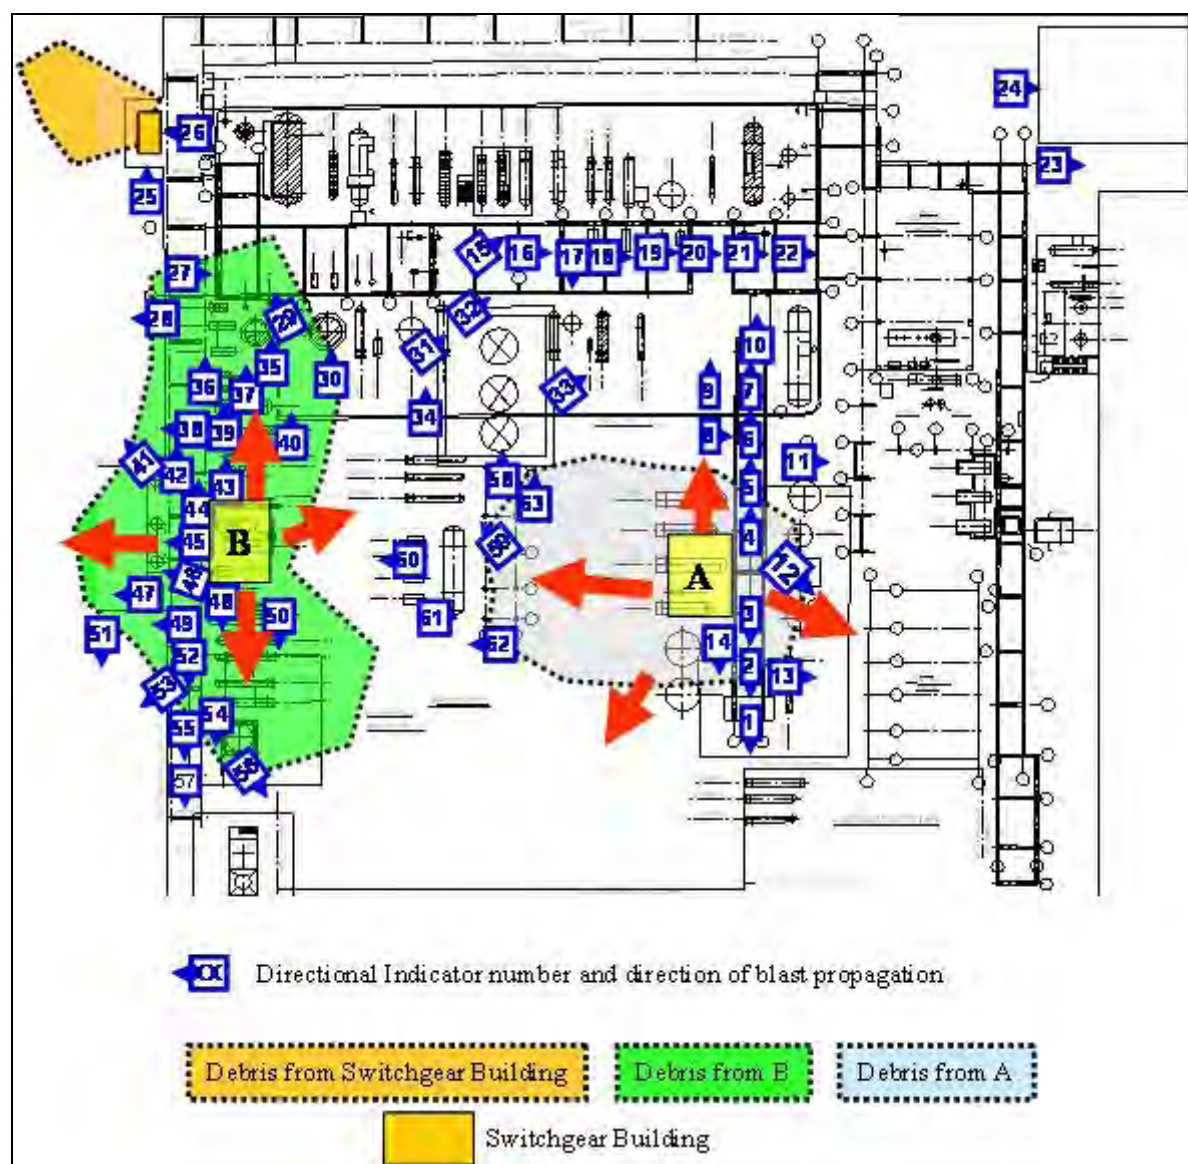
- Areas surrounding the intense pressure regions in the ISOM unit, including the satellite control building, experienced 5 psi and greater overpressures.
- The catalyst warehouse and the six temporary trailers sited directly north of it experienced approximately 2 to 2.5 psi overpressure.
- The east edge of the NDU, first layer of storage tanks south of Ave. G, and the south edge of the ULC unit experienced about 1 psi overpressure.
- The west edge of the NDU, second layer of tanks south of Ave. G, the south portions of ULC and ARU units, and the western edge of the ARU unit experienced 0.5 psi and greater overpressures.
- Five ULC turnaround trailers sited west of Sixth Street; the remainder of ULC and ARU units, and storage tanks farther south experienced 0.25 psi and greater overpressures.

Figure H- 1. Intense blast regions in the ISOM unit

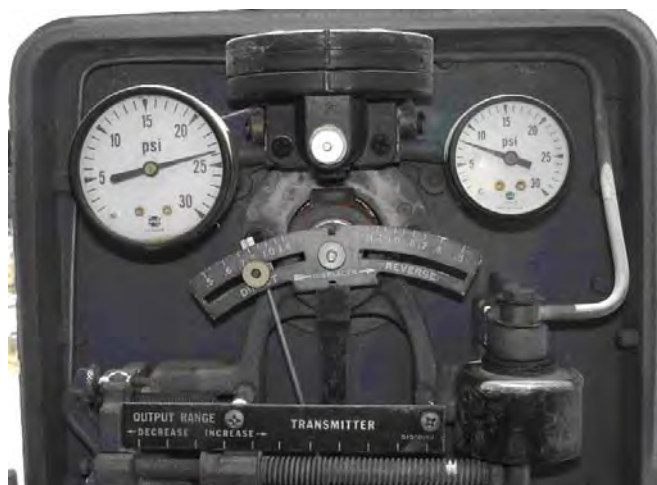
Figure S- 3. LT-5100 cabinet showing calibration set for 0.8 specific gravity

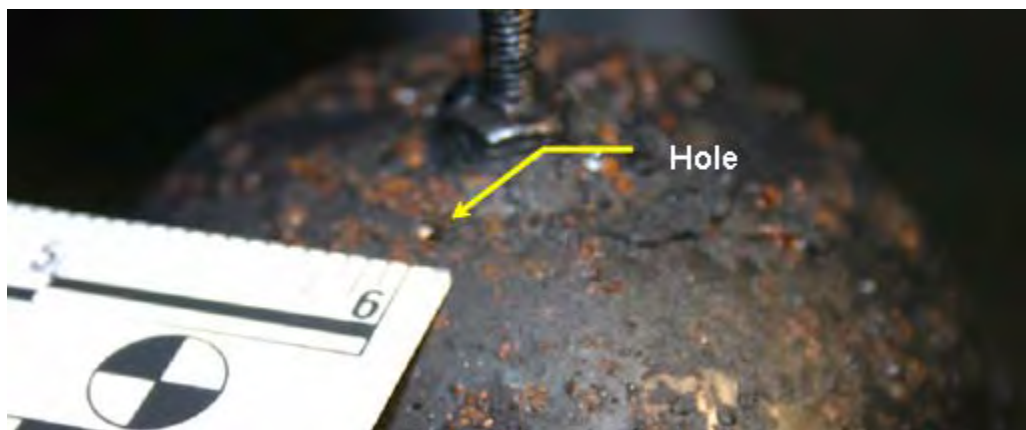
Figure S- 6. Close-up of LSH-5020 float, showing corrosion and hole
