Year of construction: 1924	Intervention:
----------------------------	---------------

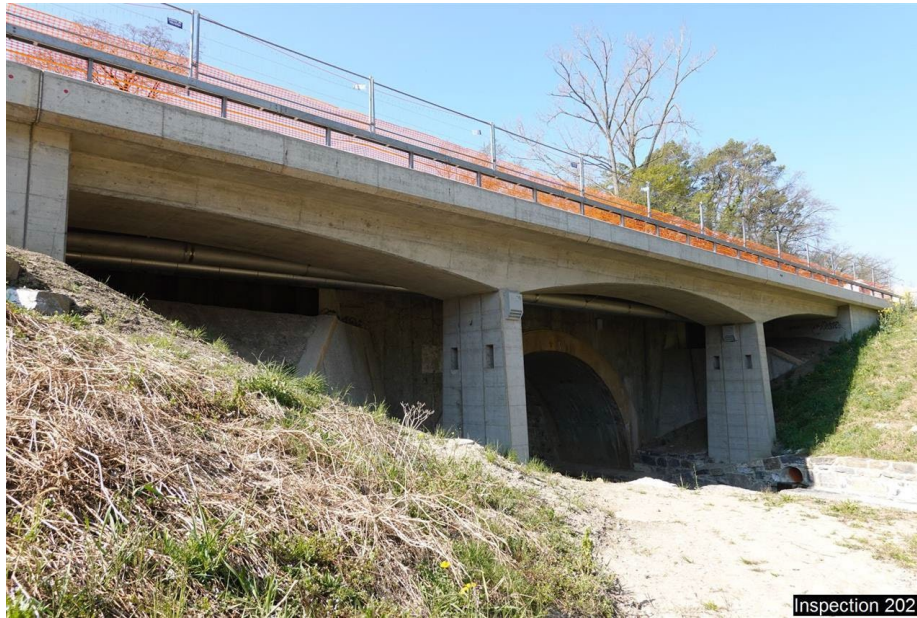
<b>Info. Additional :</b>	
Total length:	36.80 m
Total width:	17.50 m
Total surface area:	644.00 m <sup>2</sup>
Usable roadway width :	7.80 m
Historic monument :	
<input checked="" type="checkbox"/> yes	<input type="checkbox"/> no
Waterproofing of bearing slab :	
<input checked="" type="checkbox"/> yes	<input type="checkbox"/> no

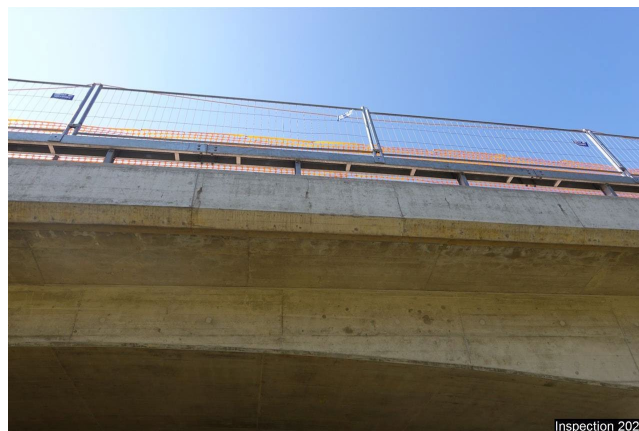
BoDr Right Edge  
1216 other cracks  
Scattered along the entire edge. Shrinkage crack.

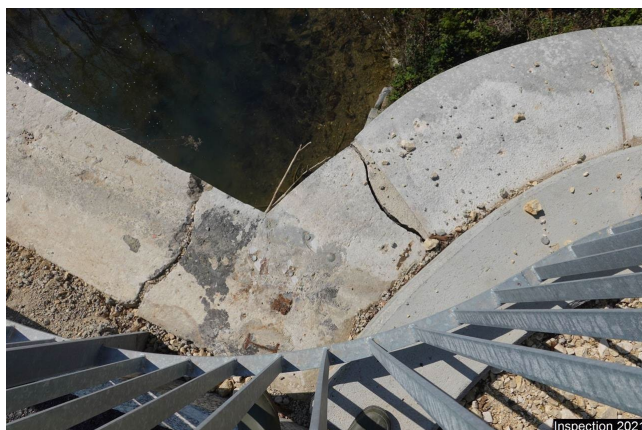
BoGa Left Edge  
1216 other cracks  
On the head of the old border. Various cracks and chips.

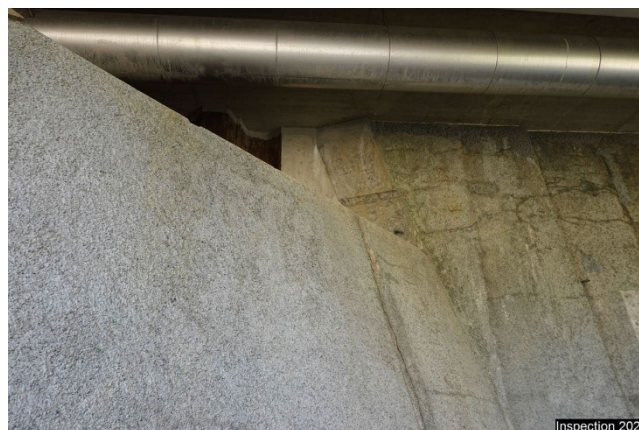
CuDr0 Right wing wall axis 0  
1209 Joint cracks  
Vertical joint. Crack in plaster mortar.

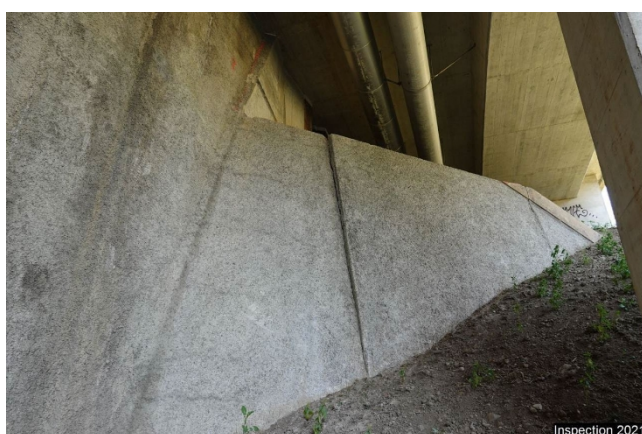
CuDr1 Right wing wall axis 1  
1209 Joint cracks  
Vertical joint. Crack in plaster mortar.

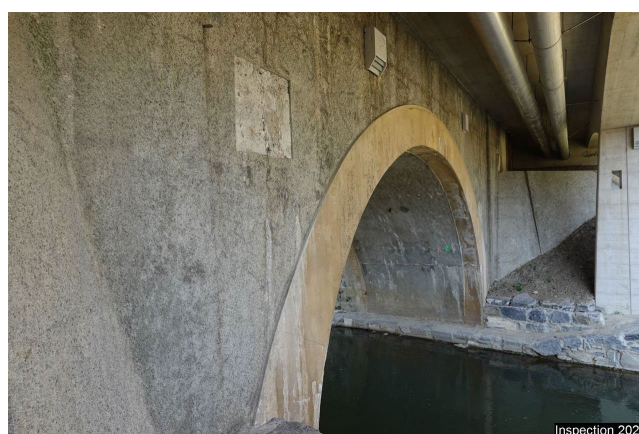
MuDr Tympanum right side  
301 Wetlands  
In various places. Old traces.

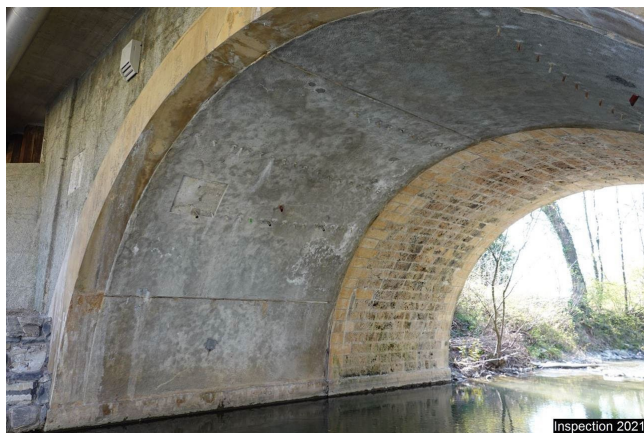
**Pd0 Pedestal**  
1210 Longitudinal cracks  
Internal face. Slight cracking of the visible surface with old limestone.

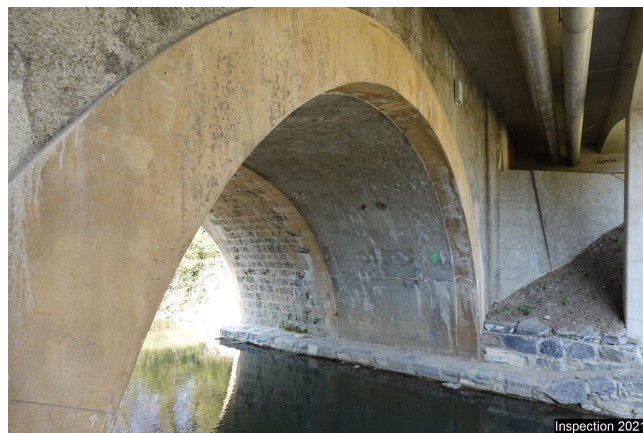
**Pd1 Pedestal**  
301 Wetlands  
Internal face. Slight cracking of the visible surface with old limestone.

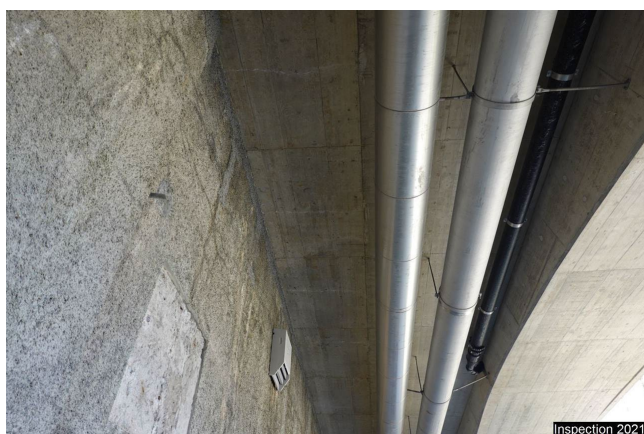
**TaDr Apron Right**  
1216 other cracks  
Intrados. Shrinkage cracks with calcareous occurrences.

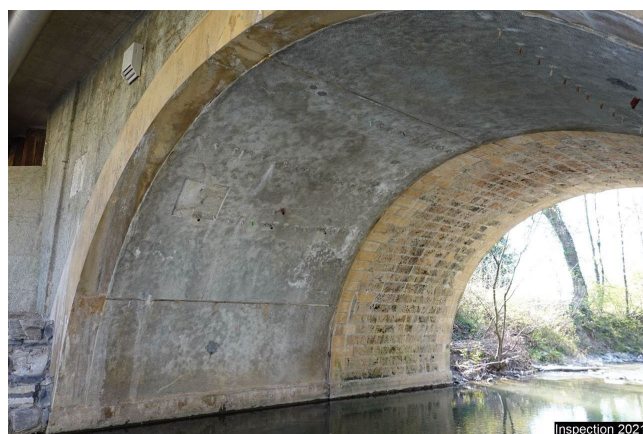
**VoDr Voûte Droite**  
301 Wetlands  
Distributed over the entire element. Slight surface cracking visible with old calcareous deposits.

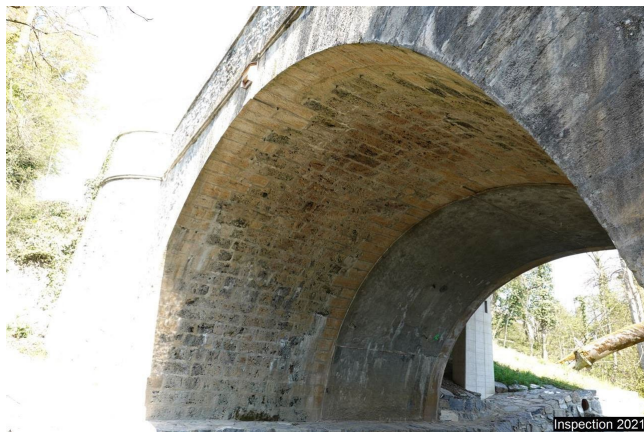
**VoGa Voûte Gauche**  
301 Wetlands  
Distributed over the entire inner surface. Ancient limestone sources.
