## ICOLD 2022 May 31, visit at Malpasset

Some illustrations prepared by B. Goguel, from references available in the CFBR paper, and 2018 talks with Pierre Duffaut.

Rev g : 06.06.2022

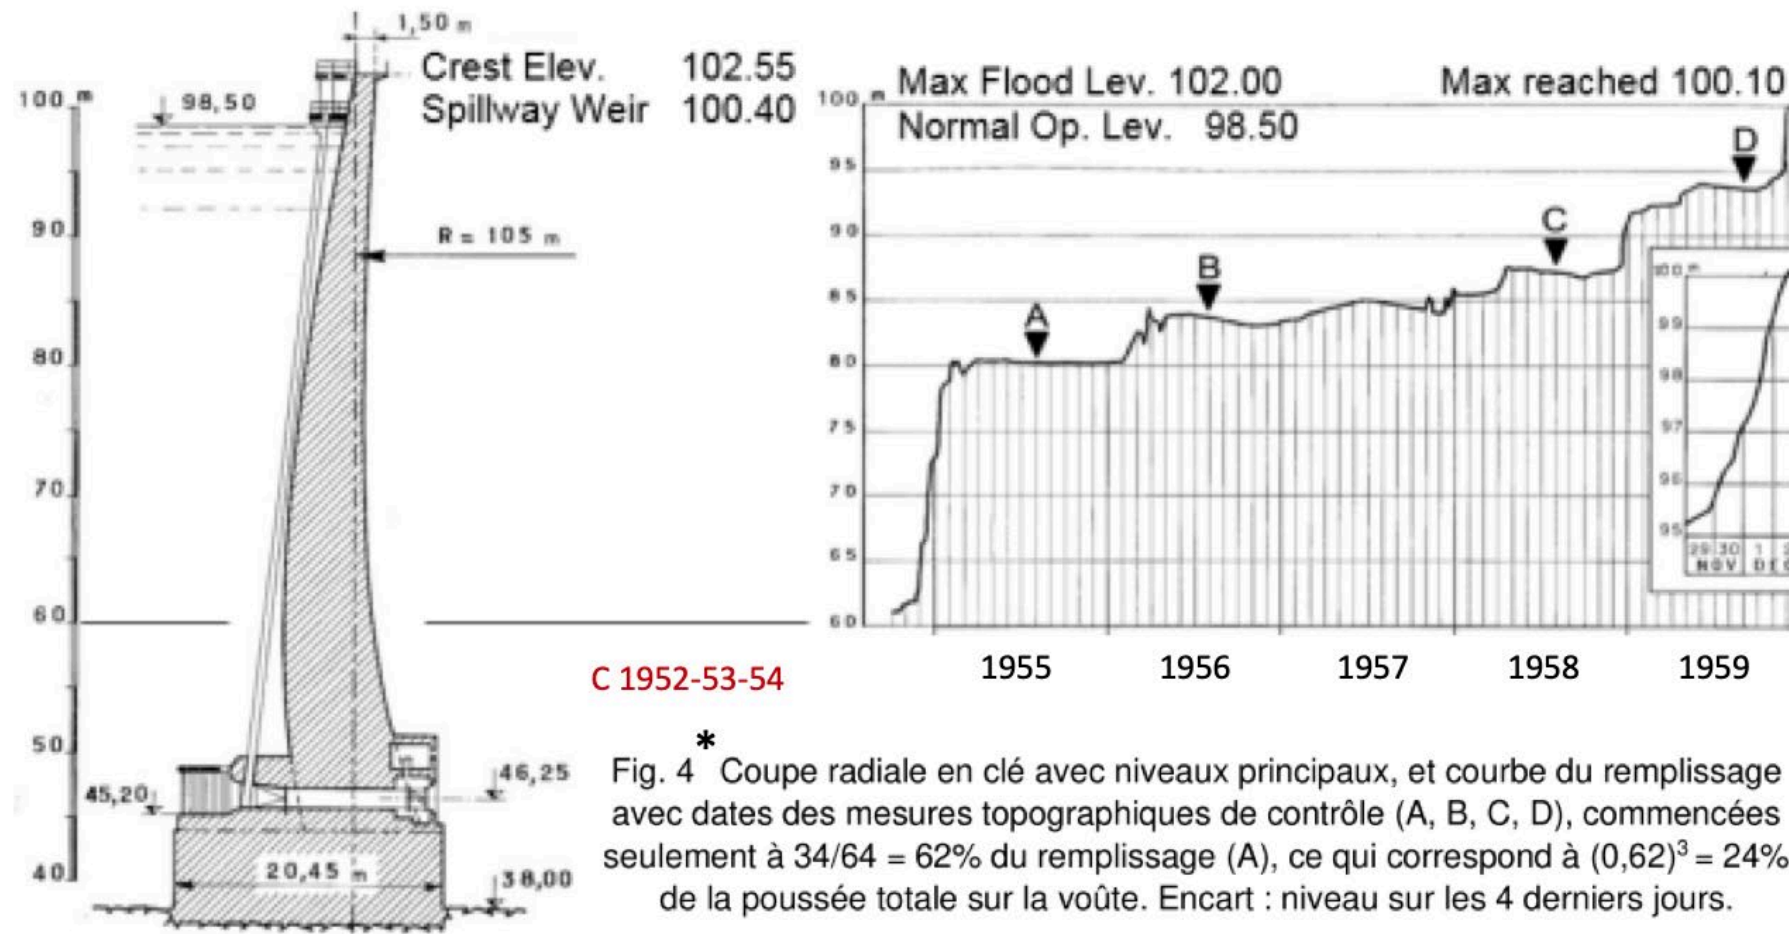
## Block UJ radial section

\*  
Fig. 4 Coupe radiale en clé avec niveaux principaux, et courbe du remplissage avec dates des mesures topographiques de contrôle (A, B, C, D), commencées seulement à 34/64 = 62% du remplissage (A), ce qui correspond à  $(0,62)^3 = 24\%$  de la poussée totale sur la voûte. Encart : niveau sur les 4 derniers jours.

*Crown section with main levels, and impounding graph. Geodetic measurements (A, B, C, D) started at 34/64 = 62% of impounding, which corresponds to  $(0.62)^3 = 24\%$  of the total thrust on the dam. Box : 4 last days of reservoir rise.*

Fig. 2 : radial section on the outlet gate (block IJ), and reservoir impounding at *same vertical scale*

Fig. 2 : coupe radiale sur la vidange de fond (plot IJ), et remplissage à la même échelle verticale.

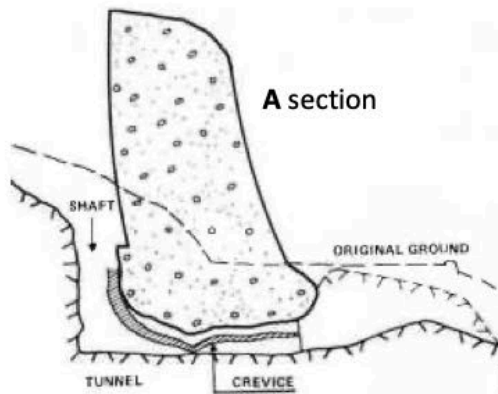
1962 exploration under Block FG  
in the lower Right Bank

L/B investigation adit :  
was excavated in **spring 1960**,  
*after the failure*  
Photo Joseph Duffaut May 1960

Post-failure investigations : 1960 L/B gallery, and 1962 lower R/B gallery below block FG

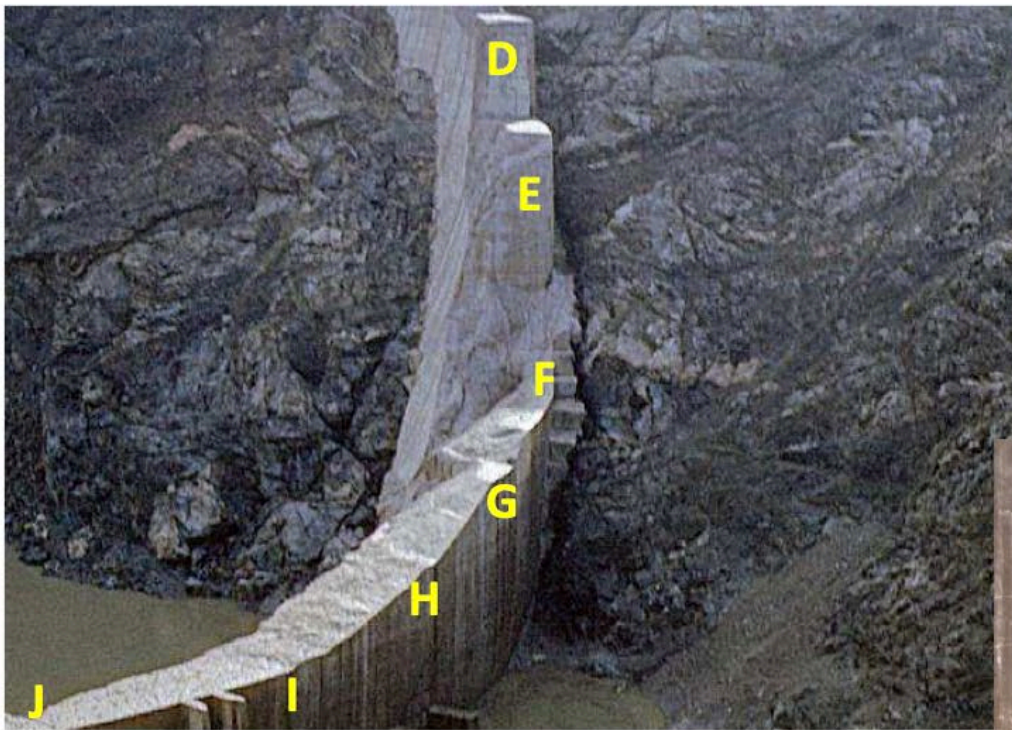
**Right Bank U/S crack**  
**<= 1959**

Fig. 5 : Right Bank upstream side, where a large open vertical crack resulted from the general Rotation, as evidenced by the topographic survey of the remains displacements : rotation like a solid body (+ additional movement of the upper L/B overloaded Thrust Block).

Fig. 5 : amont rive droite : fissure verticale largement ouverte, résultant de la *rotation en bloc du barrage, autour de son extrémité rive droite*, avant sa complète dislocation. Un déplacement additionnel de la culée atteste de sa surcharge après l'amputation des arcs inférieurs.

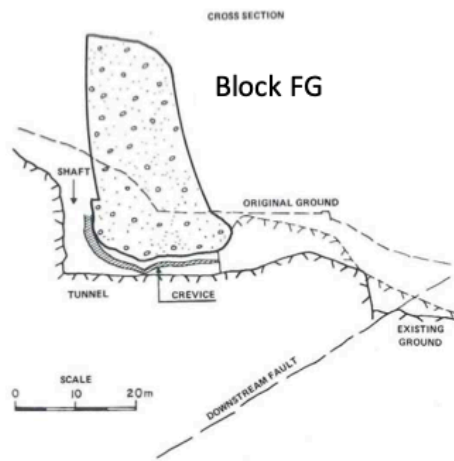
Fig.6. Investigations beneath the dam.

During summer of year **1962**, river being dry, an investigation shaft was excavated in the u/s crack at mid length of Block FG ; and extended below that block for inspecting the sheared cracked open rock. This enlarged the passage for the river, which is transporting sands and gravels and could over the years excavate a larger tunnel : found in 2014 extending over more than one block width. The lower part of FG Block was at that time already 5 cm down. **It felt by 2-3 m end of 2019.**

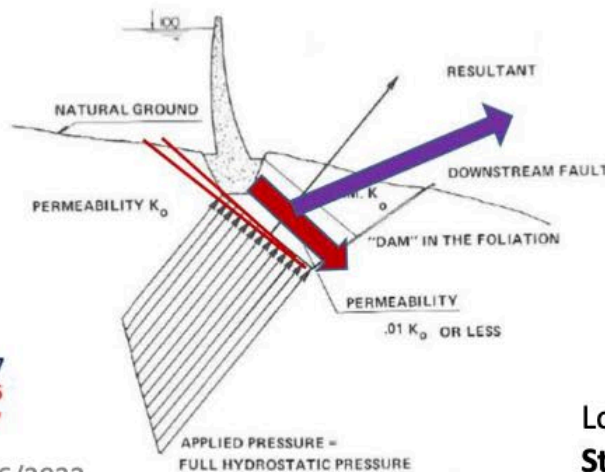
Fig.11. Water pressure on the "underground dam".

**Uplift at depth in the foundation** was a major explanatory factor of Malpasset left abutment failure ; combined with the downstream fault, with the gneiss permeability sensitivity to stress (having created an underground impervious dam, adversely located without any drainage), and with the rock mass excessive deformability (low elasticity modulus).

**La sous-pression en profondeur dans le massif rocheux d'appui** a été un facteur explicatif majeur de la rupture ; combinée avec la présence de la faille aval, avec la sensibilité particulière du gneiss local à la contrainte (ayant créé un barrage souterrain étanche, mal placé en l'absence de drainage), et avec la déformabilité excessive (trop faible module) du massif rocheux.

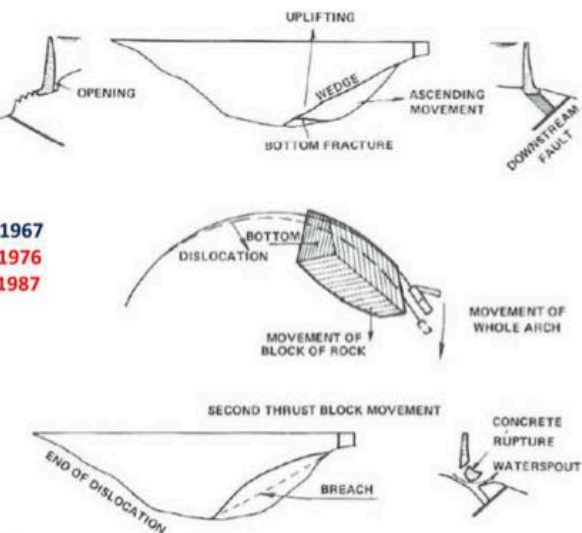
Fig. 8 - Schematic representation of the "explosive" failure phase

- 1 Water enters the upstream fissure
- 2 The dihedron is pushed higher and downstream
- 3 The thrust block receives the whole arch thrust
- 4 It cannot bear it and gives ?
- 5-6 Deprived of arch effect, monoliths break in flexion

Fig. 11 : Proposed failure mechanisms, and main lesson : grouting and drainage layout.

## MAIN LESSON : grouting and **DRAINAGE** layout
