| General Directorate of<br>Mobility and Roads | <b>Bridge inspection<br/>report</b> | | <b>Main inspection</b> | | <b>RC</b> |
| | | | <b>N°: 4</b> | <b>Date: 01.06.2023</b> | |
| <b>Marcolet cut-and-cover tunnel - Crissier</b> | | | | | <b>NO.: 082TC2834</b> |

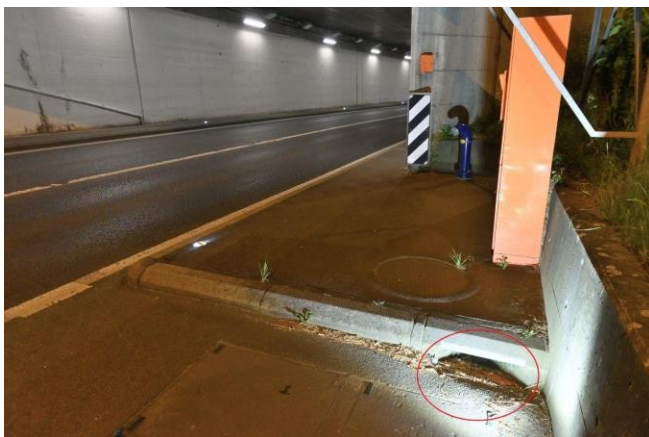
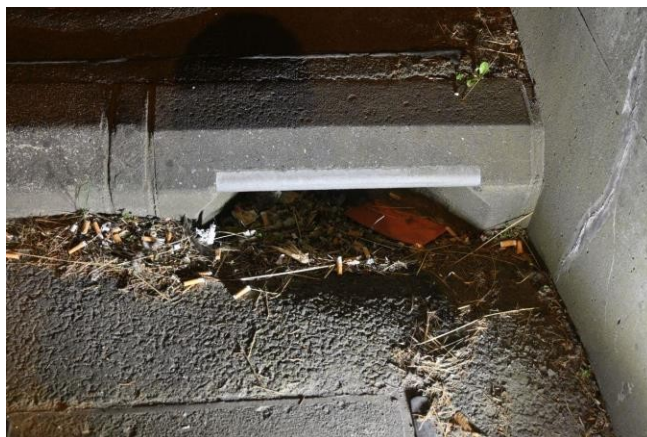
Bo Bordure  
411 Malfunctions  
Drain near left edge of Axis 1. Drain partially blocked by garbage.

| Structural element | | | | | | |
|---|---|---|---|---|---|---|
| Border | Bo | 411 | I | C | Drain partially blocked by garbage. | 1, 2 2 |

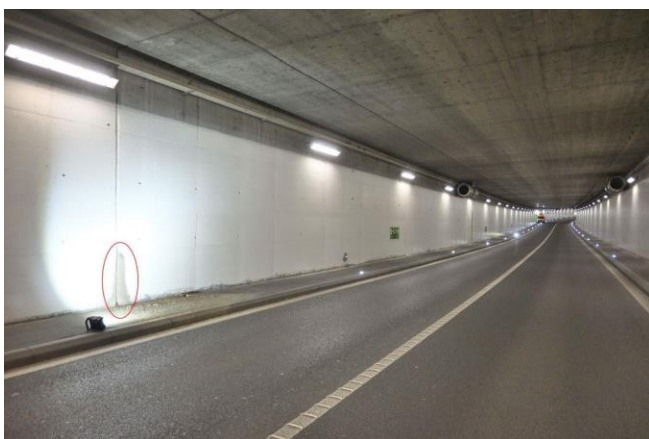
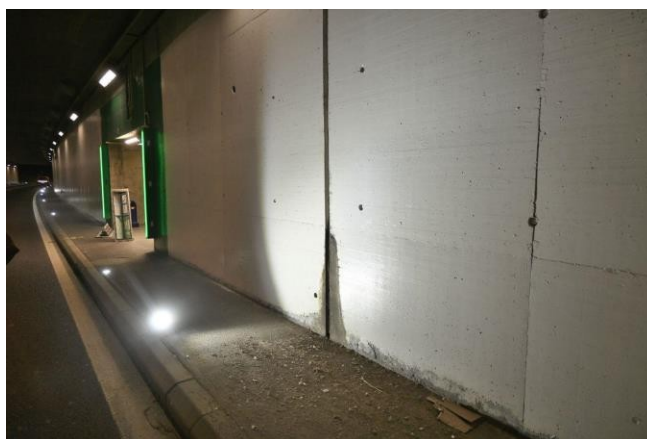
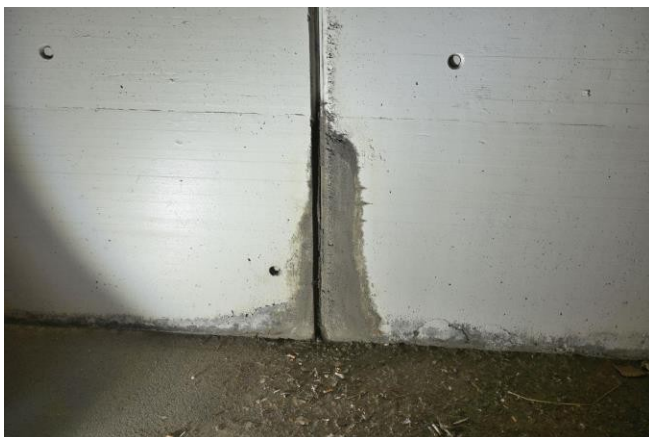
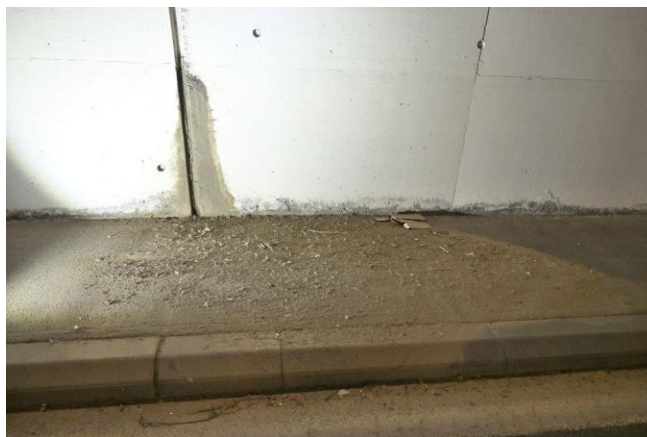
CuDr Straight Cillwall  
301 Wetlands  
Lower part of wall (150m N). Leaky joint, causing seepage.

| Structural element | | | | | | |
|---|---|---|---|---|---|---|
| Right Culée wall | CuDr | 301, 301 | II | C | Leaky joint, causing seepage, concrete spalling and seepage. | 3, 4, 5, 6, 7, 8, 9, 10, 11, 12 2 |

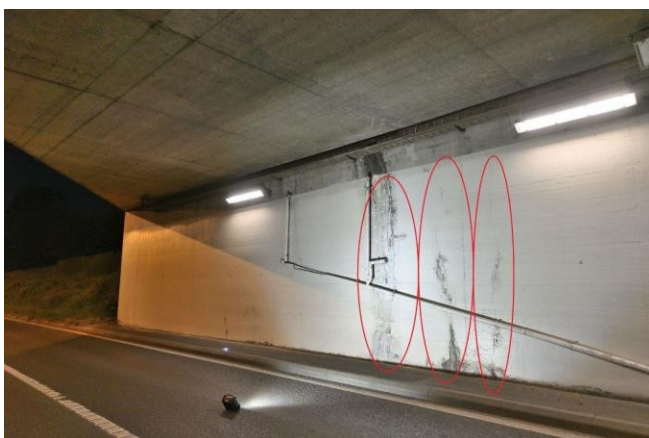
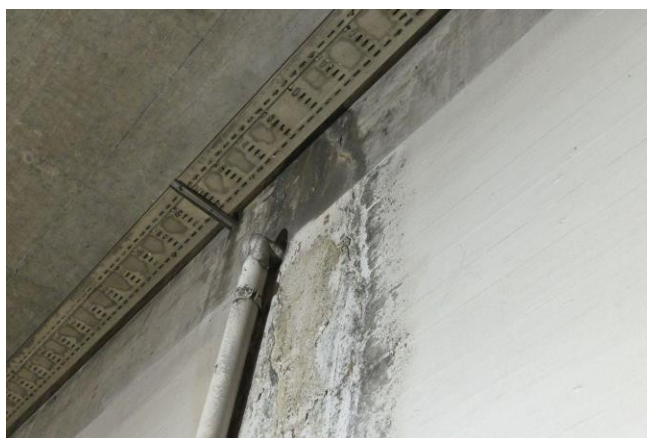
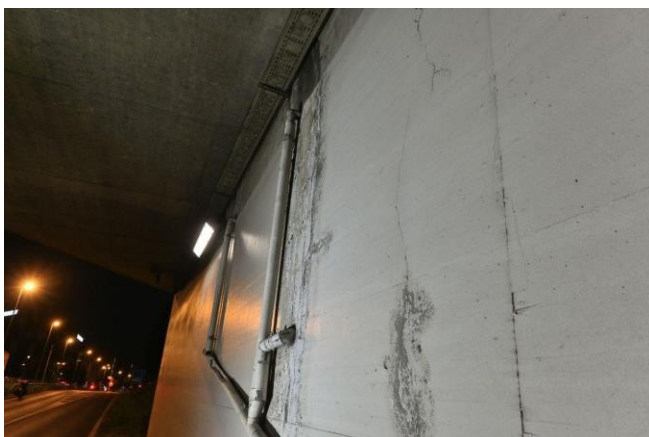
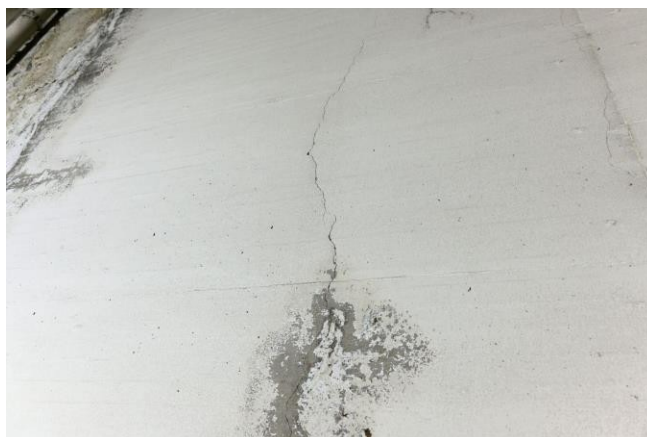
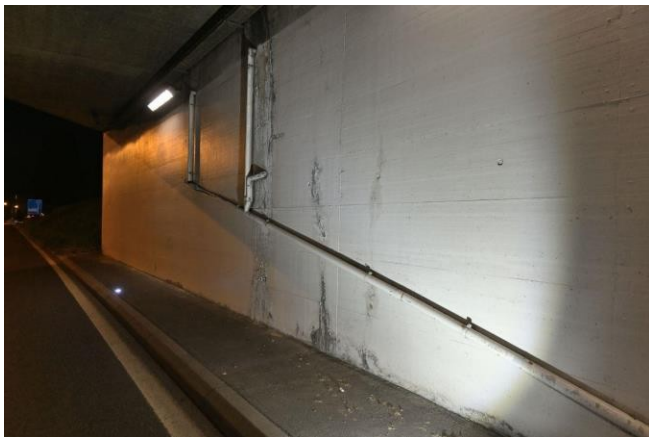
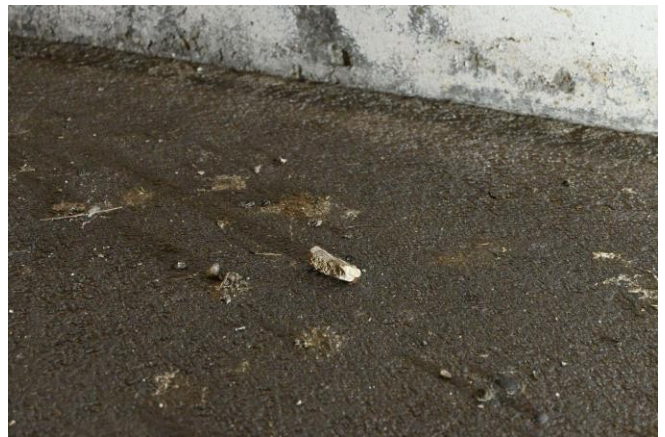
CuDr Straight Cillwall  
301 Wetlands  
Piping zone - Axis 1 exit (3m N). Concrete spalling and seepage.

CuDr Straight Cillwall  
301 Wetlands  
Pipe zone - Axis 1 exit (3m N). Concrete spalling and seepage.

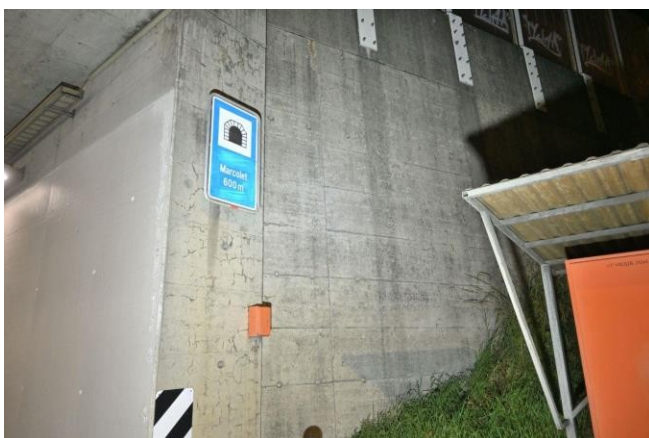
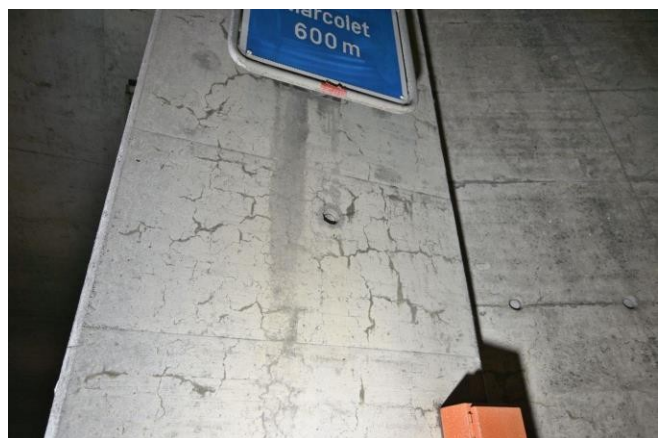
CuDr0 Wing wall Straight Axis 0  
1216 other cracks  
Front face of gate. Surface microcracks.

| Structural element | | | | | | |
|---|---|---|---|---|---|---|
| Wing wall Right Axis 0 | CuDr0 | 1216 | II | C | Surface microcracks. | 13, 14 2 |

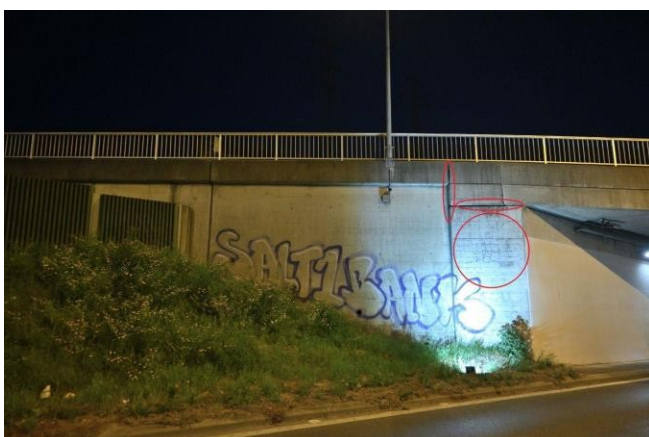
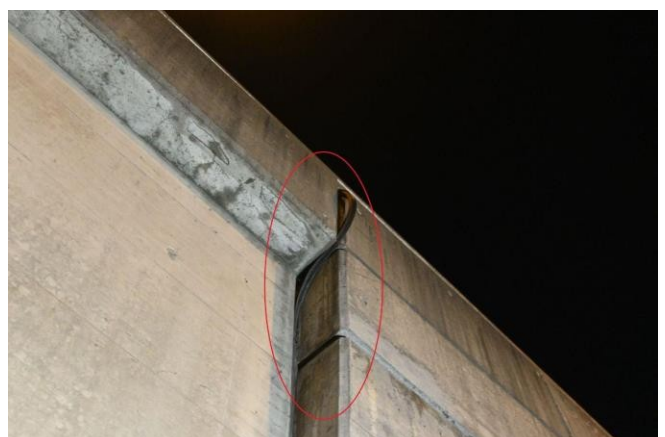
CuDr1 Wing wall Right Axis 1  
1209 Joint cracks  
Upper part of the infrastructure object. The rubber is partially torn off.

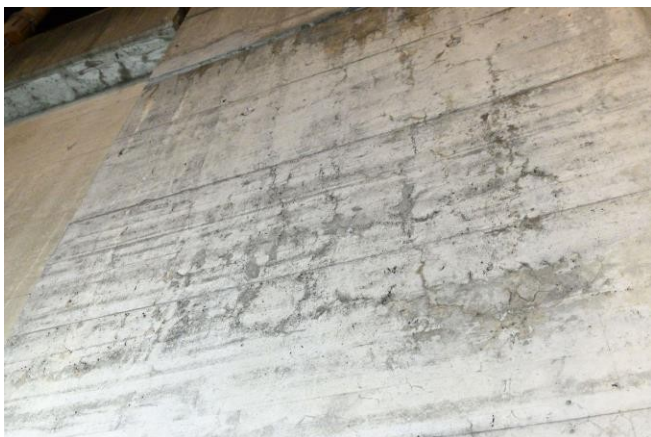
Photo N°: 17 / 36

CuDr1 Wing wall Right Axis 1  
1303 Eclats  
At the center of the infrastructure object. Concrete spalling and cracking.

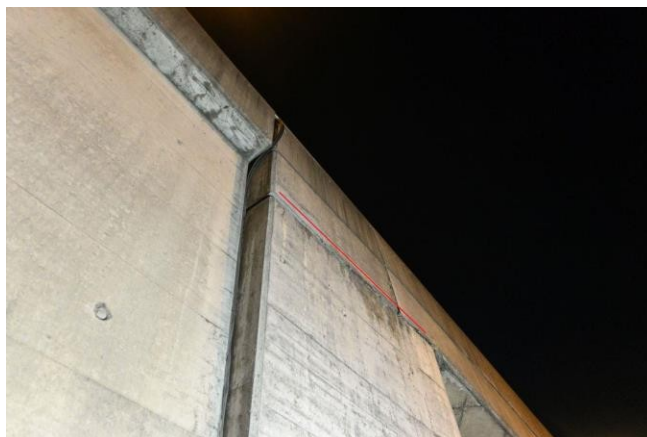
Photo N°: 18 / 36

CuDr1 Wing wall Right Axis 1  
301 Wetlands  
Upper part of the infrastructure object. Non-tight joint.

| Structural element | | | | | | |
|---|---|---|---|---|---|---|
| Wing wall Right Axis 1 | CuDr1 | 1209, 1303, 301 | II | C | Rubber gasket partially torn off, concrete splintering and cracking, leaky joint. | 15, 16, 17, 18 2 |

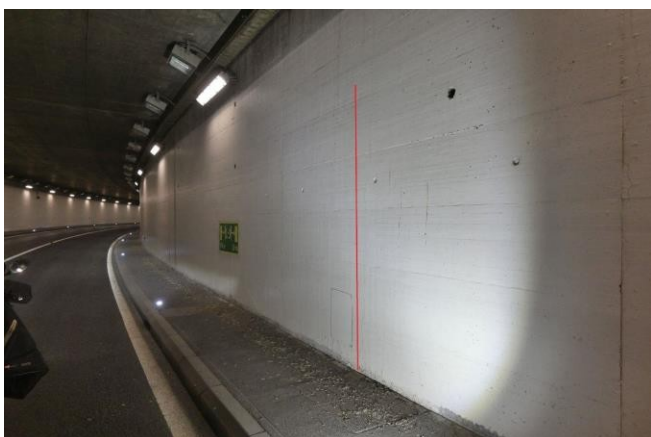
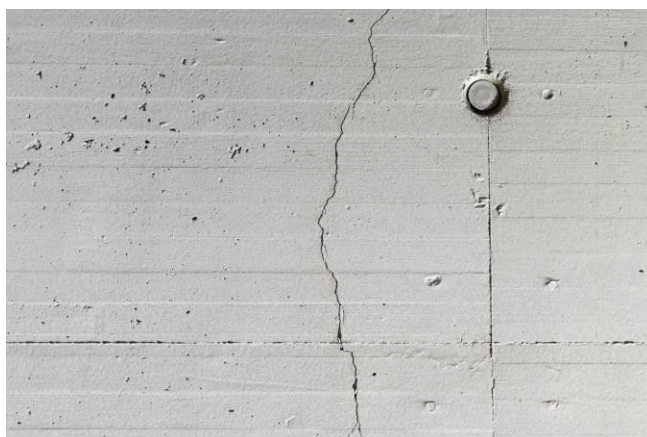
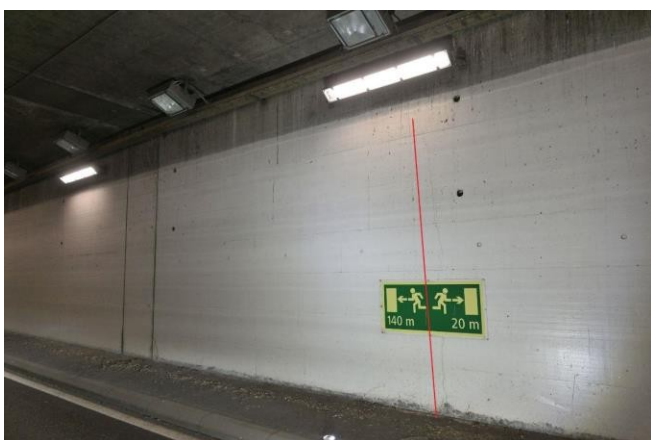
CuGa Culée Wall Left  
1216 other cracks  
Recurrent cracks all along the wall. Microcracks all along the wall.

CuGa Culée Wall Left  
1216 other cracks  
Recurrent, all along the wall. Microcracks all over height.

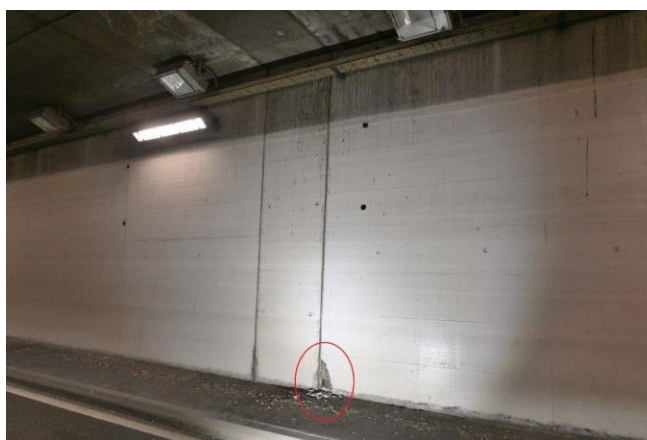
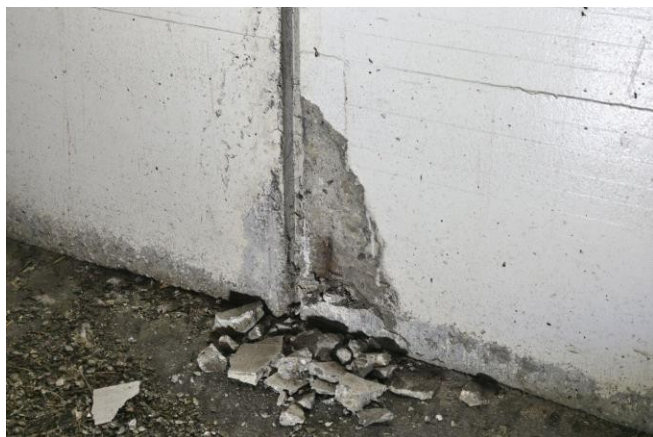
CuGa Culée Wall Left  
1303 Eclats  
Lower part of the wall (25m N). Shattering of the coating.

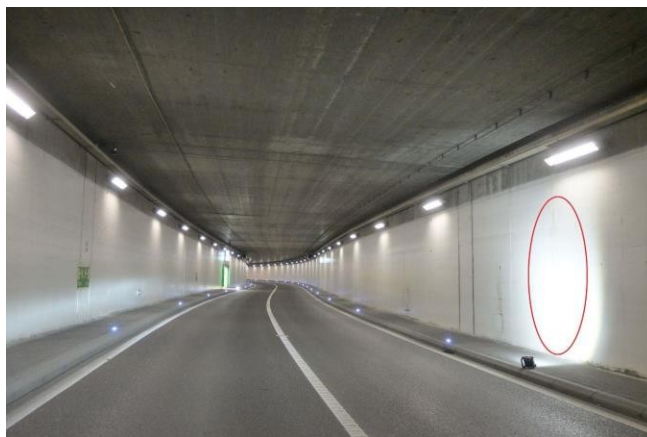
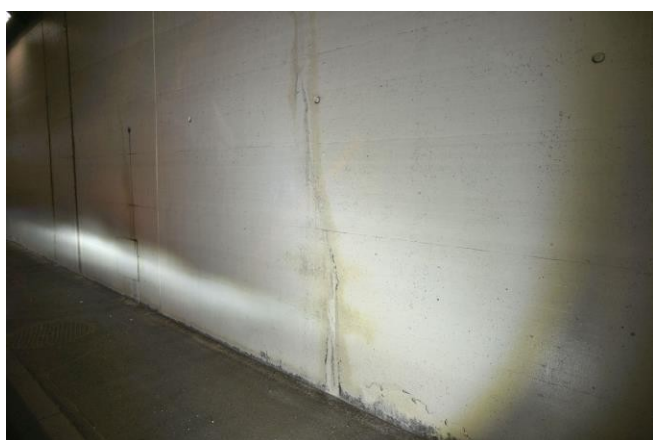
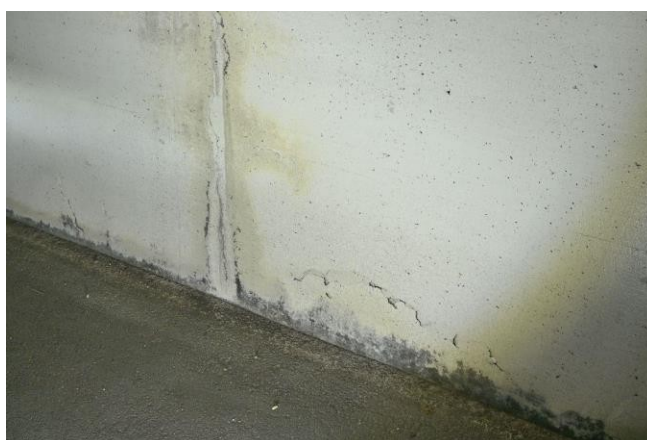
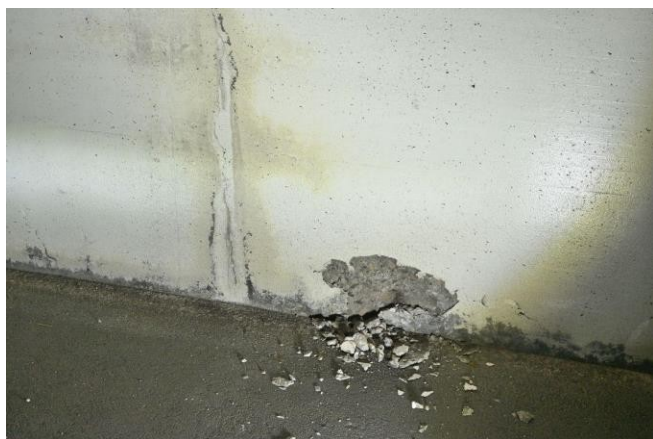
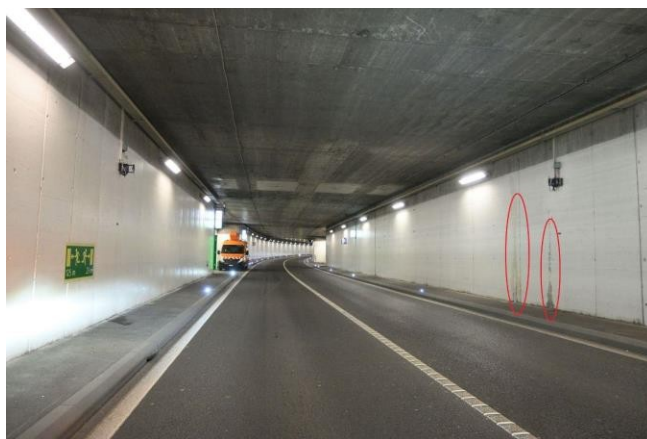
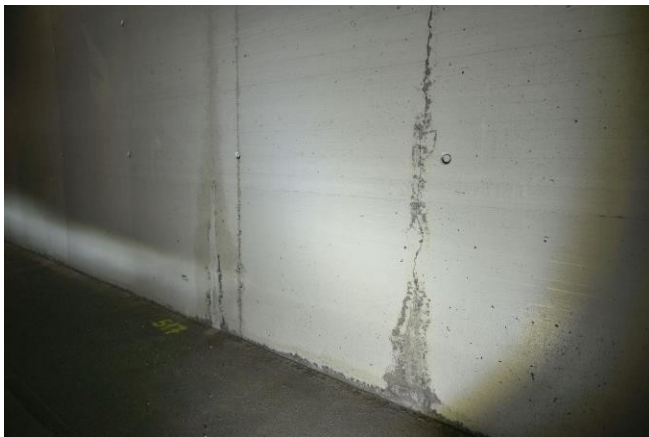
CuGa Culée Wall Left  
301 Wetlands  
Over the entire height of the wall (140m N). Infiltration weakening the concrete.

| Structural element | | | | | | |
|---|---|---|---|---|---|---|
| Culée Wall Left | CuGa | 1216, 1303, 301, 309 | II | C | Full-height microcracks, Shattered coating, Infiltration weakening concrete, Bird droppings. | 19, 20, 21, 22, 23, 24, 25, 26, 27, 28, 29, 30 2 |

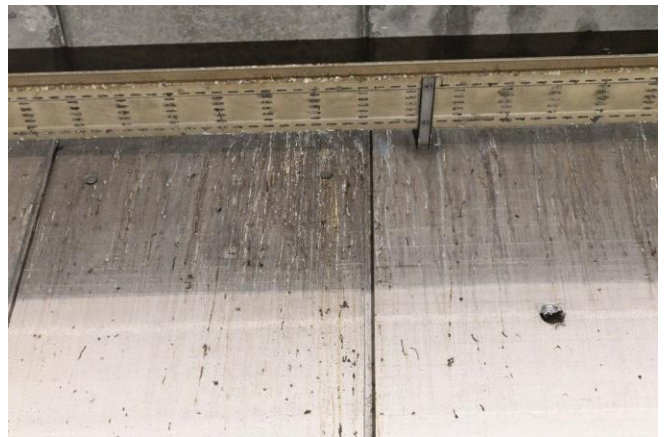
Photo N°: 30 / 36

CuGa Culée Wall Left  
309 Fouling  
Upper part of the wall (50m N). Bird droppings.

The structure is in acceptable condition (2). Routine maintenance measures (treatment of joints, cleaning, anti-pigeon device) are recommended.

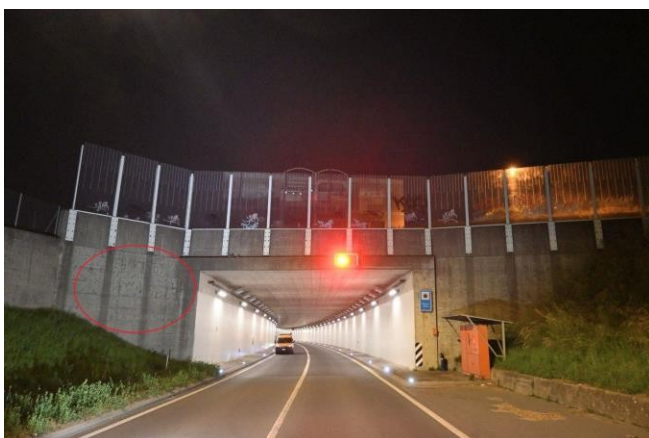
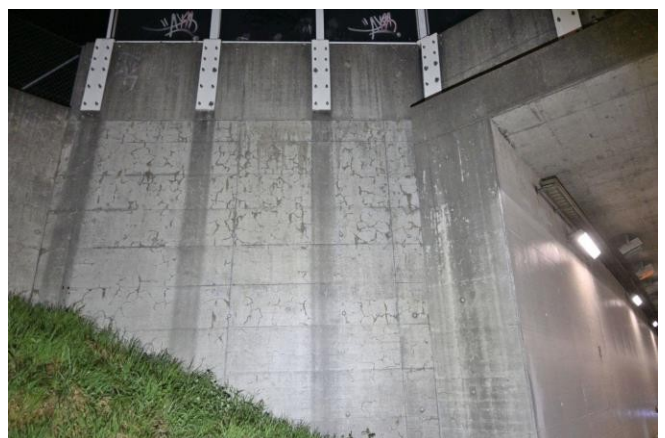
CuGa0 Left wing wall Axis 0  
1216 other cracks  
Entire wall. Surface microcracks.

| Structural element | | | | | | |
|---|---|---|---|---|---|---|
| Left wing wall Axis 0 | CuGa0 | 1216 | II | C | Surface microcracks. | 31, 32 2 |

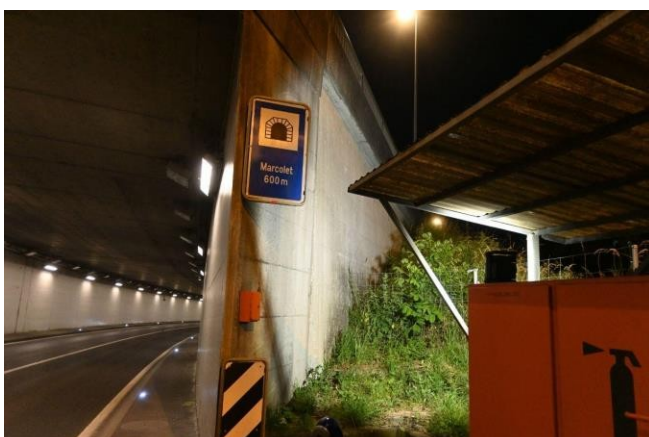
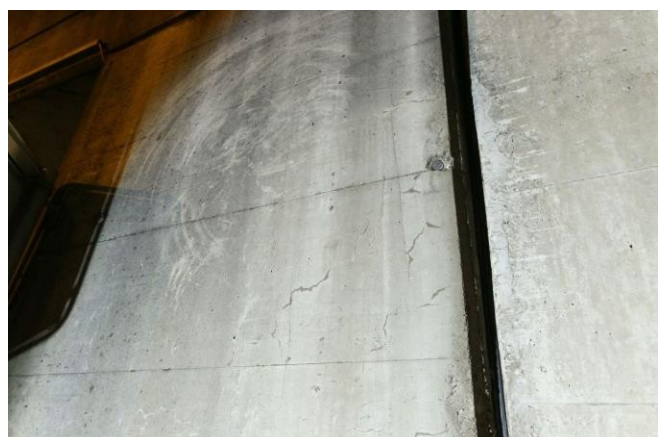
CuGa1 Left wing wall Axis 1  
1216 other cracks  
Close to rubber gasket. Scattered cracks.

| Structural element | | | | | | |
|---|---|---|---|---|---|---|
| Left wing wall Axis 1 | CuGa1 | 1216 | II | C | Distributed cracks. | 33, 34 2 |

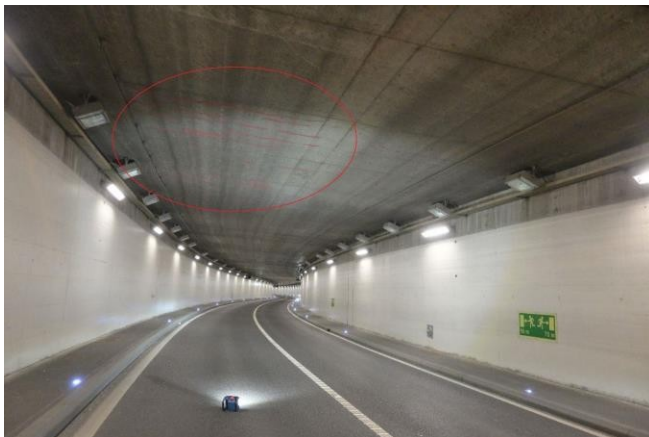
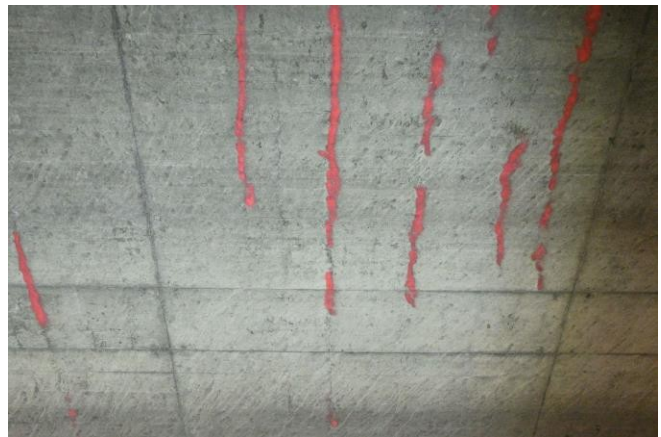
Da Dalle  
1216 other cracks  
Above the track on the right (70m N). Microcracks  
marked with red spray.

| Structural element | | | | | | |
|---|---|---|---|---|---|---|
| Slab | Da | 1216 | II | C | Transverse microcracks marked with red spray. | 35, 36 2 |
