Assessment of a UHPFRC based bridge rehabilitation in Slovenia, two years after application

Aljoša Šajna¹, Emmanuel Denarié², Vladimir Bras¹

1: Slovenian National Building and Civil Engineering Institute, ZAG, Ljubljana, Slovenia.

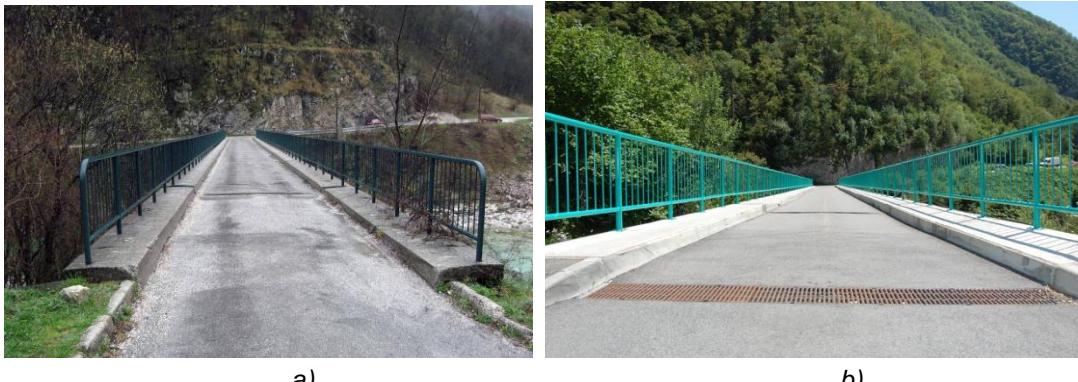
Figure 1: The Log Čezsoški bridge before a), and two years after the application of the UHPFRC layer b).

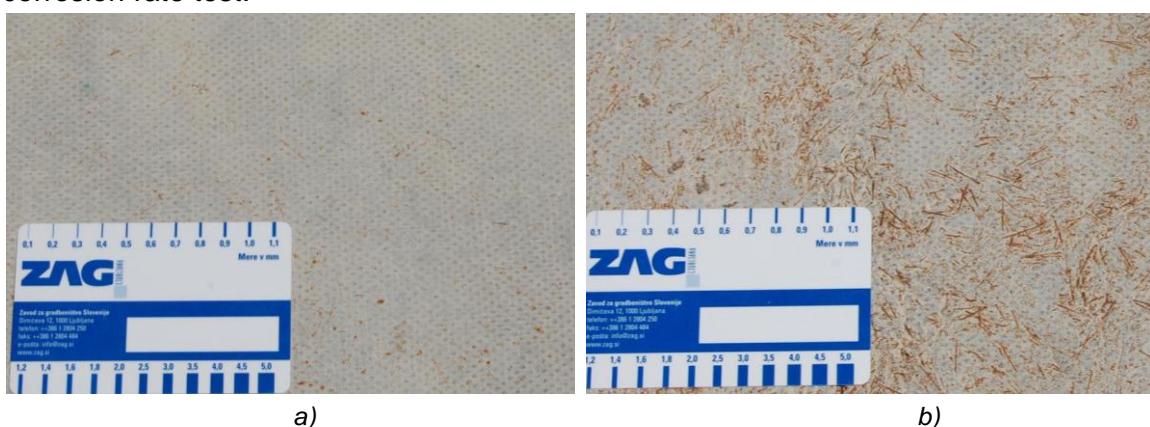
Generally the UHPFRC layer was found to be in very good condition. Compared to the inspection performed directly after the completion of the rehabilitation works, no additional flaws or new damages could be seen. The horizontal and vertical surfaces, which were well finished using a Controlled Permeability Form liner (CPF), were still in very good shape, Figure 2a. They are still "smooth", and the "textured" structure of the CPF "printed" on the UHPFRC surface is still undamaged. Almost no traces of corrosion or fibres protruding from the surface were observed in these zones. No new damages, compared to the inspection of 2009, were observed either on the surfaces with protruding fibres, or on the areas around the formwork spacers where UHPFRC had not penetrated properly, on the internal vertical face of the kerbs, and which were refilled with a UHPFRC. Where finishing of the UHPFRC surface by the means of the CPF was of poorer quality, the steel fibres protruding from the UHPC matrix kept corroding, resulting in a red-brownish colour, but no spalling of the UHPFRC occurred (Figure 2b). Even on the highly loaded area on the bridge turn, where traces of truck tyres are visible on the kerbs, no damage to the UHPFRC layer was observed. No cracking occurred on the joint between day 1 and day 2 casting, nor did it occur on the corners between the horizontal surface of the footpath and the vertical surfaces of the kerbs. Due to asphalt layer laid on the bridge deck, the joint between the vertical surface of the curb and the bridge deck couldn't be inspected. The unfilled zones around formwork spacers, repaired using UHPFRC directly after the completion of the rehabilitation works, were inspected by the means of hammering. No problems with adhesion were detected. The areas around the outlets were also in unchanged condition.

Based on the results of the visual inspection it can be concluded that no damage has occurred to the UHPFRC layer since its application and that 80 % of the apparent UHPFRC surfaces are close to the visual rendering shown in Figure 2a.

Figure 2: UHPFRC surface of excellent a) and poorer quality, with apparent fibres b).

Two years after the application the UHPFRC layer was found to be in very good shape; as no damage, cracks or spalling was found during the thorough visual inspection. Areas with poorer concrete finishing, i.e. steel fibres extruding from the UHP cement matrix, continue to corrode, resulting in a red-brownish colouring of the surface, but no spalling of the concrete was recorded. The deficient areas repaired just after the application are fully functional.

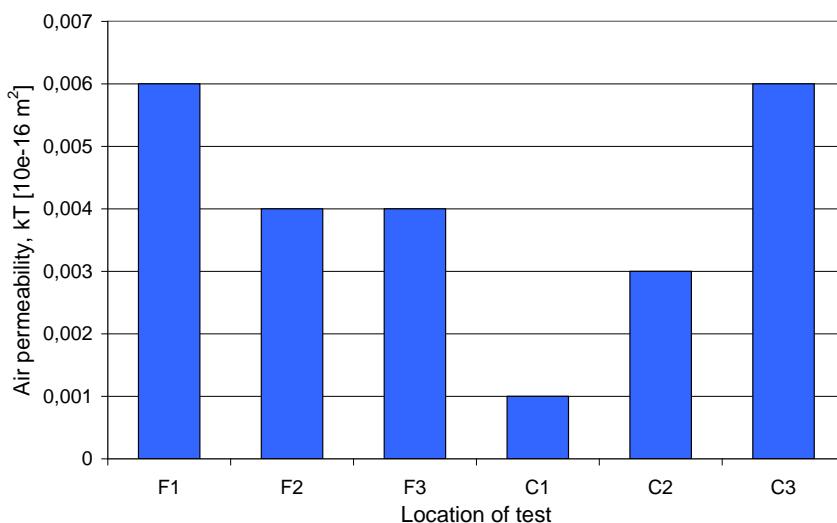
Figure 3: Results of the *in situ* air permeability tests.

Comparing the air permeability of the two concrete mixes it can be concluded that their air permeability is of the same order of magnitude. Furthermore, the air permeability of the *in situ* cast UHPFRC two years after application is very close to that of the laboratory made UHPFRC. Both UHPFRC mixes having the permeability of $0,004 \times 10^{-16} m^2$ in average, can according to the quality classes of cover concrete introduced by Torrent et all 0, be classified as “very good”.

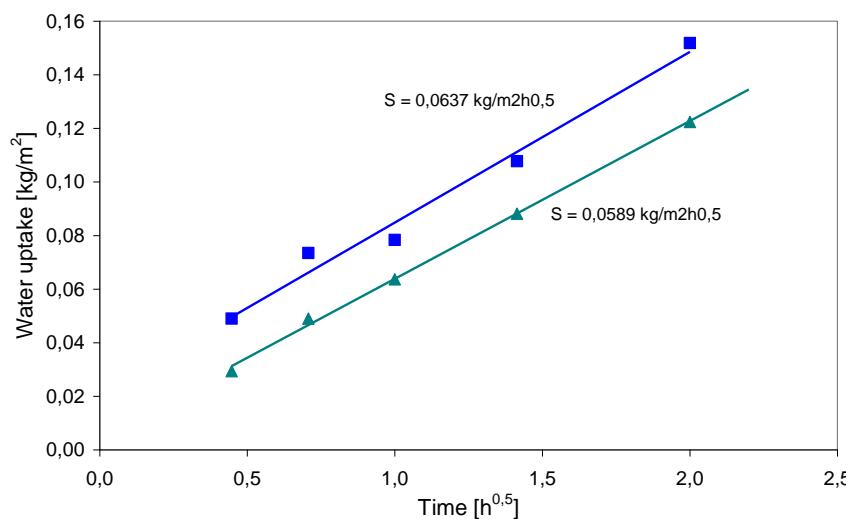
The capillary absorption test results, performed according to EN 13057, 0, are presented in Figure 4. The sorption coefficient values for the cores CS1 and CS2 were $0.064 \text{ kg/m}^2 \text{h}^{0.5}$ and $0.059 \text{ kg/m}^2 \text{h}^{0.5}$ respectively. The difference between the two sorption coefficients, taking into account that the sample CS1 represented good quality concrete and CS2 bad concrete, is relatively small. Surprisingly, a higher sorption coefficient was measured on sample CS1, which was supposed to represent better concrete. In any case, the sorptivity S of the UHPFRC placed on the bridge footpath is one order of magnitude lower than $0.5 \text{ kg/m}^2 \text{h}^{0.5}$, the value required by EN 1504-3 for Class R4 repair products.

Figure 4: Capillary absorption of the UHPFRC cores.

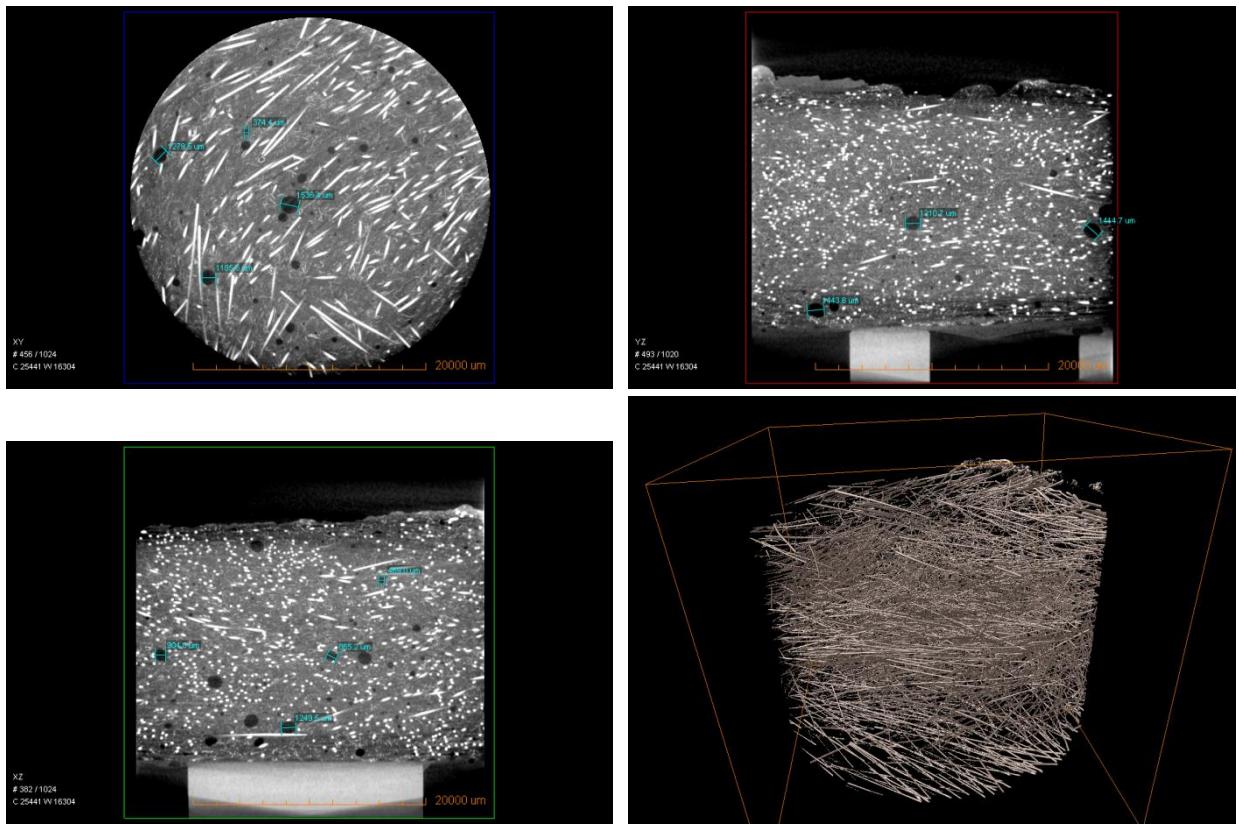
voids and bunches of steel fibres. The CT scan of core PO3 is presented in Figure 5 (cores are turned up-side-down). As on the core surface the concrete microstructure and especially the steel fibres are damaged during the drilling process, only the inner part of the cylinder, approx. 30 mm in diameter, but of the whole core height, which corresponds to the actual height of the UHPFRC layer, is presented. A horizontal cross-section of the core is presented on the upper left, and in the upper-right and bottom-left figures two perpendicular vertical cross-sections are shown. All three cross-sections were located through the largest air void found in the core (in the middle of the horizontal cross-section), 1.5 mm in diameter. The black spots are air voids, whereas the white colour represents the steel fibres and steel wool, and the grey-coloured part is the UHPC matrix. On the bottom-right figure the distribution of the steel fibres is presented as an 3D image.

- The CT images of the cores confirm the conclusions of the visual inspection. The UHPFRC layer is homogenous, with few small pores visible, and the steel fibres are evenly distributed. Additionally the CT images confirm that all the fibres lie in the direction of the UHPFRC layer's plane, as expected.

Figure 5: Computer microtomography based image of core PO3; upper-left: horizontal cross-section, upper-right and bottom-left: vertical cross-sections, and bottom-right: 3D image of the steel fibres.
