Partial Blackout of the Balkans 21st of June 2024

June 21, 2024 at approximately 12:20 CET

Blackout in Albania, Montenegro, Bosnia and Herzegovina and parts of Croatia

General cause, voltage collapse following multiple trips

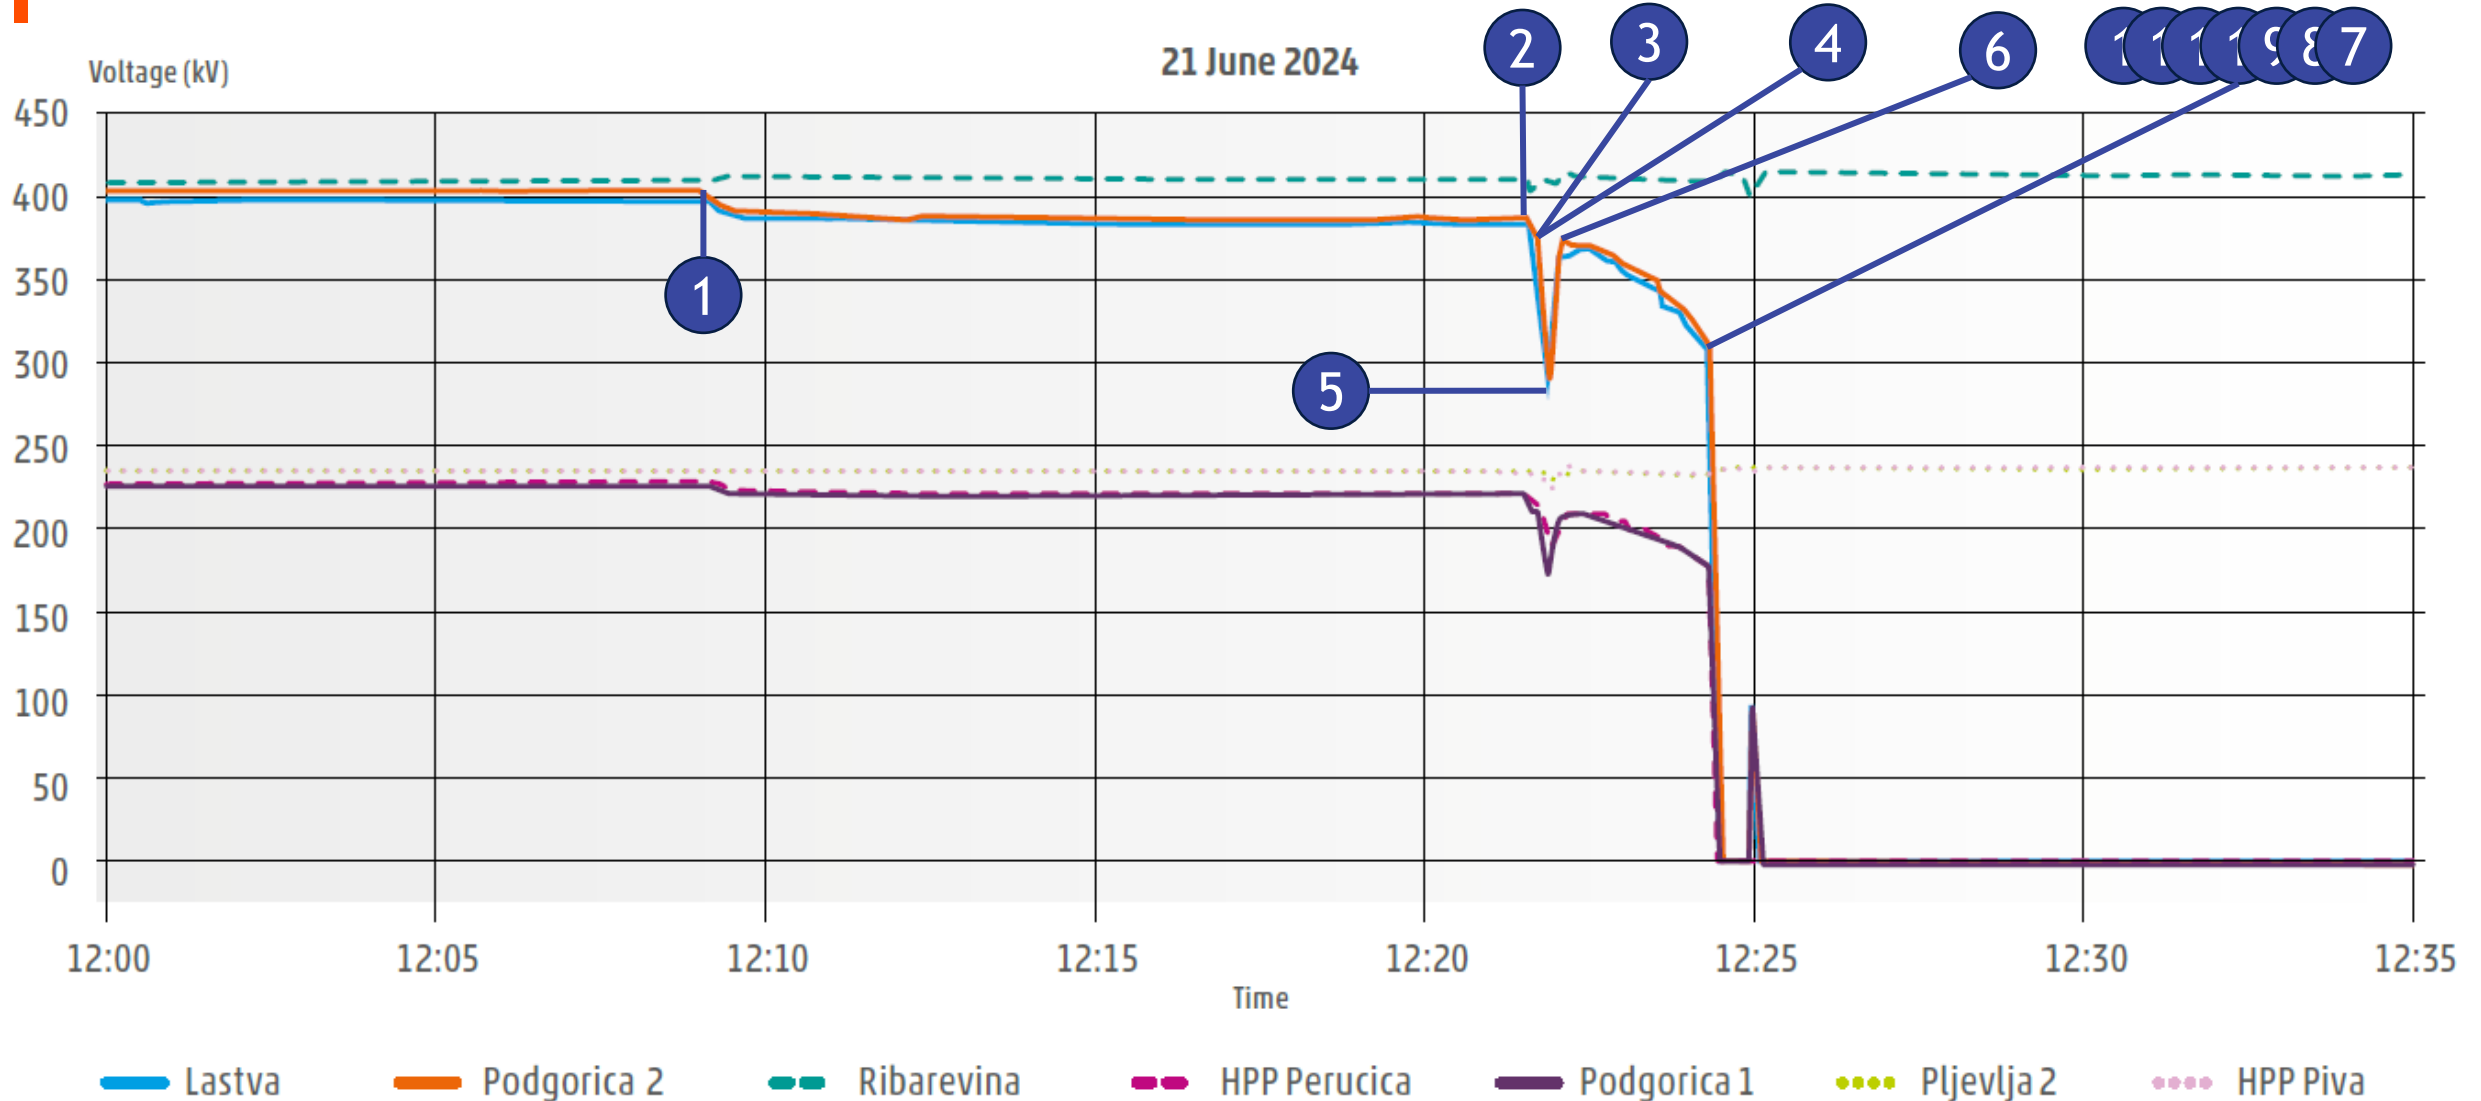
Voltage evolution in CGES network on the 400 kV and 220 kV levels

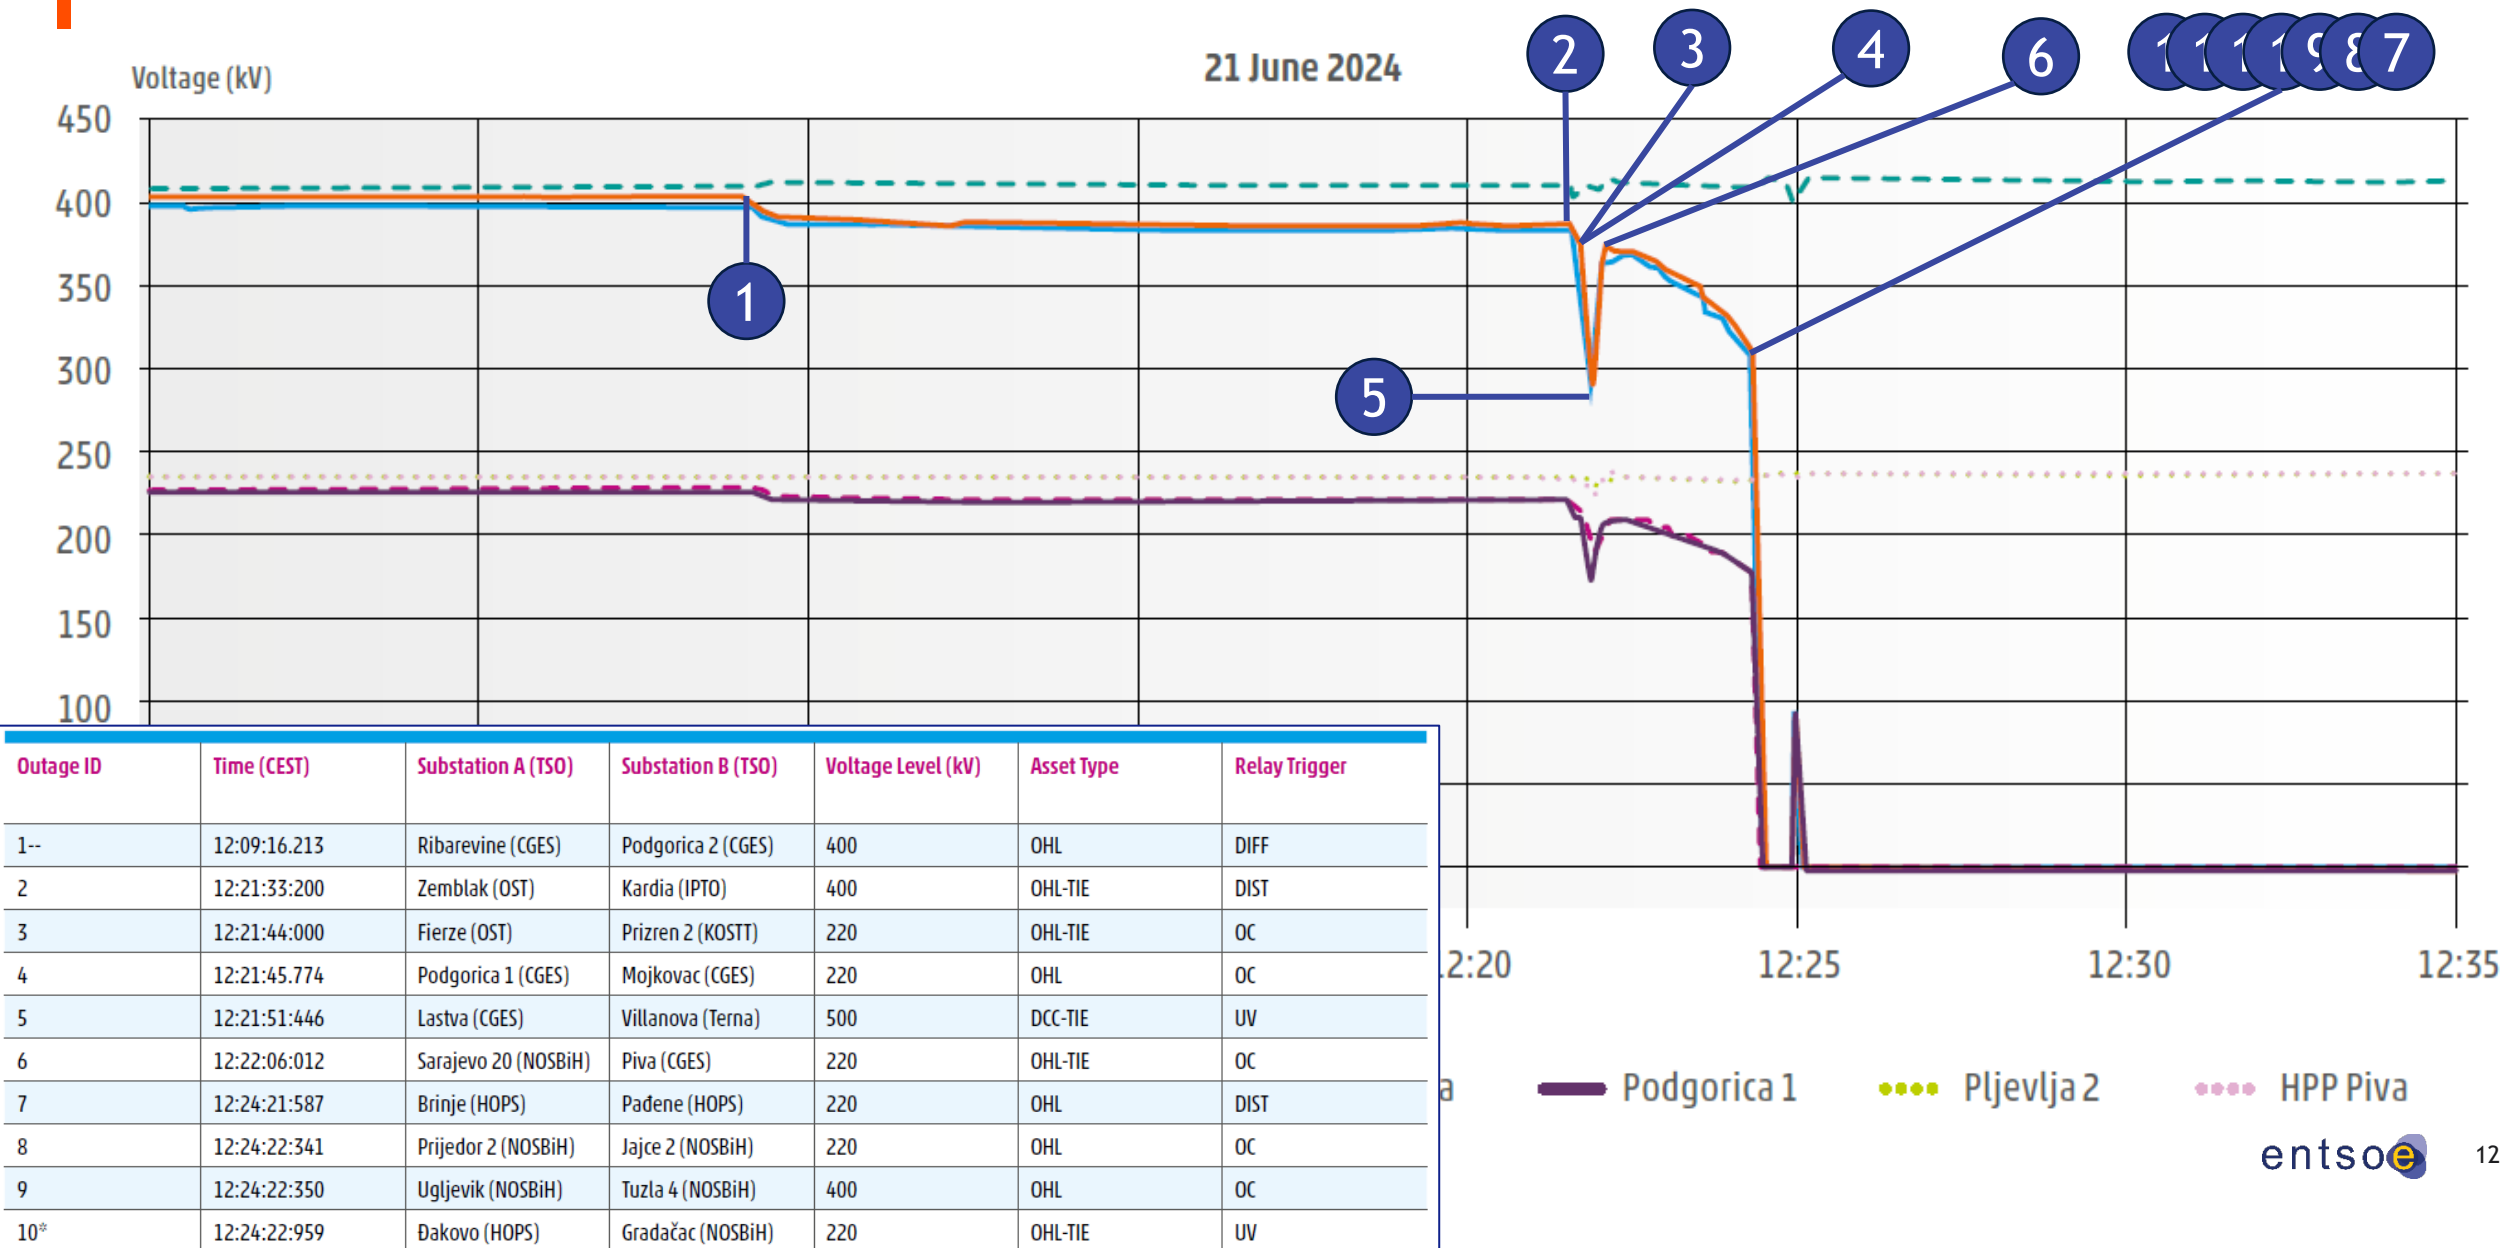
Voltage evolution in CGES network on the 400 kV and 220 kV levels

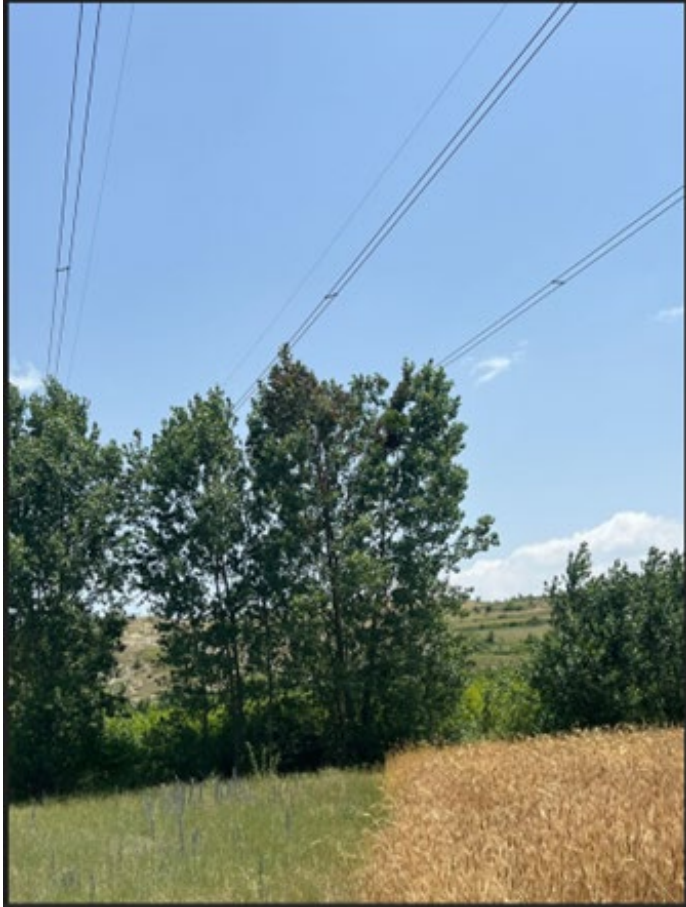
Root Cause 1: Vegetation higher than expected

Picture of the area of the short circuit -TIE 400 kV
Zemlak - Kardia

- 1 Check the national policy and operational process of vegetation growth control near the OHL and review them if needed.
- 2 Evaluate the N-1 calculations of incidents in the neighbouring grid in the real-time SCADA-EMS systems, and if needed adjust the Observability Area.

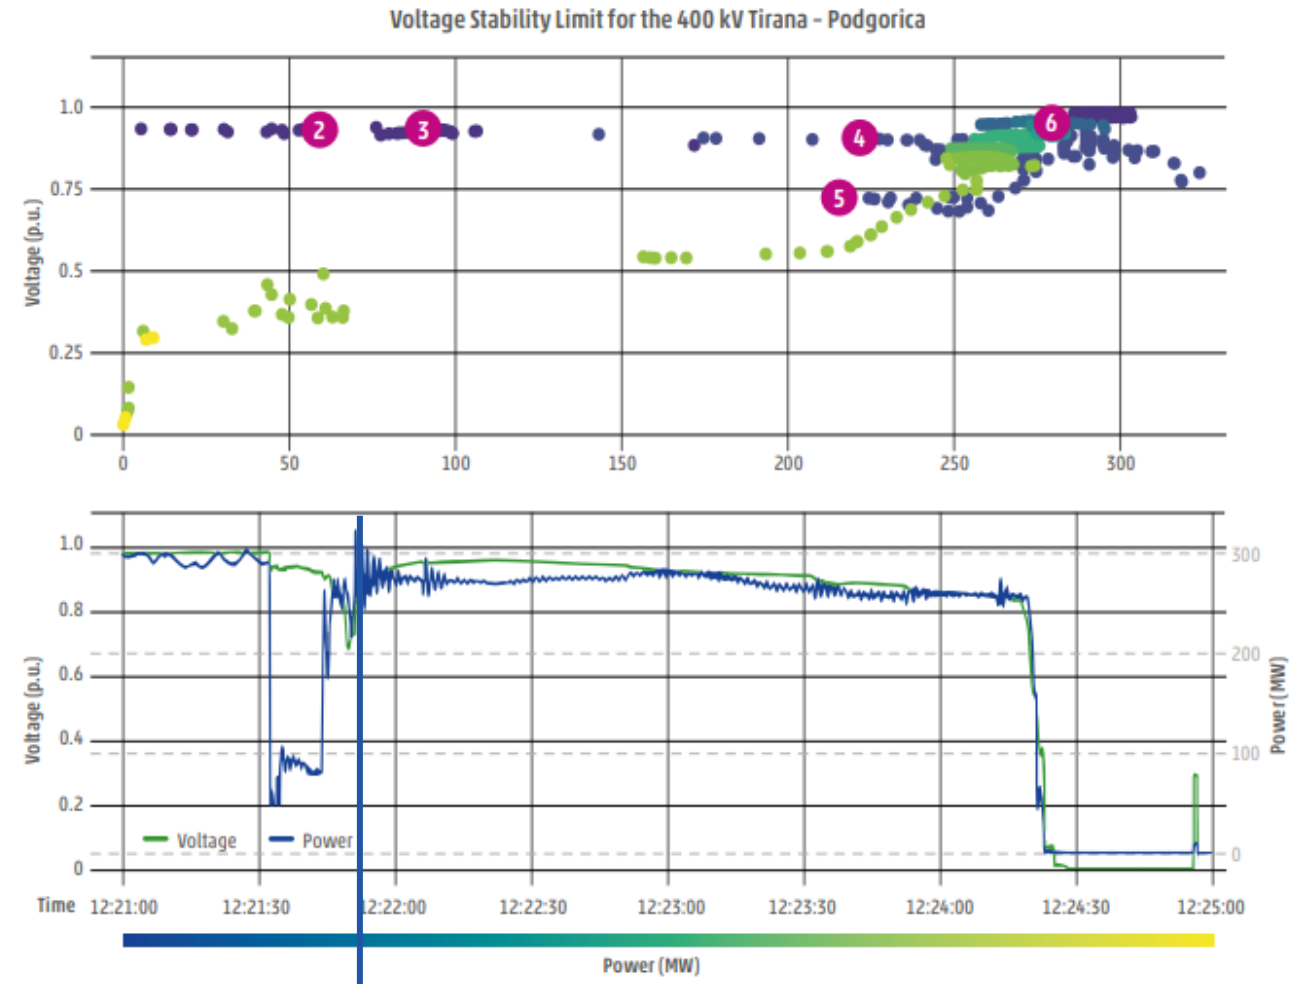
- The available and existing tools, were by design not able to detect any risk of voltage instability
- The situation was not considered abnormal nor requiring any urgent action. Voltages were regarded as normal and even better than usual as they were below 420 kV, as this region is typically struggling with very high voltages
- Post analysis, however, showed that the system encountered voltage instability after Event 4 or approximately two minutes before the voltage collapse

- By plotting the active power over the voltage for the line 400 kV Tirana – Podgorica we can see that we were below the critical voltage after event 4 and before event 5

System not stable anymore

- 3 Regular assessment of voltage stability aspects in operational planning.
- 4 Analyse the possibility to identify easy to use KPI to detect reduced voltage stability and risk of voltage collapse

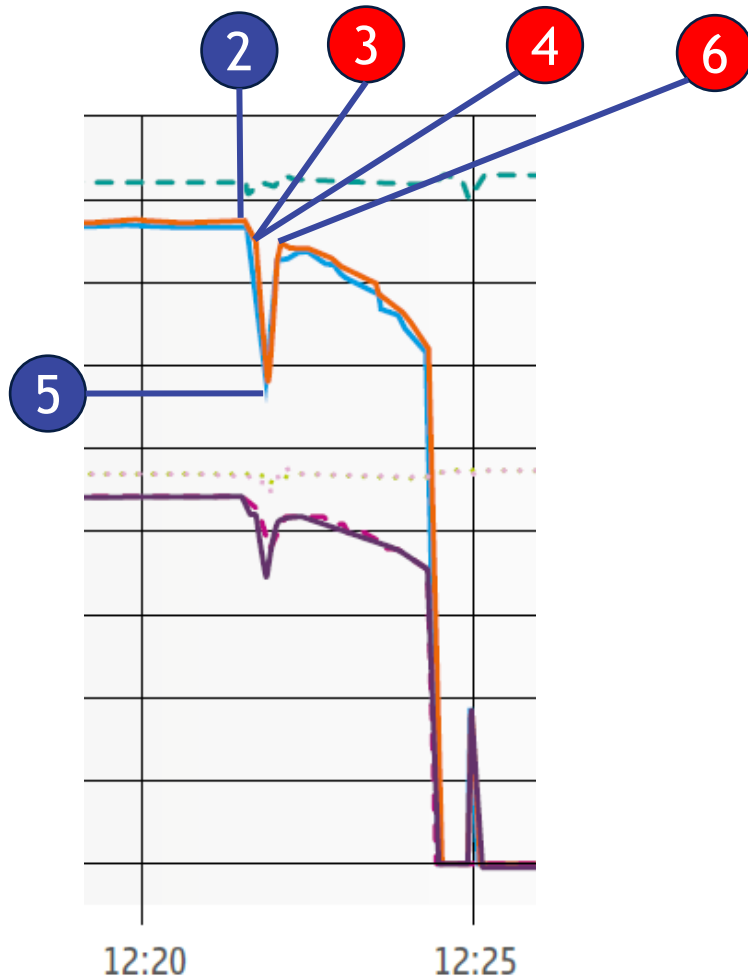
Root Cause 4: Overload protections activated

- Subsequent to the second outage several overloads occurred in the grid and 3 lines were disconnected by an overload protection.
- These protections acted within seconds and did not allow for any action to be taken by the dispatchers to reduce the flows in the grid.
- The analysis revealed a very quick (within 31.5 seconds) cascading trip of three lines caused by overcurrents (around 120-130 %) and due to a short time delay setting of the protection.

- 5 Review the already existing guidelines of ENTSO-E with respect to overcurrent protections in OHL to analyse a potential update if said guidelines with the findings of this incident.

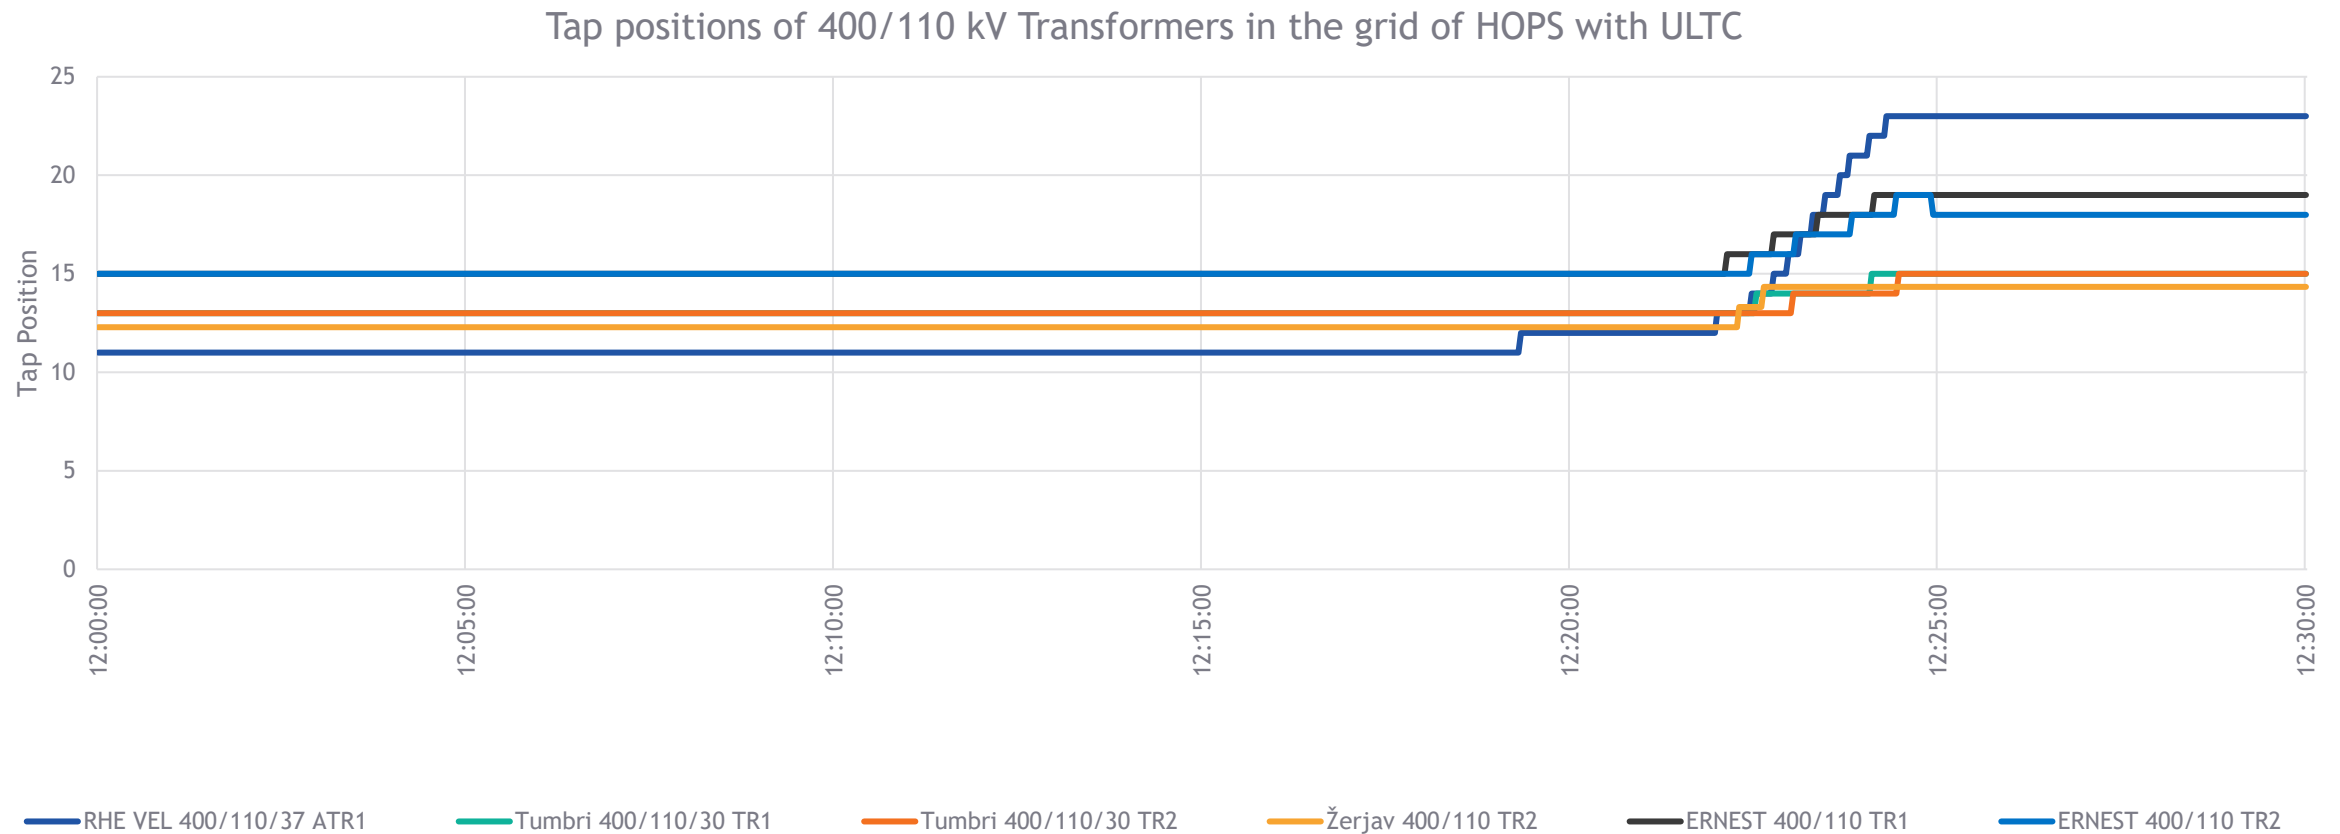
Root Cause 5: Tap changing transformers reaction (1)

- 6 Blocking of ULTC (under-load tap changers) of Transformers (V)HV-MV and VHV-HV, where appropriate (depending on renewable infeed and load characteristic).

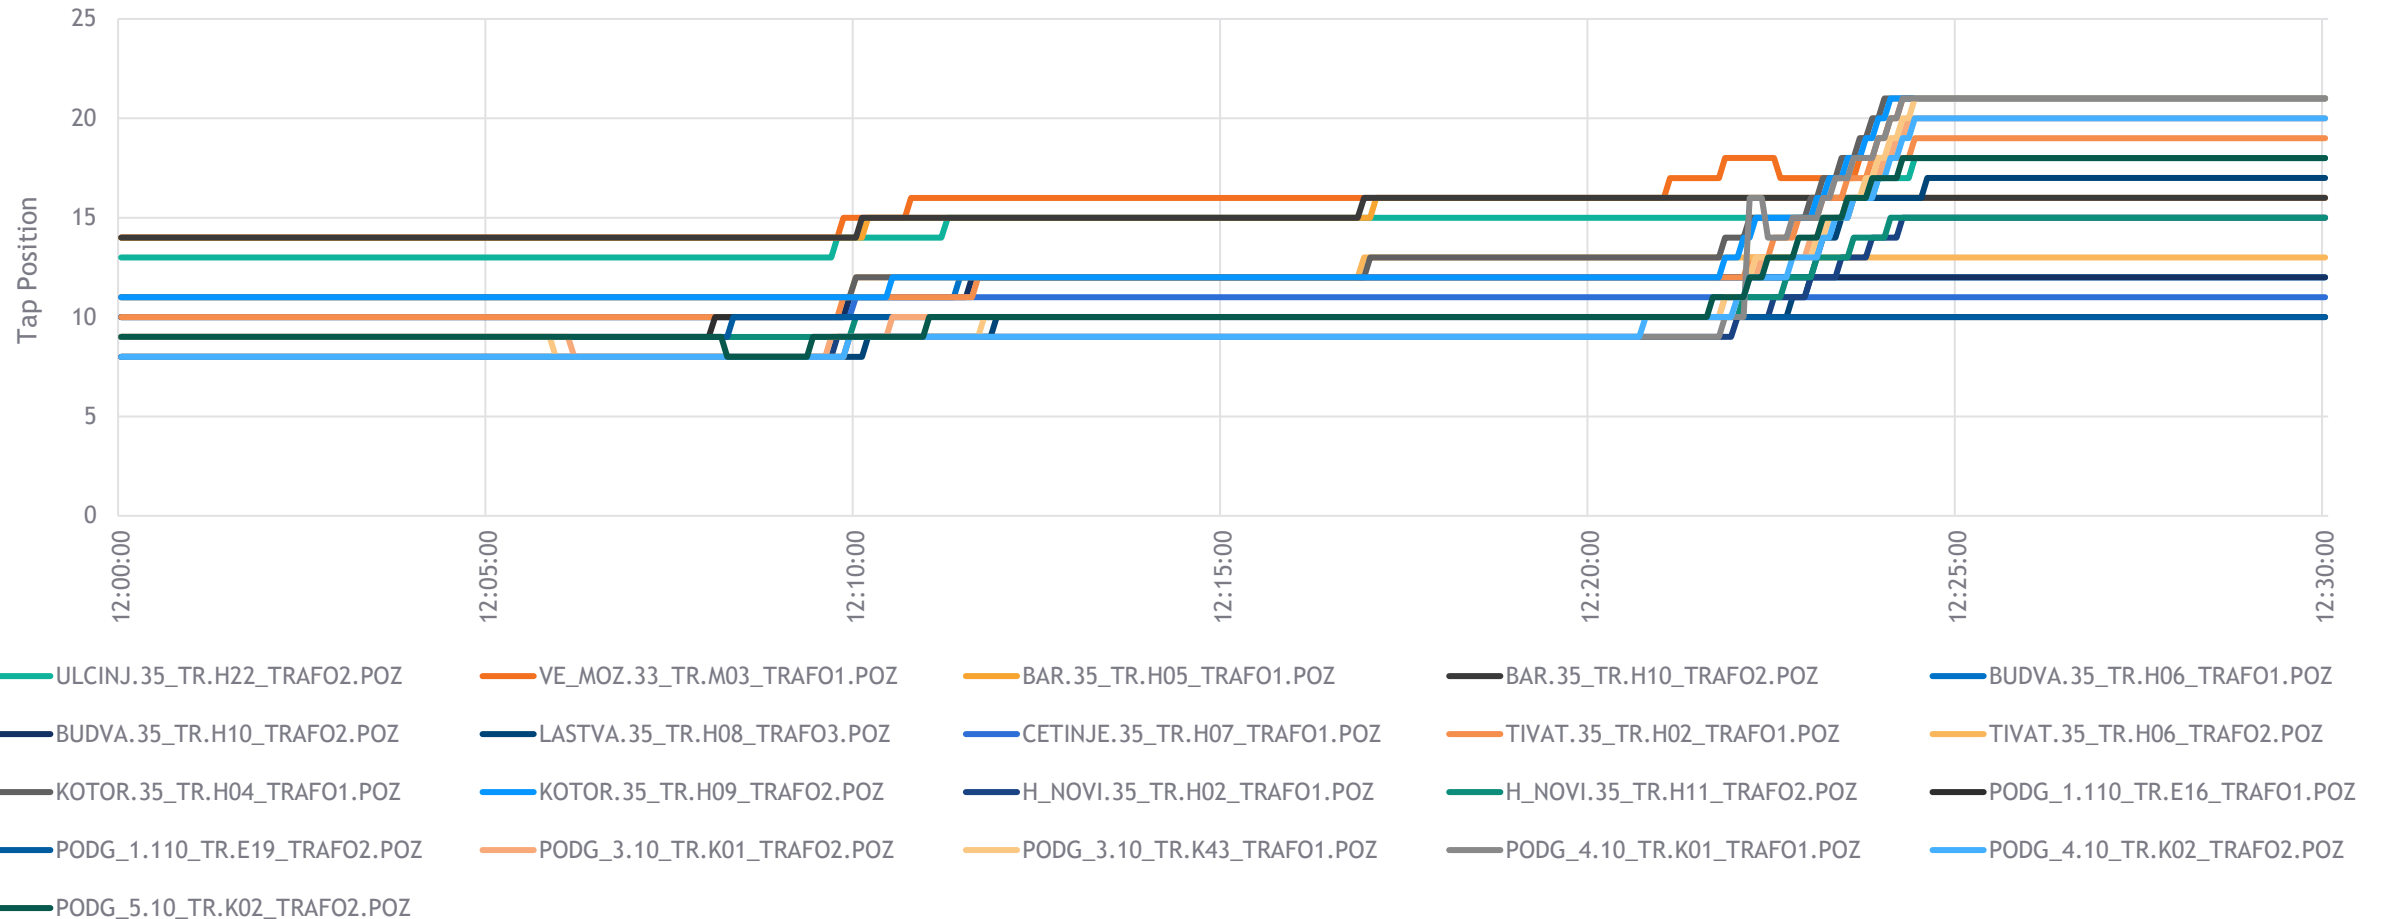
Root Cause 5: Tap changing transformers reaction (1)

Tap positions of 110/X kV Transformers in the grid of CGES with ULTC

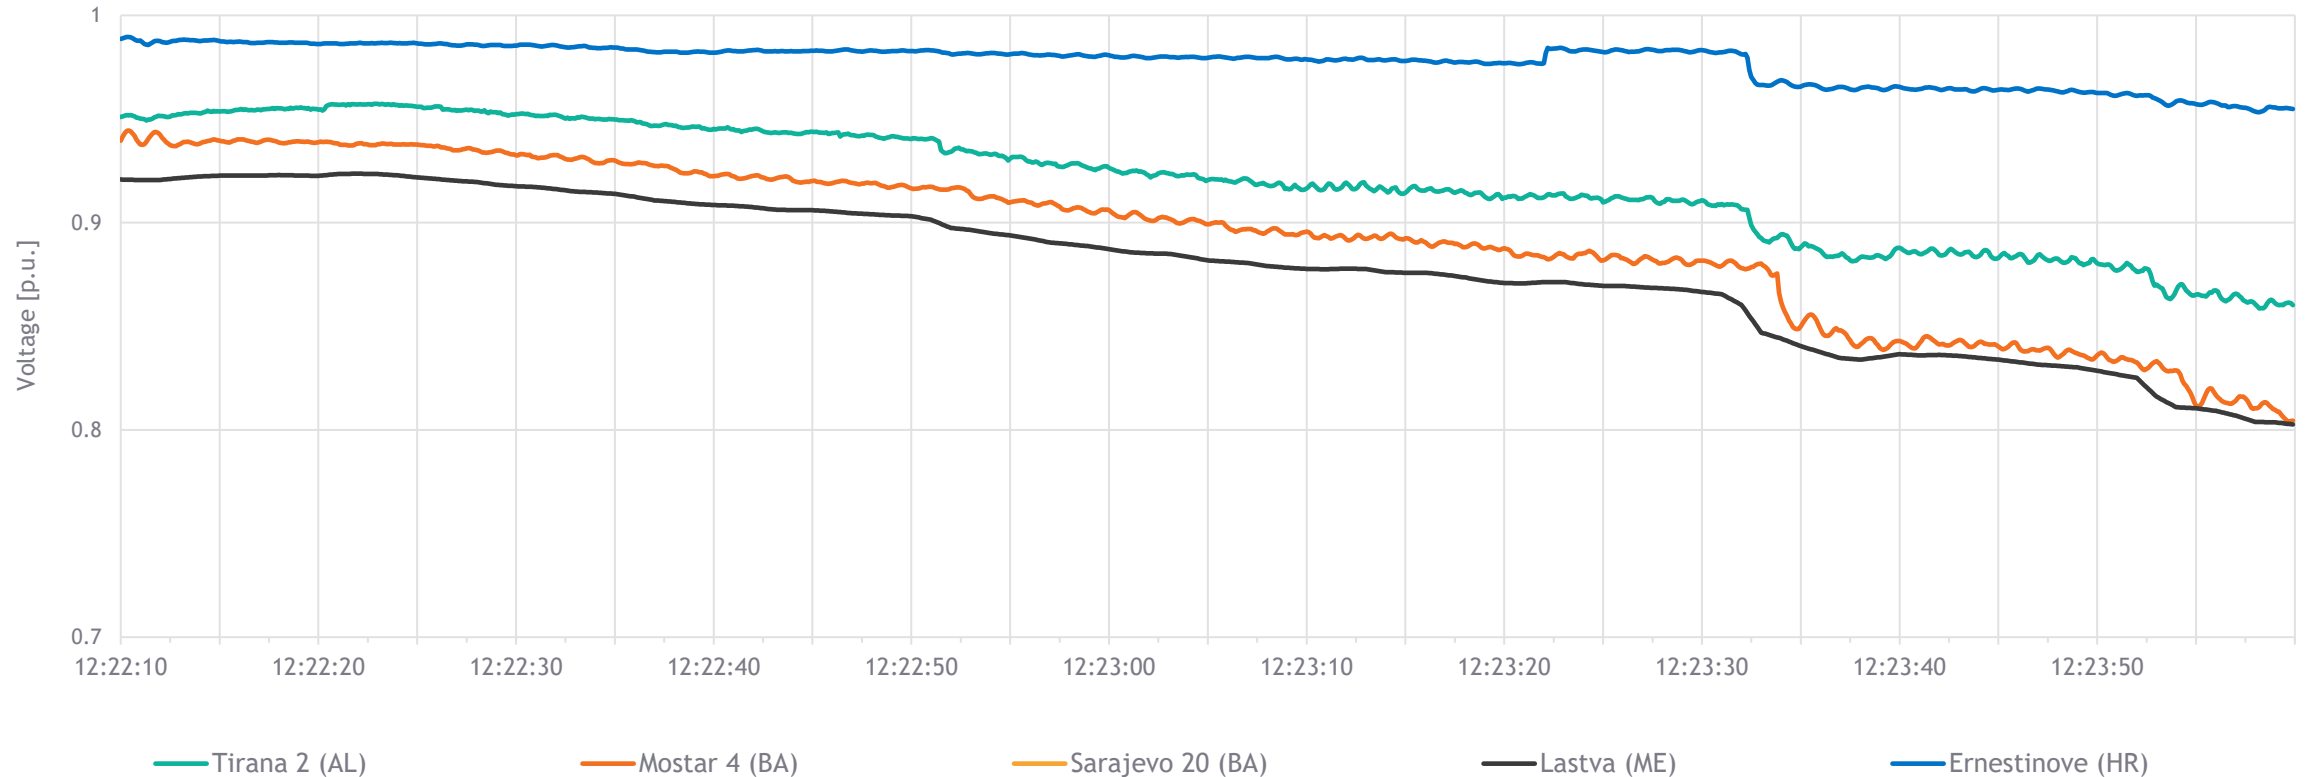
Root Cause 5: Tap changing transformers reaction (2)

Voltages from 12:22:06 to 12:24:10

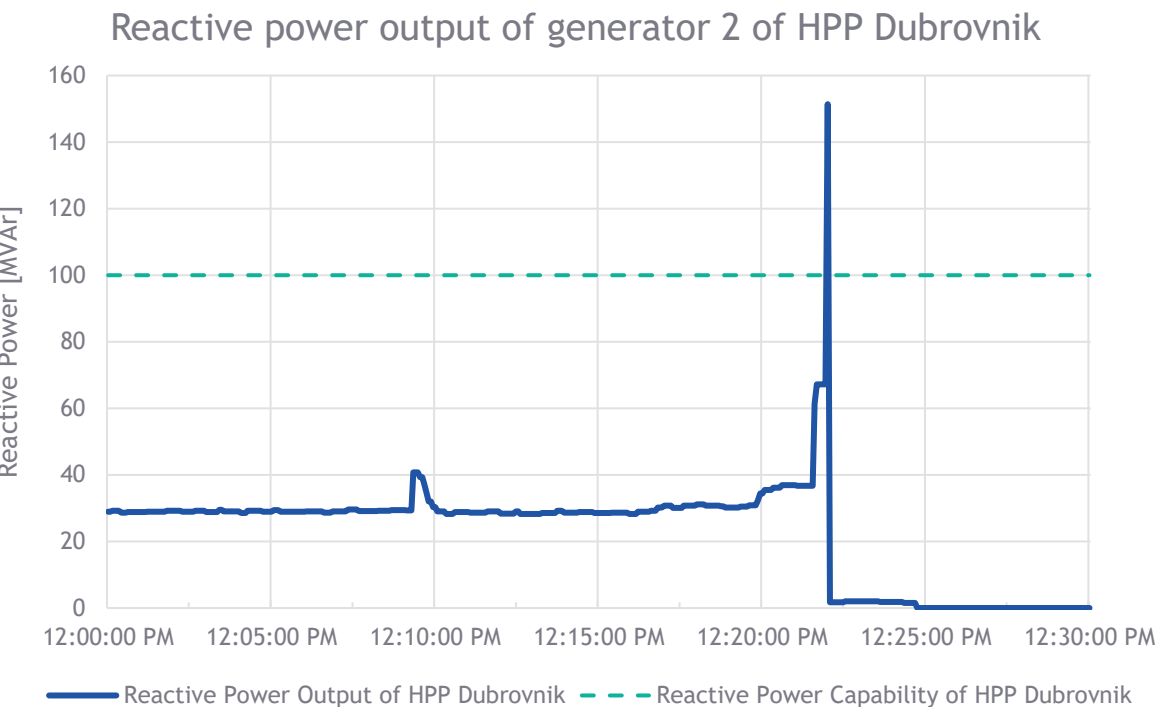
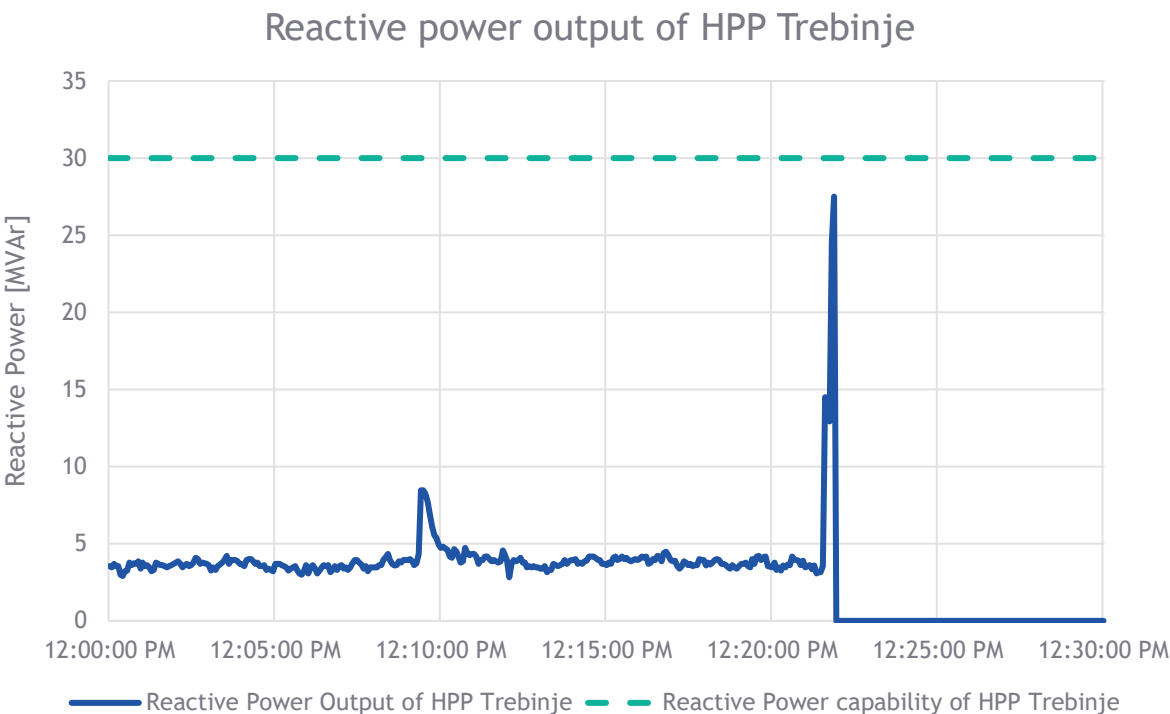
Root Cause 6: Insufficient other sources of MVA_r

Reactive power support of generators during the incident

- 7 Perform a voltage and reactive power assessment for potential low-voltage situations to be considered during the system design. Review the installation of support measures in areas where there is a risk of voltage collapse.

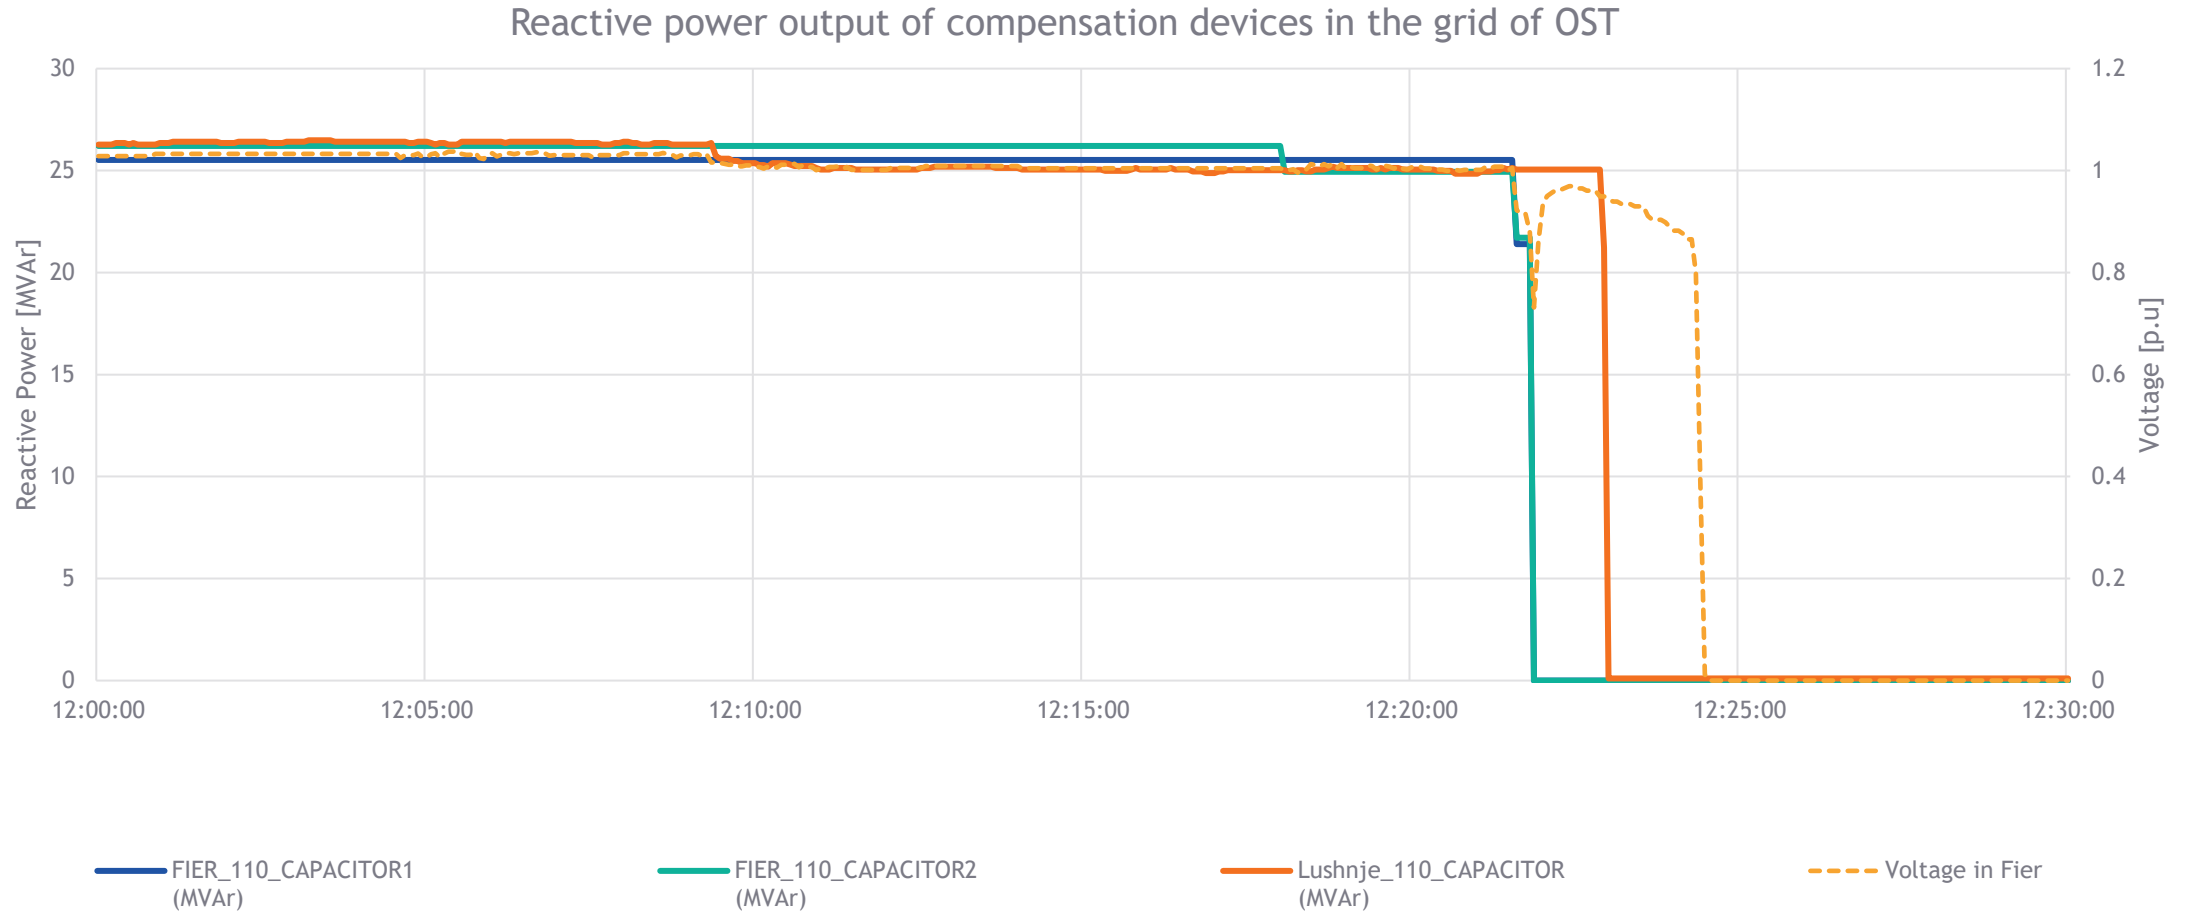
Root Cause 6: Insufficient other sources of MVar

Reactive Power Compensation devices during the incident

- 8 Study the possibility of implementing of an automatic emergency control concept for reactive power compensation devices on Mvar sources (capacitors IN, inductors OUT) at preset extreme voltage levels.

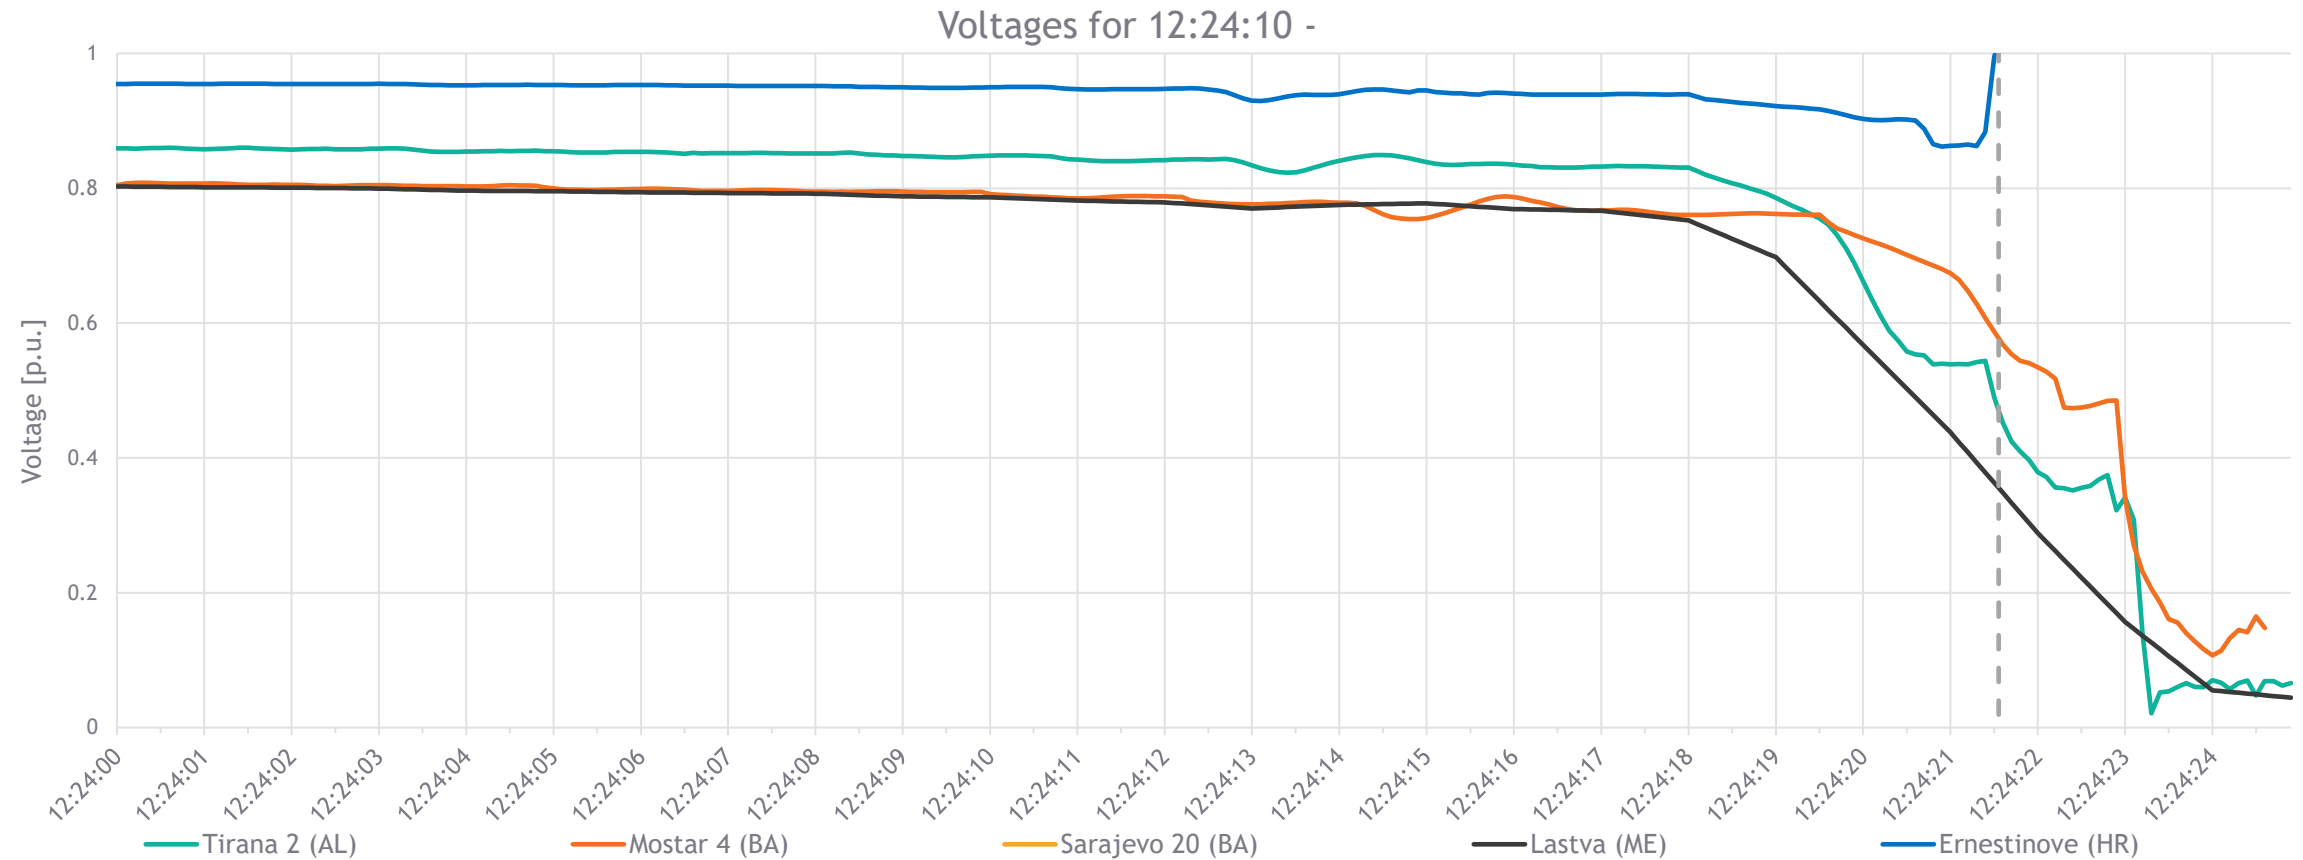
Root Cause 7: Absence of voltage collapse preventive measures

- 9 Assessment and installation of under-voltage load shedding (UVLS) at loads with a positive contribution on voltage in cases where insufficient other means of voltage support are available.
