## The traps behind the failure of Malpasset arch dam, France, in 1959

Pierre Duffaut\*

Expert in Geological Engineering, France

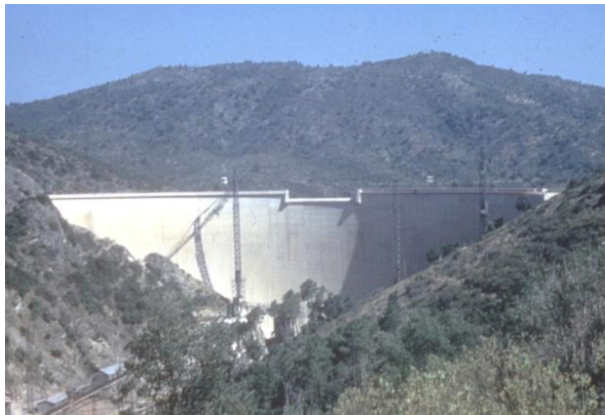
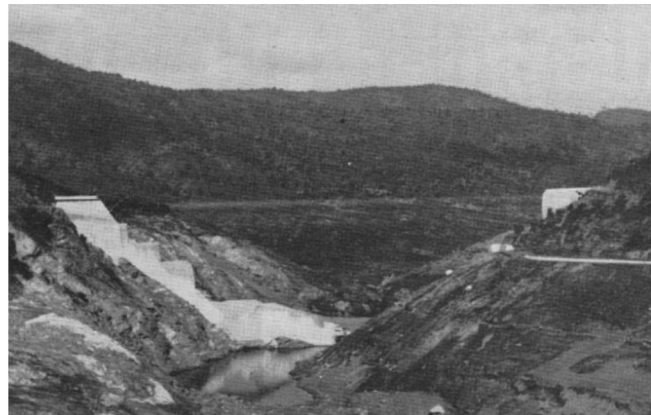
Fig. 1. Malpasset dam, left, at end of construction, summer 1954 (photo COB); right, soon after failure, end 1959 (photo Mary).

On 2 December 1959, the failure of Malpasset dam (Fig. 1) was a prominent industrial catastrophe in France within the 20th century, only second by number of victims to a coal dust explosion in Courrières mine 53 years before. It was also a clap of thunder in the world dam community as never before any arch dam had failed, as André Coyne had pointed when opening a symposium on arch dams in 1957 as president of International Commission on Large Dams (ICOLD). It is well known that many more have been built since worldwide, and far higher, without any failure either. Many papers have described the Malpasset case, from the early studies to construction, operation and failure, the expert reports, the trial minutes and many lab and site investigations launched in order to understand what went wrong, ending with five papers published in 2010 in *Revue Française de Géotechnique* (Carrère, 2010; Duffaut, 2010; Goguel, 2010a, b; Habib, 2010).

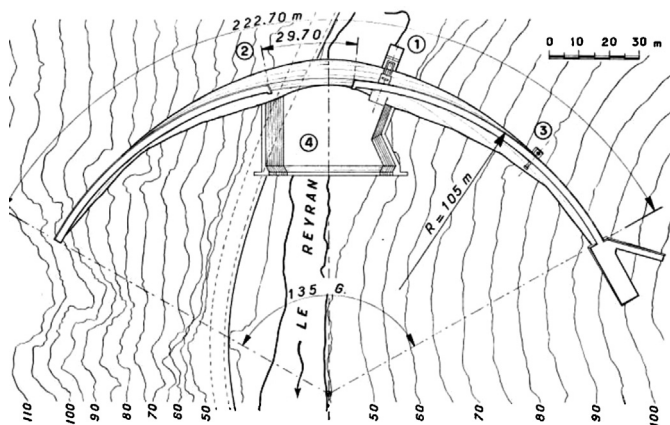
Fig. 2. Site map, contours in meters over sea level (1: bottom gate; 2: surface weir; 3: water intake; 4: stilling basin); at right a gravity thrust block protected from water thrust by a wing wall counteracts the crest arch thrust.

About 15 km from Fréjus, an old Roman city on the Côte d'Azur, along Mediterranean Sea, at a place called Malpasset (a bad pass for passing people), a dam had been designed and built in 1950s to provide irrigation and drink water from Reyran, a very small river. Prof. G. Corroy of Marseilles University delivered the geological report, André Coyne and his Bureau COB designed the arch dam (Figs. 2 and 3) and supervised the whole construction works, made

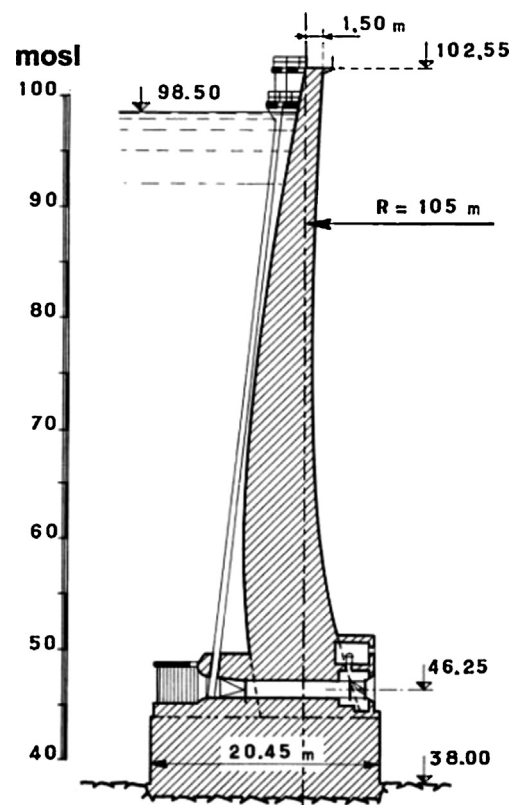
Fig. 3. Highest dam cross section (mosl means meter over sea level). The support of the hollow valve and its control gate explains the widened foundation at this place only. Crest elevation: 102.55 m over sea level; spillway elevation: 100.4 m; normal operation level: 98.5 m; bedrock level: 38 m.

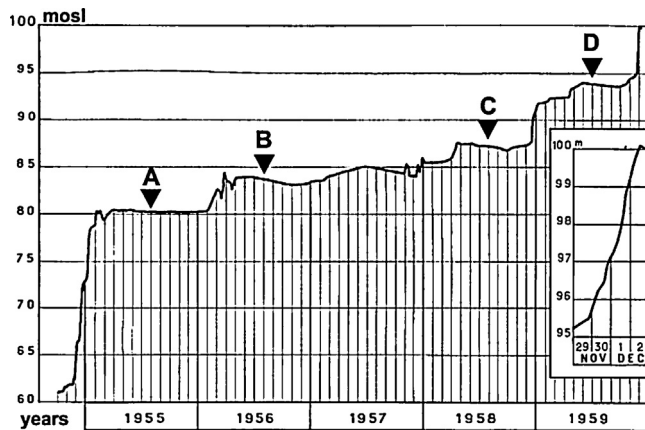
Fig. 4. Graph of the reservoir level along years 1954–1959. The box magnifies the four latest days, and triangles mark the dates of geodesy measurements A–D (after Mary, 1968).

**Flash flood:** At the end of November, a flash flood occurred and the level rose dramatically (box in Fig. 4). One may notice such floods had been neglected from the design stage.

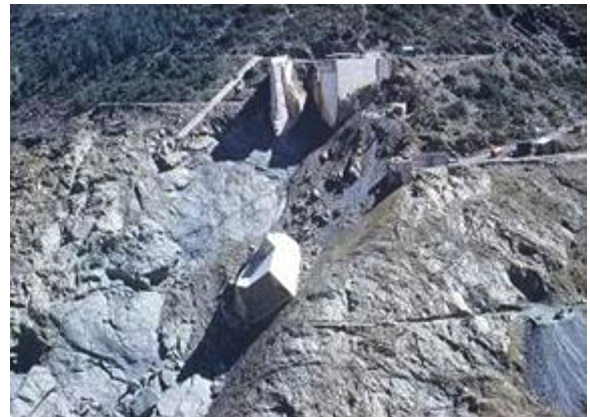
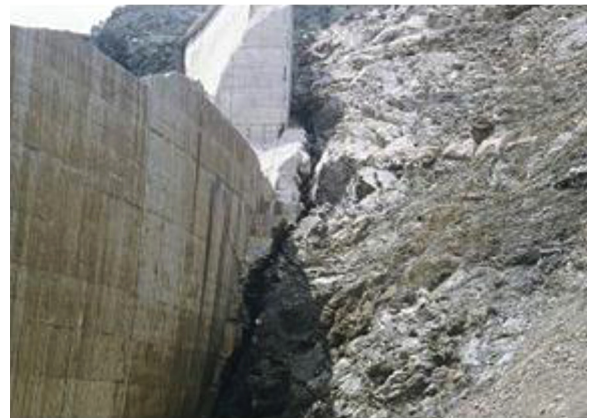
Only the failure daylighted two features of the rock mass which proved instrumental. A huge block of foundation rock was missing where was the left half of the dam arch, leaving an excavation in a dihedral form limited by two subplane faces, always visible now (top of Fig. 5). Its downstream face is a true fault plane with a thin cover of crushed rock (fresh scratches on the surface proved the whole block had moved upwards). Its upstream face looks as a set of tears along two or more foliation surfaces, without any crushed rock. Neither the fault nor the foliation had been recognized before; the contours on Fig. 2 could have helped to infer the position of the fault, but its strike perpendicular to the valley axis and its dip about 45° upstream would have considered it as perfectly neutral with respect to the thrusts received from the dam; the continuity of rock foliation had not appeared either, within the so heterogeneous structure of the gneiss. So a geometrical trap was in place, waiting for a force susceptible to move the block, which will appear later.

Fig. 5. The most conspicuous features of the site exposed after failure. Top, the “dihedral” excavation with half of the thrust block fallen after the flow (the exploratory adit at right was bored early after the failure to make jack tests in situ); below, a wide crevice is open just upstream of the concrete arch, wider at the base and closing more higher (photos Duffaut, 1960).

deformability was susceptible to play the same role: when the dam moves downstream under the water thrust, the rock upstream does not follow and a crack opens between the concrete and the rock as seen in Fig. 5 (below). The more deformable the rock mass is, the wider the crack opens, the deeper it extends, so increasing the height of the dam with a hydrostatic thrust increasing as the square of the height. Whichever mechanism prevails, the force on the dihedral is the same.

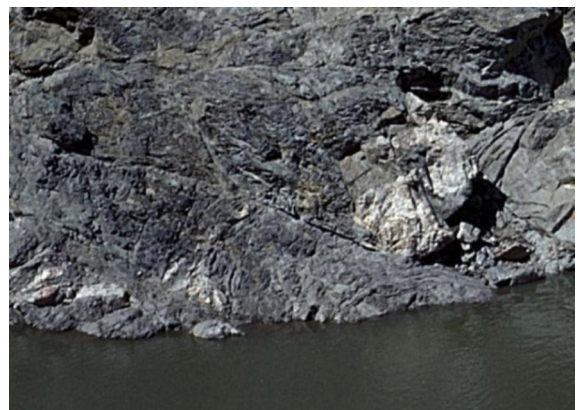
One may question why boreholes had not previously located the fault. First, most boreholes investigated the depth to the sound rock, under alluvium in the river bed and under any loose grounds along the valley slopes. Second, it is today difficult to recall that the technology of core recovery was not able to investigate such features. On many dam sites where contour lines accidents suggested a weak zone, their investigation used trenches instead of boreholes. The cleaning action of the flow made the fault path visible on the right bank and daylighted its cross section at either bank toe (Fig. 6).

Fig. 6. Close view of a cross section of the main fault on right bank. The finely crushed borders of the fault zone are well visible, thickness about metric (photo Duffaut, 1960).

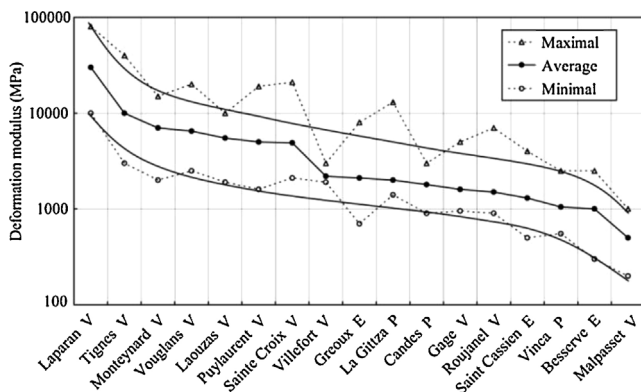
Fig. 7. Deformation modulus measured on 17 dam sites (V: arch; P: concrete gravity; E: rockfill). Modulus scale in MPa, logarithmic; sites classified by decreasing modulus along three curves, maximal, average and minimal values (graph designed by B. Goguel, from EDF data).

Later the practice became usual on most new sites, as shown in Fig. 7 which gathers the results for 17 sites and confirms the very high deformability of the rock mass, ten times less than that on most sites, hundred times less than that on best sites.

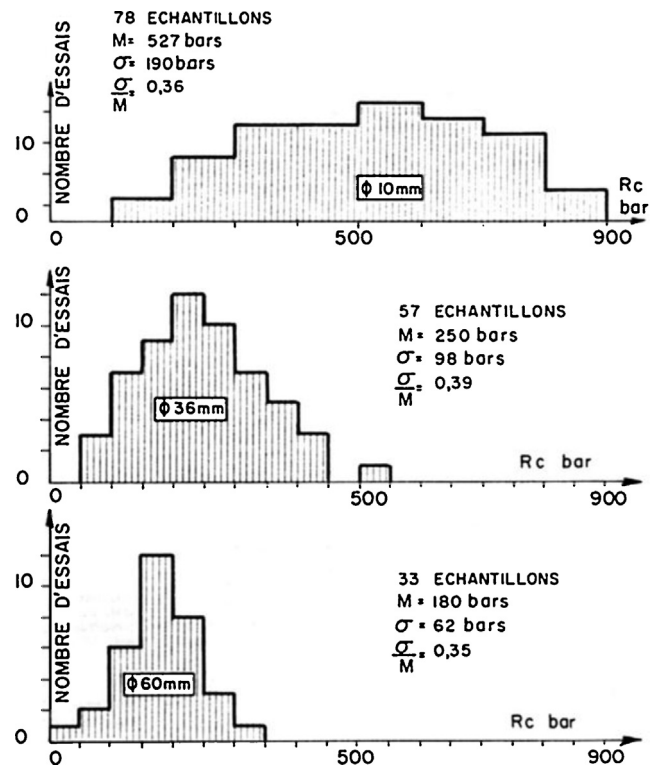
Fig. 8. Distribution of unconfined compressive strength  $R_c$  in bar ( $\approx 0.1$  MPa) on dry samples (échantillons) collected on the left bank; three sets of cylinders, diameters 10, 36, and 60 mm (Bernaix, 1967). Comparison between three cases shows the scale effect: maximum strength occurs on smaller cylinders, where scatter also is the highest (vertical axis: number of samples;  $M$ : average value;  $\sigma$ : standard deviation).

Standard uniaxial compressive and tensile tests were performed on cylinders with diameters 10–60 mm and the same height to diameter ratio, 2.0. Strength values did not appear too low in average (58 MPa at dry state, and 42.5 MPa at saturated), but their scatter appeared by far wider than usual (coefficient of variation about 0.36), so providing many spots with high deformability. Taking various dimensions, a high scale effect was detected, as seen in Fig. 8. Systematic studies on various rock types showed that scatter and scale effect went together and provided a reliable fracturation criteria.

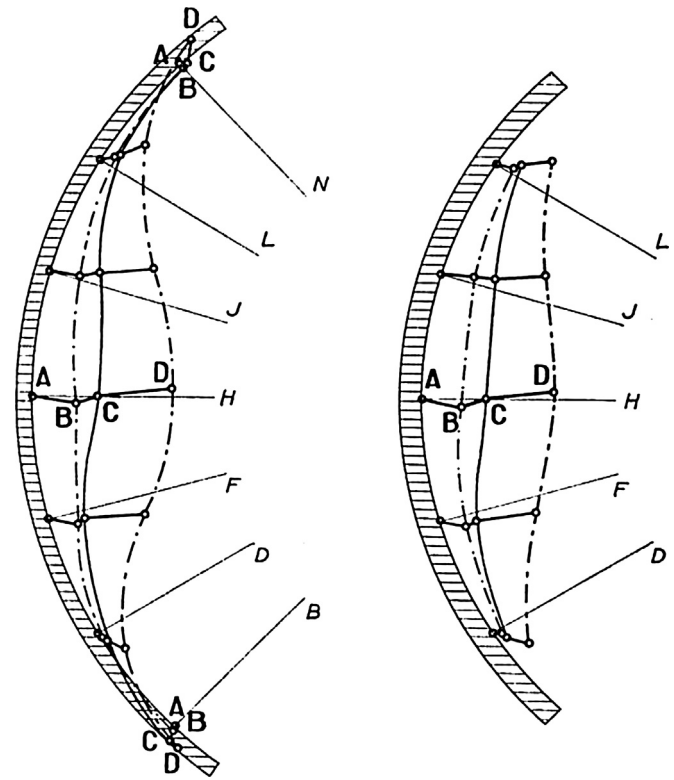
Fig. 9. Displacements of the targets along arches at elevation 78 and 90 m (after Mary, 1968); bold letters refer to measurement dates (Fig. 4); other letters name the construction joints between monoliths; the scale applies to target displacements: segments CD, between measurements 1958–1959, show a general move toward the left bank, a fact any professional could have noticed as a change of behavior, long before the latest 5 m rise.
