**ARCHES**

**Assessment and Rehabilitation of Central European Highway Structures**

**Guideline for Smart Cathodic Protection of steel in concrete**

**Deliverable D12**

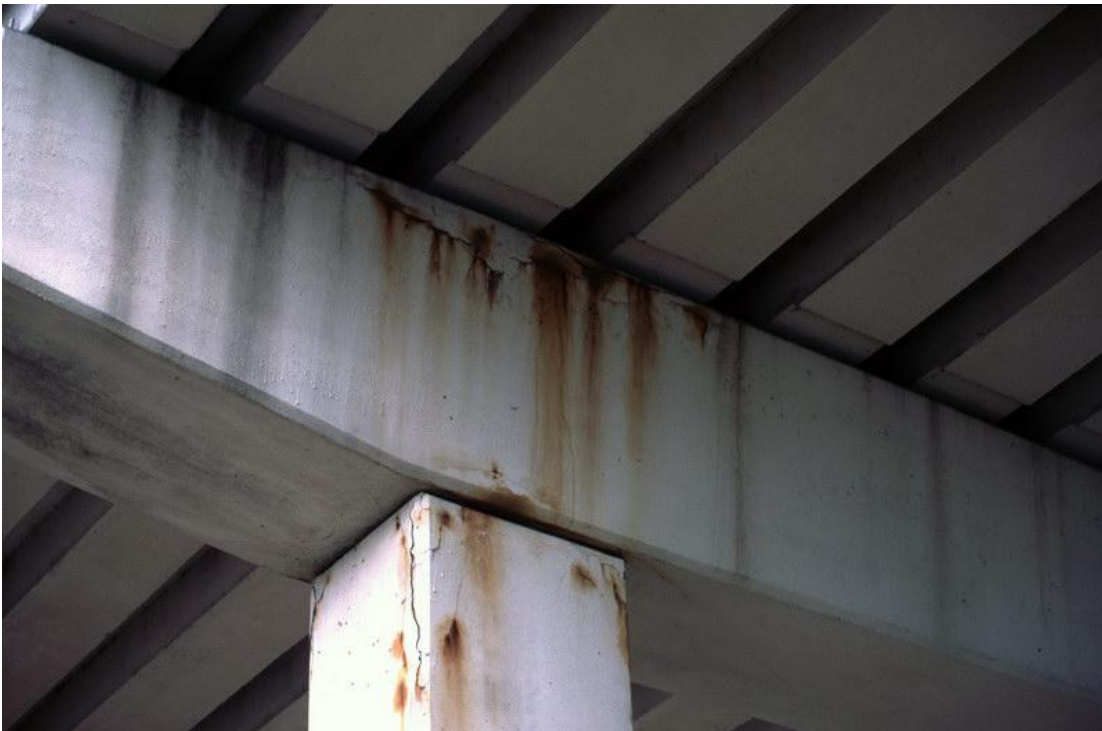
Figure 2 Rust stains and cracking in bridge cross beam due to reinforcement corrosion

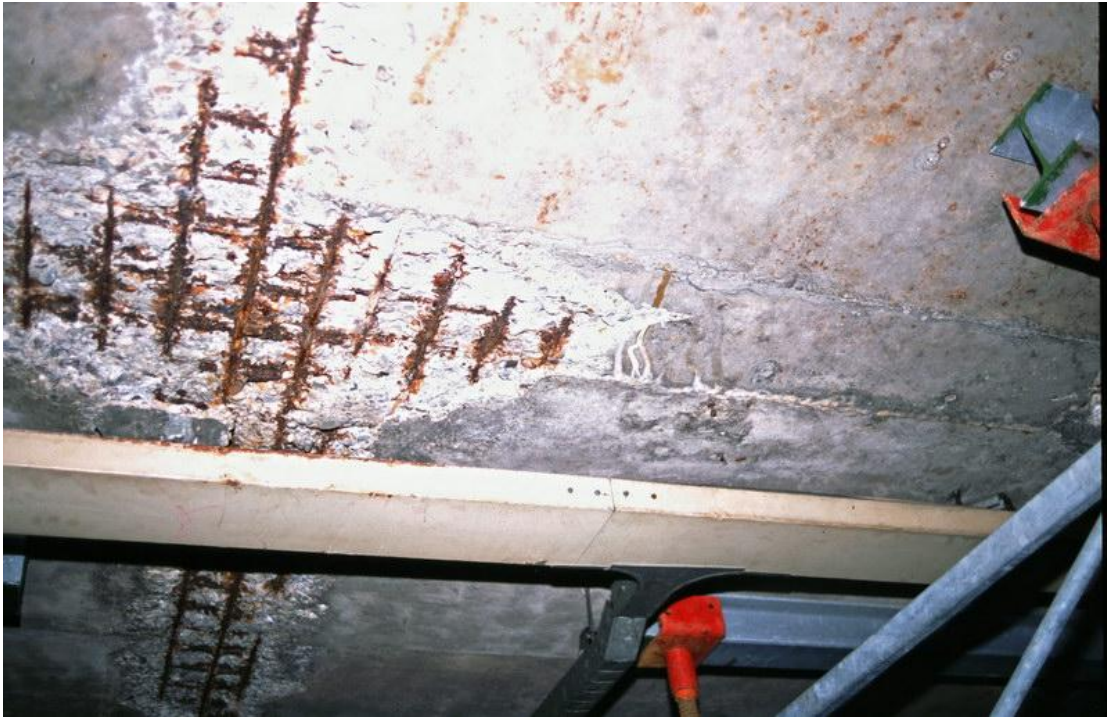
Figure 3 Spalling and delamination due to corrosion

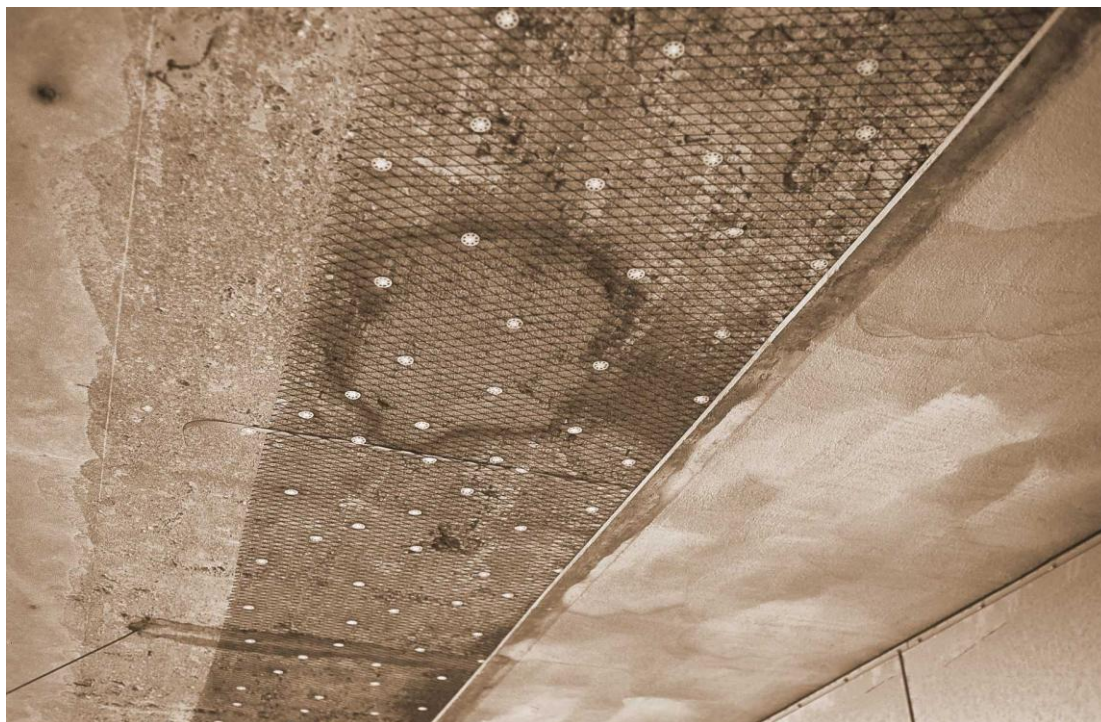
Figure 6 Three stages of application of a titanium mesh to the underside of a concrete slab; *left*: prepared surface; *middle*: titanium mesh attached (note repair patch and plastic fixing pins); *right*: shotcrete overlay applied

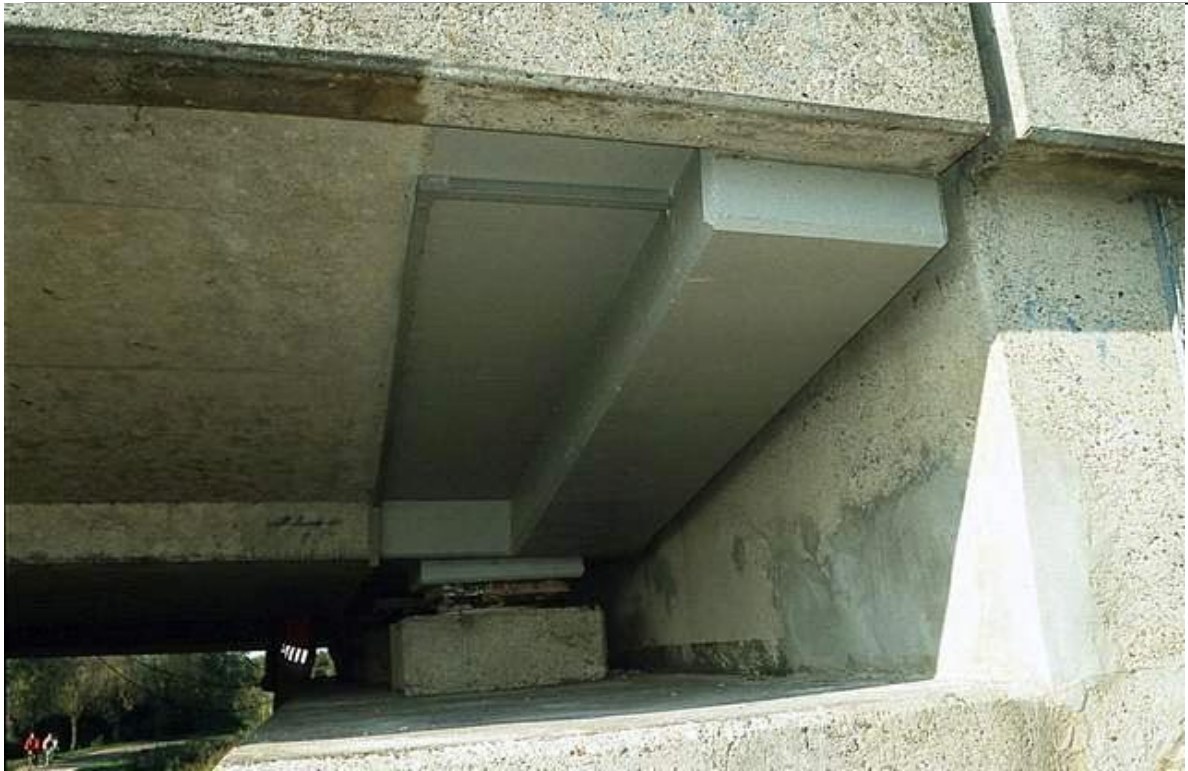
Figure 7 Conductive coating anode applied on edge beam of bridge deck adjacent to abutment

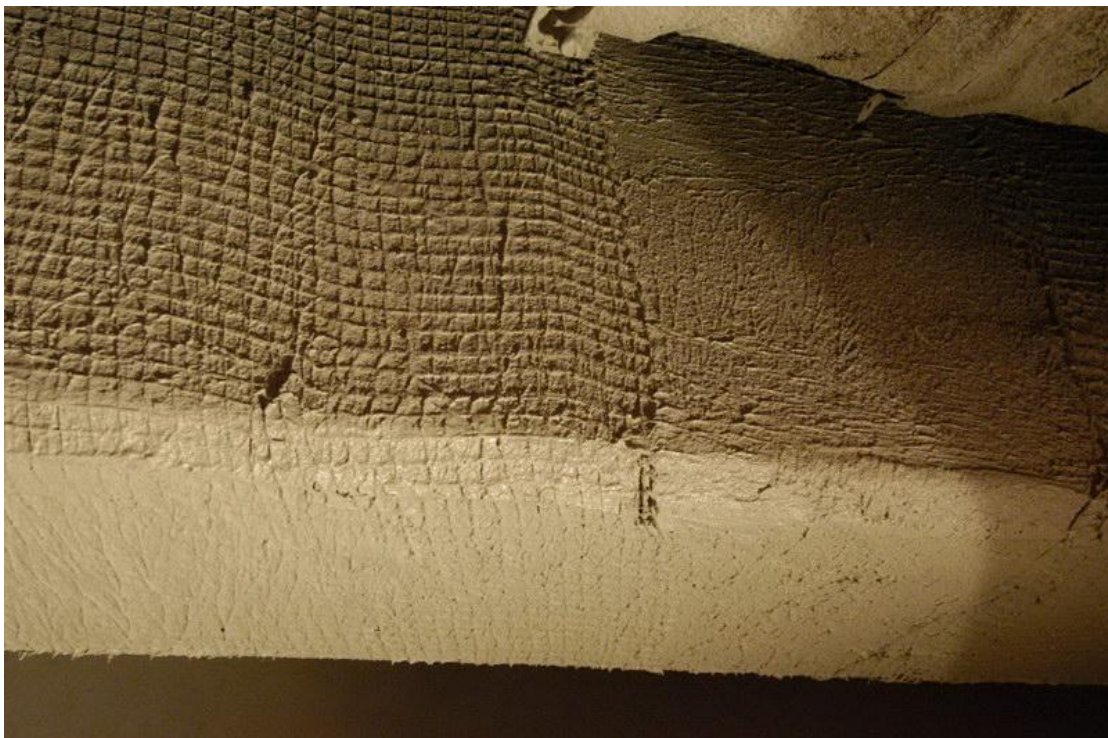
Figure 8 Carbon fibre mesh applied in first layer of cementitious mortar (to be finished with another layer of mortar)

Carbon fibre materials including woven mats (textiles) constitute a new type of anode materials, which supposedly combine the advantages of titanium mesh and conductive coating. They are claimed to provide durable anode properties and can be applied in thin overlays of polymer modified cement mortar, thus adding little weight, Figure 8.

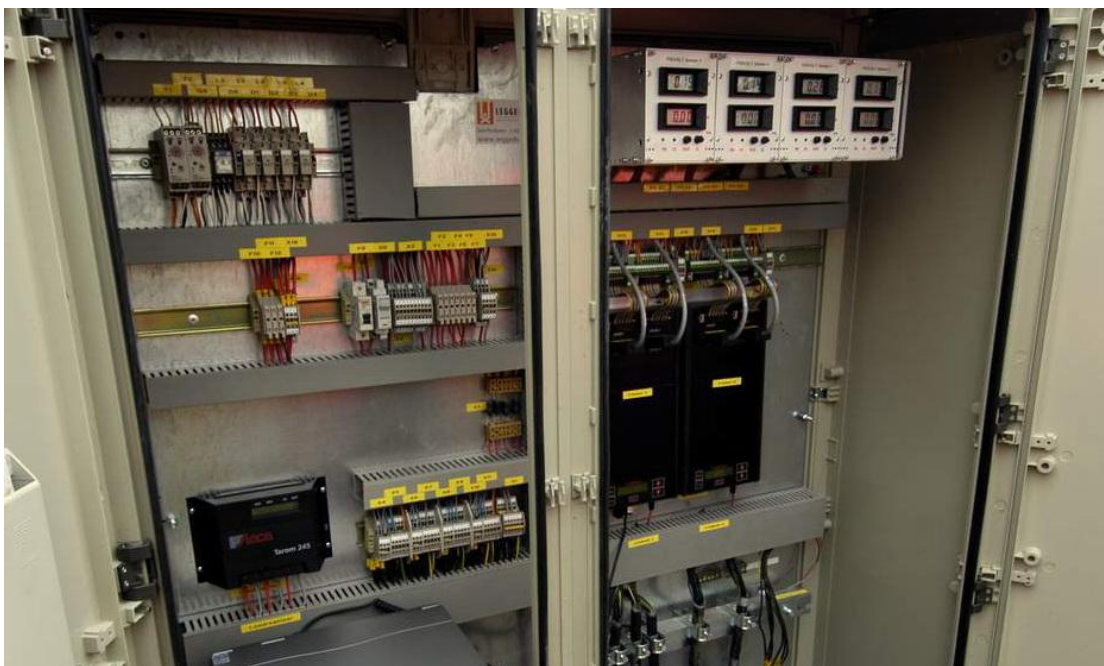
Figure 9 CP system control box with four power units (top right), datalogger/remote control (middle right), cable connections and testing points (left)

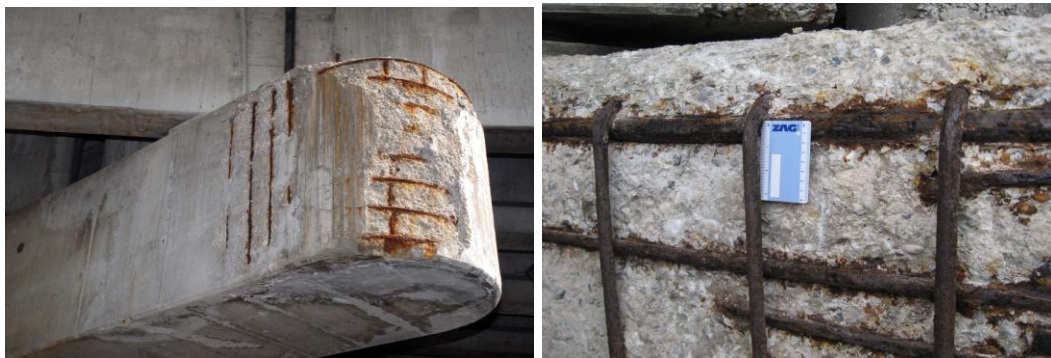
**Figure A.1.1: The damaged bridge substructure in Slovenia**

CP was applied to part of the substructure of a bridge near Ljubljana, Slovenia. The case was used for cost calculations in chapter 4.6. Details on the bridge and the corrosion damage observed are presented in Appendix B3. From March 2008 until August 2008, the evaluation of the corrosion damage, the repair works and the application of the CP system were performed. Figure A.1.1 presents a view of the damage in one cantilever head and a detail of exposed reinforcement. Figure A.1.2 presents a map of corrosion potentials on the vertical surface of a cantilever head. Further investigations showed both chloride ingress and carbonation had caused corrosion, in combination with local low cover to the steel.

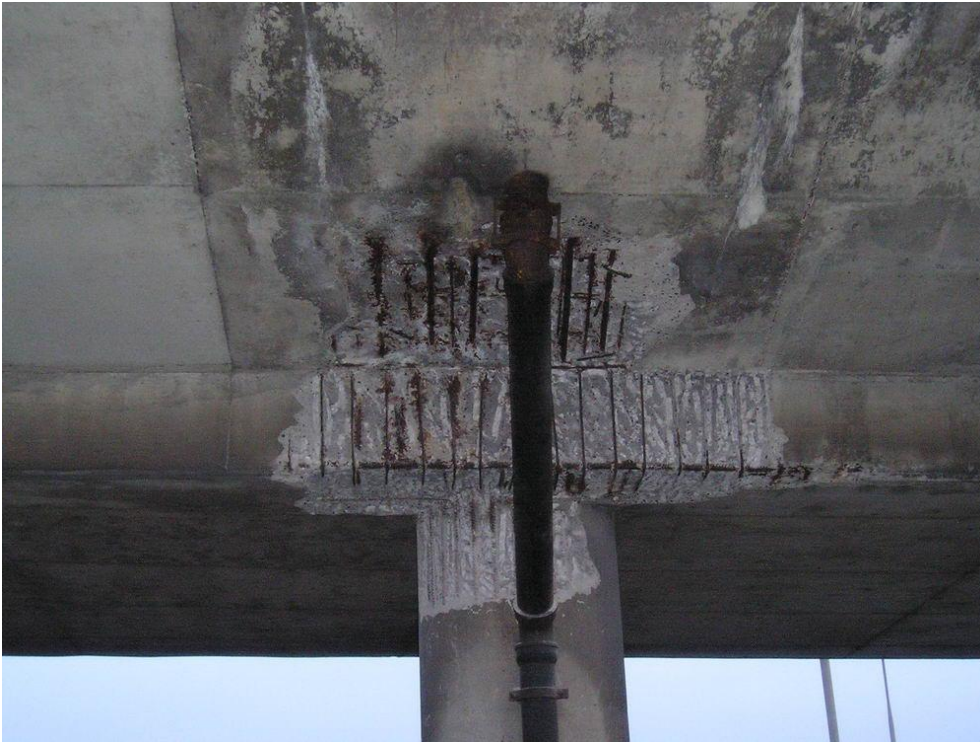
**Figure A.1.4 Corrosion damage due to leaking drain system in motorway bridge near Warsaw**

The CP trial was installed on a motorway bridge near Warsaw, Poland, in late 2008 – early 2009. The case involves corrosion damage due to leaking drains as shown in Figure A.1.4. Preparing for CP trial application, the reinforcement was exposed; a repair mortar was applied and titanium strip anodes were installed as shown in Figure A.1.5 and subsequently overlaid with mortar. The system had not been activated yet at the time of closing this report.

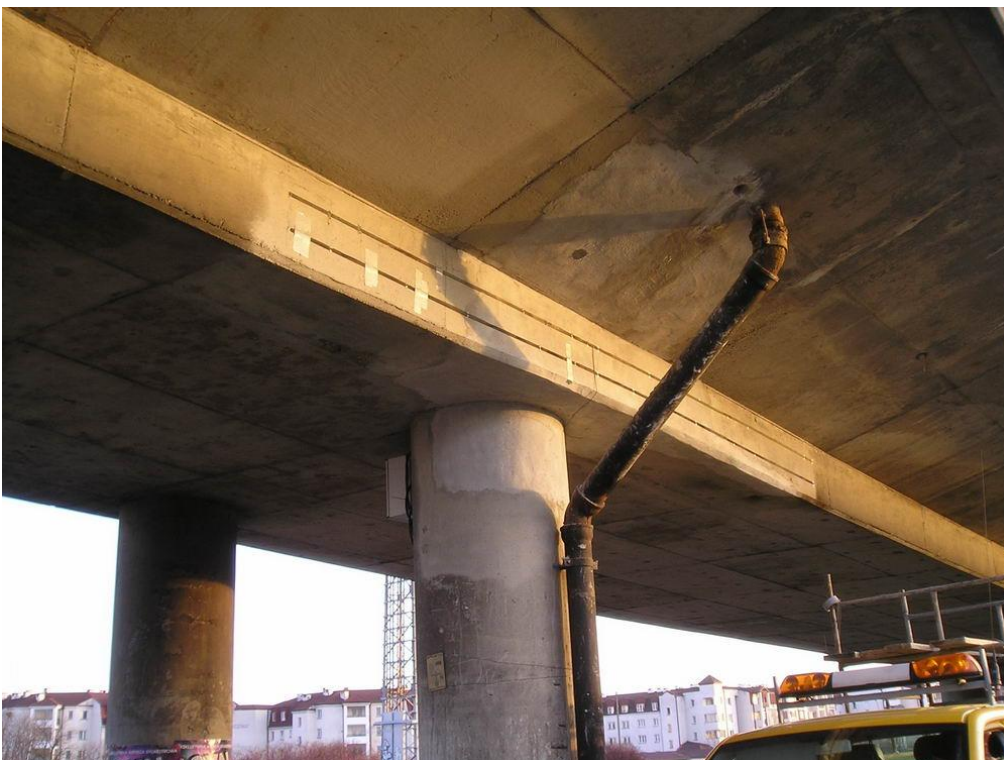
**Figure A.1.5 Titanium strip anodes installed before overlaying on side surface; three strips have already been overlaid in the bottom face**

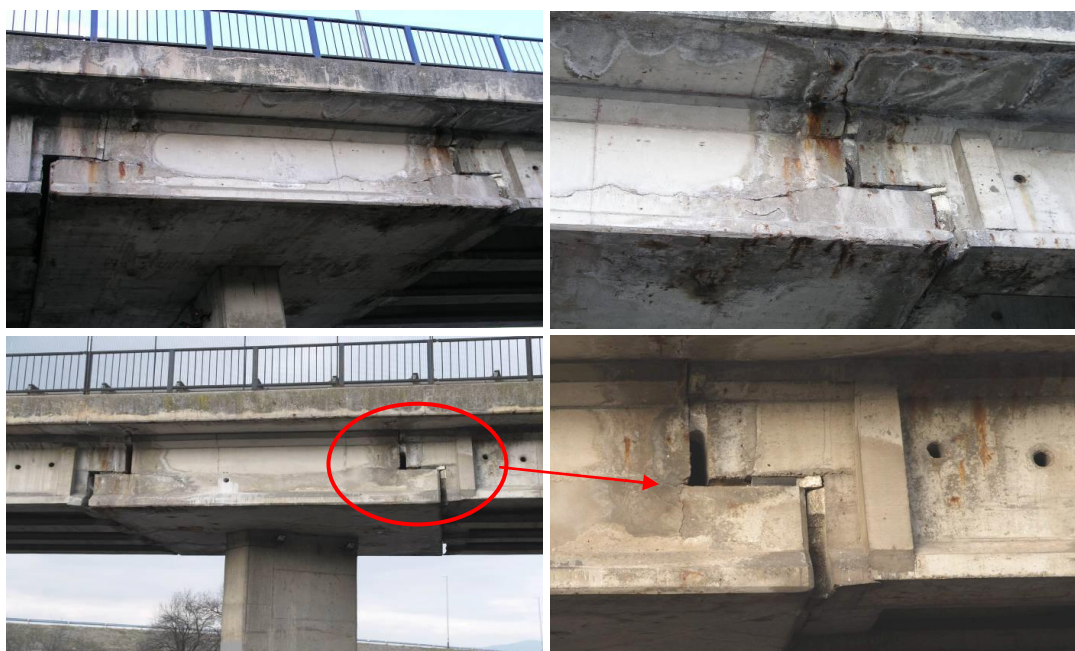
**Figure B.2: Support areas on the cantilever head beams and main girders**

The unforeseen access of de-icing salts to the concrete has caused reinforcement corrosion and cracking and spalling of concrete. The deeper cause lies in the applied structural system, which is a set of Gerber girders as primary main load bearing system with a continuous deck slab made out of precast slabs as secondary system. The concept was based on one assumption that proved to be faulty. This assumption was: it is appropriate to lower costs by not installing rail expansion joints on the discontinuities in the main bearing structure. Thus, all elements above the main girders (deck slab, pedestrian ways, cornices, asphalt pavement, curbs and all fences) were carried out in continuity over all spans with only two additional rail expansion joints within the overpass (two were installed above the abutments), [1].

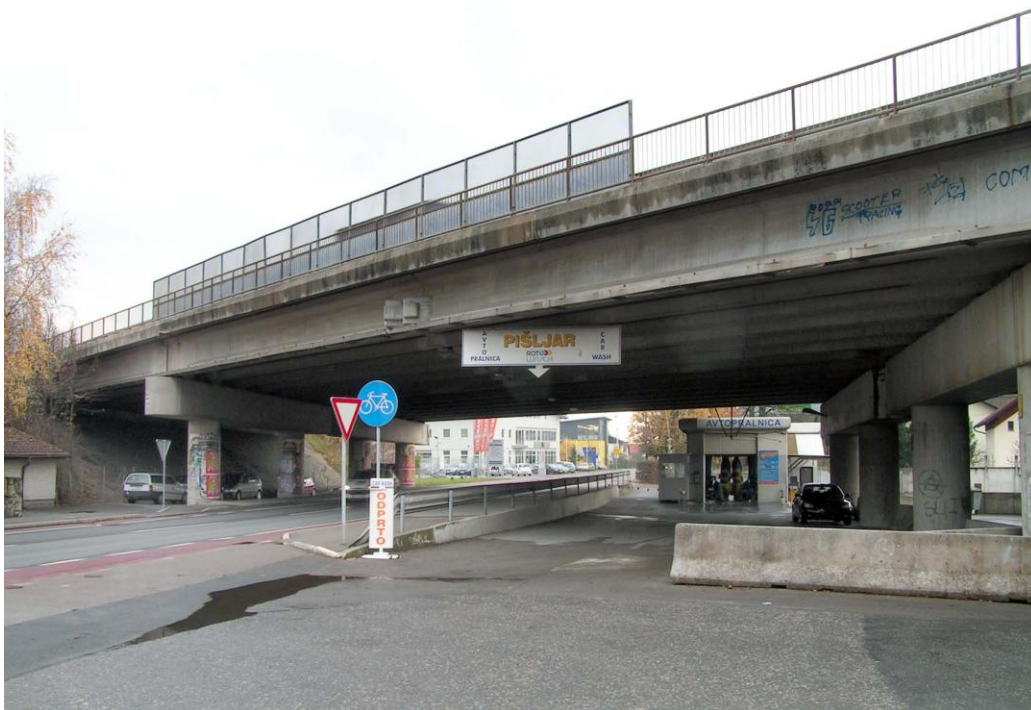
The VA0128 overpass on the Ljubljana - Koper highway is located in the suburban area of Ljubljana; it was built in 1979. The substructure of this bridge was chosen for the trial application of a smart CP system (see A1.1).

The overpass consists of two parallel structures, one for each driving direction. Each has a total span of 89.34 m with two supports (spans 25.67 + 38.00 + 25.67 m) and is about 20 m wide (total width 40 m). The bearing system of each structure (substructure) consists of 4 piles, two 2-pier frame intermediate supports per bridge. The superstructure consists of 7 main pre-tensioned precast simply supported girders and an on-site cast concrete deck. The main girders are interrupted at the intermediate supports, but the concrete deck is cast continuously, without a construction joint over the two intermediate supports. The support beams have a length of 20 m, with a mid-span of about 10 m and two cantilever heads of 3.8 and 4.1 m.

**Figure B.4** Overpass view from NE

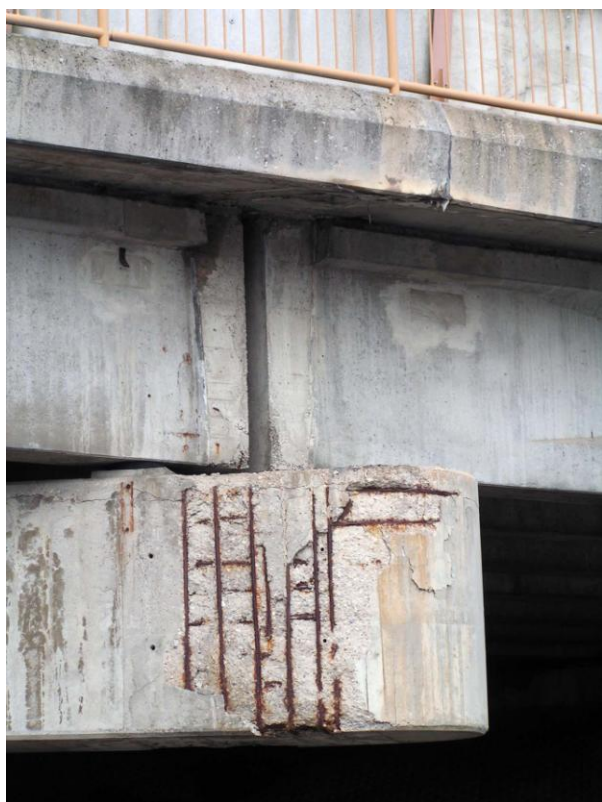
**Figure B.5 Reinforcement corrosion and concrete spalling**

Although a waterproofing membrane was applied on the concrete deck, the superstructure is leaking. In winter time de-icing salts are applied on the highway. Melted snow and ice contaminated with de-icing salts leaks across the cross beams causing deterioration of concrete and reinforcement. In addition, the drainage system of the bridge is leaking. Investigations on the beams showed that the concrete cover depth varies strongly, with average 25 mm but locally even lower than the designed 15 mm. Carbonation depths were typically 20 mm and more; chloride contents were raised but relatively low. The combination of various faults (improper design, shallow construction and superficial maintenance) resulted in severe, but locally restricted corrosion damage.
