# Exercise 1: values appraisal of an existing structure

## Hauteroche mansion

### Background and objective

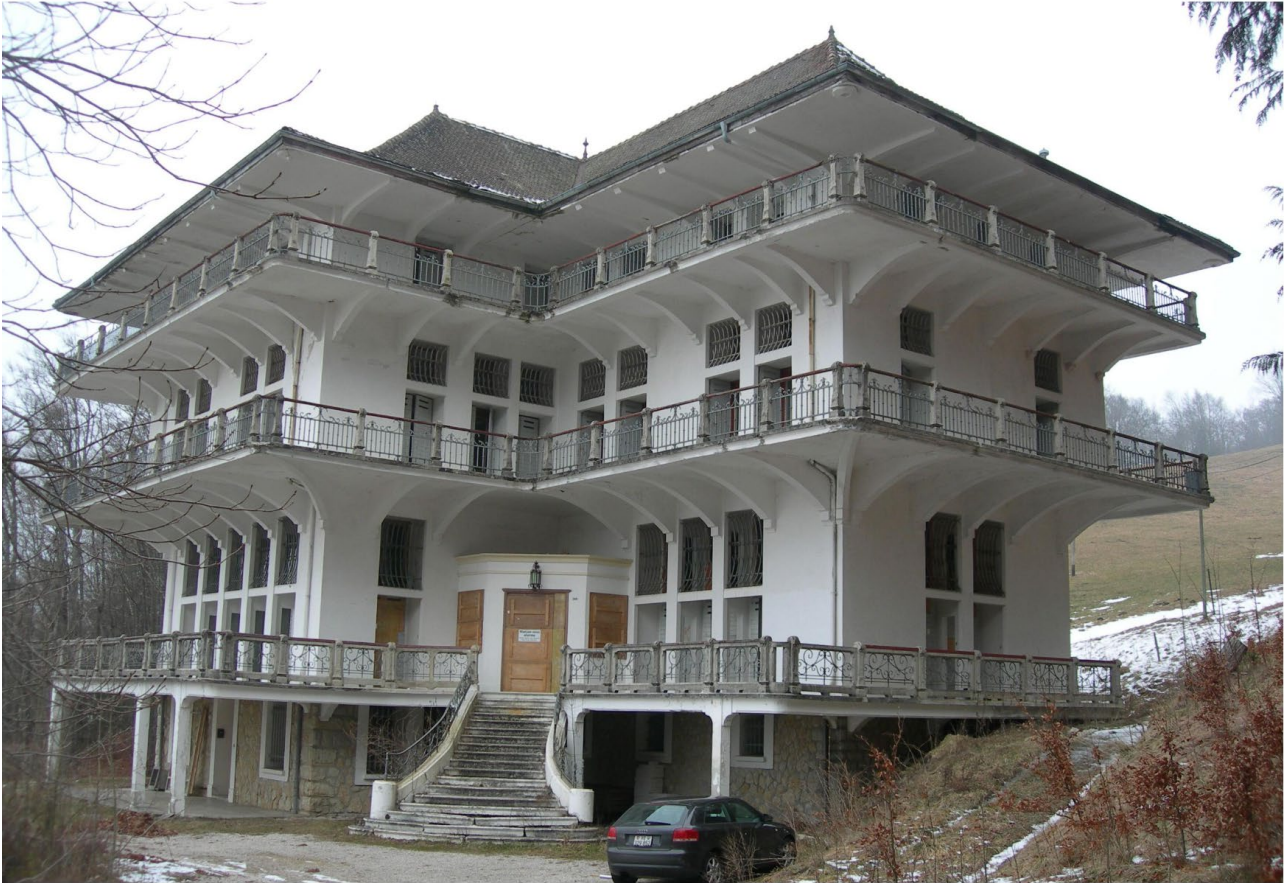
Figure 2: overview of the building [5].

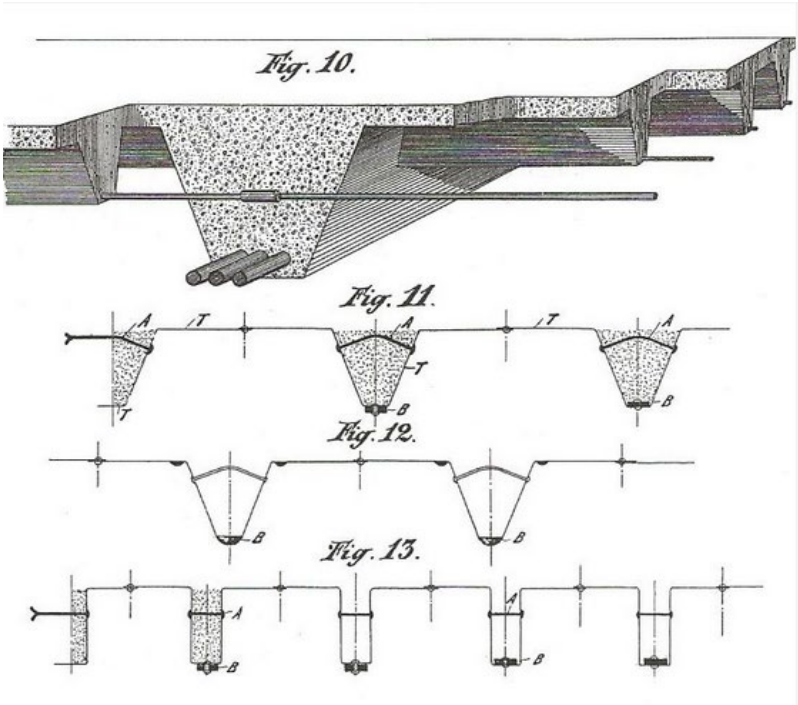
Figure 5: excerpt from Hennebique’s patent [4].

The “Hauteroche” mansion is located in Swiss Jura (Le Pont), above the Joux lake, Figure 1. It is one of the first reinforced concrete structures in Switzerland. The structure was designed in reinforced concrete following the pioneering patent of François Hennebique [3]. It was erected between 1911 and 1913. The verification of the structural safety of the building in 2013 showed that it was sufficient. More detailed information is given in Annex A.

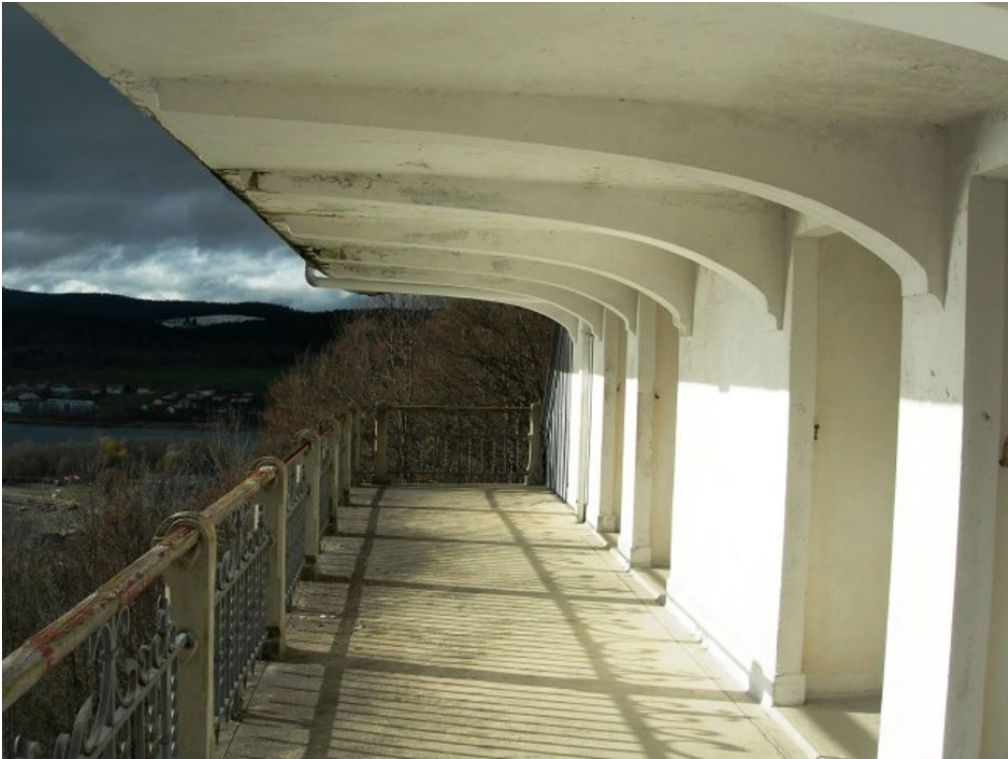
Figure 6: condition of the building in 2013, photo E. Brühwiler.

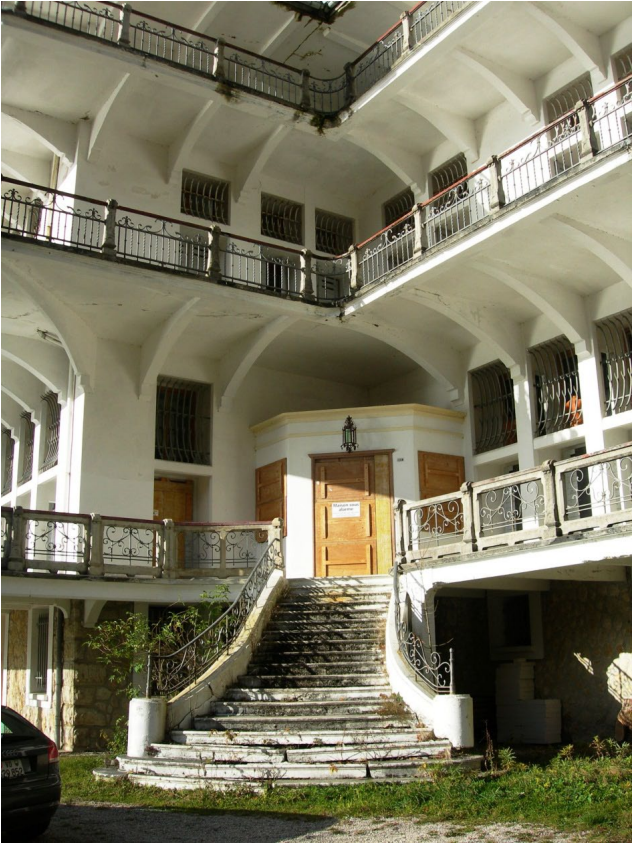
Figure 7: condition of the building in 2013, photo E. Brühwiler.
