Underground heating system leak detection using Aerial IR Thermography and advanced data analysis neural algorithms

EPFL Lausanne - 19th May, 2025

Dipl. Ing. Luca Del Nero
DarkWave Thermo Schweiz GmbH

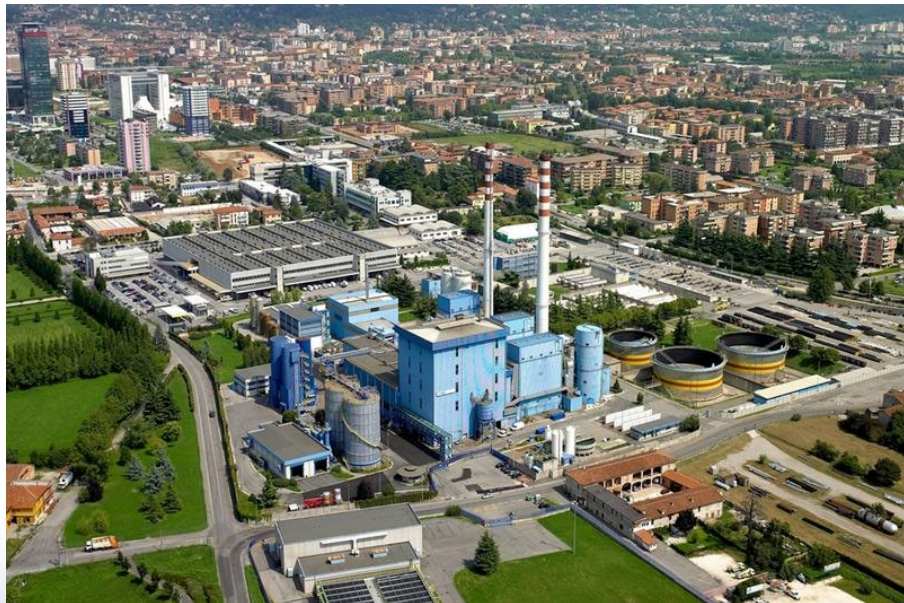
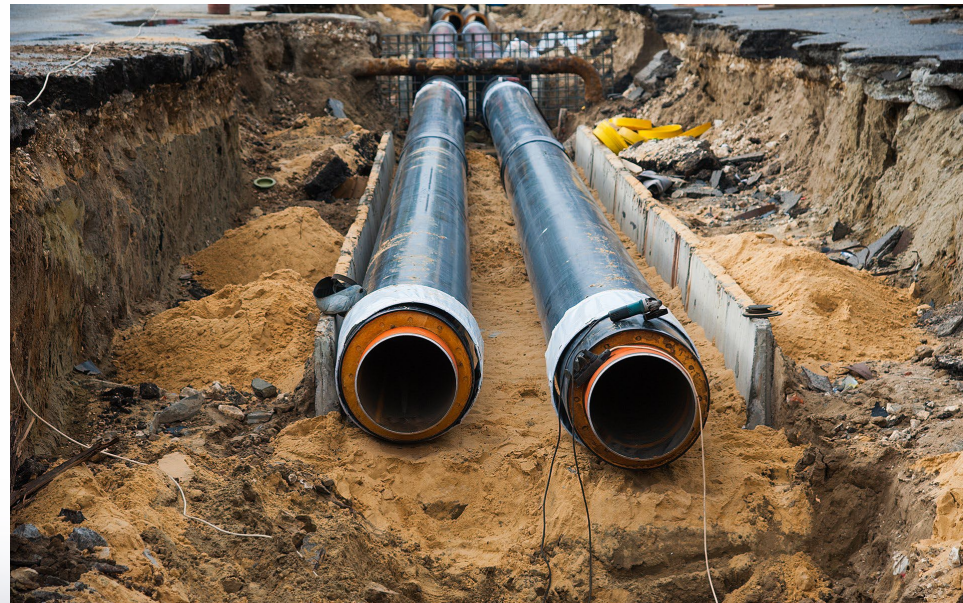
Challenge/Needs:

Multi-utility companies offer services to improve energy efficiency in large urban centers, including building district heating.

The distribution network for heating fluids spans hundreds of kilometers and is subject to losses and leaks.

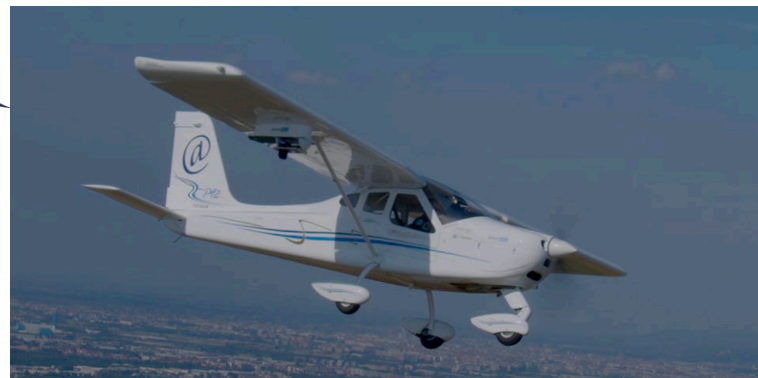
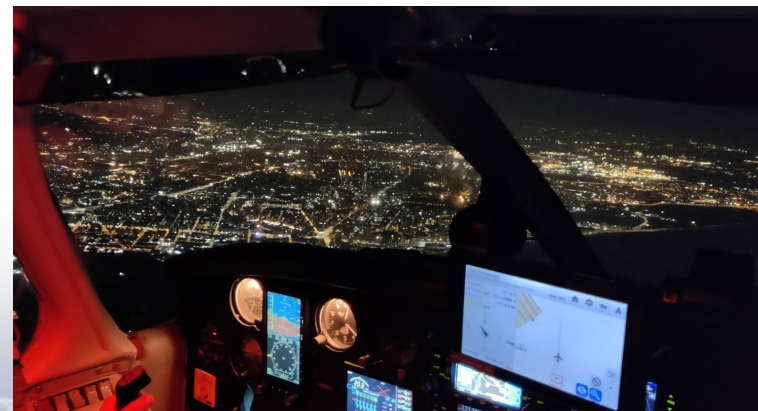
Technological Solution:

Night aerial thermography with high-end MWIR camera allows to obtain accurate maps with a GSD of approximately 15 cm and positional accuracy under one meter, during hours with minimal interference from vehicles on the road.

The map (orthophoto) can be overlaid onto the distribution network to detect thermal "spots" that indicate a network leak.

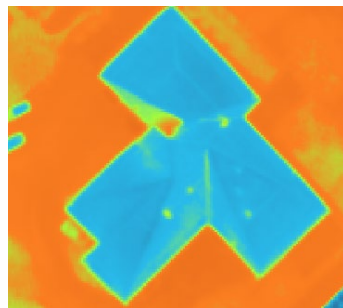
Buildings

False positive typologies

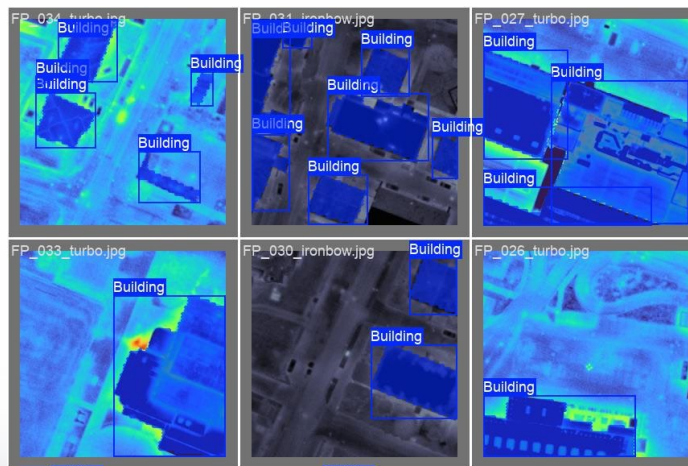
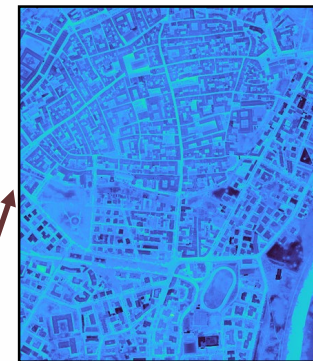
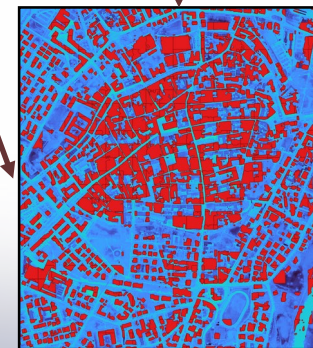
YOLOV8
Output

False positive prediction DL

Training samples:

>1000

Deep learning architecture:

YOLOV8

Bands:

1 (Thermal MWIR)

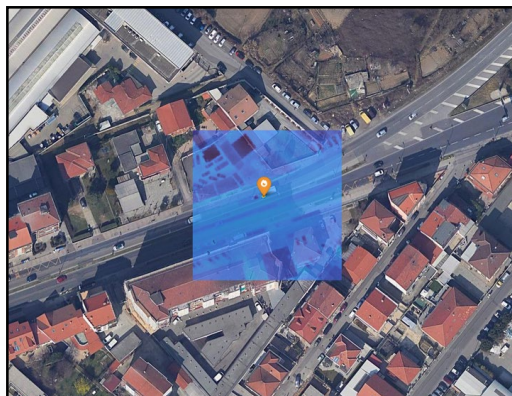
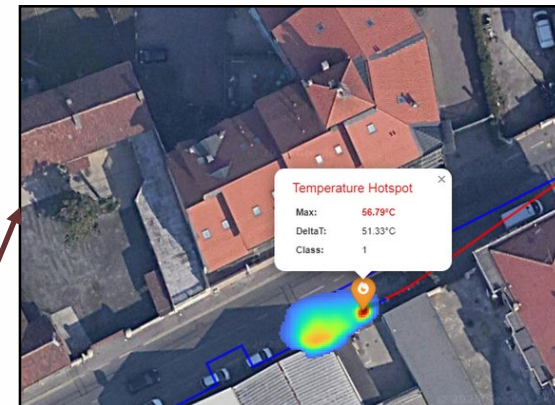
Class 1 anomaly

Anomaly prediction DL

Training samples:

>500 (*per class*)

Deep learning architecture:

DeepLabV3
