Accident at Russia's Biggest Hydroelectric

Sayano-Shushenskaya – 2009 August 17

Euler Cruz
Consulting Engineer – Turbines

This is a preliminary analysis made based only on pictures and films, done no longer than one week after the accident. Only hypotheses are formulated.

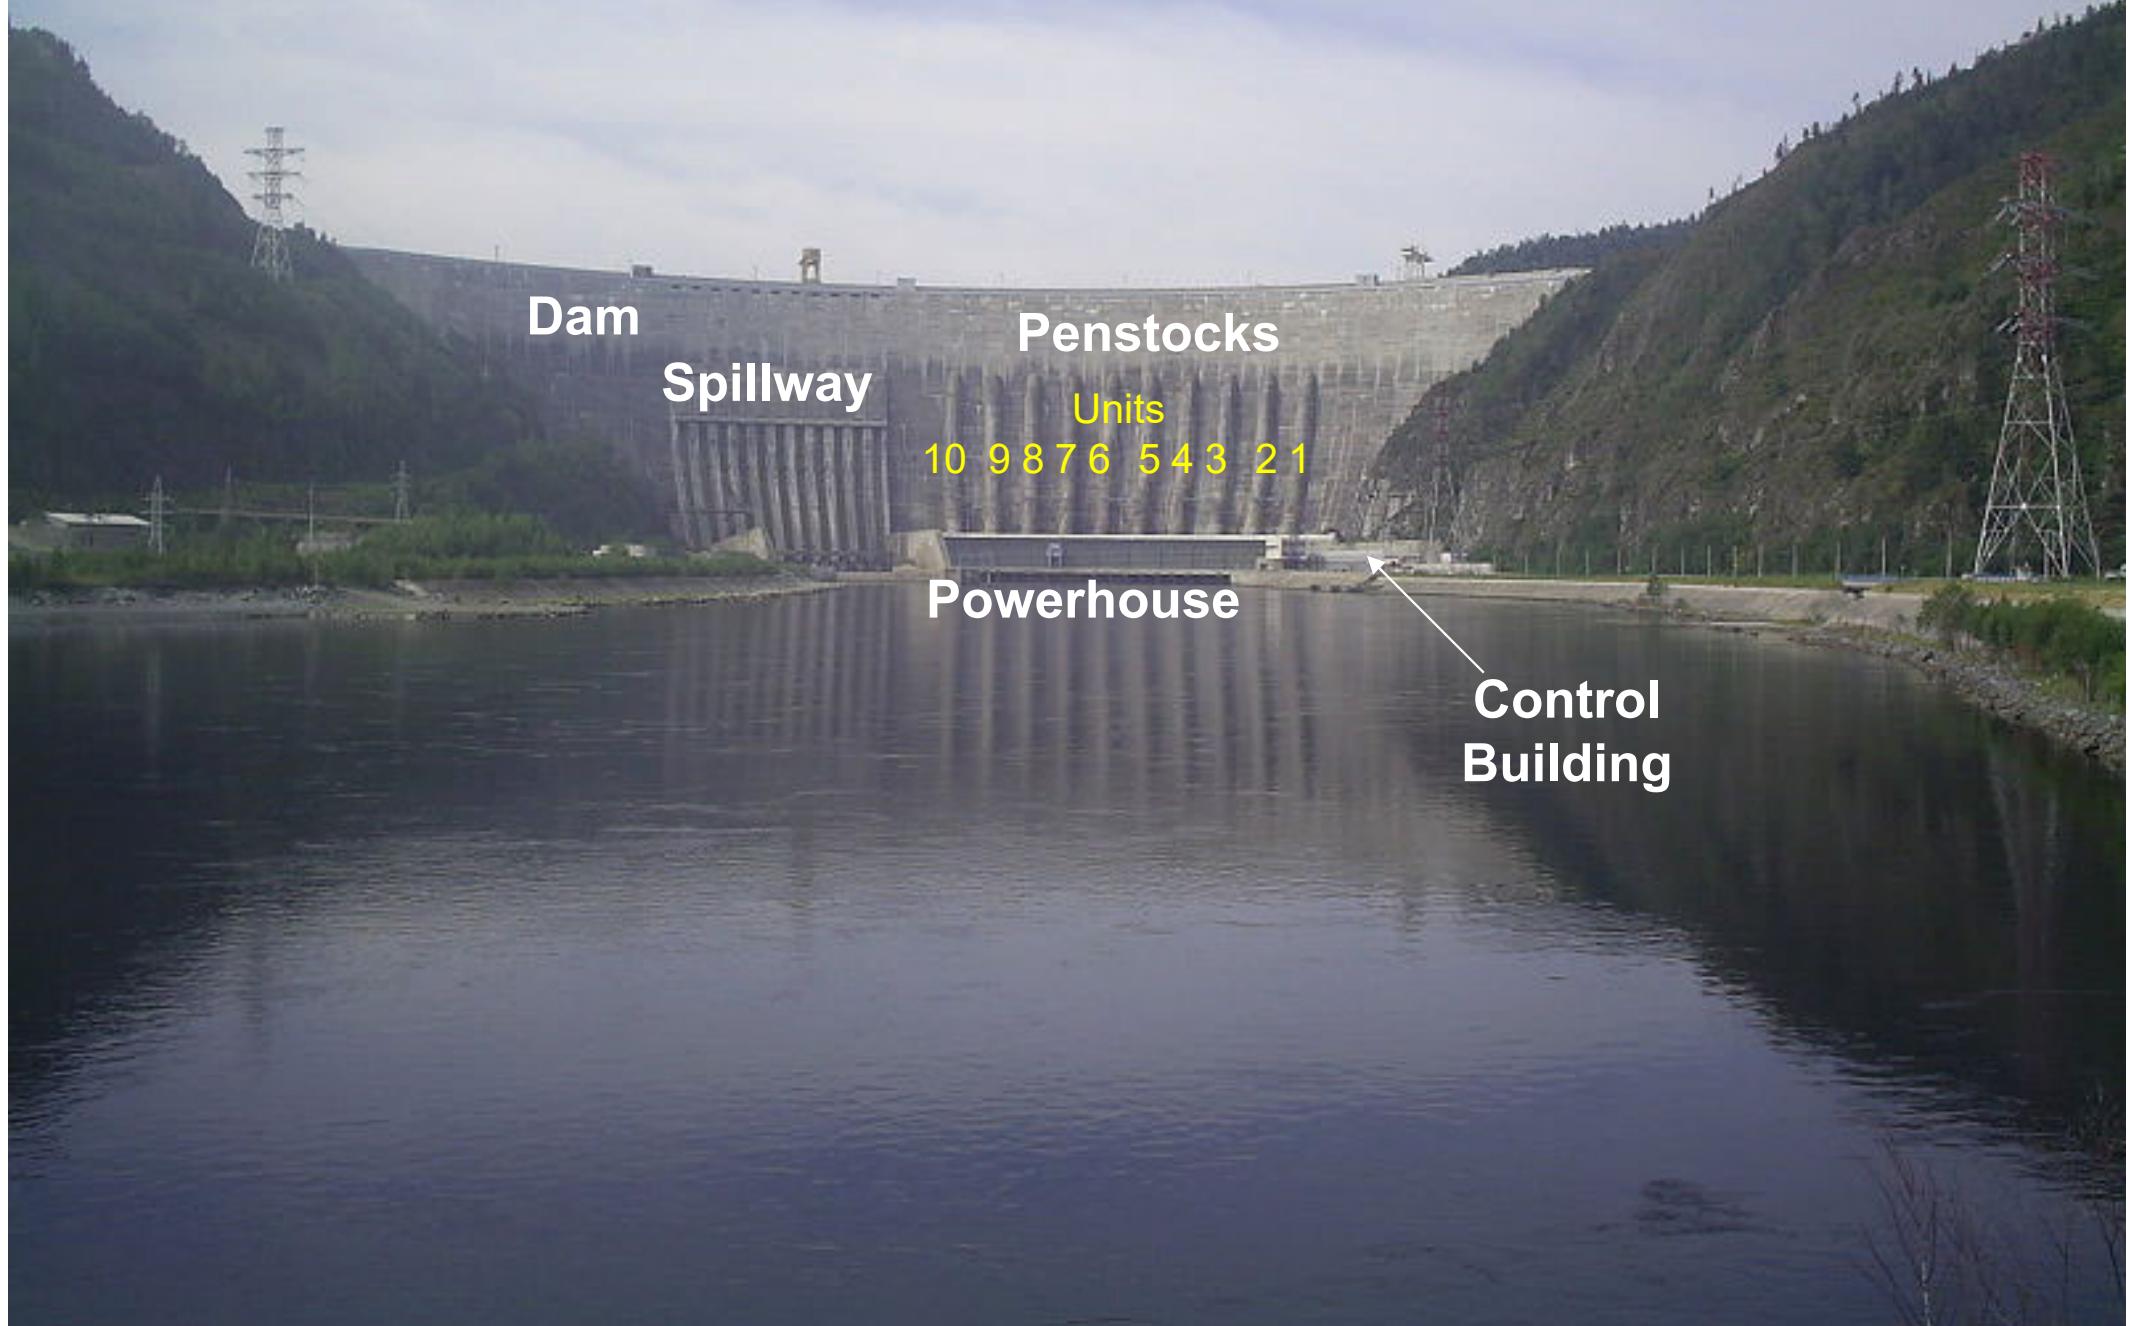
Dam

Spillway

Penstocks

Units

10 9 8 7 6 5 4 3 2 1

Powerhouse

Control
Building

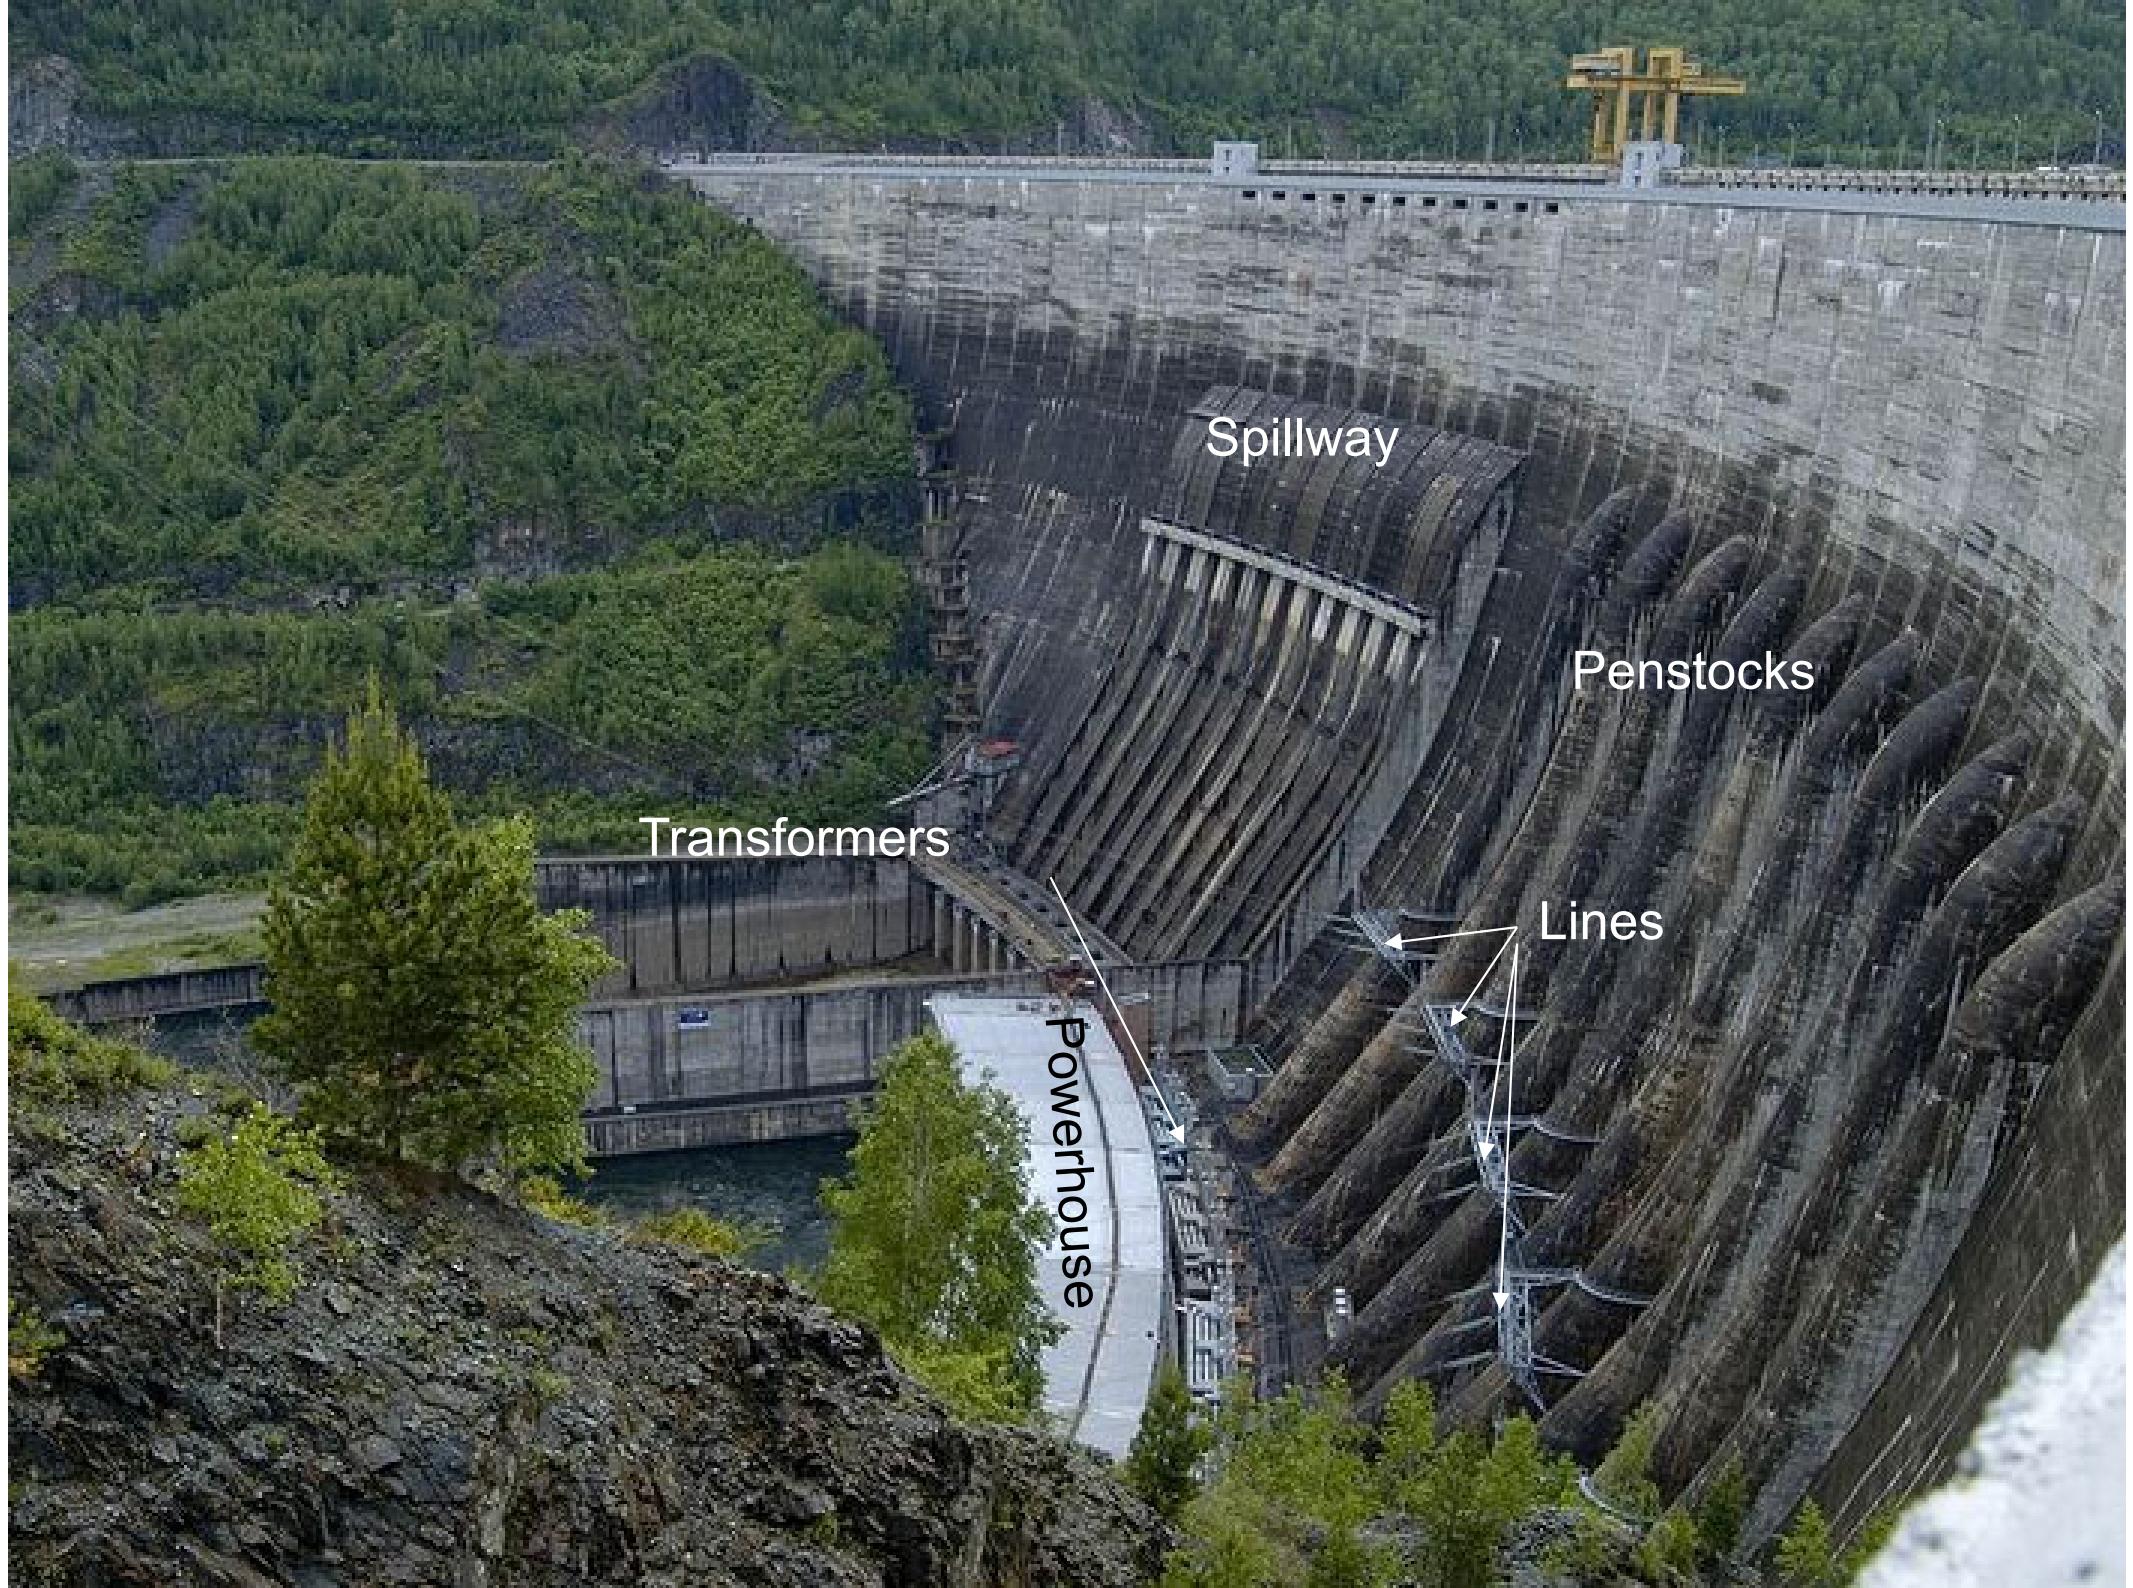
Spillway

Penstocks

Transformers

Powerhouse

Lines

Sayano-Shushenskaya hydro-electric power plant

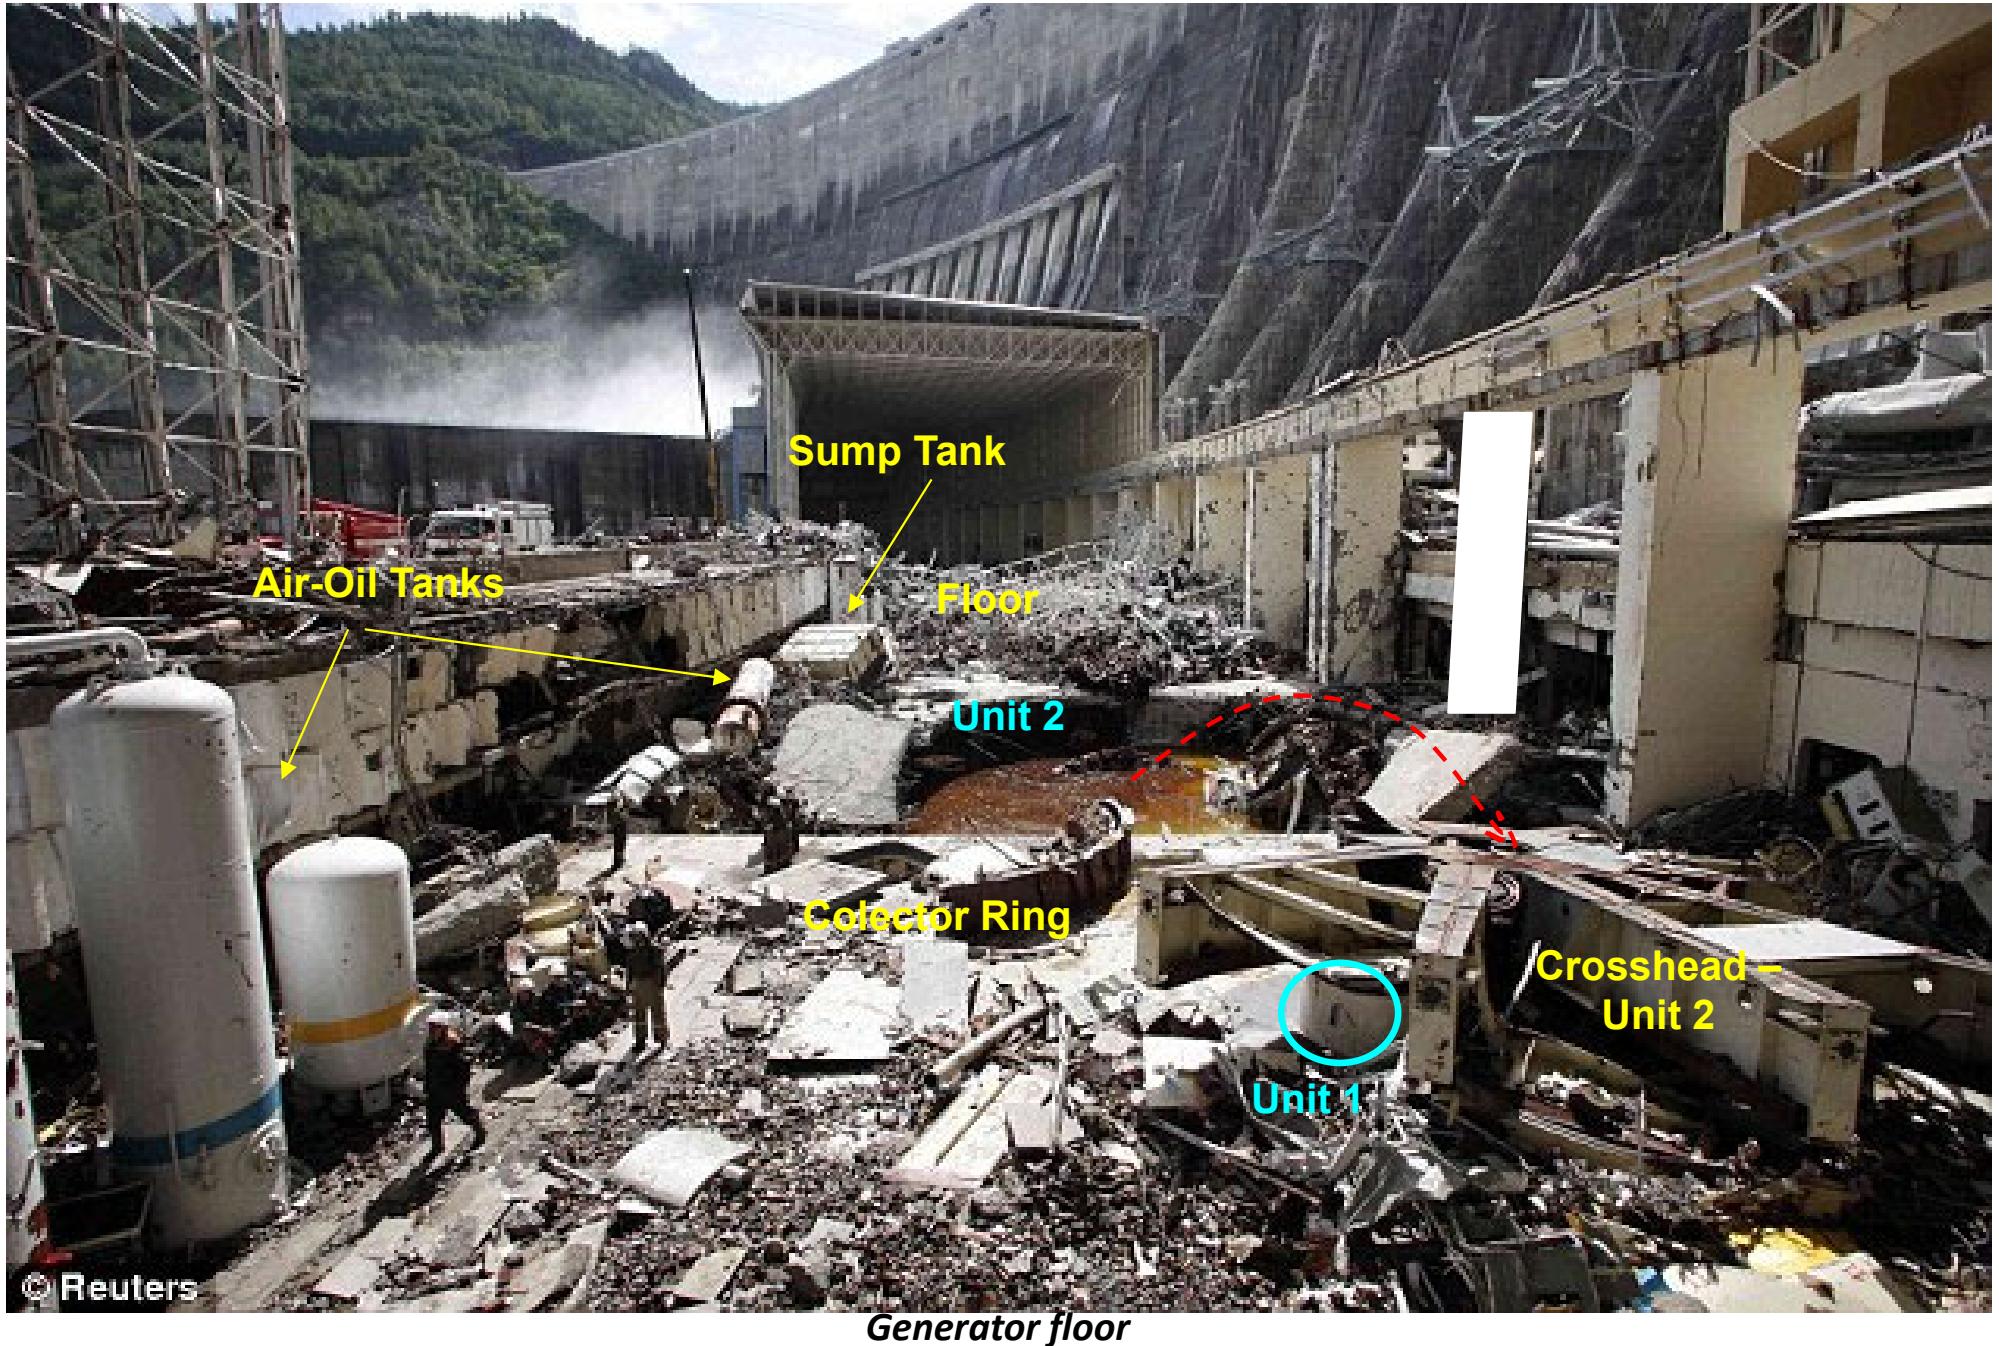
After the Accident

At 08:13 local time (00:13 GMT) on 17 August 2009, the station suffered a catastrophic "pressure surge" in turbine known as a water hammer. The sudden water pressure surge resulted in the ejection of turbine 2 with all equipment, a total weight some 900 tons, from its seat.

Turbines 7 and 9 also suffered from severe damage, while the turbine room roof fell on and damaged turbines 3, 4 and 5. Turbine 6, which was in scheduled repair at the time of accident, received only minor damage as it was the only one of the station's 10 turbines that did not receive electrical damage due to shorting of transformers, and it will be restarted as soon as possible.

Water immediately flooded the engine and turbine rooms and caused a transformer explosion.

- Sudden closing of the Unit 2 wicket gates.
- Heavy waterhammer in the spiral case and penstock, causing their collapse.
- Upward force, resulted from the waterhammer, destroying the civil structure over the spiral case and penstock.
- Pressure of the upstream water causing elevation of structures and peaces.
- Heavy reverse waterhammer (draft tube) causing elevation of the turbine cover, shaft, etc.
- Rapid flooding of the Powerhouse.
- Units 7 and 9, without closing, in runaway speed with the generators inside the flood water.

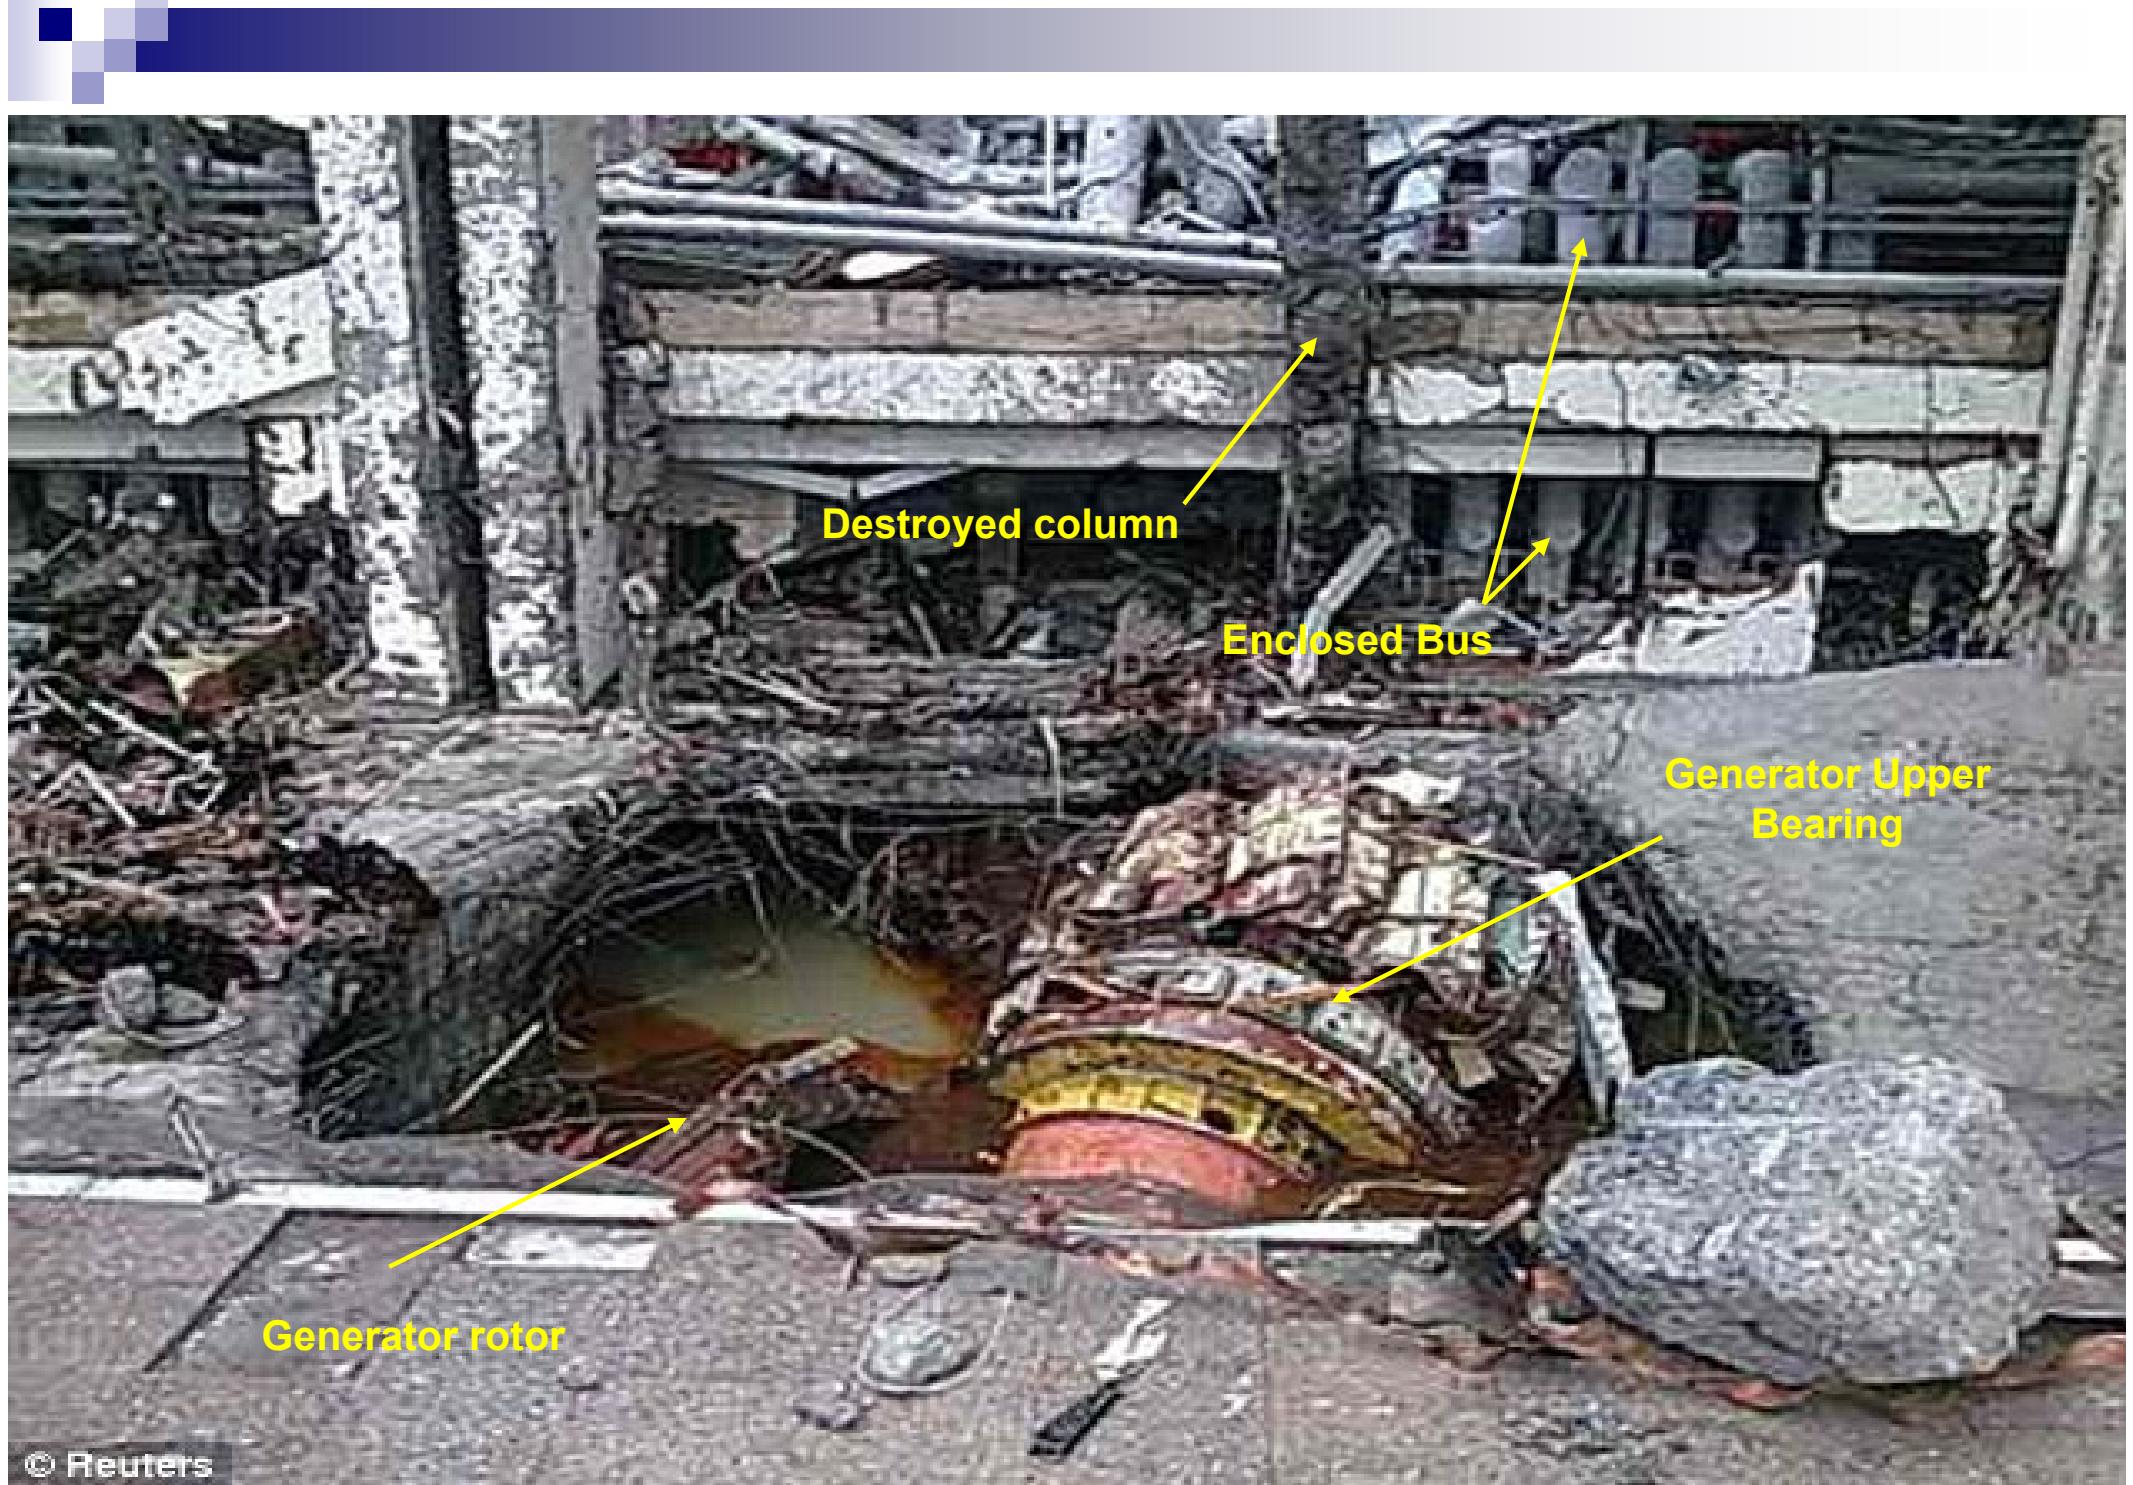
The Powerhouse crane is above the assembly area

The remains of the rotor spider

Water + Oil

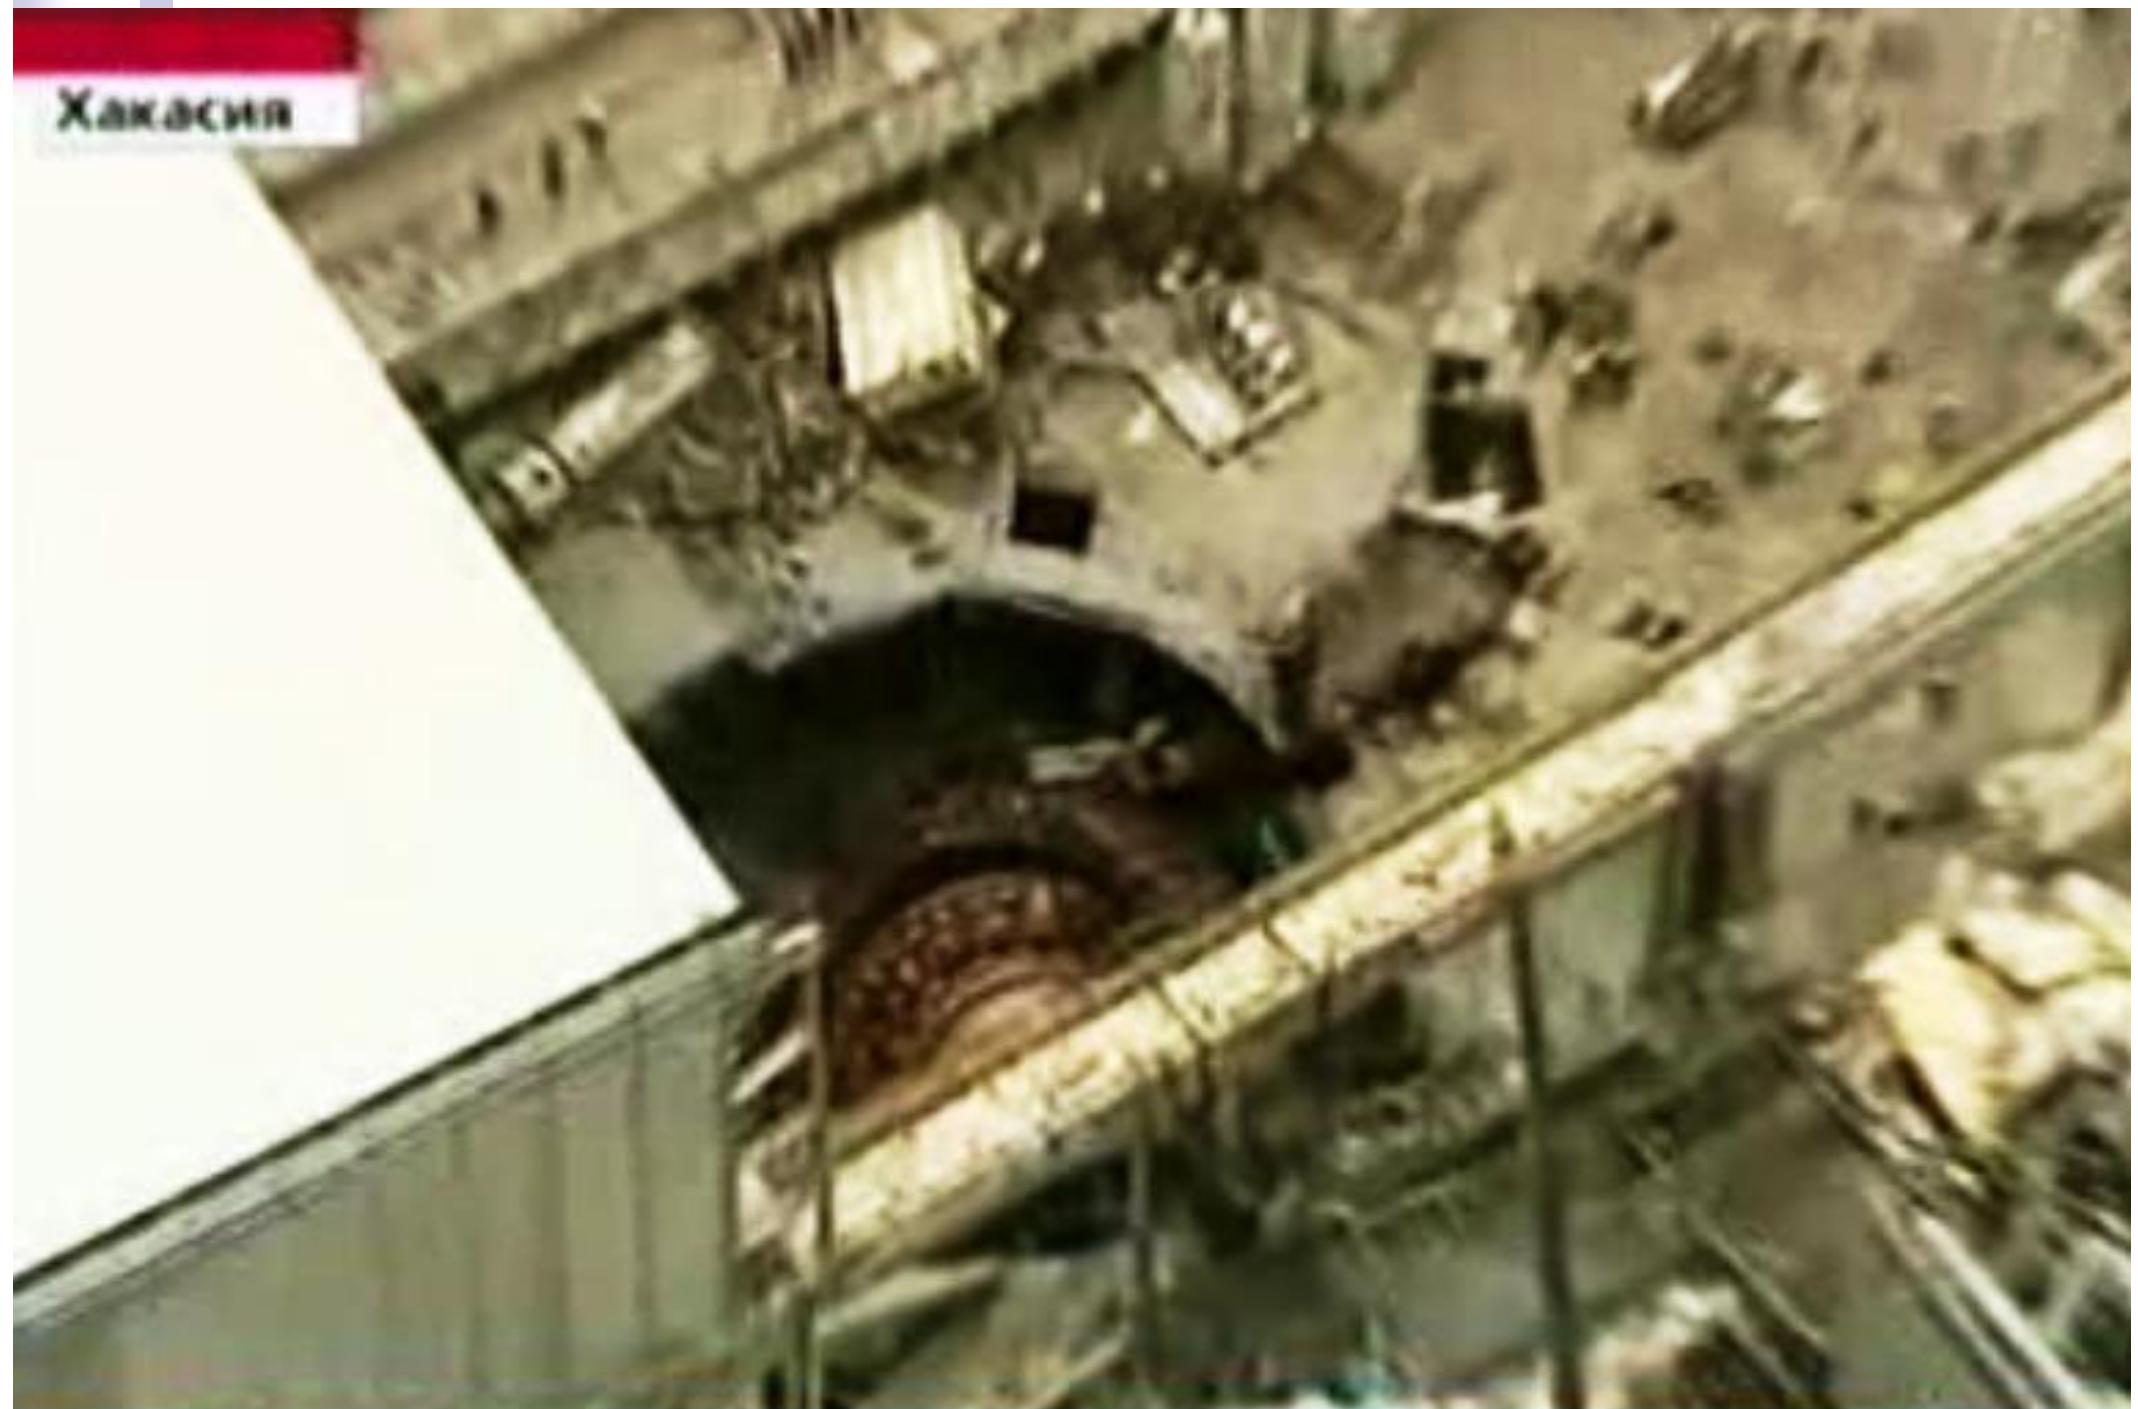
Aparently the
water is already
drained
