# Rock mass characterization for engineering design

Compilation of case  
studies of applied  
geophysics for tunnels

# How rock mass characterisation and geophysical investigation can help a geotechnical engineer?

# Case study: Serre de la Voûte tunnel

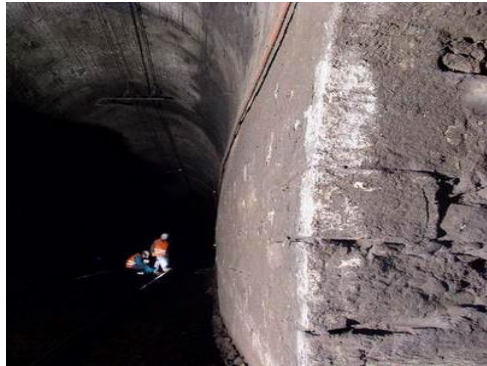
- The majority of the masonry joints is highly weathered
- Dripping points, mainly located on the tunnel crown
- **Local deformation of the side wall** on a 30 m long zone close to the North portal
- Convergences monitoring during 7 years → no remarkable changes → local event

**Tunnel enlargement by lowering the invert may affect the equilibrium conditions!**

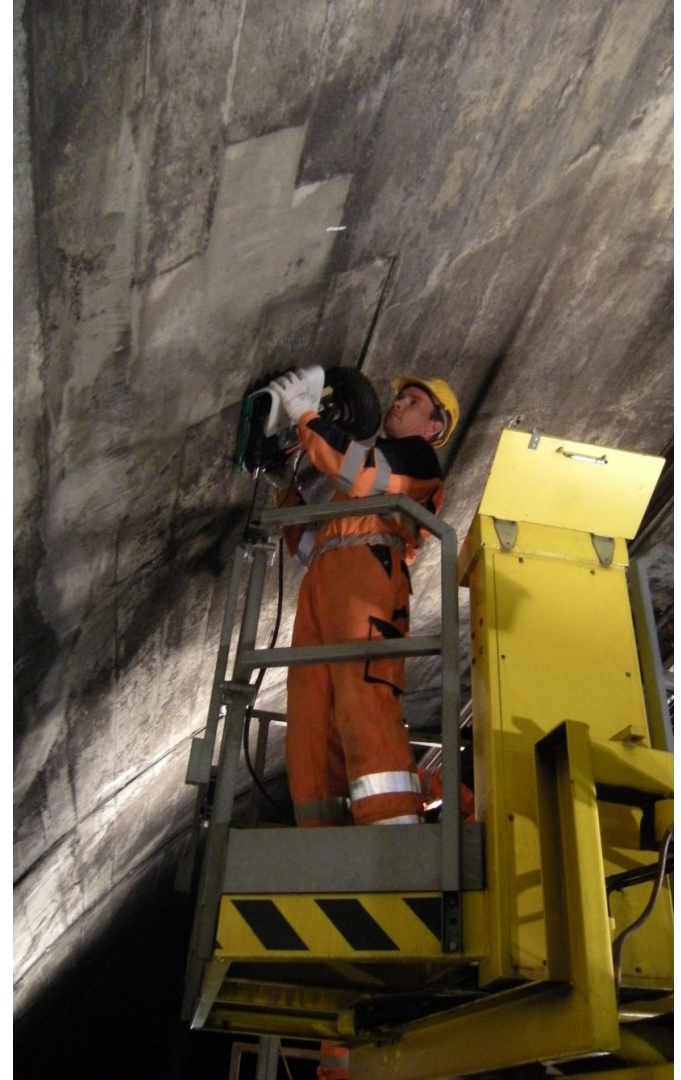
- GPR system detects reflections of electromagnetic radiation emitted by a portable radar transmitter (antenna)
- The antenna is moved across the surface and a transit time curve is generated and plotted thereby locating defects or irregularities
- The reflection comes from objects, defects and layers which alter the speed of transmission of the radar signal

- Thickness of the lining changes from 40 to 60 cm
- Masonry blocks characterised by a quite homogeneous rock and the ground mass behind which, on the opposite, results very heterogeneous
- Cavities or backfilling material with bad quality behind the lining in the deformed zone

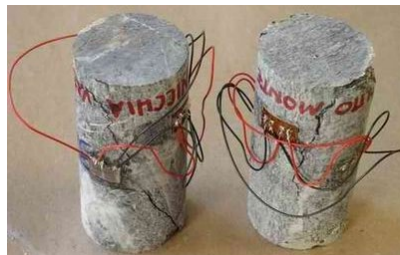
2 boreholes in the deformed side wall and 1 in the other one:

Masonry ~ 40-60 cm

Backfilling ~ 20 cm

Rock → lower quality than masonry blocs

Brazilian tests →  $\sigma_t = 3-5 \text{ MPa}$

UCS tests →  $\sigma_c = 31-49 \text{ MPa}$  (! schistosity)

→  $E = 28.5 \text{ GPa}$ ;  $\nu = 0.2$

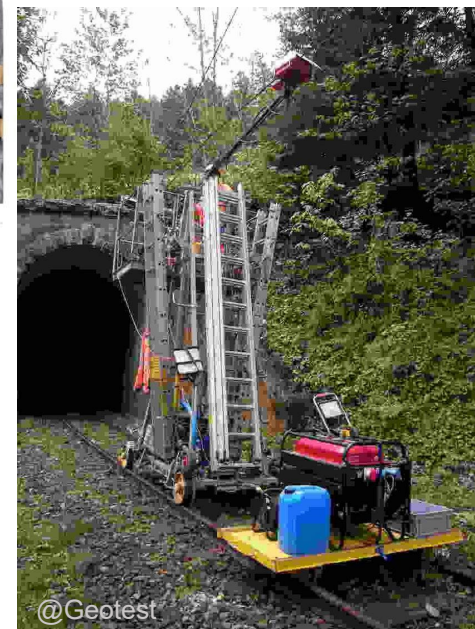
Georadar investigation of natural stone masonry linings was done in order to have a general view on the geometry of the lining and the quality of the lining / rock mass interface

Geophysical measurements were coupled with local investigation / core drilling and lab tests.

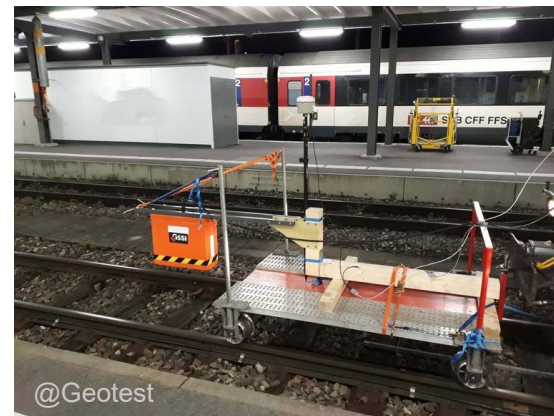
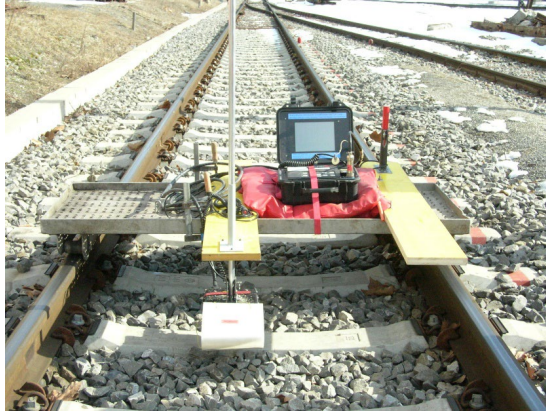
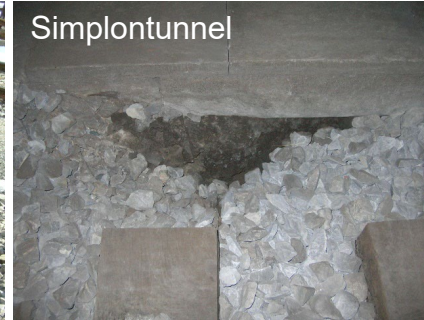
- Double-track tunnel, 1.3 km long
- Night closure of about four hours
- Locate the presence of a concrete invert under the track ballast
- Calibration by sampling drill holes

**Results:**

**Based on the analysis, various locations with the same problem were identified**

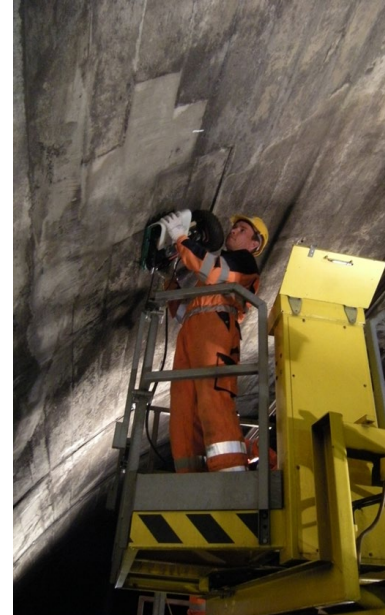
- Identifying existing anchors behind concrete wall.
- Avoiding dismantling of the entire structure

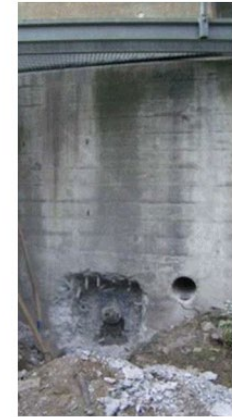
frei gespitzter  
Ankerkopf

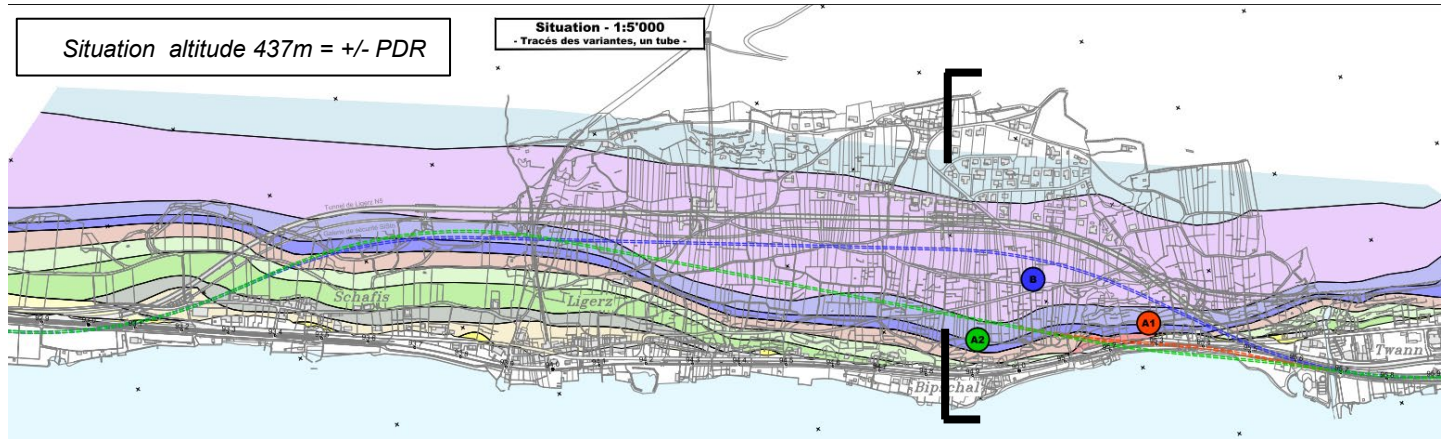
- 2 tracés (A: +/-idem projet 1992; B: récupération du portail N5)
- A1: sortie sur la rive; A2 sortie sur le lac (remblayage du lac)

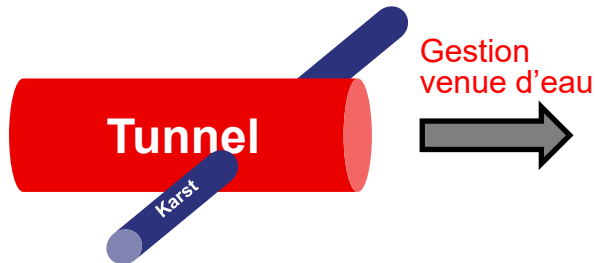
| Débit issu d'un conduit recoupé par la galerie de sécurité (recoupement admis à 440 m) | | | | | | | | |

Tableau 3. Débit probable en cas de recoupement d'un conduit karstique en fonction du diamètre du conduit et de la charge hydraulique du système au moment du recoupement.

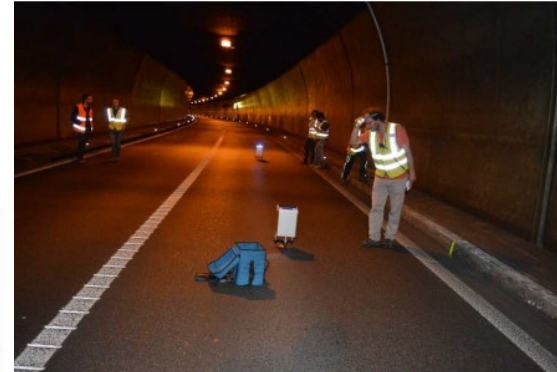
*Mesure très fine des micro-variations de la densité du sous-sol; réalisé de nuit dans le tunnel routier. Mise en évidence des anomalies correspondant soit à des zones de fracturation, soit à des grottes.*

- **7 zones** d'anomalies mises en évidence
- Bonne concordance avec les zones où des zones fracturées ont été observées lors du percement du tunnel routier
- Bonne concordance avec les venues d'eau ● dans le drainage du tunnel routier (toutes sont mises en évidence par les mesures de micro-gravimétrie !)

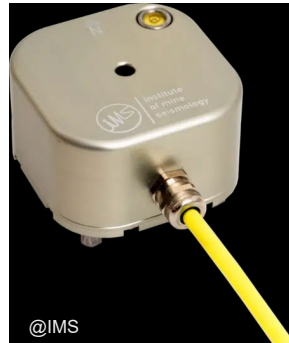
- **Geophones** are placed on the surface/on the structure so that they could detect the velocity of the waves induced by the tunnel excavation.
