Deliverable 3.2

Critical review of retrofitting and reinforcement techniques related to possible failure

ACRONYM: NIKER

TITLE: New integrated knowledge based approaches to the protection
of cultural heritage from earthquake-induced risk

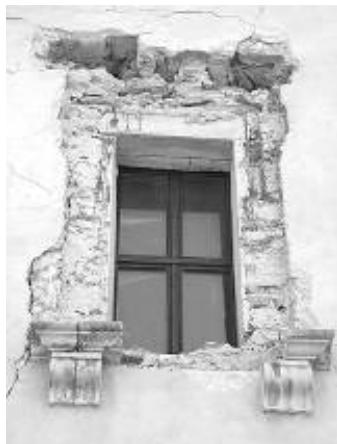
Figure 3.2 Poor results of applied injection, (Binda et al., 2003a).

Surveys after the 1997 earthquake in Umbria on damaged walls often showed the difficulty of diffusion of the grout injection within stone masonry sections. Frequently only some spots were injected in the case of this wall with a very low percentage of voids (Binda et al., 2003a), (Figure 3.2 and Figure 3.3).

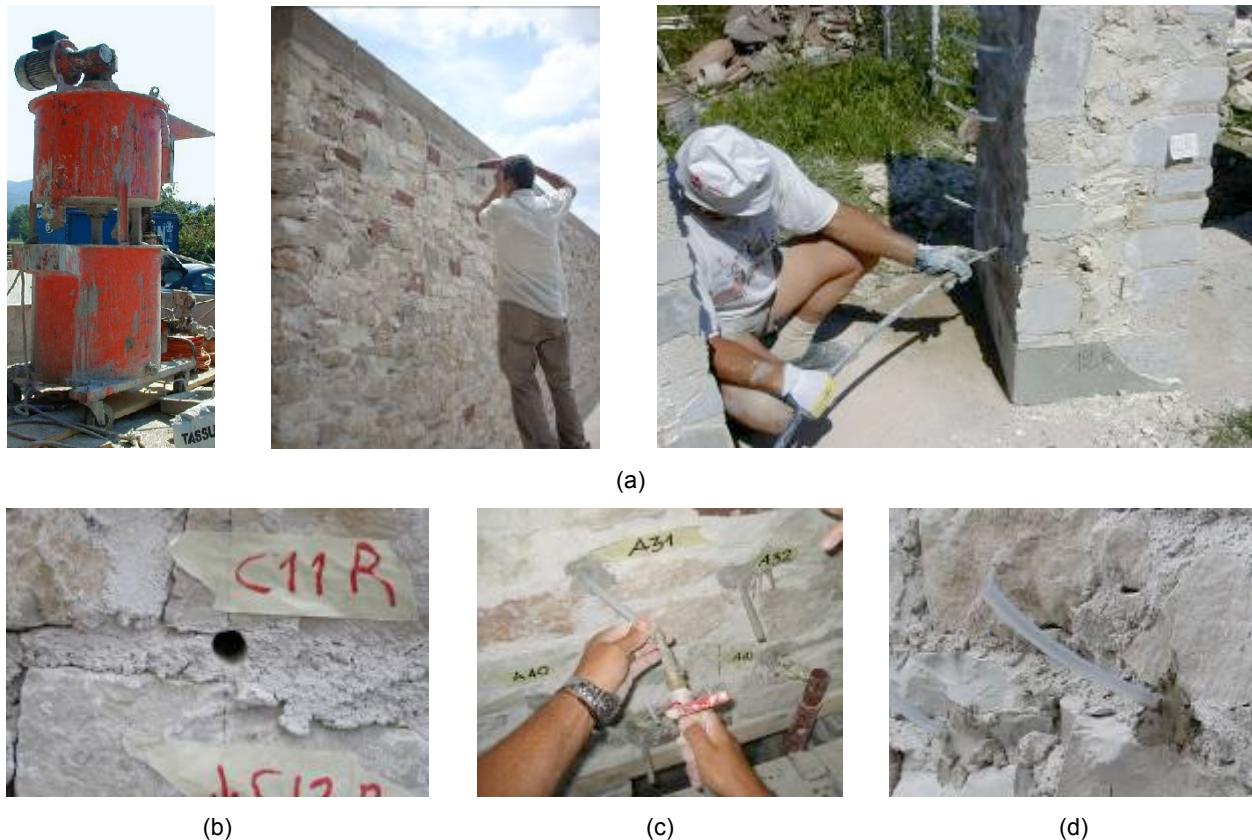
Figure 3.4 Grout injection procedure. (a) General overview of the process. (b) Drilling holes in mortar joints. (c) Fixing plastic pipes. (d) Injecting grout (Source: UNIPD).

1. study of the grout composition;
2. choice of the injection point, the distance between injectors and their layout, according to the masonry characteristic (presence of cracks, porosity, geometry, etc.); 2-3 injections point/m² could be effective;
3. removal of the damaged plaster and superficial crack filling (to avoid loss of grouts);
4. hole drilling (diameter: 40.0mm);
5. positioning of the injection devices and repointing by mortar
6. preliminary water injection in order to remove dust and disaggregate materials but also to saturate the wall, avoiding the masonry suction. The segregation and shrinkage of the grout due to the high rate of absorption of the masonry should be prevented.
7. evaluation of the injection pressure
8. grout injection, starting from the lower part of the crack.

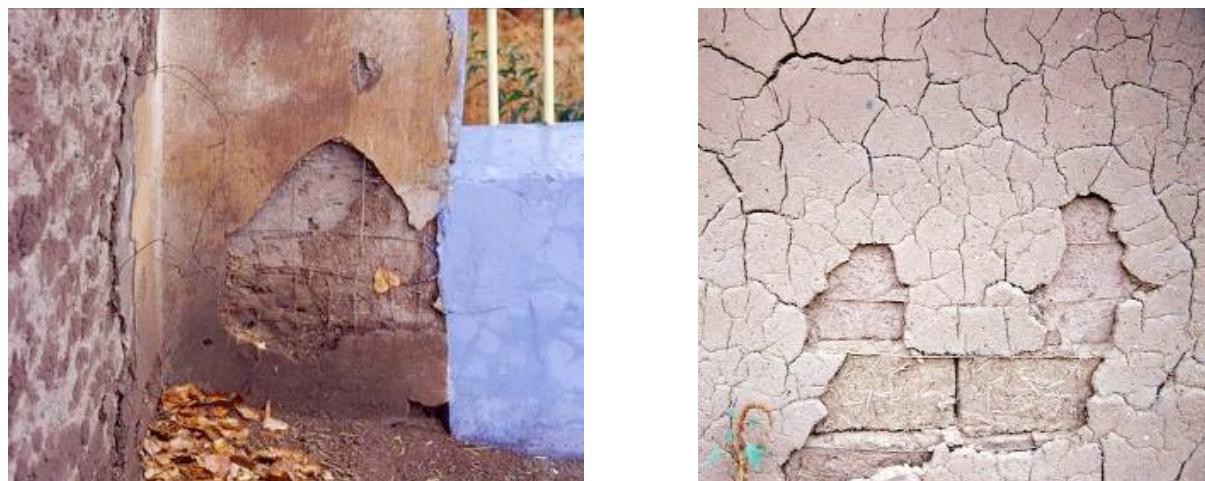
Figure 3.14 Cracking and spalling of earthen mortar over steel mesh reinforcement, Chile (Source: BAM).

In addition, cementitious materials are chemically, mechanically and physically incompatible with earth due to its low strength, high porosity and a different hygrothermal behaviour in comparison to cement based material, resulting in a decrease in durability performance due to two factors, the first being incompatibility between cement plaster and earthen materials as described in section 3.2.6.1; the second being steel corrosion, expansion and contraction due to temperature increase and decrease underneath the plaster, which can cause the earth plaster to spall. The latter phenomenon is a hypothesis which has not been studied in depth and is not supported by evidence in research, but can be observed on site (see Figure 3.14). The corrosion of the steel mesh and spalling of the overlaying cement render seems to be attributable to the insufficient thickness of the cement render, resulting in carbonation.

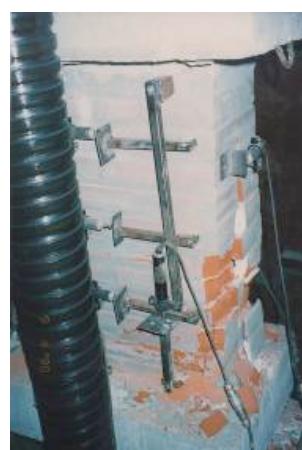
Figure 3.17 Spalling of bricks due to incomplete filling of mortar joints during deep repointing.

Inspection of specimens after testing has demonstrated that in those cases, parts of the joints were left un-filled. The observed failure mode, attributed to stress concentration to the faces of masonry, is associated with compressive strength of masonry lower than the initial one.

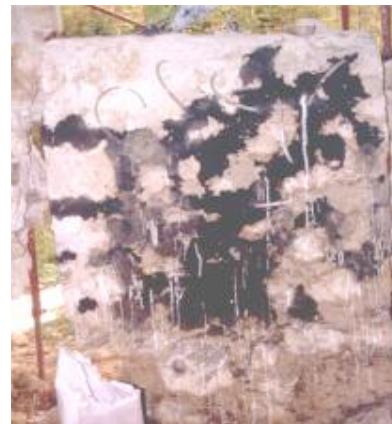
Figure 3.18 Filling of the cracks, (Binda et al., 2005).

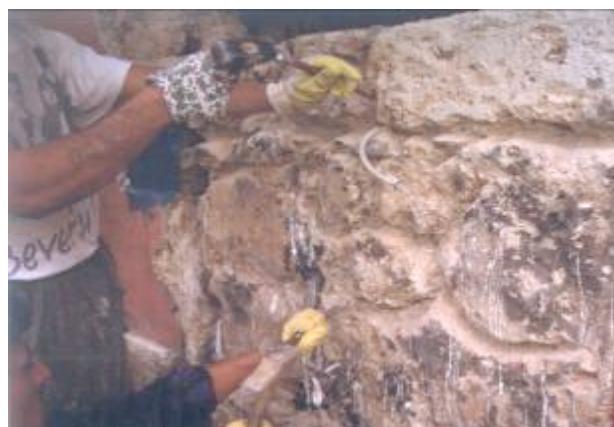
Figure 3.19 Cleaning of the joint up to 70.0mm, (Binda et al., 2005).

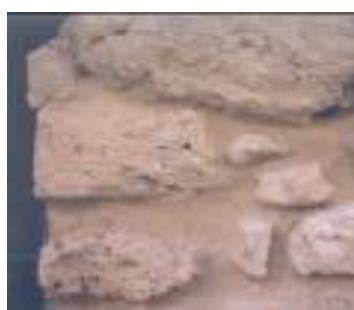
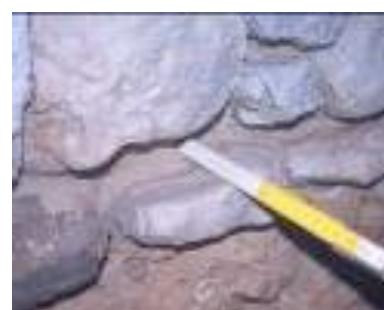
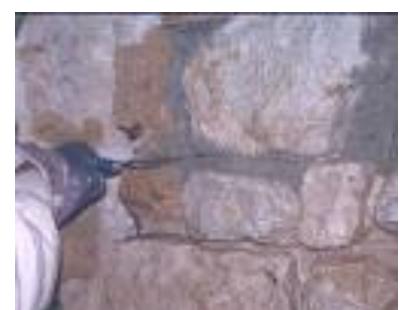
Figure 3.20 (a) Joint after cleaning, (b) detail of the joint depth, (c) first layer of repointing, (Binda et al., 2005).

3. Joint cutting and cleaning up to a depth of 70.0mm made by hand with hammer and chisel, (Figure 3.19). Figure 3.20a and Figure 3.20b show the joints after cleaning by sandblasting. These operations have to be carried out on both faces of the wall. It is worth to remind that sandblasting is not always allowed, and alternative technique should be used for the cleaning;

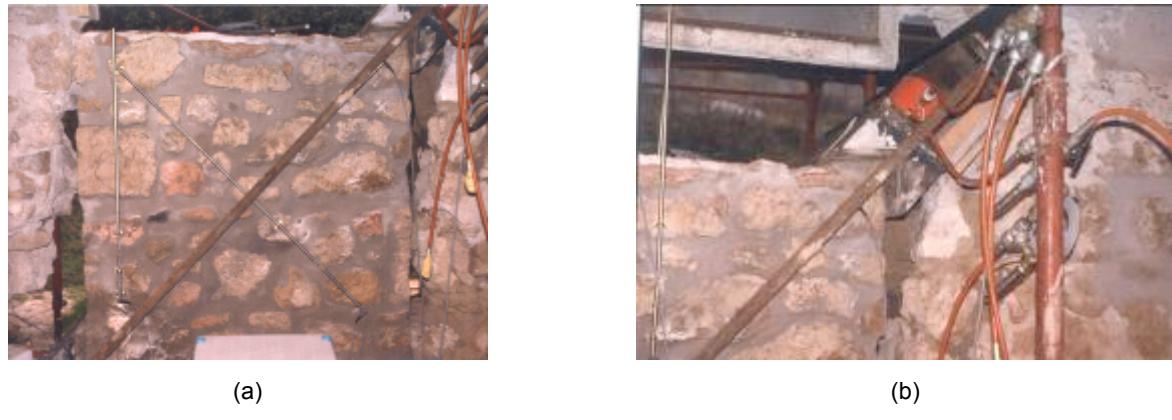
Figure 3.25 Measuring devices, (Binda et al., 2005).

The pointing was performed on a stone panel partially collapsed after a first shear strength static tests which caused a diagonal crack. The crack was previously grout injected. This grout is declared by the producer as a grout for injection based on natural hydraulic lime. For the deep pointing the above described steps from 2 to 5 were followed. The pointing was carried out with a lime-cement mortar; the choice was made due to the fact that the stones were rather stiff and strong and that this repair was structural, then aiming to a better connection between stones but in a compatible way. 28 days after repair a diagonal test was again carried out, on the repaired panel. Figure 3.25 shows the measuring devices applied across the panel and the jack used for the test. At collapse the panel was only cracked along the diagonal, and not badly damaged.

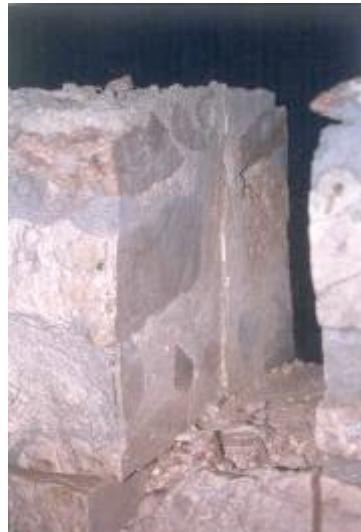
Figure 3.27 A cut section of the repointed wall, (Binda et al., 2005) and (Corradi 2008).

Later on the panel was dismantled and the pieces taken to the Laboratory of DIS for study and control. In Figure 3.27 the good penetration of the mortar can be seen on the section of the panel.

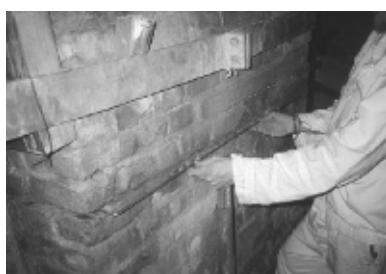
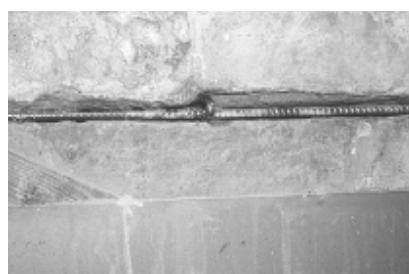
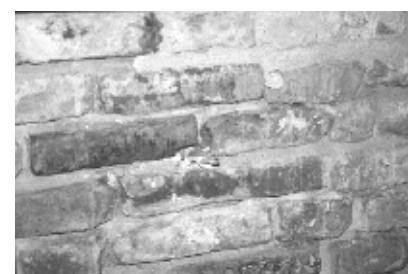
Figure 3.34 Phases of the repair intervention: (a) insertion of the reinforcement; (b) detail of the wall before repointing, showing the transversal steel tie position; (c) view of the wall after repair, (Binda et al., 1999).

After which, comes the phase of repointing with the insertion into the joints, each 30.0 to 50.0cm in the vertical direction, one or two steel or FRP reinforcement bars with a diameter of approximately 6.0mm, to increase the masonry ductility and the ability to dissipate energy. Normally are used two bars of limited diameter rather than a single larger bar, because, in ordinary masonry, the joints have dimensions between 10.0 and 15.0mm and, as so, do not allow the introduction of larger elements. The bars should be placed on a thin layer of mortar, and then be covered with hydraulic lime mortar, or with a additive or polymeric mortar, in which case, in order to ensure also a good aesthetic result, it should be included in the joint a final layer of finish, about 15.0 to 20.0mm deep, made with natural or pigmented material in order to reproduce the original appearance of the joints themselves, Figure 3.33. The final aesthetic operations are composed by scraping and cleaning of the joints, to remove the mortar smears/debris of the resistant elements.

The execution of this technique, Figure 3.34, should be as uniform as possible throughout the entire leaf object of intervention, and must proceed with continuity both vertically and horizontally.

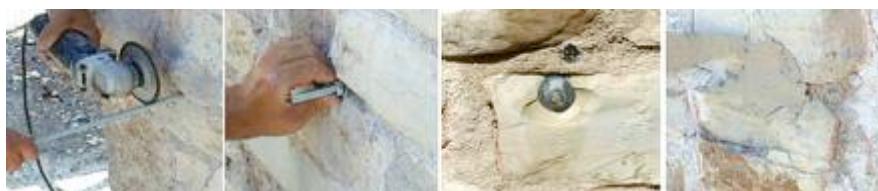
Figure 3.41 Positioning of anti-expulsion tie-rods.

In the case of the ties for pre-stressing of the masonry, special attention should be paid to the application of the actions to the bars and, not to lose the pre-stress effect, if the holes were not injected and the anchoring systems are accessible, it is possible to perform a periodical control of the state of tension in the bars.

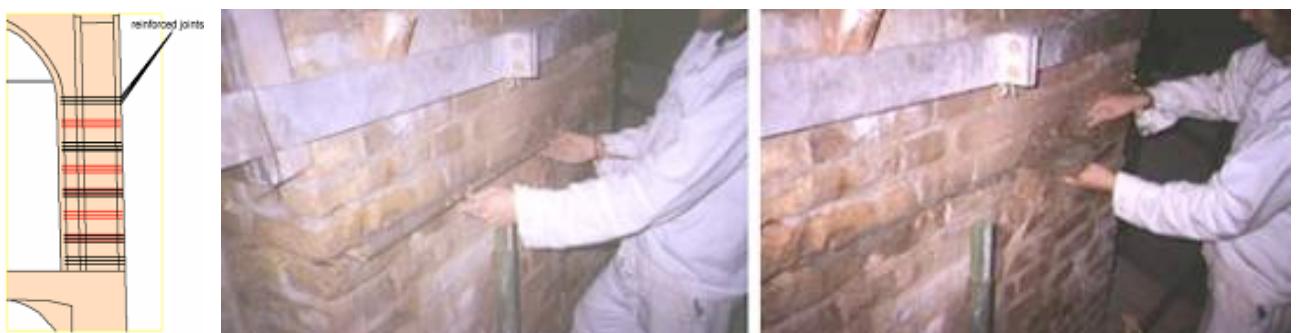
Figure 3.46 Bed joint reinforcing of a compressed pillar, (Source: UNIPD).

On large structures made by regular masonry, the confinement actions could be obtained by the joint steel reinforcing technique, afore described, (Figure 3.46).

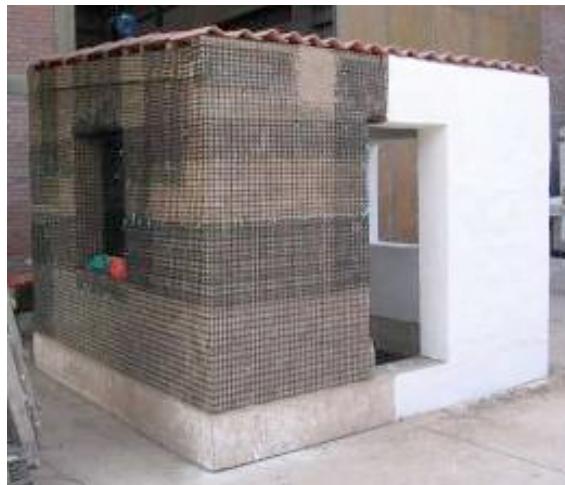
Figure 3.48 Adobe test-house reinforced with polymer mesh and partially plastered.

Since 2003, dynamic testing at PUCP has moved away from the testing of steel-mesh-reinforced earthen structures, (see section 3.1.2.1), the limits of which are described in the previous section, and focused, instead, on the testing of polymer mesh reinforced walls (mesh is applied to both sides of the wall and connected through the wall thickness), the advantage of which (Torrealva et al., 2009a) lies in its compatibility with earth as a building material, and with its ability to provide ductility at high deformations, (Figure 3.48 and Figure 3.49). Cyclic testing has shown that, the initial shear strength and stiffness of walls reinforced with mesh increase significantly when mud plaster is applied over the mesh, (Torrealva et al., 2009a,b).

Also in this case the technique was tested only on new laboratory prototype and considering only mechanic aspects. Durability and applicability on real cases are not yet studied.

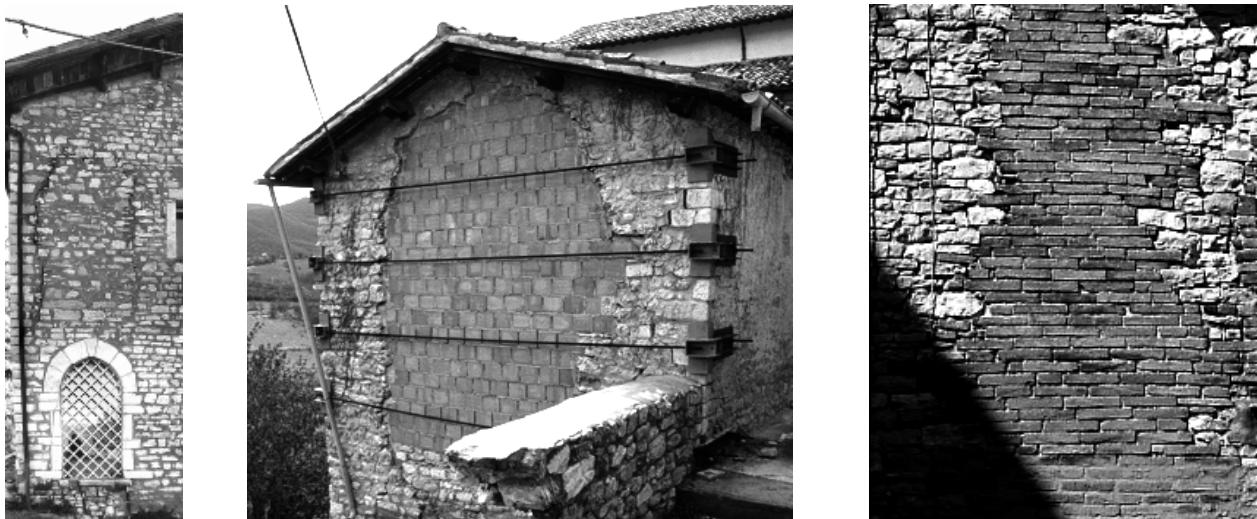
Figure 3.51 Masonry replacement intervention. The repairs are ineffective due to the lack of compatibility between the masonry portions (source: POLIMI).

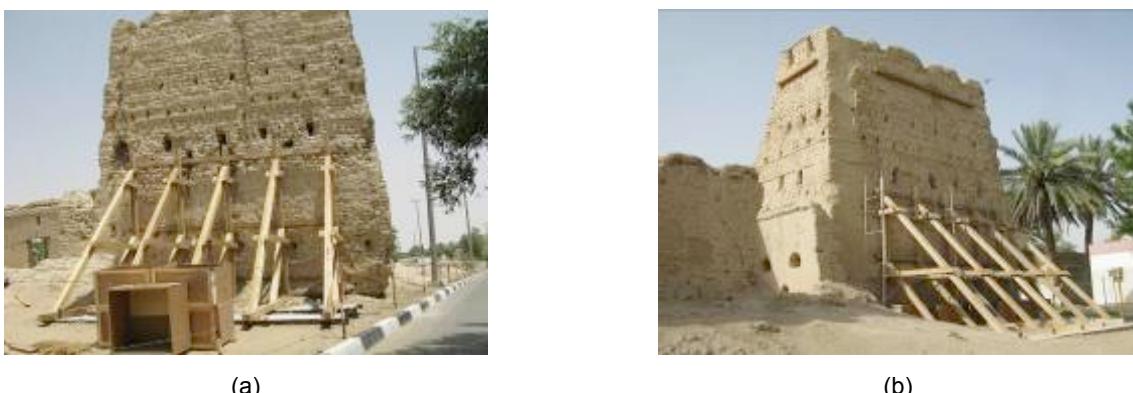
Figure 3.52 Application of the “scuci-cuci” technique to the gate at Al Damarki as crack repair, (source: ZRS).

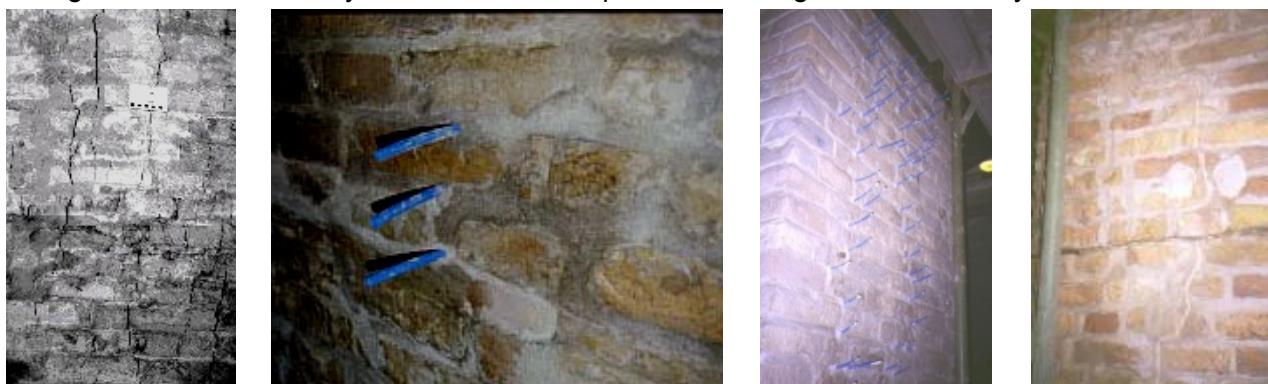
Figure 3.53 Crack injection, (source: POLIMI-UNIPD).

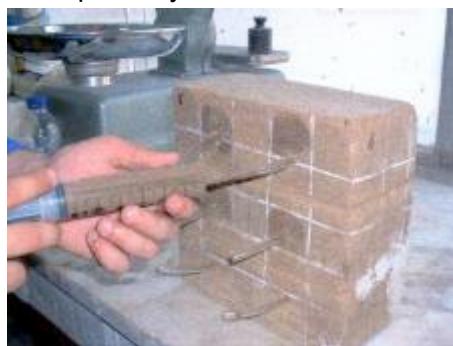
Figure 3.56 Alternative method for repair/strengthening of clay masonry, (by courtesy of Papayianni, 2006).

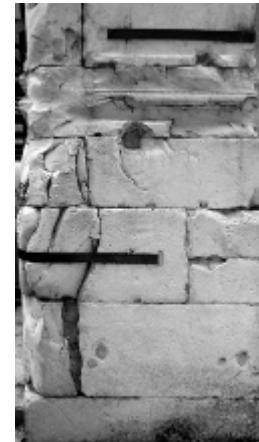
Figure 3.57 Crack stitching my metal bars, (Source: POLIMI).

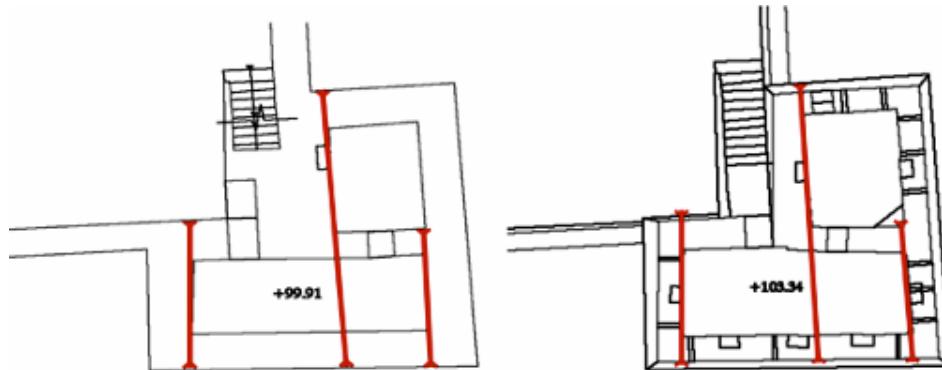
Figure 3.60 Schematic plans of anchors in South East Tower, Al Muwaiji Fort, UAE.

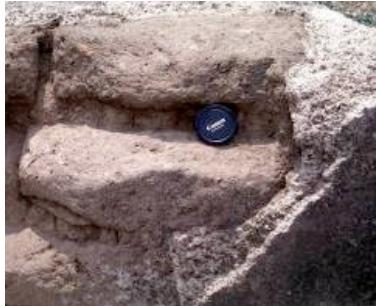
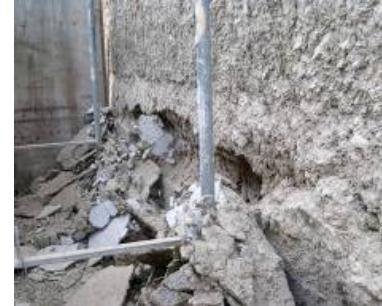
Figure 3.61 (a) Cement stucco on an adobe masonry, San Andres, El Salvador (left, source: BAM) (b) Damage underneath cement stucco in cob house, Germany (right, source: ZRS).

Particularly counter-productive is the use of cement plasters, since cementitious materials are chemically, mechanically and physically incompatible with earth due to its low strength, high porosity and different hygrothermal behaviour. When cement plasters are applied as means to protect the walls from moisture, they can cause swelling and loss of strength, in some cases due to the higher capillary action described by Minke's (2006) studies, based on German DIN Norm 52617, which suggest that the addition of cement to earth can increase its water absorption w (kg/m^2) by 100-400%, resulting in a decrease in mechanical strength. Figure 3.61 shows damaged earthen materials under cement stucco introduced as repair, the addition of which not only increases capillary action, but also prevents the release of moisture from the earthen material when they are vapour tight, resulting in strength loss. Excessive moisture in walls is one of the conditions described by Tolles (2006) as being the most critical within the scope of the seismic

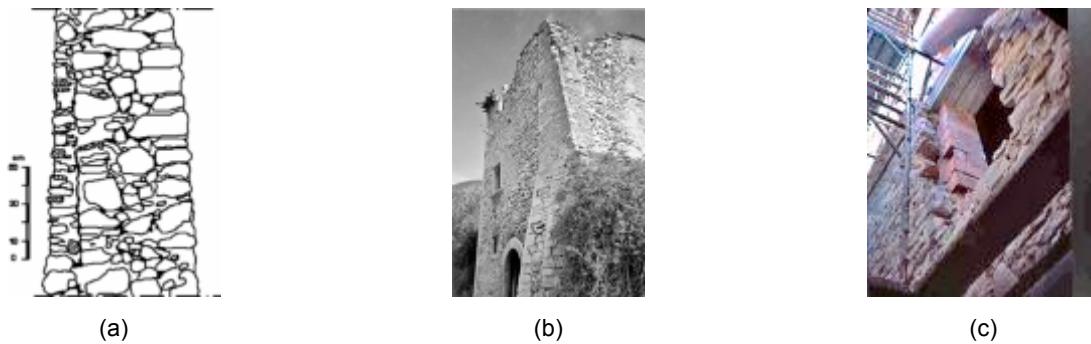
Figure 3.62 Example of wall enlargements, (Source: POLIMI).

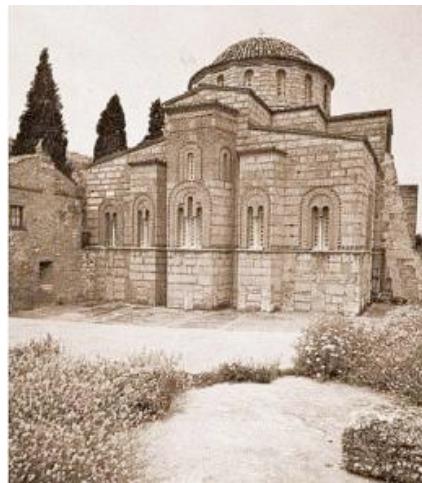
Figure 3.63 Katholikon of Dafni Monastery, (Source: NTUA).

Katholikon of Dafni Monastery, (Figure 3.63). Two stone buttresses were added (in the beginning of the 20th century) in the north façade of the church. Buttresses would be needed also in the south façade. However, due to the fact that this would harm the access to the church, buttresses were constructed only in the north façade.

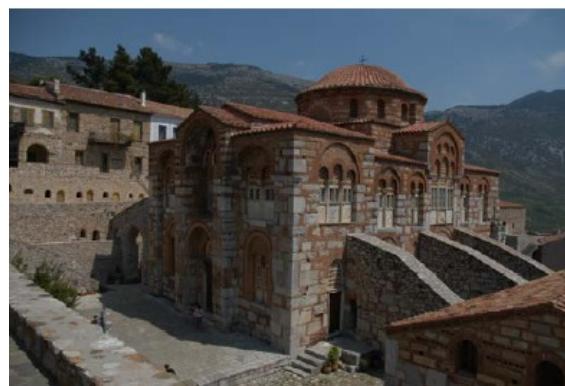
Figure 3.64 Katholikon of Ossios Lucas Monastery-Added buttresses (south façade), (Source: NTUA).

Katholikon of Ossios Lucas Monastery-Added buttresses (south façade) (Figure 3.64). In the north façade, buttresses were not needed, because there, there is another church serving the same purpose.

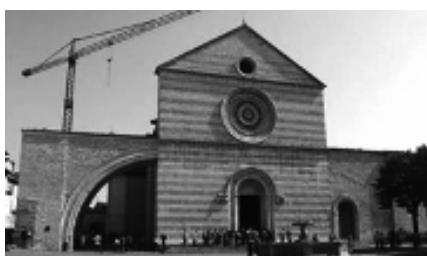
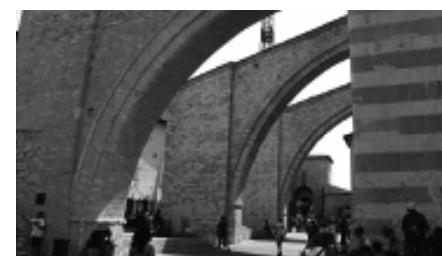
Figure 3.65 Buttress at S. Chiara Church in Assisi, (Source: POLIMI).

Flying arches produce stabilizing forces, without the structure having to laterally deform, as soon as they are built. Moreover, these forces will persist in spite of possible differential soil settlements between the buttress and structure. External buttresses combined with flying arches may provide a very efficient way to increase the seismic capacity of the structure (Figure 3.65). Due to its external character, this solution will normally be fully non-invasive and removable.

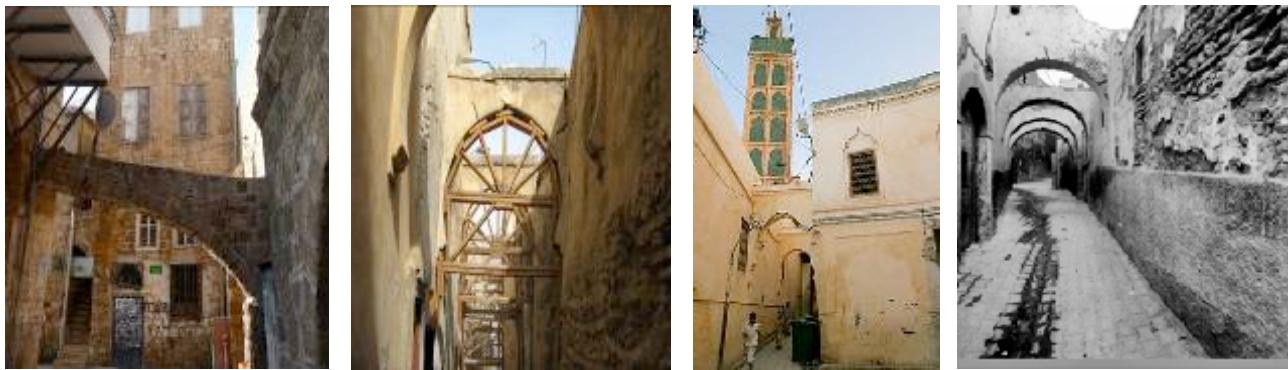
Figure 3.66 Flying arches between walls in (a) Israel (Sorce: IAA) and (b) Morocco, (Source: ENA).

Flying arches between buildings were frequently built up in order to prevent the overturning of walls, Figure 3.66. In time, some of them were also transformed in passages or lodges.

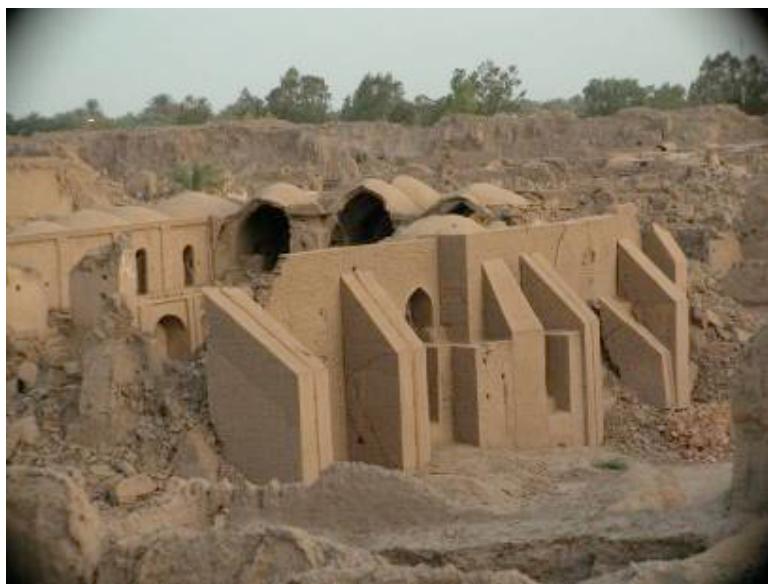
Figure 3.67 Collapse of domes adjacent to newly built buttresses, (Source: Randolph Langenbach).

The addition of buttresses to adobe and cob structures has in some of the literature been held responsible for the collapse of the parts of the structure adjacent to the newly built buttresses (Langenbach, 2004), though it is not always clear in the literature what materials have been used to construct the newly built buttresses. Photographic evidence, (Figure 3.67), of the collapsed Caravanseray in Bam (Langenbach, 2004) shows that the domed rooms behind the added buttresses collapsed, while the domes opposite, where there are no buttresses, still remain, possibly due to a difference in stiffness between the newly introduced buttresses and the historical material. When a compatible material is used for the purposes of strengthening, the introduction of buttresses is believed to aid structural behaviour under seismic loading.

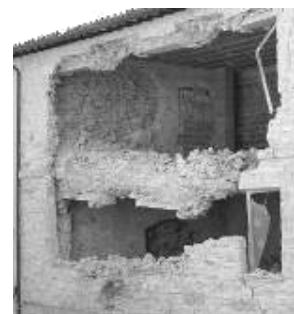
Figure 4.5 Out-of-plane collapse of a wall with R.C. tie beams (a) (Gurrieri, 1999) and (Avorio, 2002); (b) (Binda et al., 2003a).

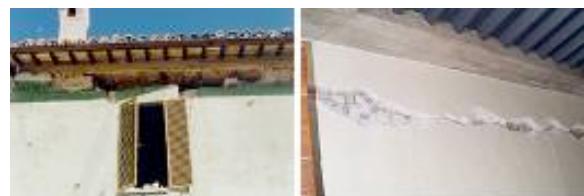
Figure 4.6 Difficult connection between the tie beams and the walls.

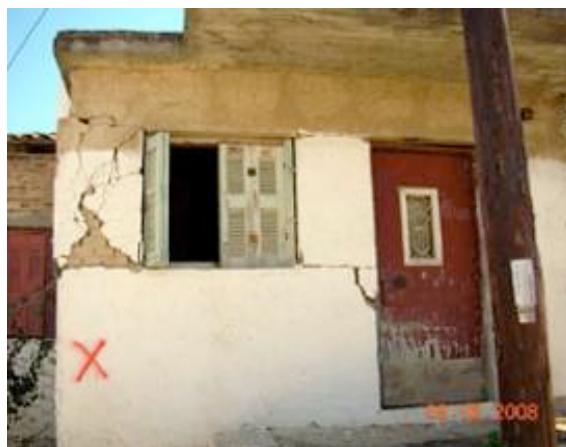
Figure 4.8 A R.C. tie beam is constructed over the opening. Disintegration of the pier and horizontal sliding is observed, (Source: NTUA).

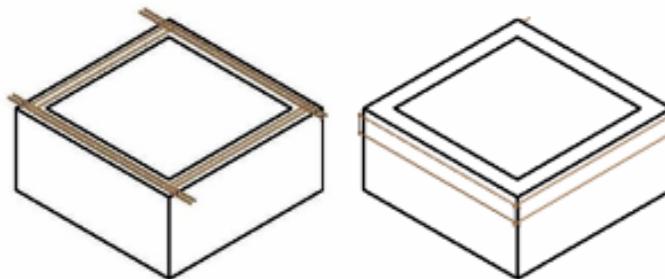
Figure 4.9 Timber Bond Beam (left) traditional and (right) a Nepali vernacular technique which includes vertical wooden ties at each corner, as described and reintroduced by Sikka and Chaudry (2006).

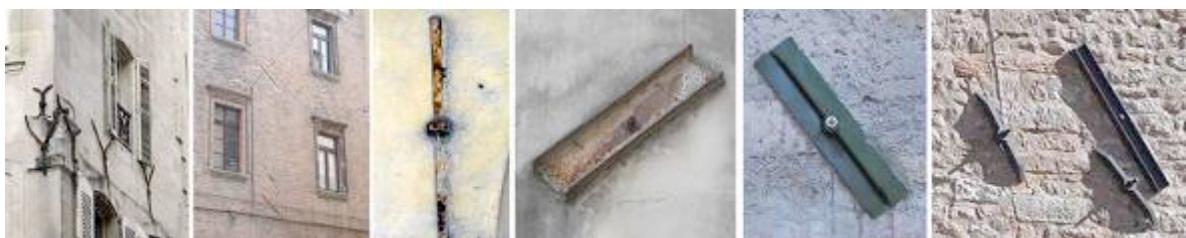
Figure 4.14 Example of tie anchors.

Ancient ties had a low stress according to the time technology by heating. Their anchoring system is generally only a bar or a decorative element. Recent ties, instead could be high tensioned, but require greater anchoring devices, (Figure 4.14 and Figure 4.15).

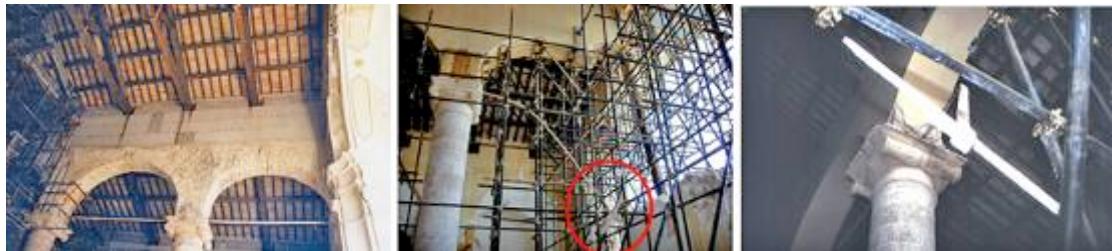
Figure 4.16 The tie was not able to restrain the wall overturning; the stiff and heavy R.C. tie beam pushed over the church façade, (Source: POLIMI).

In general metal ties are very effective restrain systems. Failure is generally related to anomalous added masses as shown in Figure 4.16.

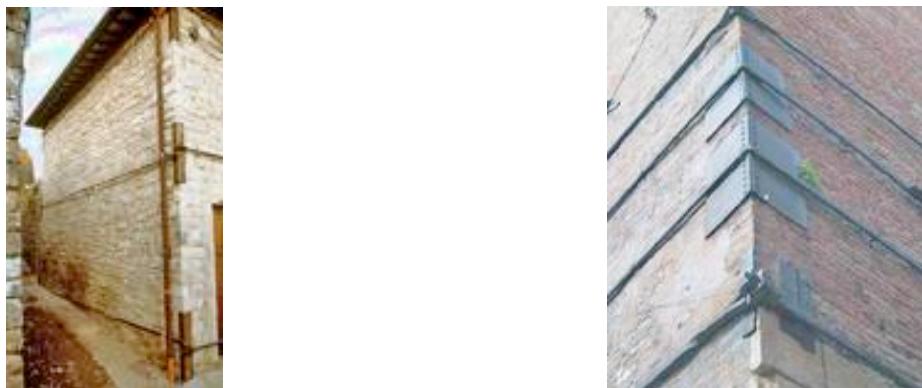
Figure 4.17 External confinement by metal tie, (Source: UNIPD).

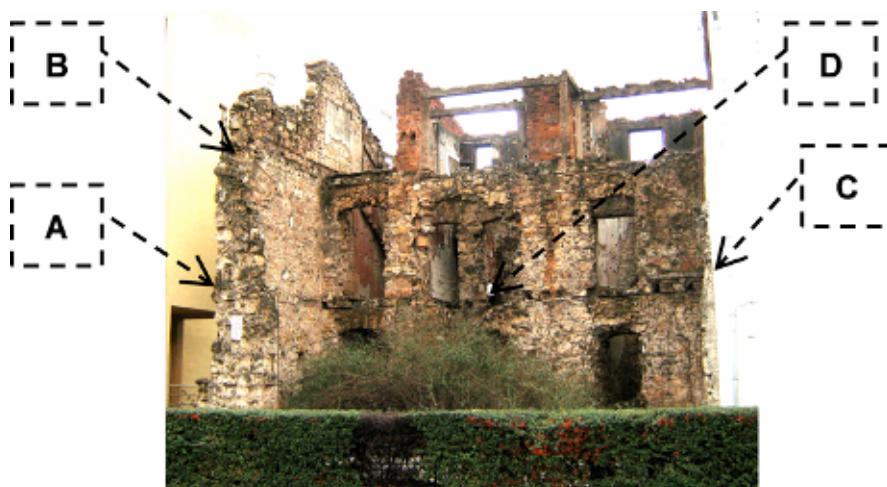
Figure 4.18 Residential Building Bulevar 25 in Mostar, Bosnia and Herzegovina. Position of visible metal ties marked A to D. Front facade wall demolished above the ground level. Photo Interprojekt, December 2009.

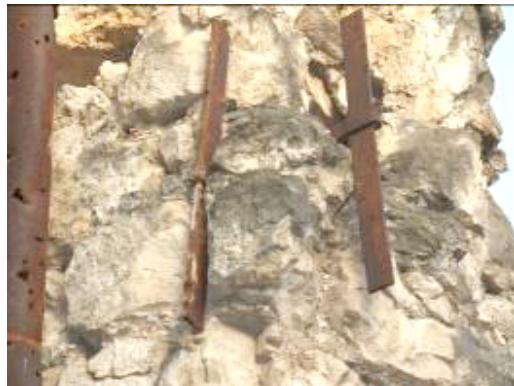
Figure 4.19 Residential Building Bulevar 25 in Mostar, Bosnia and Herzegovina. Detail A. Detail of the anchors on the facade. Photo Interprojekt, February 2009.

Examples of the traditional metal ties used at historical masonry buildings in Bosnia and Herzegovina dating from the end of the 19th and the beginning of 20th century are presented in Figure 4.18, Figure 4.19 and Figure 4.20. Metal ties, normally invisible are found exposed due to partial or significant damage of the buildings as consequence of the recent war destruction and/or the long-term influence of weather conditions.

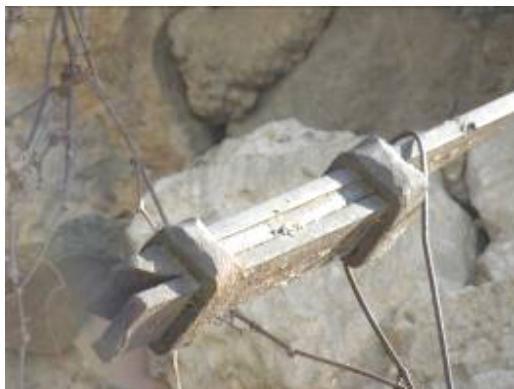
Figure 4.20 Residential Building Bulevar 25 in Mostar, Bosnia and Herzegovina.

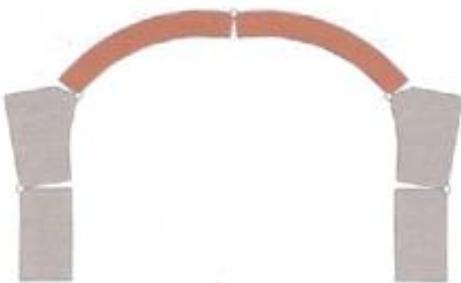
Figure 5.1 FRP at extrados, (Gurrieri, 1999).

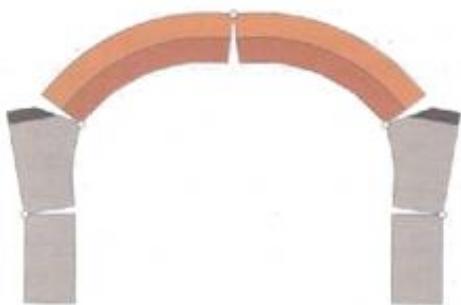
Figure 5.2 Reinforcement arch at intrados, (Gurrieri, 1999).

In Figure 5.2 the reinforcement arch or “frenelli”, which increases the thickness of the vaulted structure, thus increasing the effective thickness and stability of the element, but do not change the mode of collapse.

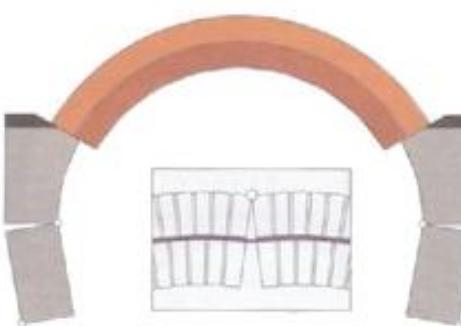
Figure 5.3 Reinforcement arch and FRP, (Gurrieri, 1999).

In Figure 5.3, strengthening combines the previous two: FRP are included between vaults and reinforcement arch; this technique changes the mode of collapse, but the springing sliding, is no real way of collapsing.

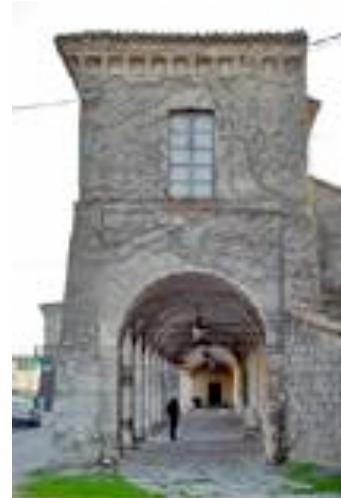
Figure 5.10 Buttressed vaults, (Source: POLIMI).

When the masonry walls strengthening, in foundation and along the height, are not able to counterbalance the thrust of arches or vaults, can increase their effectiveness by creating buttresses, placed at the centres of thrust, (Figure 5.9 and Figure 5.10). Their characteristics and weight lead the result of the inclined and vertical forces inside the central core of sections.

This solution is often not feasible for aesthetic reasons, and economic dimensions, yet it is used for provisional structures, (Caleca et al., 1983). However in traditional architecture is often present, particularly at the end of sequences of arches, (Figure 5.10).

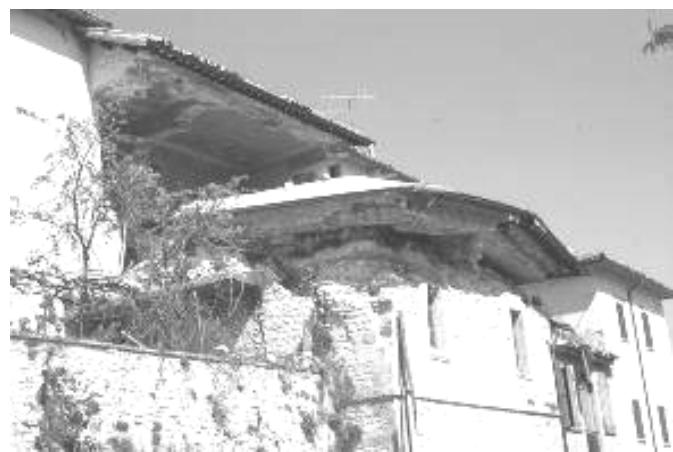
Figure 6.1 Structural failure due to the insertion of a stiff R.C. roof (a) (Avorio, 2002), (b) (Binda et al., 2006).

In the highly seismic Umbria-Marche region, seismic retrofitting may have been the principal intention in replacing roofs. The added masses and the stiffness of the new roof cracked the supporting walls and frequently causing their total collapse; or damaged the external leaves of multiple leaves masonry walls, (Figure 6.1).

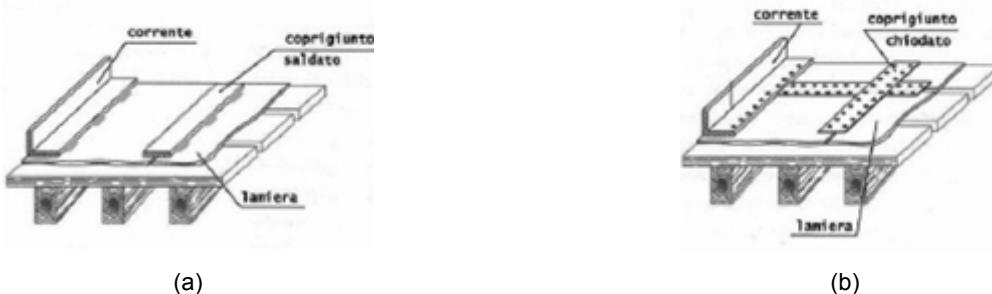
Figure 6.7 In-plane stiffening of floors with metallic plates: (a) welded plates, (b) nailed plates, (Giuriani and Plizzari, 2003).

However, this reinforcement technique, as well as presenting higher costs than Others solutions, doesn't increase the floor's bending stiffness and is ill-suited to the geometry, often irregular, of historical constructions.

The weak point of this intervention it's the joining of several elements, (Giuriani and Plizzari, 2003). Moreover, this reinforcement technique is applicable almost exclusively in the case of simple geometries; the problematic related to the weight increase and to the economic factor are particularly restrictive for the execution of this type of intervention, (Borri, 2004b).

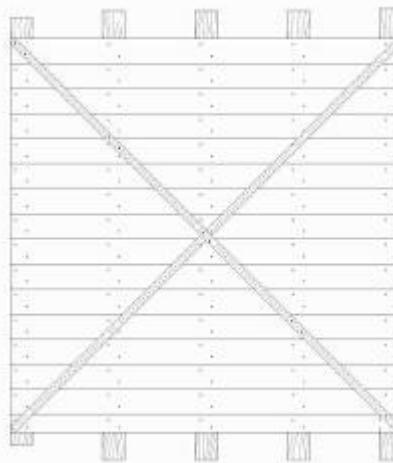
Figure 6.8 In-plane stiffening with metallic diagonals.

However, this reinforcement technique, doesn't increase the out-of-plane bending stiffness of the floor and, given the length of the connections and the reduced thickness of metal diagonals, has the disadvantage of having to fix the reinforcements at the points of overlap with the floor's main beams.

The increase in the number of connections is not so much a function of the stiffness increased as of an improvement of the stiffening side effects such as, ductility or energy absorption. Indeed, in terms of ductility the behaviour of a system with high hyperstaticity allows to dissipate a large amount of energy without significant loss of resistance, (Ceccotti and Vignoli, 2002).
