## FAT2 EXERCISE: DETAIL CLASSIFICATION – CORRECTION

### PROBLEM 1: Detail photos, detail categories

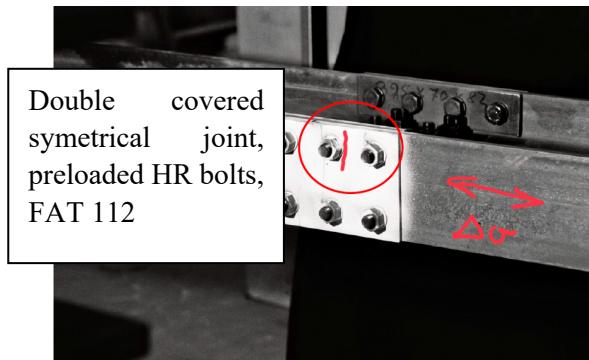
a) Cover joint with preloaded high strength bolts      (b) Web of a bridge box girder with longitudinal and transverse attachments/stiffeners
