## Case History 14: Buncefield Incident

## Buncefield: Why did it happen?

The underlying causes of the explosion and fire at the Buncefield oil storage depot, Hemel Hempstead, Hertfordshire on 11 December 2005

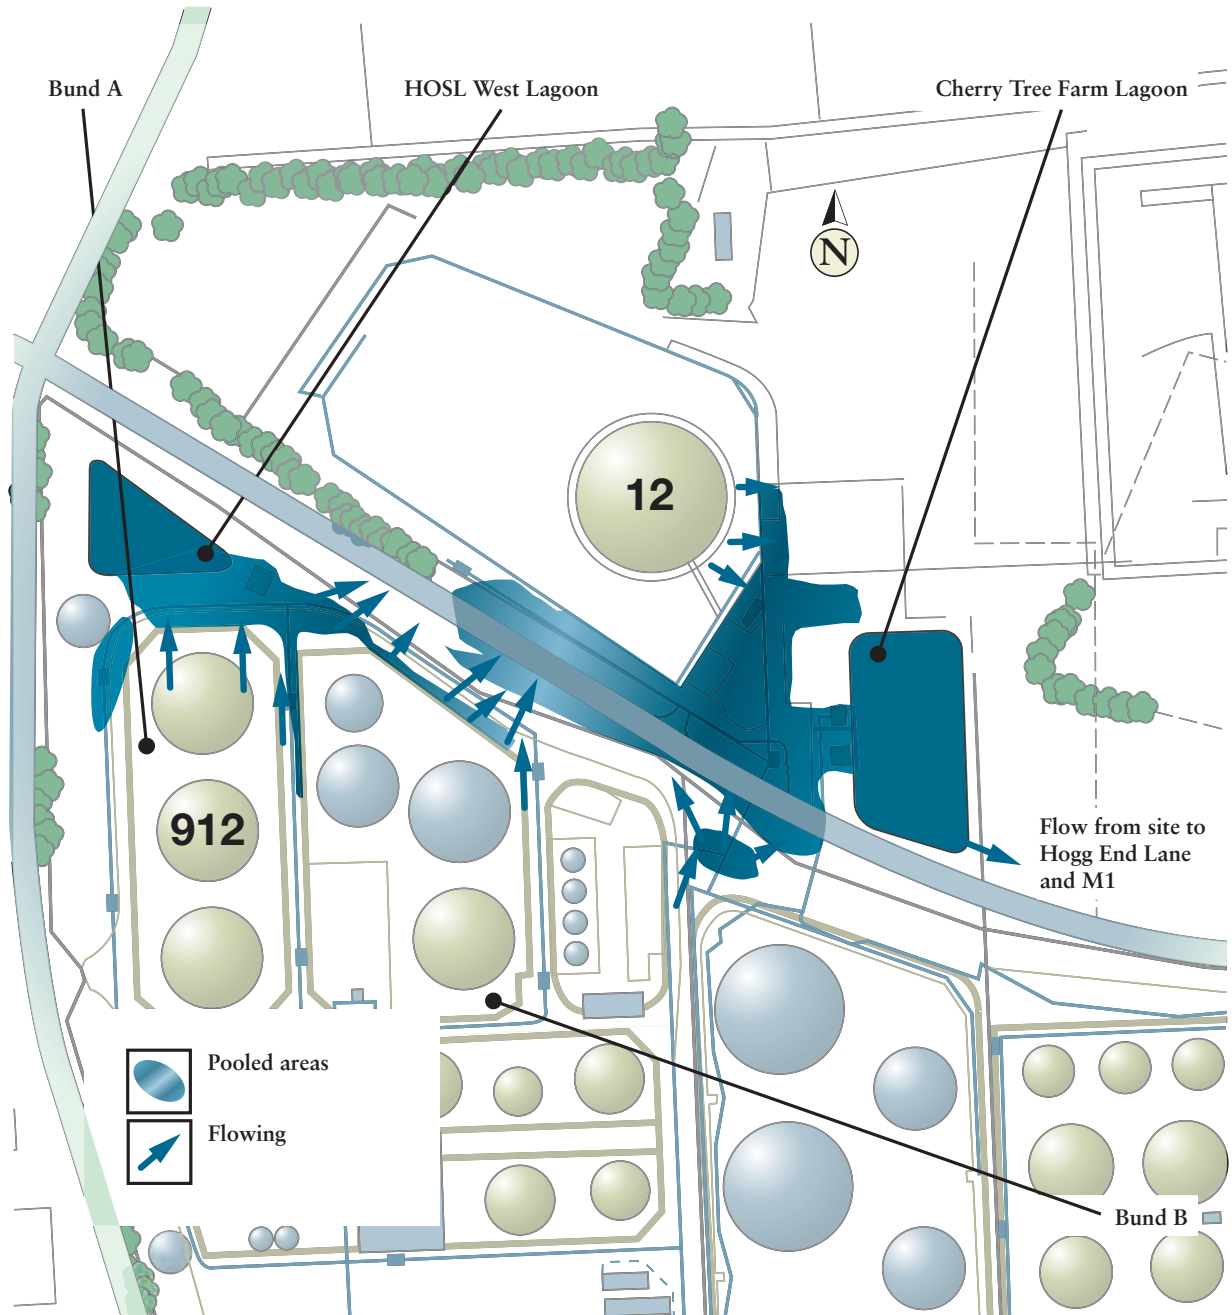
**Figure 3** Layout of the Buncefield site showing flow of liquids

Having failed to contain the petrol, there was reliance on a bund retaining wall around the tank (secondary containment) and a system of drains and catchment areas (tertiary containment) to ensure that liquids could not be released to the environment. Both forms of containment failed. Pollutants from fuel and firefighting liquids leaked from the bund, flowed off site and entered the groundwater. These containment systems were inadequately designed and maintained.

13 CCTV evidence showed that soon after that a white vapour was seen to emanate from the bund around the tank. In the windless conditions this vapour cloud, which was likely to have been a mixture of hydrocarbons and ice crystals, gradually spread to a diameter of about 360 metres, including areas off the HOSL site. This included a car park on the Maylands Estate, and onto the BPA north site where Tank 12, containing aviation kerosene, was situated.

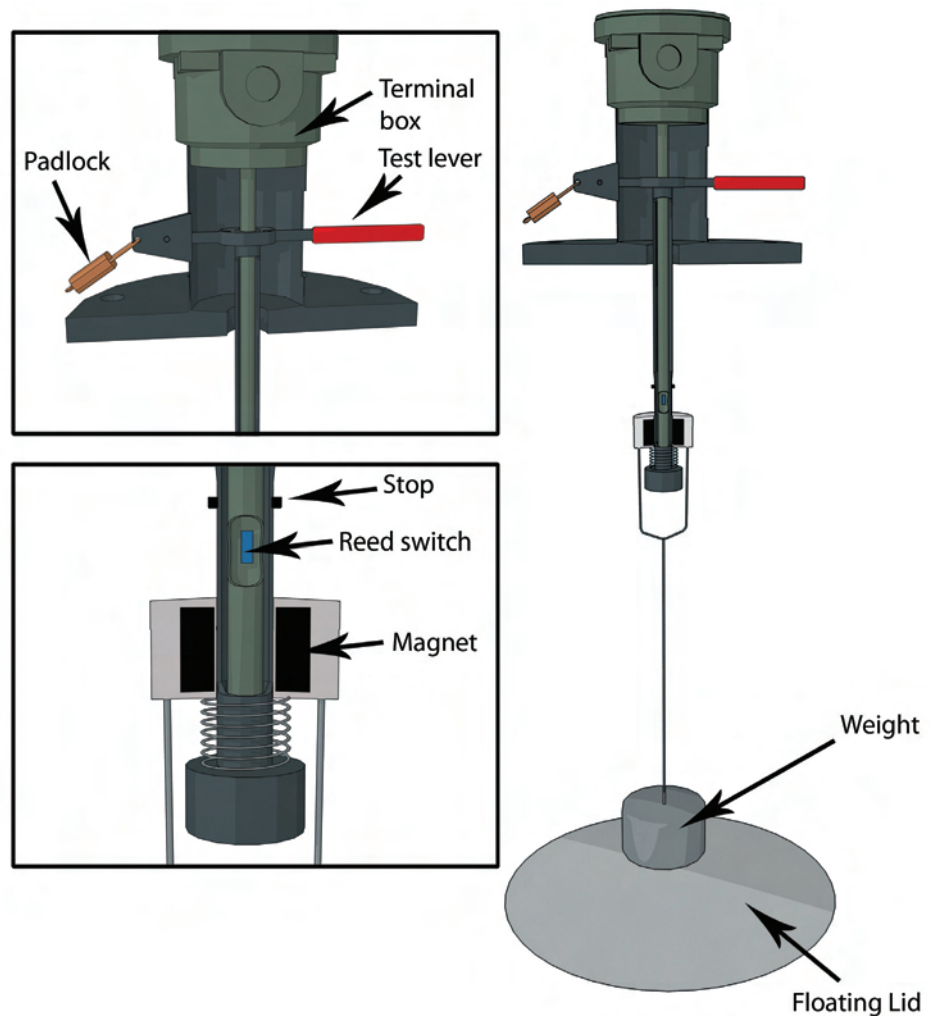
**Figure 12** The working principles of the IHLS

- 1 The switch worked – ie activated the alarm circuit – when the floating internal deck (lid) contacted and raised the internal suspended weight. This in turn raised a magnet which activated a reed switch.
- 2 The check lever allowed the switch and the alarm circuit to be activated independently of the movement of the floating lid. In effect the checking action simulated exactly what should happen if the floating lid arrived at that point.
- 3 There were three positions for the lever. The horizontal position was the normal operating position. In this position the switch operates as expected, ie if the floating lid lifts the weight, so that it is no longer hanging from the switch, the reed switch changes state and this initiates an emergency shutdown. The IHLS installed in Tank 912 was designed so that a padlock should be used to secure the lever in the horizontal position.
