## **Case History 016:**

### **Heat exchanger rupture and ammonia release in Houston, Texas**

## Heat exchanger rupture and ammonia release in Houston, Texas (One Killed, Six Injured)

2008-06-I-TX  
January 2011

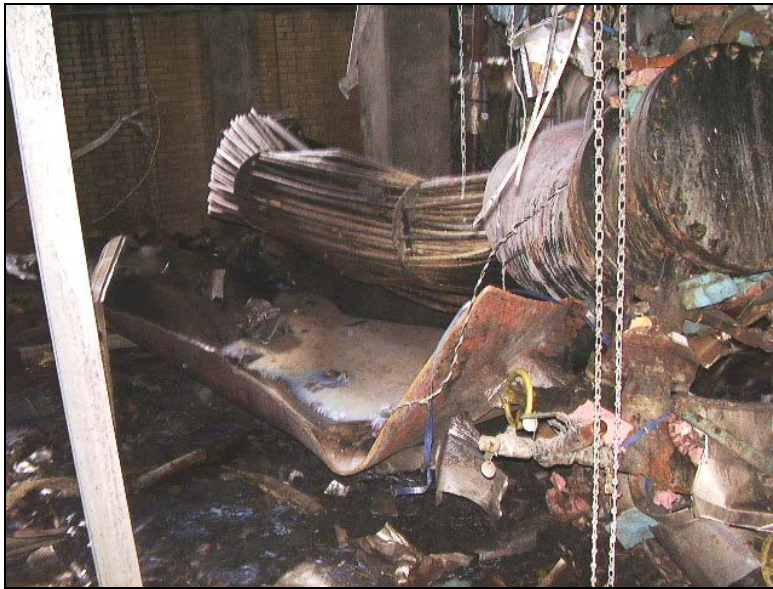
The catastrophic rupture threw debris that struck and killed a Goodyear employee walking through the area.

Several hours later, after plant operations had resumed, a supervisor assessing damage in the immediate incident area discovered the body of a Goodyear employee located under debris in a dimly lit area (Figure 1).
