## Case Study 17: Metal Dust Flash Fires and Hydrogen Explosion

## Hoeganaes Corporation: Gallatin, TN Metal Dust Flash Fires and Hydrogen Explosion

5 Killed, 3 Injured

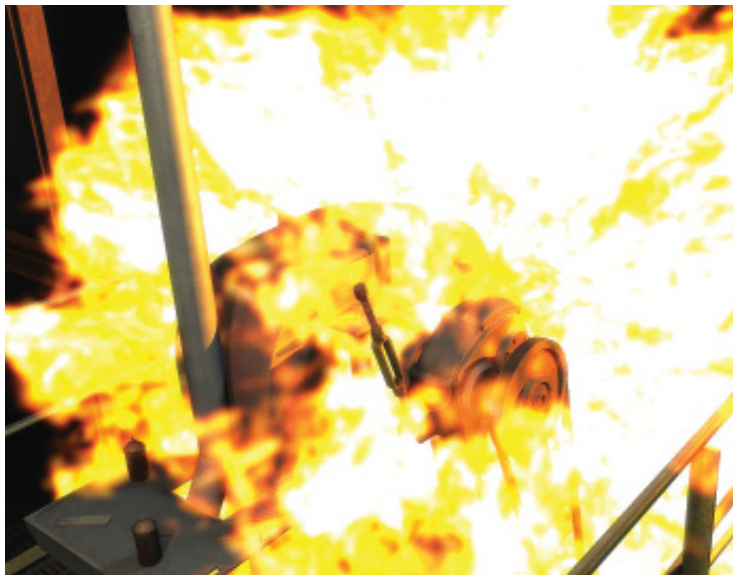
**FIGURE 5**

Computer graphic of January 31 iron dust flash fire.

City of Gallatin emergency responders arrived with ambulances and transported the mechanic and electrician to the Vanderbilt Burn Center in Nashville, TN. Both employees were severely burned over a large percentage of their bodies. The first employee died from his injuries two days later. The second employee survived for nearly four months before succumbing to his injuries in late May 2011.

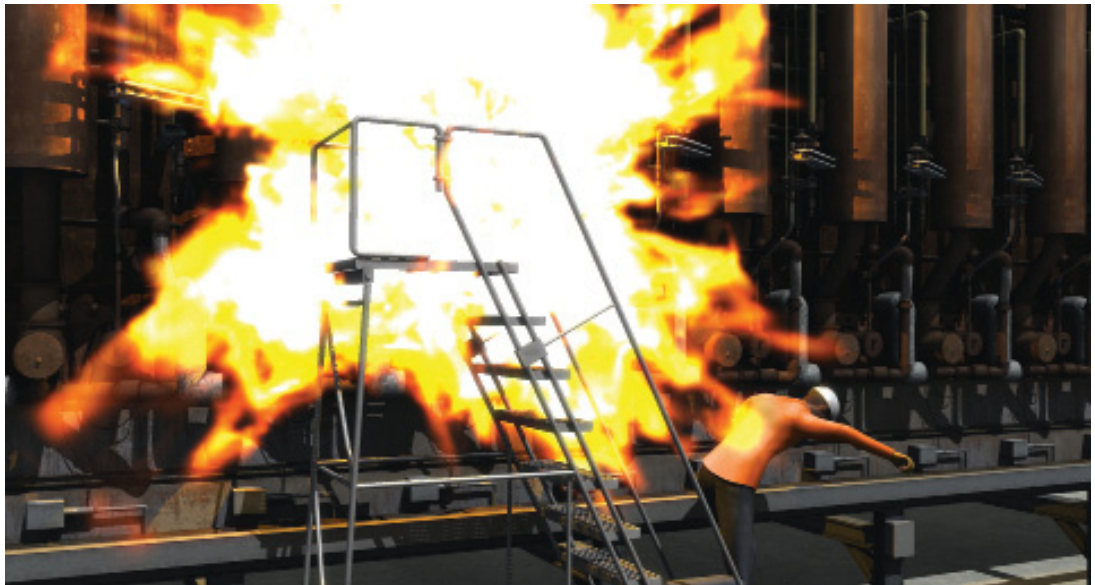
**FIGURE 8**

Computer graphic of March 29 iron dust flash fire.

The engineer was wearing the Hoeganaes-designated personal protective equipment, which included pants and a shirt that were rated as flame resistant clothing (FRC). He was also wearing an FRC rated jacket that provided extra shielding to his upper torso from the flash fire.

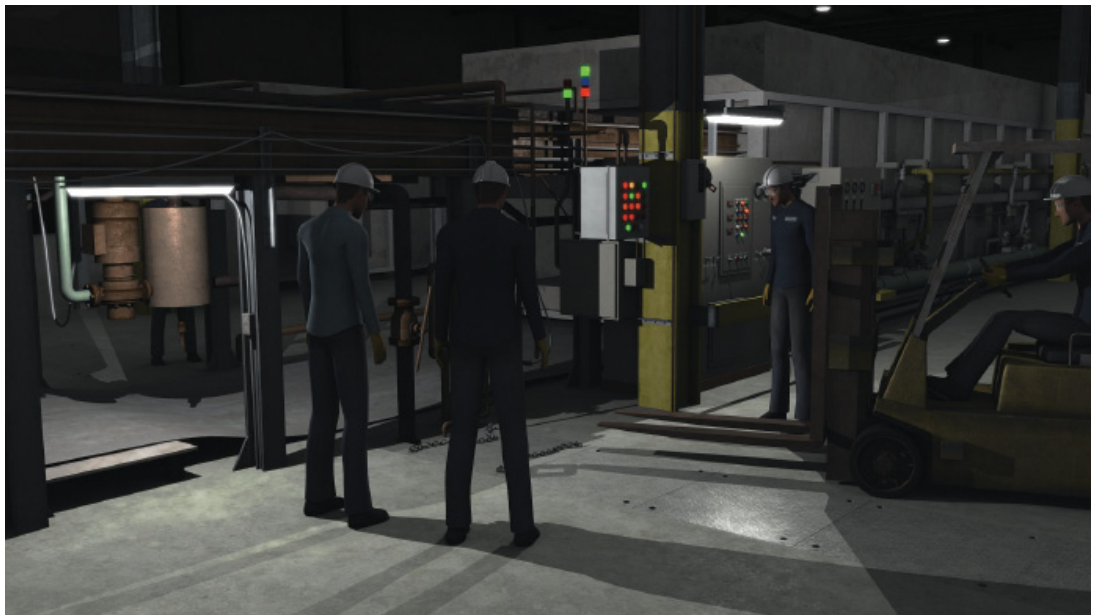
Computer graphic of maintenance crews starting to remove the trench covers using a forklift just prior to May 27 explosion.

covers were too difficult to lift without machinery. Using an overhead crane, they were able to remove some of the trench covers. They determined that the leak was near the southernmost trench covers, which the crane could not reach. Shortly after 6:30 am, maintenance personnel acquired a forklift equipped with a chain on its forks, and were able to reach and begin removing the southernmost trench covers.

Interviews with eyewitnesses indicate that just as the first trench cover was wrenched from its position by the forklift, friction created sparks, followed by a powerful explosion. Several days after the explosion, CSB investigators observed a large hole (approximately 3 x 7 inches) in a corroded section of piping that carried hydrogen and ran through the trench (Figure 11).

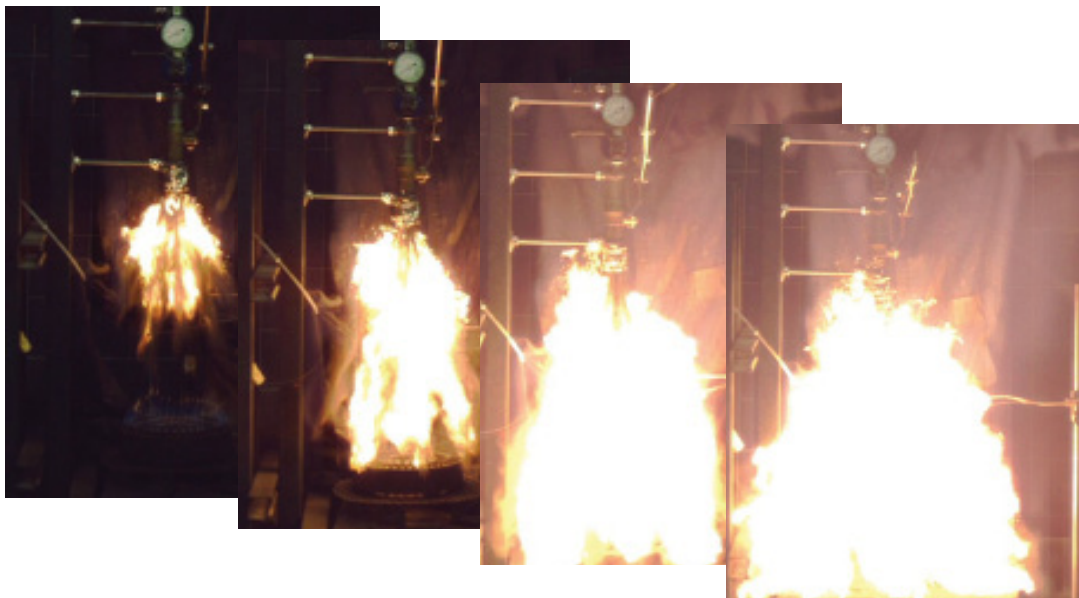
FIGURE 14

This test dispersed about 30 grams of iron dust—sampled from the baghouse<sup>9</sup> associated with the bucket elevator from the January 31, 2011, incident—above an 8 inch burner. Upon being released, the dust auto-ignites in air due to the heat given off from the burner below (Figure 14). An intense white flame was produced that reached a peak diameter of 18 inches.

CSB iron dust combustibility demonstration, see Section 4.1.1.1.
