## **Case History 02 : « Distillation »**

# The fire at **HICKSON & WELCH LTD**

A report of the investigation by the  
Health and Safety Executive into the fatal  
fire at Hickson & Welch Ltd, Castleford  
on 21 September 1992

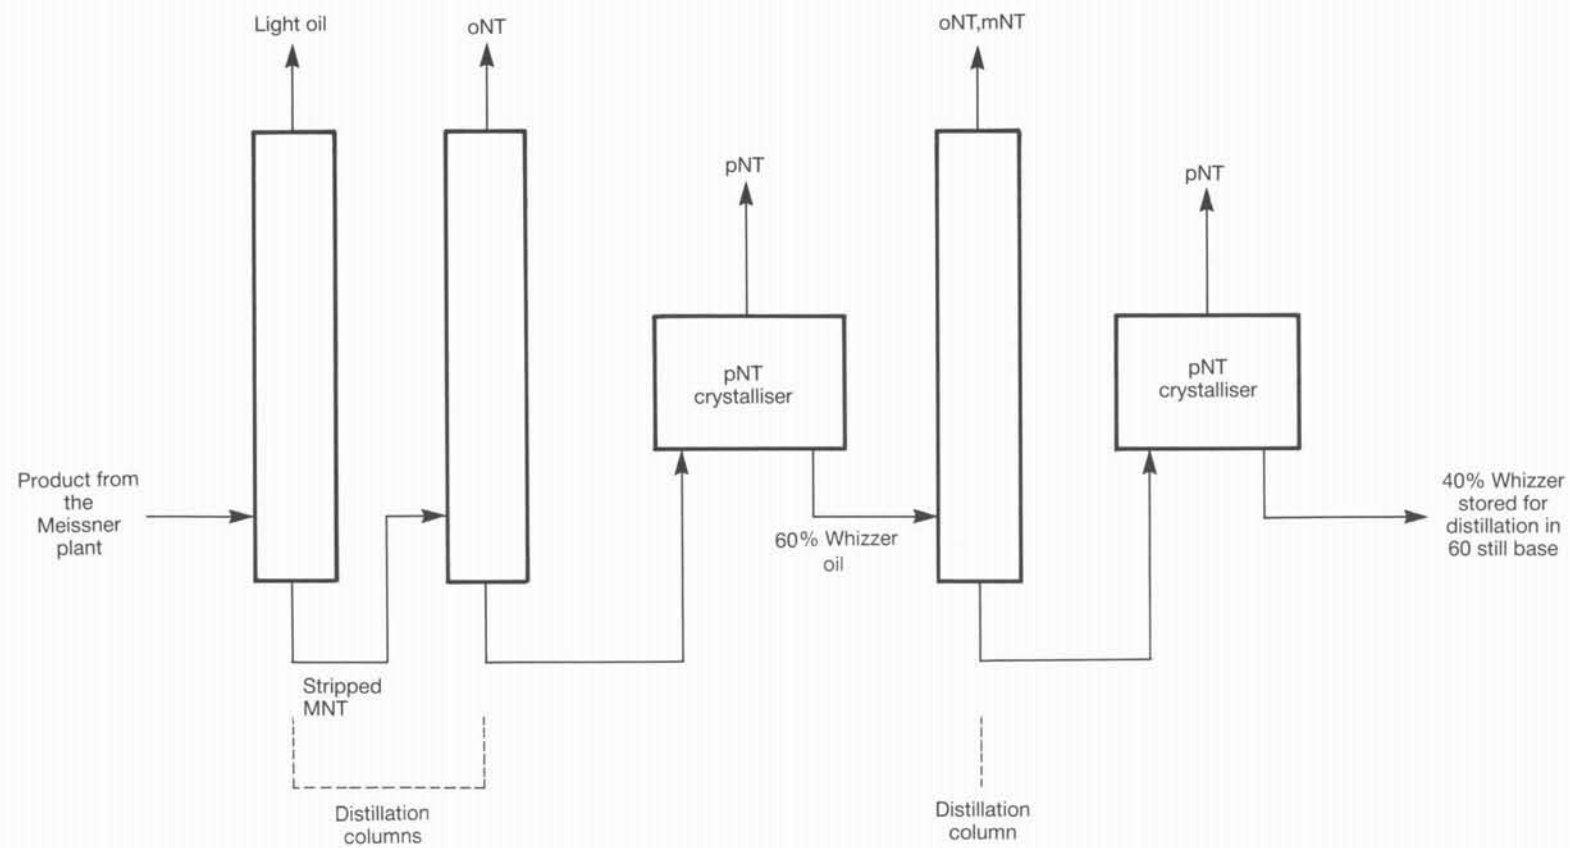
**Figure 2** Simplified flow diagram of the MNT separation

- 15 At the time of the incident MNT isomers (oNT, mNT and pNT) were separated from each other and from DNT and nitrocresols via a complex sequence of distillations and crystallisations which have been summarised in a simplified flow diagram (Figure 2).

- 16 The first distillations in two fractionating columns removed oNT, unreacted toluene and water. The bottom liquors from the second column were rich in pNT and they were passed through box crystallisers where the pNT crystallised to leave a liquor that was called '60% whizzer oil'. This liquor was collected and distilled through the second or similar fractionating columns to remove a mixture rich in oNT and mNT. Bottom liquors leaving that were rich in pNT. They were passed through box crystallisers to remove the pNT leaving a liquor known as '40% whizzer oil'. This material was kept in a number of large vertical storage tanks (see Figure 4) ready for distillation in 60 still base.

- 17 The successive distillations and crystallisations raised the concentration of the less volatile DNT and nitrocresols from circa 0.5% and 0.7% respectively to 14% and 19%, in 40% whizzer oil. The final separation involved batch distillation of this material in 60 still base to recover more MNT.

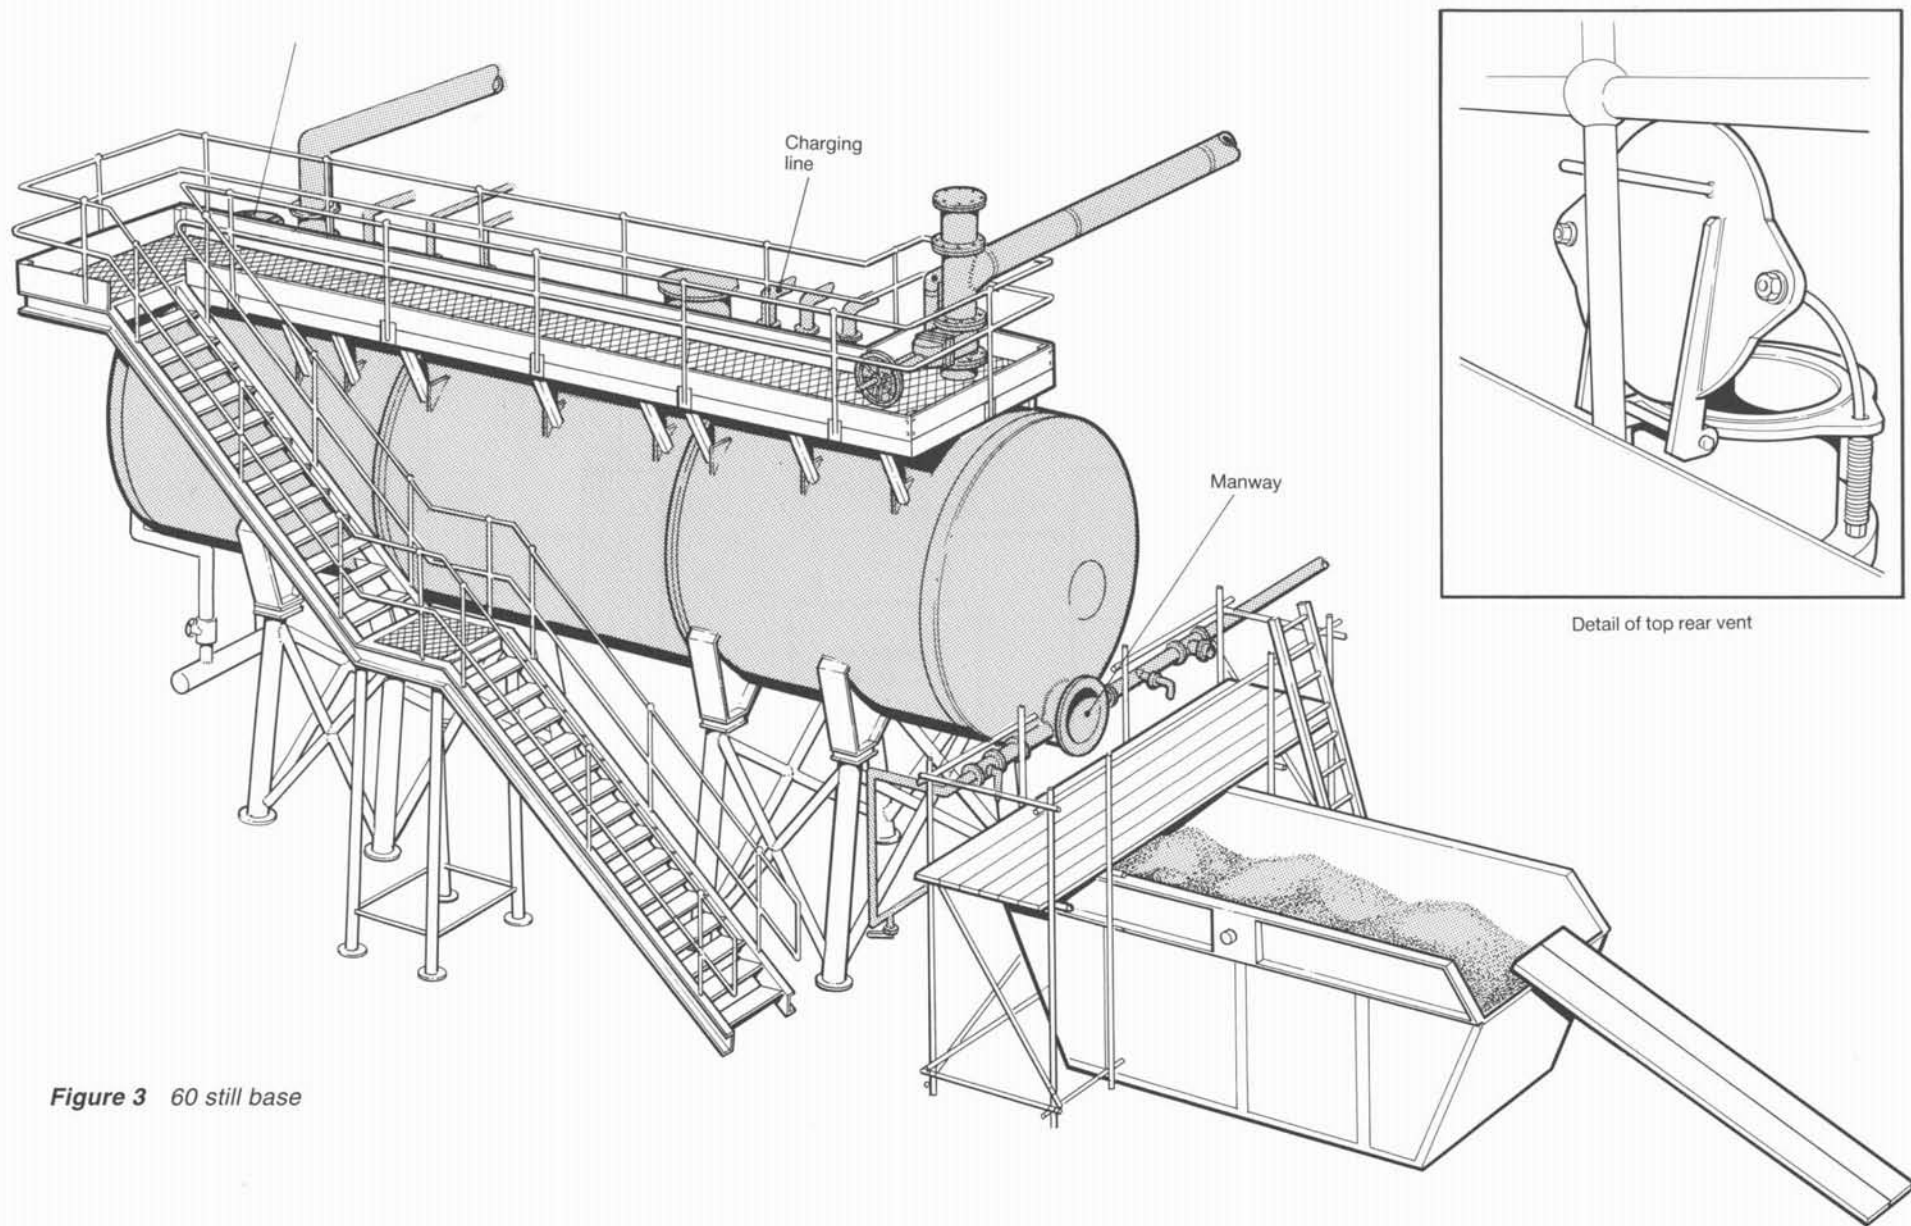
**Figure 3** 60 still base

- 26 Since it was first installed in the nitrotoluenes area, in 1961, 60 still base had never been opened for cleaning. Following the process change in 1988, manufacturing problems affecting quality and production were experienced in the nitrotoluenes area. The continuous stills were stripped and cleaned to remove residues and operators working on 60 still base began to notice and reported a build up of sludge in this vessel which was slowing the rate of distillation. Various estimates were made about the depth of sludge but the general consensus was that there was as much as 1820 litres equivalent to a uniform depth of about 10 cm (4 in). A senior employee had reported a depth of 29 cm (12 in) several months before the incident and on 21 September 1992, the day of the accident, the same employee dipped the still base on the instructions of his area manager. He used a metal dipping rod and estimated that the sludge was approximately 34 cm (14 in) deep.

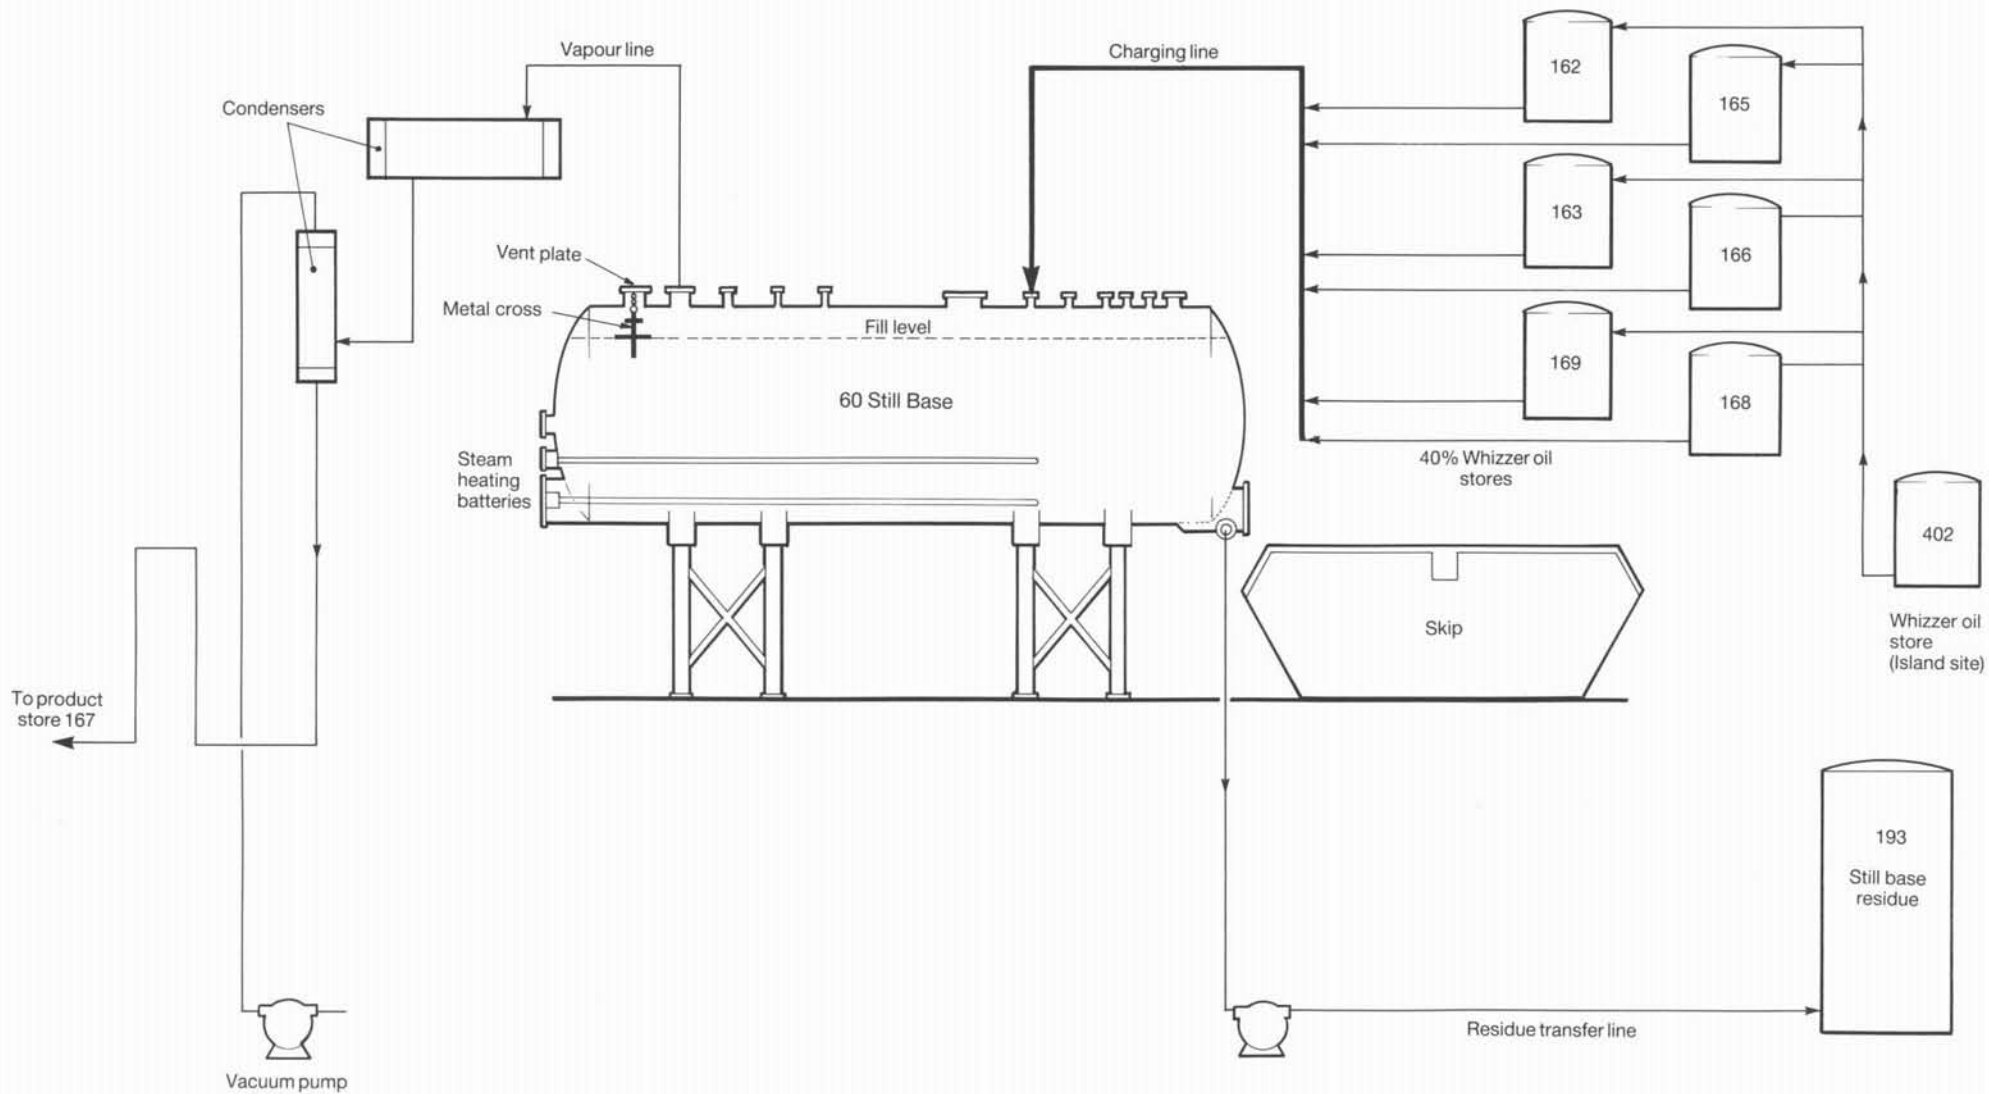
**Figure 4** Schematic diagram of 60 still base and associated plant (including metal cross fill level device)

- 27 After the incident management at the factory offered another theory to explain why this depth of sludge had accumulated. They suggested that ordinarily the sludge level in the still base ebbed and flowed leaving about 1820 litres in the still base between successive distillations. However, the company claimed that the higher than expected level noted on 21 September was attributable to material removed from whizzer oil storage tanks

- 28 The removal of residue from 60 still base was discussed by a shift manager and the area manager (AM) on Thursday 17 September 1993 (paragraph 27). The shift manager had been told by employees that the vessel had never been cleaned out. He realised that the bottom steam battery was covered by sludge and he advised the AM. They discussed preparation for the clean-out which required removal of steps and a platform in front of the vessel and provision of a scaffold and skip so that the sludge could be removed from the front face manway (Figures 4 and 7).

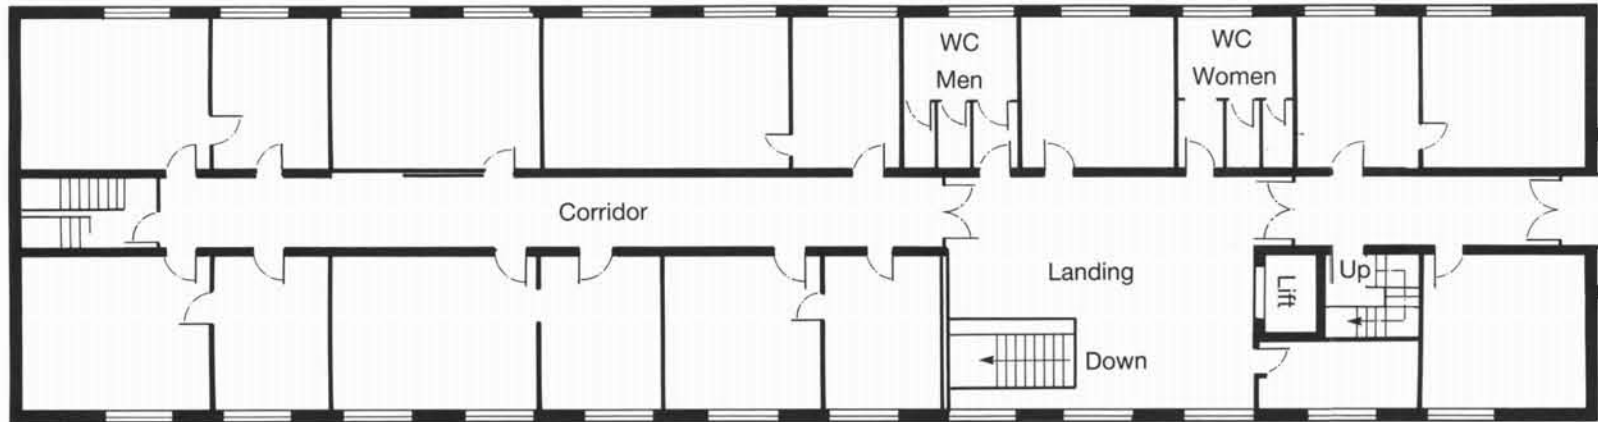
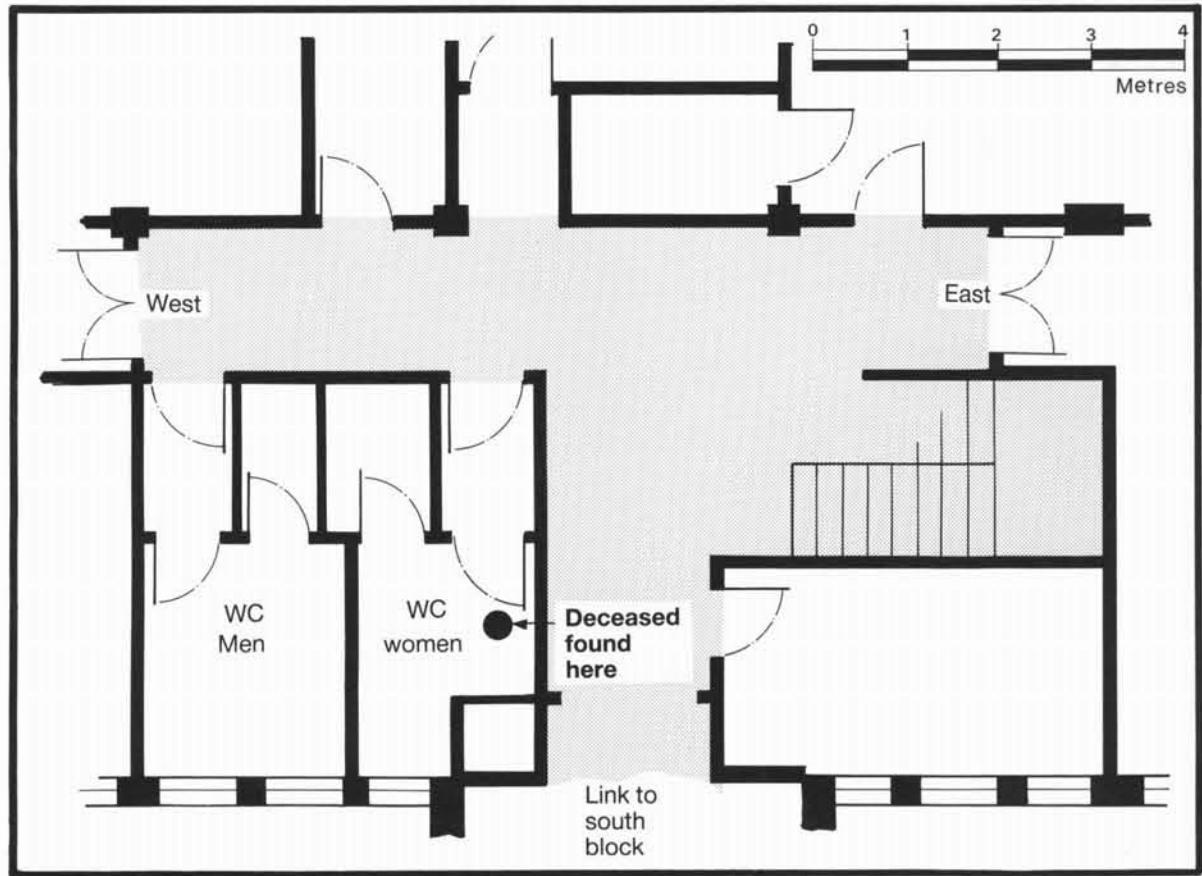
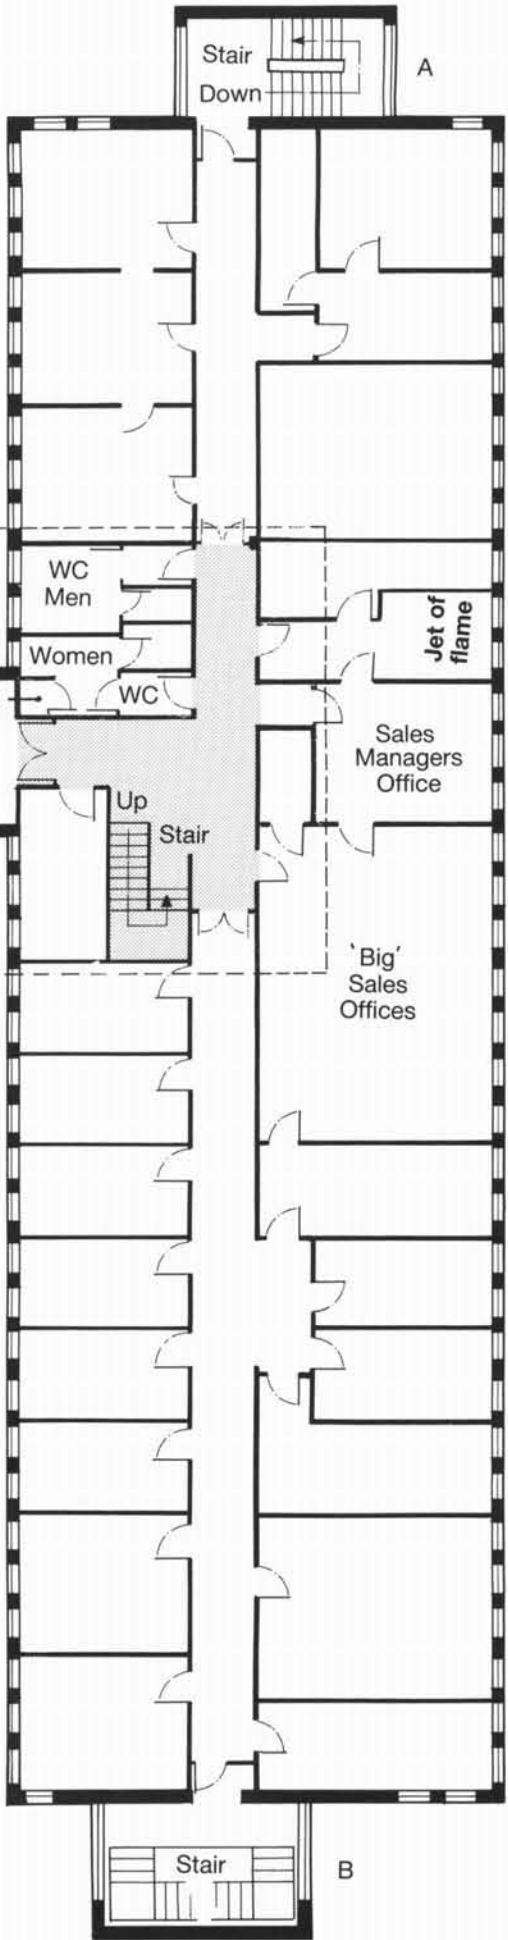
Appendix 3 Plan of the second floor of the main office block

jet flame had impacted, through protected route C into the toilet accommodation. These breaches and the false ceiling provided a direct path for smoke into the women's toilet. Smoke damage in the women's toilet is shown in Figure 11 and it was here that an office worker was found. The probable direction of smoke travel is illustrated in Figure 12 and Appendix 4.

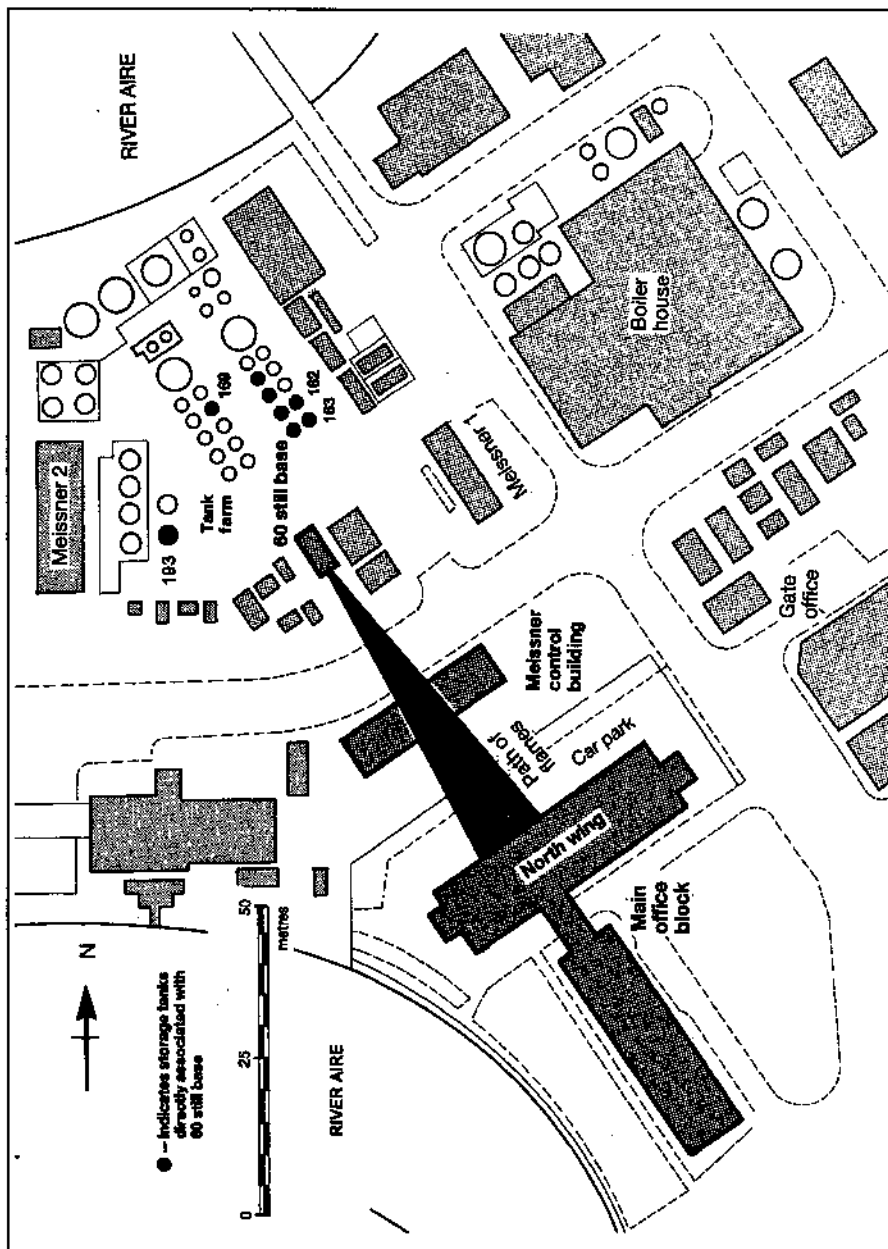
Figure 1: Plan of area around 60 still base showing path of flame

- 44 Most of the main fire damage was roughly in a V-shape emanating from the still base to an area where the flame hit the main office block 55 m away (Figure 1). However, there was some damage to scaffolding on the adjacent vertical still, caused by the jet which came out of the rear vent. The panel room beside the still base was scorched and windows were broken (Figure 8).

3.2 The flame then struck the main, four storey office block some 55 metres from the vessel. At the point of impact windows in the building shattered, brickwork spalled and window frames melted. A number of offices were set alight. At the time there were 63 people in the building. One employee was overcome by smoke on the second floor and died later in hospital. A plan of the area around 60 still base is shown as figure 1.

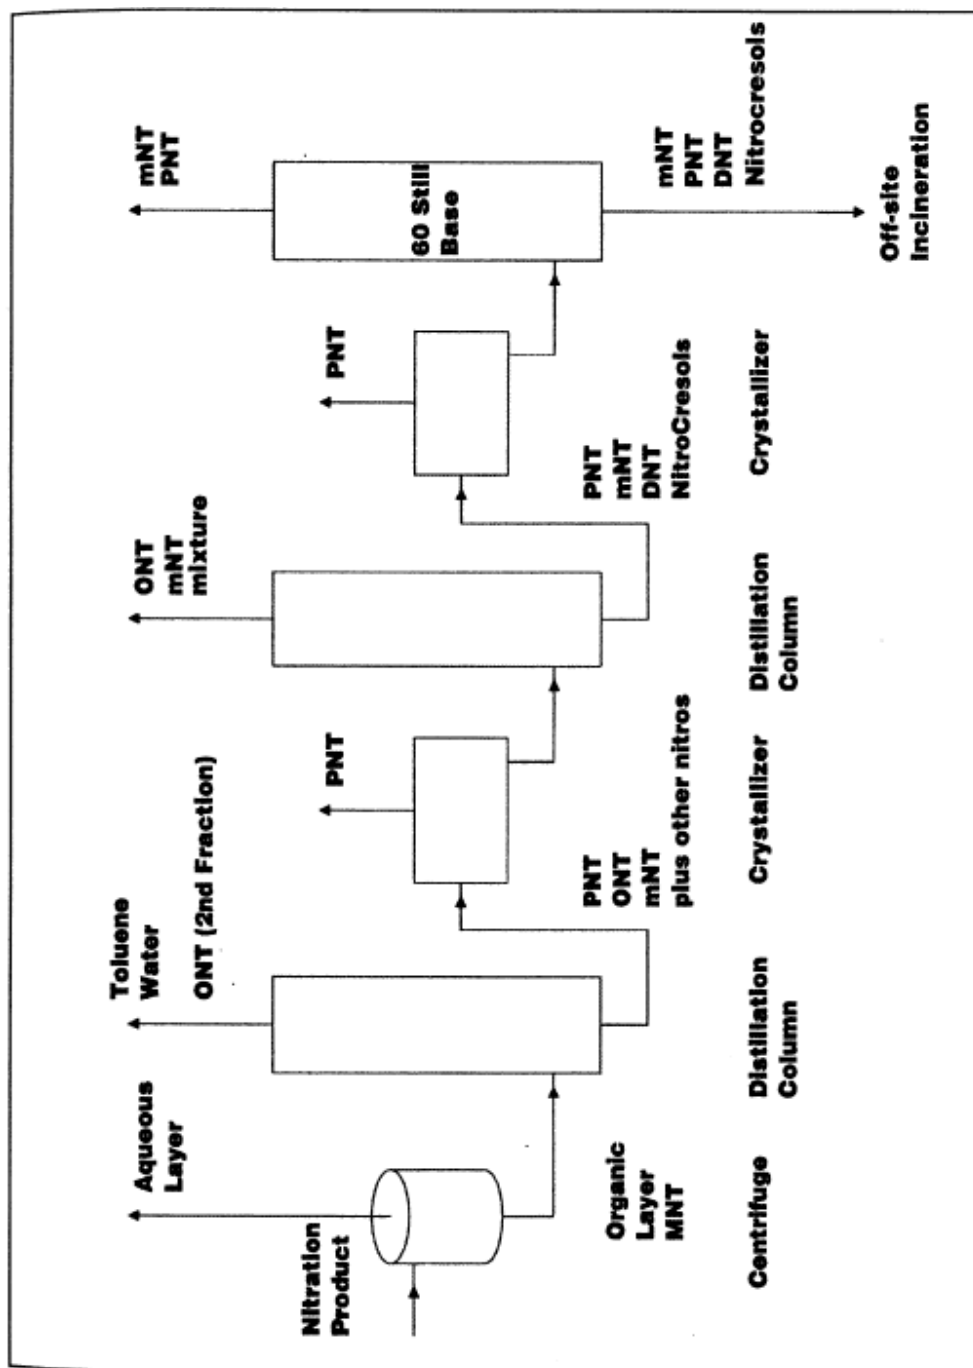
Nitrotoluene separation system

4.4 The separation of the organic stream from the nitration plant into the pure isomers is done by a series of fractional distillation and crystallization steps. These steps are summarised in (figure 2), omitting any recirculation or repetition, and produce essentially pure products for sale or as a feedstock for use on site. The crystallization and distillation steps are standard unit processes.
