## Case History 09: Ink dust explosion

## Ink Dust Explosion and Flash Fires in East Rutherford, New Jersey

2013-01-I-NJ

### **US Ink/Sun Chemical Corporation**

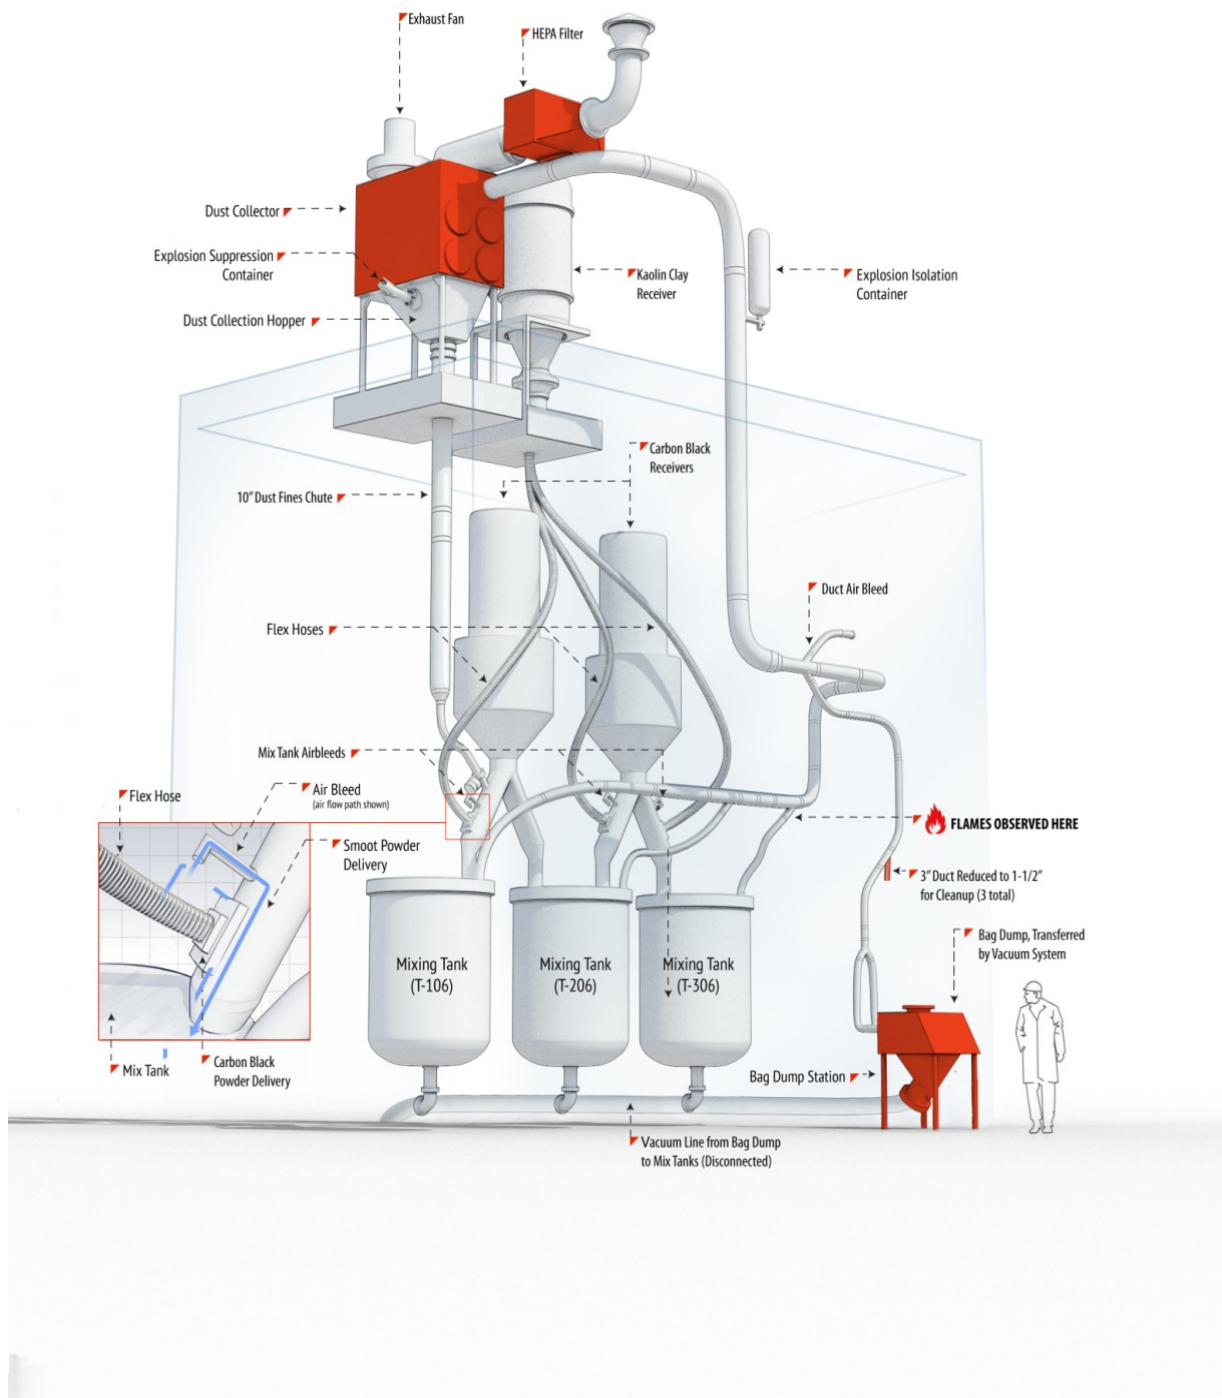
Figure 3. Overview of the newly installed dust collection system

on Friday, October 5, 2012.<sup>9</sup> The dust collection system illustrated in Figure 3 consisted of a branching system of various sizes of ducts, including flexible connectors attached to the top of each mixing tank and to the bag dump station. The flexible ducts joined an 8-inch duct, which transitioned to a 9-inch duct and ultimately a vertical 12-inch duct (riser) going up through the pre-mix room ceiling. Dust particles were suctioned through the ducts and riser into the exhaust fan–driven dust collector, located on the roof of the facility (Figure 3).

On the basis of analytical testing of the materials in the ductwork (summarized in Section 4), the CSB concluded that excessive quantities of condensable vapors were released into the ductwork of the dust collection system during its operation. An essential consideration in the design of a dust pickup of a dust collection system is how air enters the pickup and travels to the connected duct. In a closed system such as the mix tanks, air from the tanks is displaced when the tanks are filled with liquid or powders, and air must be drawn into the tanks as the liquid ink mixture is pumped out of the tank. At the US Ink East Rutherford facility, each of the three mixing tanks in the pre-mix room had a small air bleed duct (1.5 inches in diameter) on the rectangular powder fill chute from the carbon black delivery systems. Also attached was a flexible hose for delivering kaolin clay to the mixing tank. The tank was connected to the dust collection system through a flexible duct (6 inches in diameter) a few feet from the powder delivery chute (depicted in Figure 3).

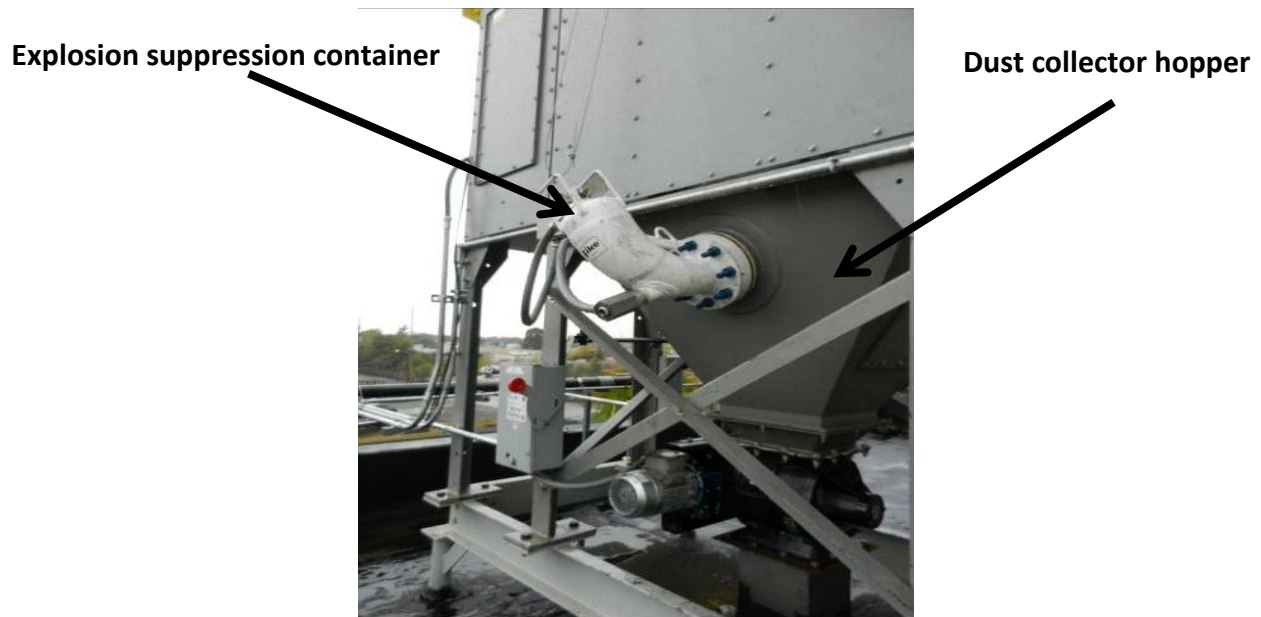
Figure 4. Dust collector with explosion suppressant

<sup>11</sup> The explosion suppression system would actuate and inject sodium bicarbonate via an independent suppression container and chemical isolation container located at two injection points in the system: the dust collector hopper (Figure 4) and the collector inlet riser (Figure 5). The suppressant was designed to be injected if a rapid pressure rise occurred in the dust collector and was intended to suppress a flame front from propagating from the dust collector back through the riser into the interconnected ductwork and pre-mix room.

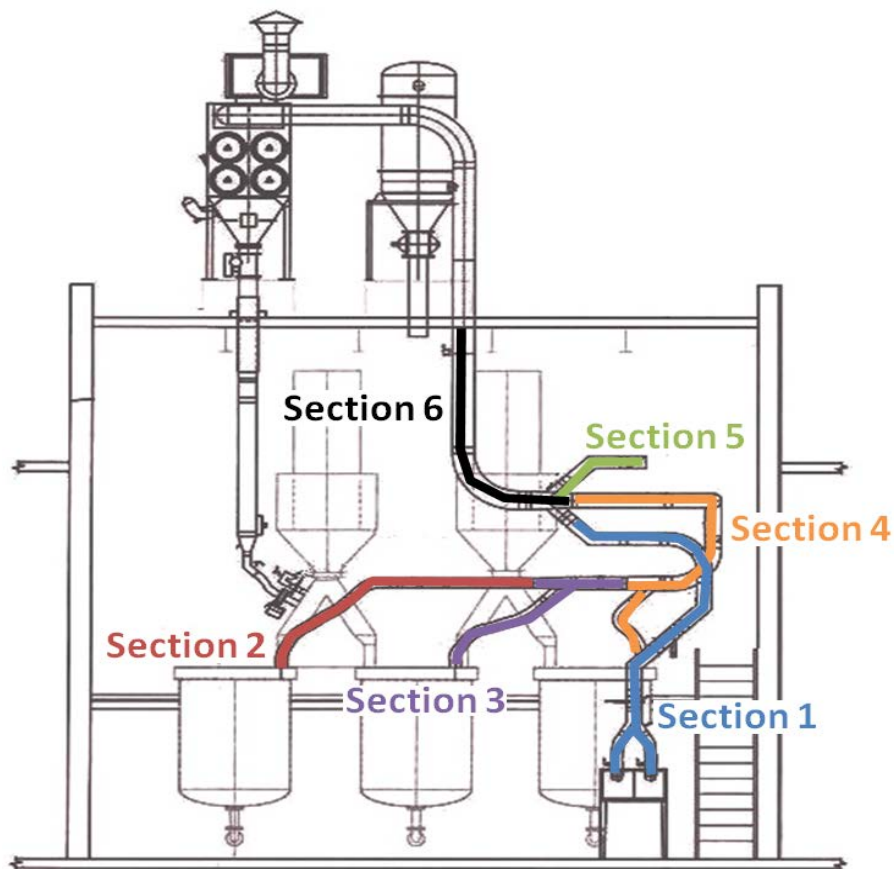
**Figure 8. Ductwork sections for sampling**

The CSB observed removal of the dust collection system ductwork in December 2012. Investigators collected residue samples from six sections of the entire ductwork system (shown in Figure 8). They inspected the interior of various ductwork sections and took material samples from inside the ducts. These inspections revealed large accumulations of black, burned, and unburned materials. Most of the accumulations appeared to be black sludge-like material. The CSB investigators collected samples of the sludge-like material for further chemical composition analysis and testing to develop possible ignition scenarios.

<sup>78</sup> The ductwork assembly from section 6 (ductwork that was vertically installed from the pre-mix room up to the rooftop and continuing to the dust collector, as shown in Figure 8) was measured at 12 inches in diameter.
