## Case History 13: BP America Refinery explosion

U.S. CHEMICAL SAFETY AND HAZARD INVESTIGATION BOARD

(15 Killed, 180 Injured)

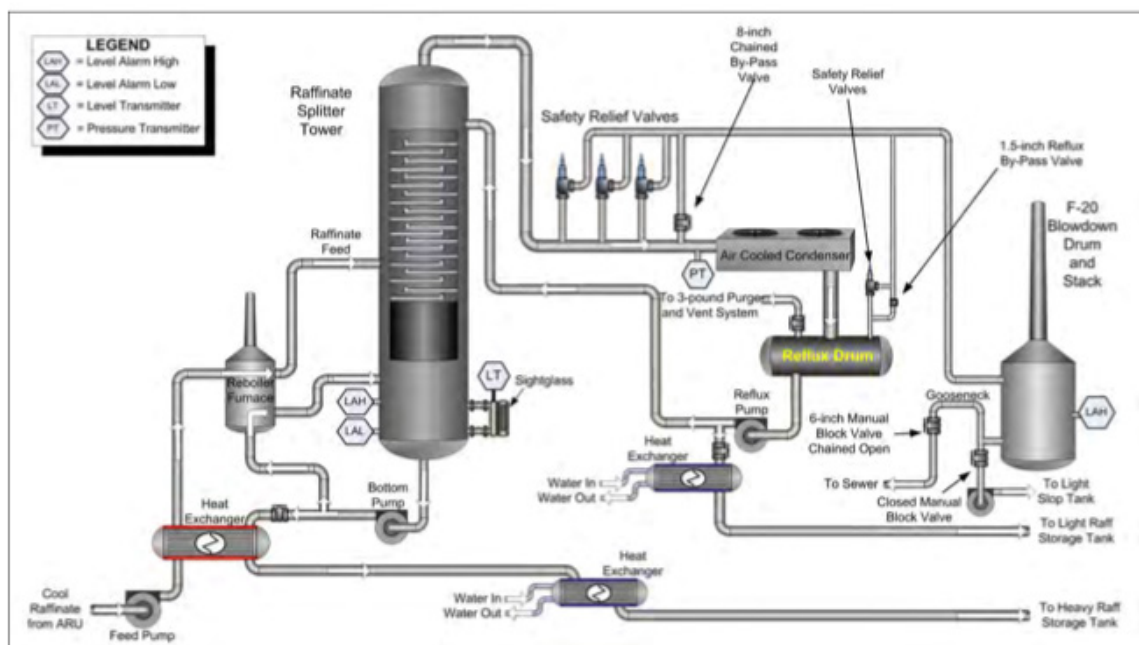
Figure 1. Raffinate section of the ISOM

As flammable hydrocarbons overfilled the blowdown drum, operators saw nearby a geyser of liquid and vapor erupting from the tower. The vapor cloud expended to the entire surface of the refinery up to the parking lot, where two workers were in a car with the motor on thus igniting the vapor cloud resulting in an explosion. This incident resulted in 15 fatalities and 180 injuries.

1. Evaluate the refinery process units to ensure critical process equipment is safely designed.
2. Ensure that process startup procedures are updated and reflect the actual process conditions.
3. Have knowledgeable supervisors or technically trained personnel to be present during especially hazardous operation.
4. Develop a fatigue prevention guideline for the refining and petrochemical industries by limiting hours and days of work and proper shift work.
5. Establish and implement an integrated and comprehensive process safety management system that systematically and continuously identifies, reduces, and manages process safety risks.

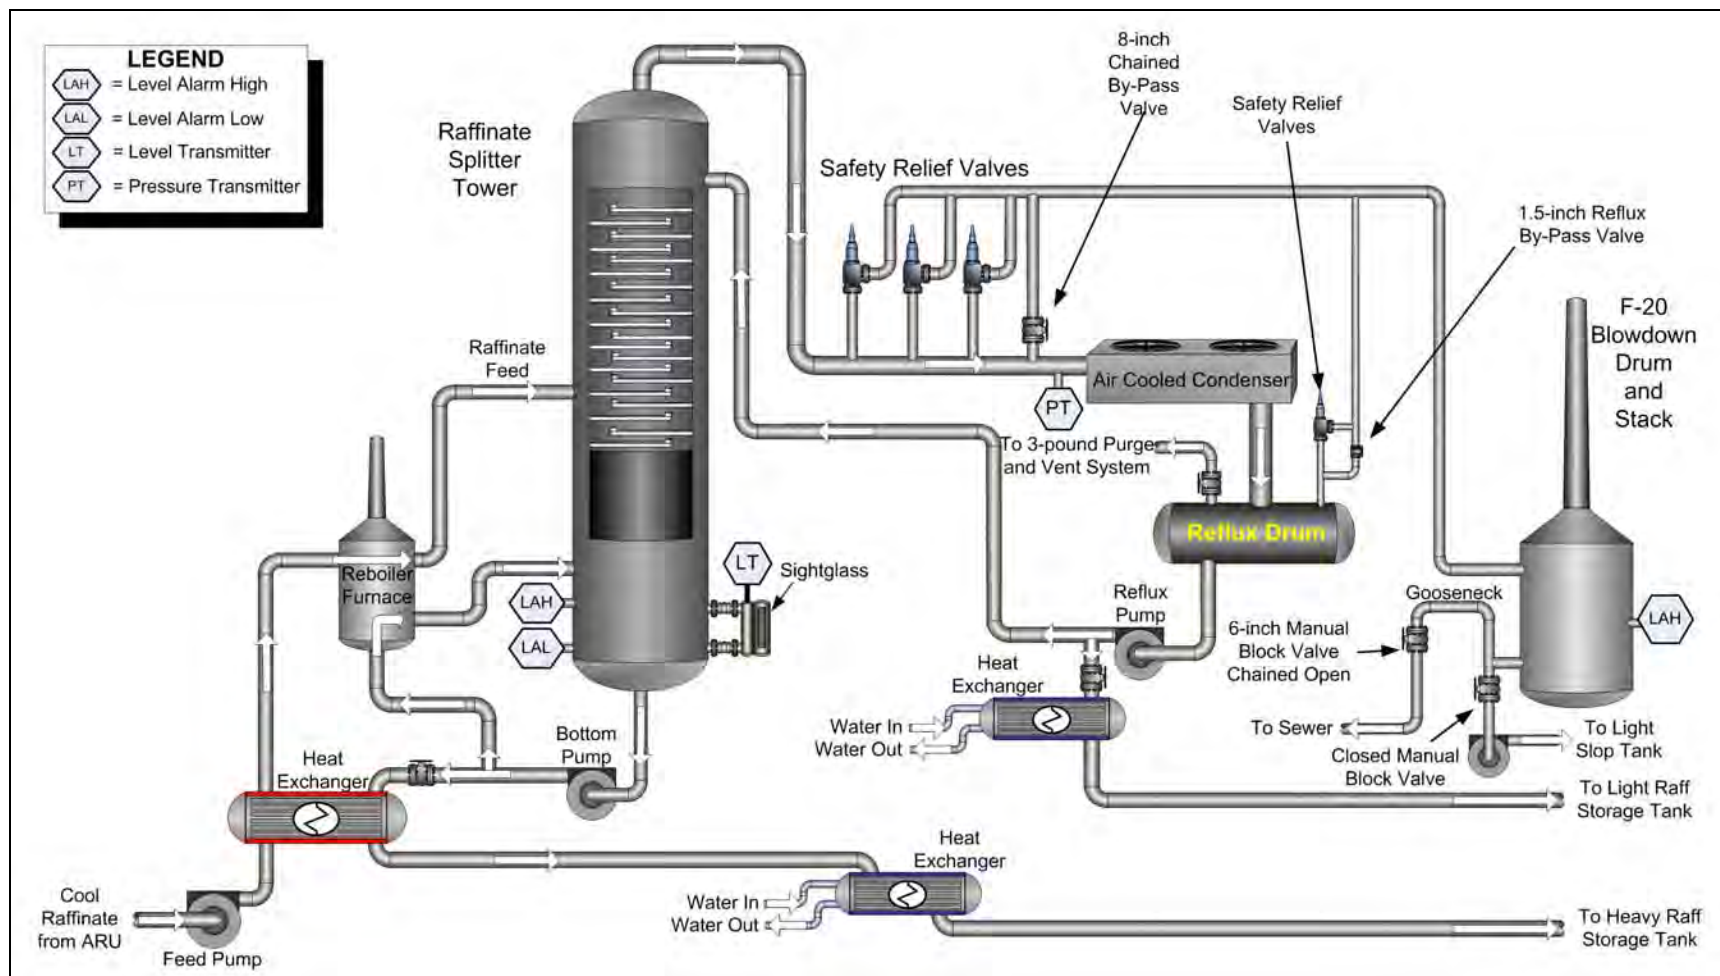
Figure 1. Raffinate section of the ISOM

The process equipment in the raffinate splitter section (Figure 1) consisted of a feed surge drum; a distillation tower; a furnace with two heating sections, one used as a reboiler for heating the bottoms of the tower and the other preheating the feed; air-cooled fin fan condensers and an overhead reflux drum; various pumps; and heat exchangers. (Appendix E provides details on the history of the raffinate splitter section.)

The tower was a vertical distillation column with an inside diameter of 12.5 feet (3.8 m) and height of 170 feet (52 m) with an approximate liquid-full volume of 154,800 gallons (586,100 liters). The tower was fitted with 70 distillation trays<sup>17</sup> that separated the light from the heavy raffinate (Figure 1).

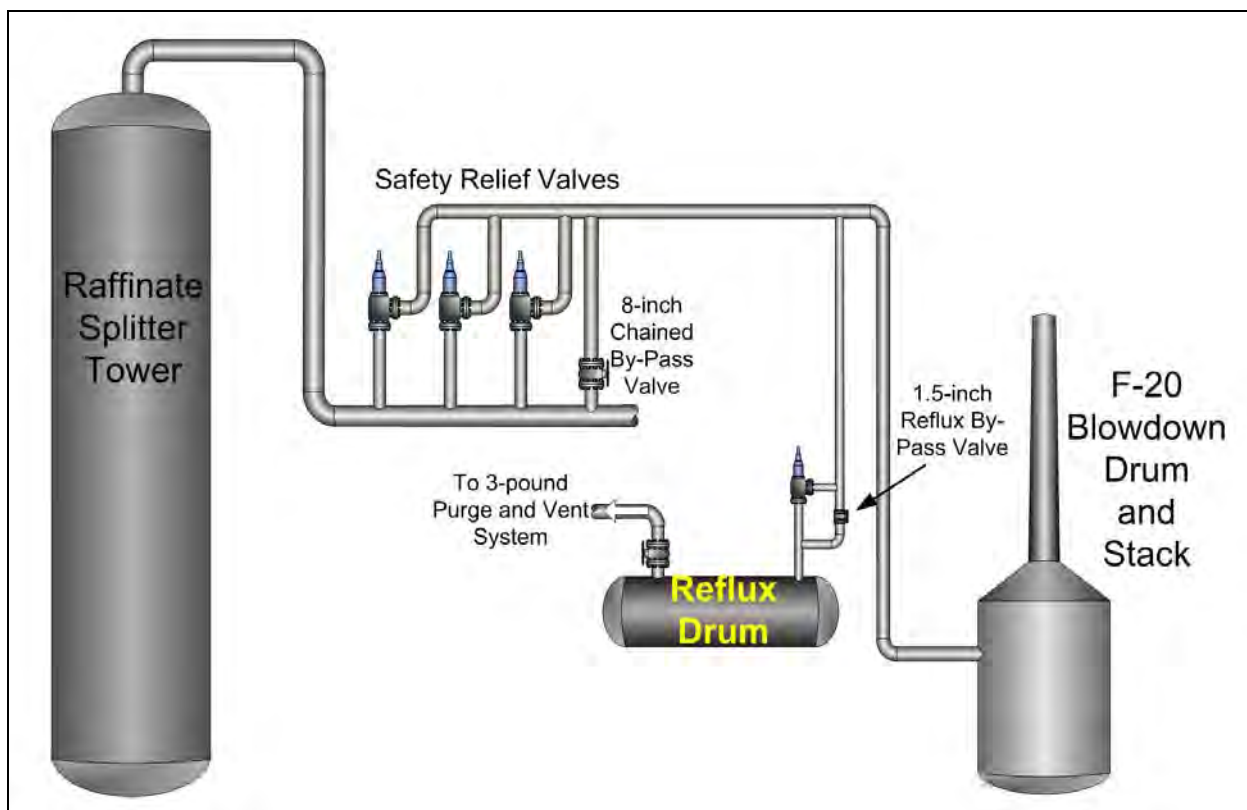
Figure 2. Disposal collection header system

The disposal header collection system received liquid and/or vapor hydrocarbons from venting relief and blowdown valves from equipment in the ISOM unit and discharged them to the blowdown drum. The header collection system included a 14-inch NPS (35.6 cm outer diameter) elevated pipe about 885 feet (270 m) long from the raffinate splitter tower (Figure 2). Other sections of the ISOM unit also discharged from two additional collection headers into the blowdown drum.

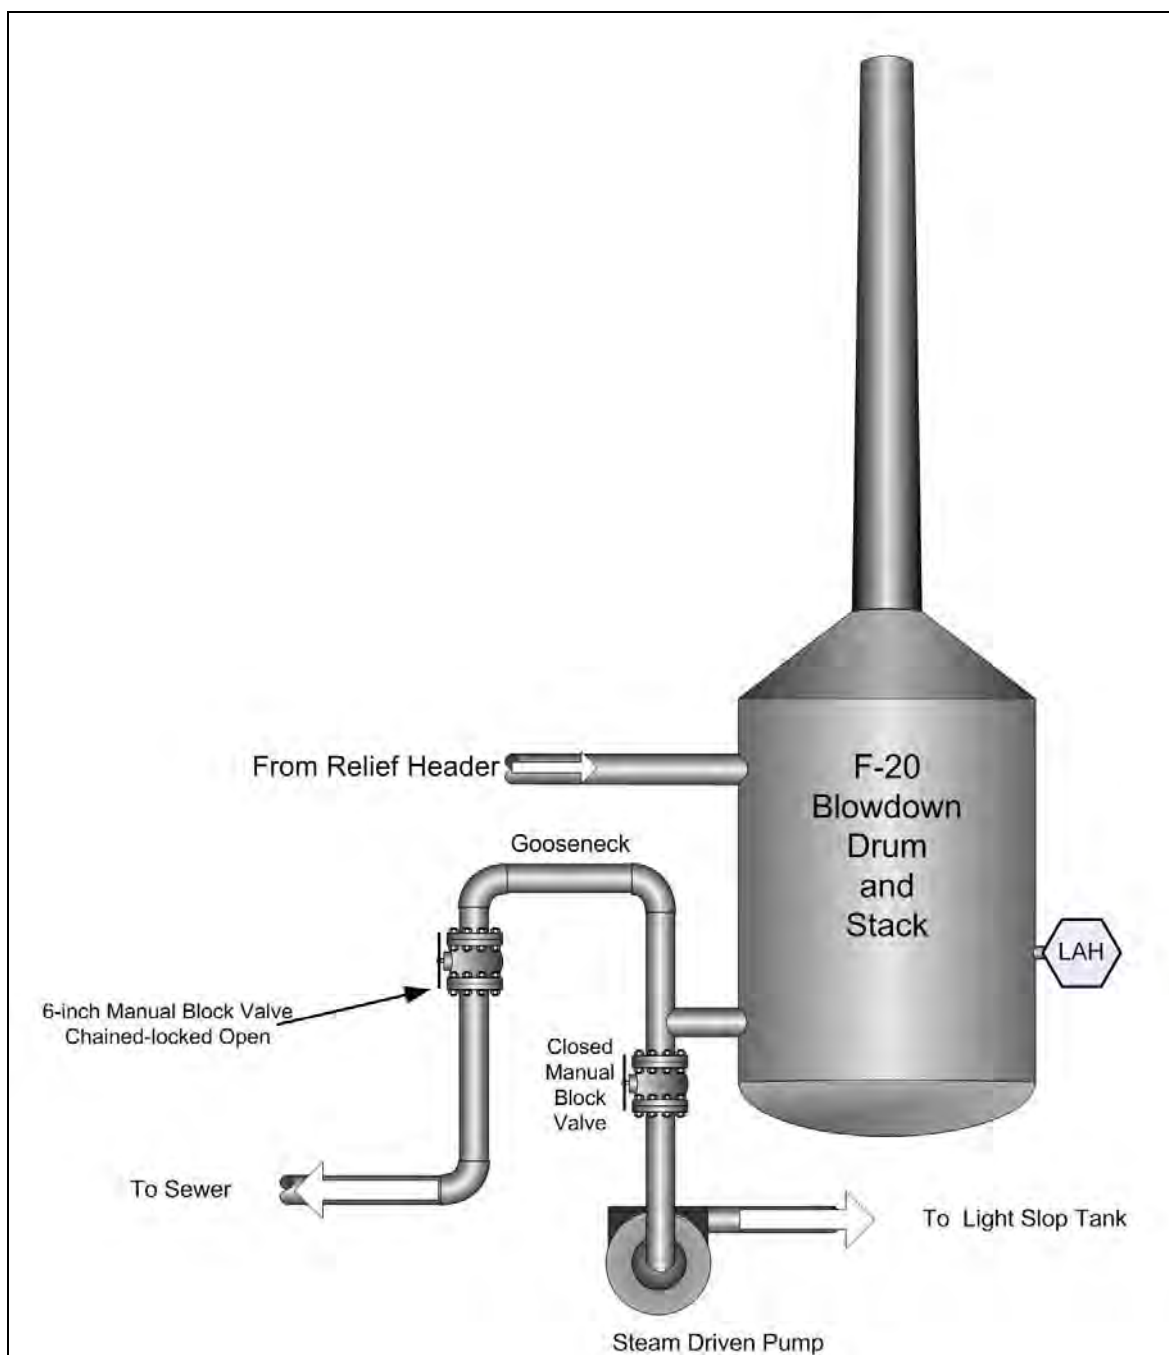
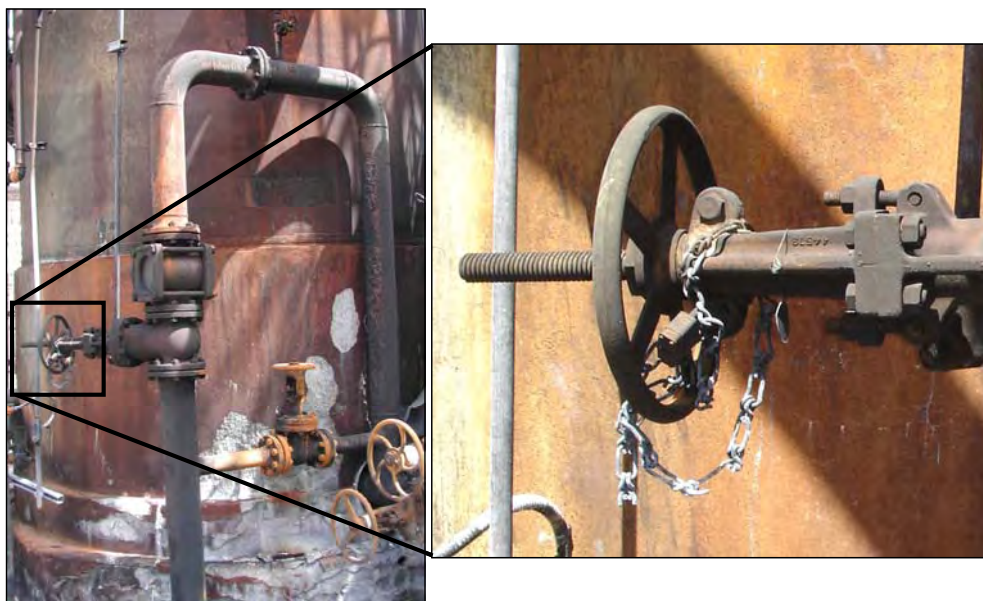
Figure 3. Blowdown drum and gooseneck

Figure 4. Left: Gooseneck piping and manual block valve (chained-locked open) Right: Close-up of manual block valve

As the blowdown drum and stack filled, some of the flammable liquid flowed into the ISOM unit process sewer system through the chained-open 6-inch NPS manual block valve (Figures 3 and 4) and the other safety relief valve discharge pipe headers. As explained in section 2.2.5, this practice of discharging to the sewer was unsafe.

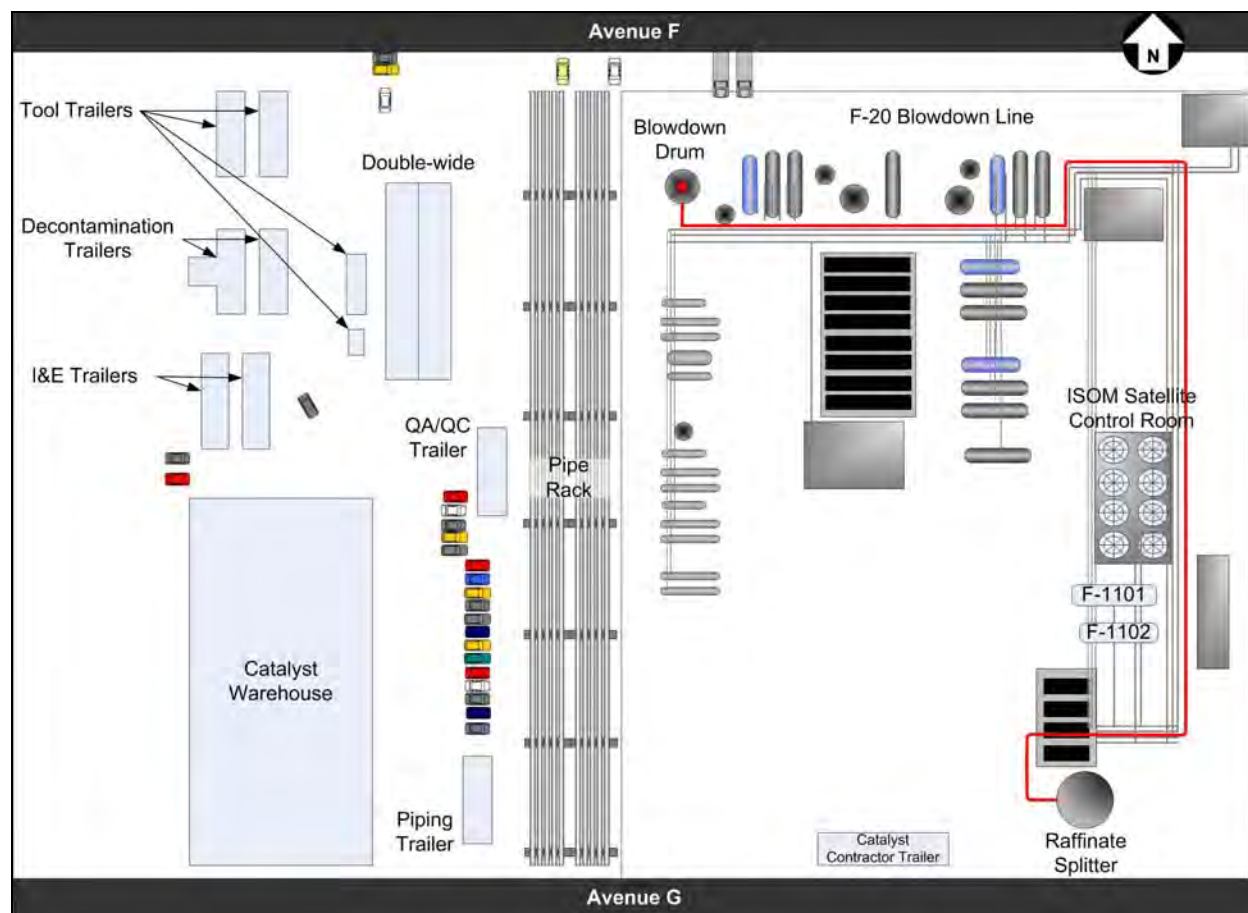
Figure 15. Trailer area and adjacent ISOM unit

BP's placement of occupied trailers close to the ISOM unit was a key factor leading to the fatalities from this disaster. All 15 who died during the March 23, 2005, incident were in or around trailers. The trailers were sited in this area primarily for convenience: the unoccupied area between the ISOM and NDU units was selected because it was across the road from the Ultracracker, (ULC) and would be a convenient staging area for the contractors in their turnaround work (Figure 15). The CCPS noted that this practice is an increasing trend:

While planning for the 2005 ULC unit turnaround, in September 2004 BP sited a double-wide trailer between the NDU and ISOM to house employees for the Motorization Project. Nine others were located in the same area to support the ULC turnaround, but a MOC was not conducted for any of them despite being required by BP policy (Figure 15). (Appendix F provides further information on the location, construction, and use of all the trailers sited in this area.)

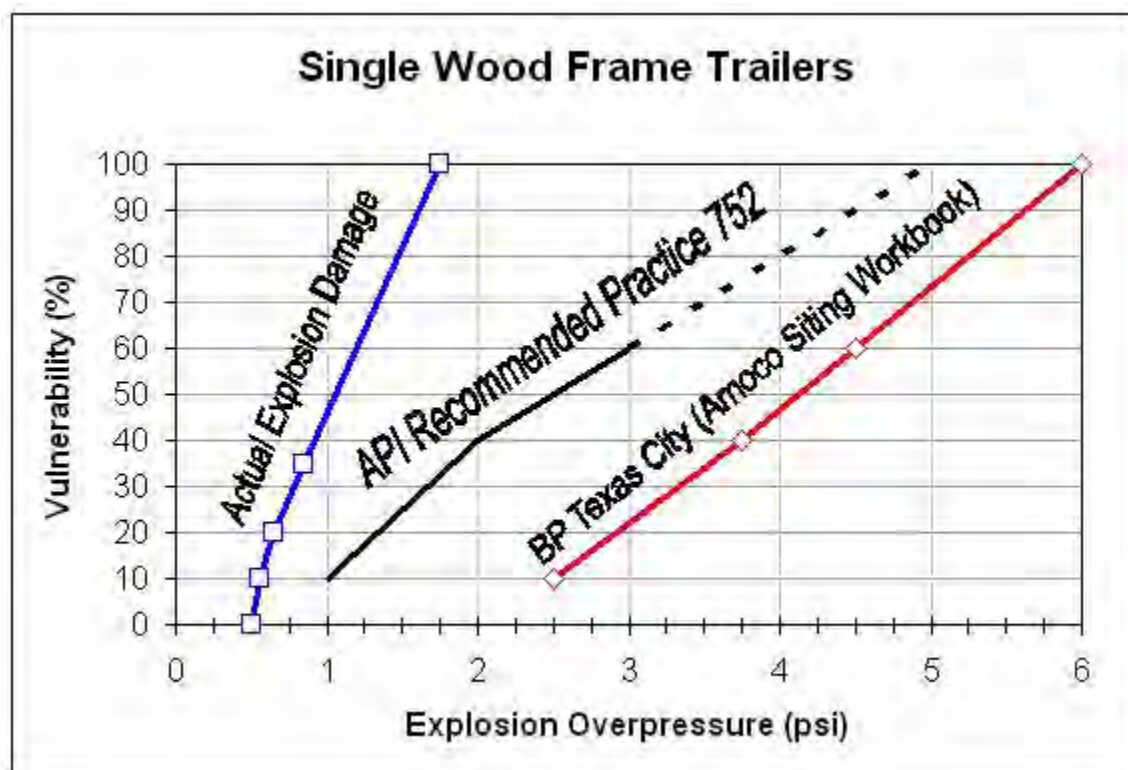
Figure 16. Comparison of explosion damage based on API and BP Texas City criteria

The data API uses to assess vulnerability of building occupants during building collapse is based mostly on earthquake, bomb, and windstorm damage to buildings. However, as vapor cloud explosions tend to generate lower overpressures with long durations (and thus relatively high impulses) (Gugan 1979), the mechanism by which vapor cloud explosions induce building collapse does not necessarily match the data being used in API 752 to assess vulnerability. The CSB found that this data is heavily weighted on the response of conventional buildings, not trailers, which are not typically constructed to the same standards. Thus, when the correlations of vulnerability to overpressure from the March 23, 2005, explosion (Figure 16) are compared against the API and BP criteria (Section 6.3.1), they were both found to be less protective in that both under-predict vulnerability for a given overpressure. Also, the data used by both API and BP to estimate vulnerability<sup>133</sup> does not include serious injuries to trailer occupants as a result of flying projectiles, which are typically combinations of shattered window glass and failed building components, heat, fire, jet flames, or toxic hazards.

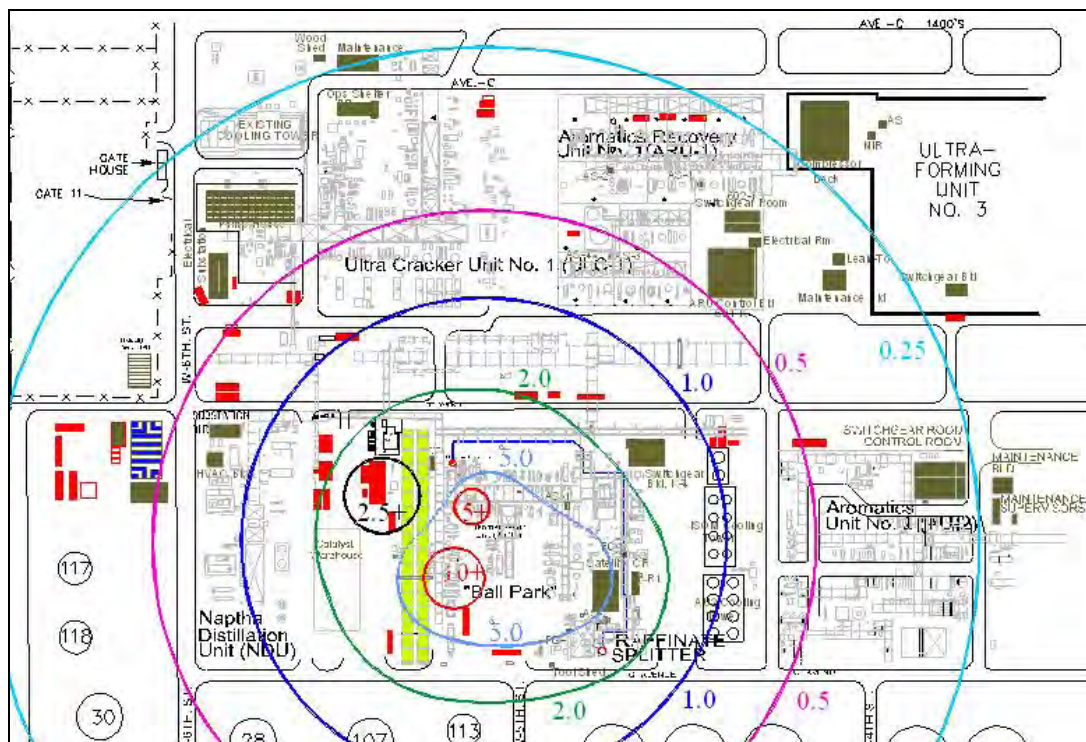
Figure H- 2. Blast overpressure map

The blast overpressures presented on the map are free-field values and do not address blast wave reflections. Objects facing the blast can experience applied blast wave pressure higher than the free-field values.

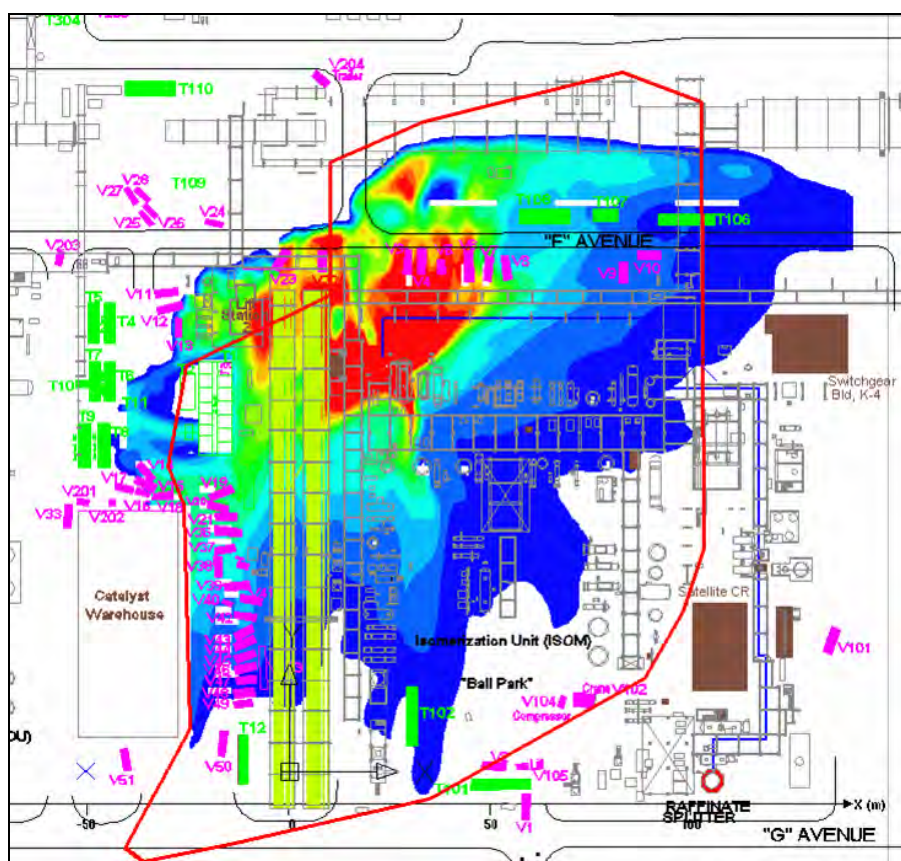
Figure H- 3. Cloud extent comparing field observations (red line) to dispersion modeling

A large domain was chosen that exceeded the expected extent of the flammable dispersion. The domain was also large enough to address sizeable objects around the perimeter of the ISOM unit that would affect wind patterns and ultimately dispersion of flammables. Steady-state wind conditions, as described, were established prior to beginning the dispersion of flammable materials. The dispersion grid was set at 1 meter in the X, Y, and Z directions for the bulk of the model. A tighter grid was chosen at low elevations where the heavy flammable vapor cloud was expected to settle. The CFD modeling attempted to simulate the release conditions and source terms described previously. The CFD model included several vapor source terms that represent vapor generated from evaporation of falling liquid, vapor generated through evaporation when liquid interacted with elevated equipment, and vapor generated by evaporation from liquid pooled on the ground. The numerically discrete nature of CFD allows specifications of definite leak locations; therefore, vapor sources were placed in the model at various locations to represent potential sources. A total of 16 discrete “leak” locations were selected that would be vapor sources in the model, including four sets, placed at various elevations, of four leaks located about the perimeter of blowdown drum. A parameter study that varied the rate of vapor generation for the source terms was then conducted and comparisons made against field data and observations. A comparison (Figure H-3) shows reasonable agreement.

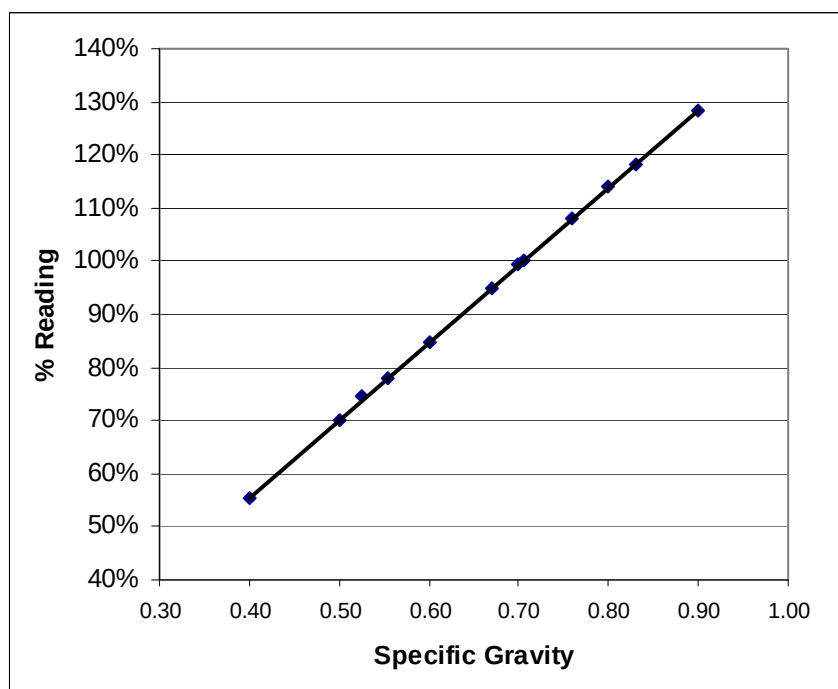
Figure S- 1. Calculated LT-5100 flooded reading versus specific gravity

The specific gravity of the hydrocarbon liquid in the raffinate splitter tower is strongly temperature-dependent. At 300°F, the temperature in the base of the raffinate splitter when it overflowed, the specific gravity is about 0.55 (Figure S-2). As Figure S-1 shows, at a specific gravity of 0.55 the transmitter would indicate a level of 78 percent when flooded, which matches the value observed when the raffinate splitter tower over-filled. The CSB concludes that the level transmitter was not calibrated for the specific gravity of fluid at its normal operating temperature.

The CSB investigators learned that the instrument data sheet, which should have been used for calibrating the transmitter, had not been updated since 1975 when the tower was part of a different process with a different feed fluid. The data sheet had never been changed to reflect the operating specific gravity in the ISOM process; furthermore, instrument technicians responsible for maintaining and calibrating the transmitter stated that the data sheets—even if they had been updated—were unavailable to them. The CSB learned that these data sheets were filed in an engineer’s office and were not typically given to technicians with work orders for instrument calibration.
