## ICOLD 2022 May 31, visit at Malpasset

Some illustrations prepared by B. Goguel, from references available in the CFBR paper, and 2018 talks with Pierre Duffaut.

Rev g : 06.06.2022

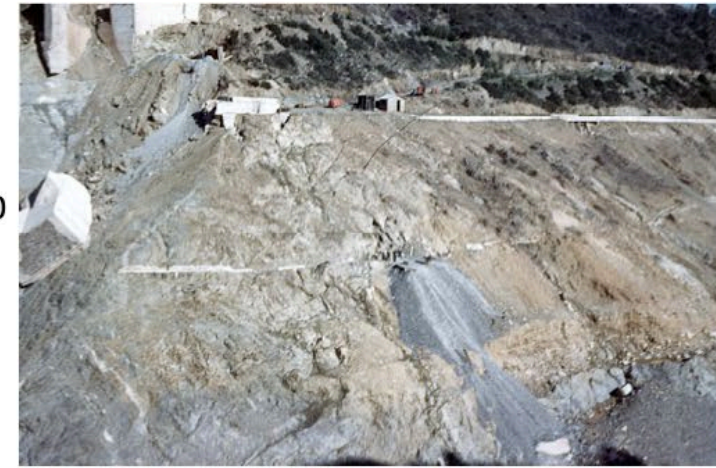
L/B investigation adit :  
was excavated in **spring 1960**,  
*after the failure*  
Photo Joseph Duffaut May 1960

Post-failure investigations : 1960 L/B gallery, and 1962 lower R/B gallery below block FG

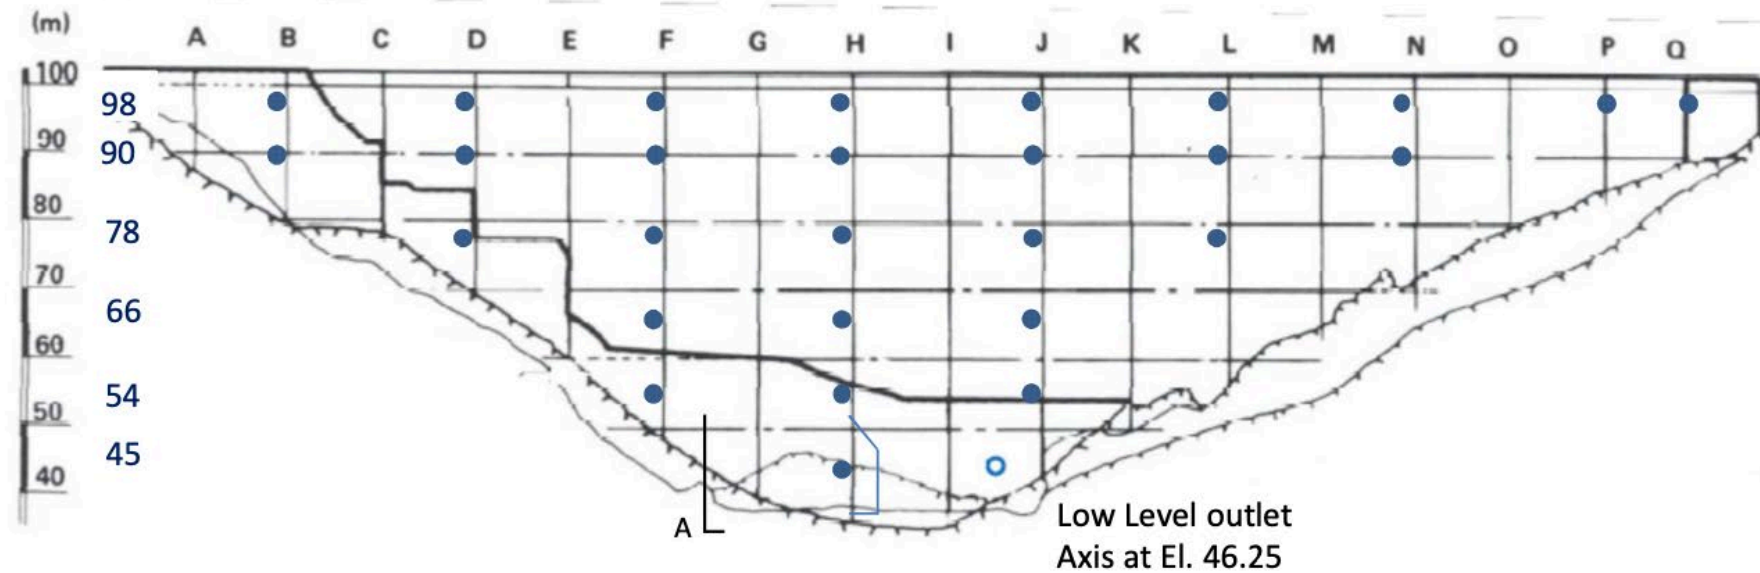
### Deflection monitoring : Géodetic Targets Grid

Fig. 3 : deflection monitoring (geodetic targets grid) ; and nothing in the foundation : no drains, no piezometers, as usual at that time.

Fig. 3 : dispositif d'auscultation (mesures topo) des déformations de la voûte ; et rien en fondation : ni drains, ni piézomètres, selon les pratiques de l'époque.  
Reconnaissances après la rupture : galeries en rive gauche (1960), et sous le plot FG (1962).

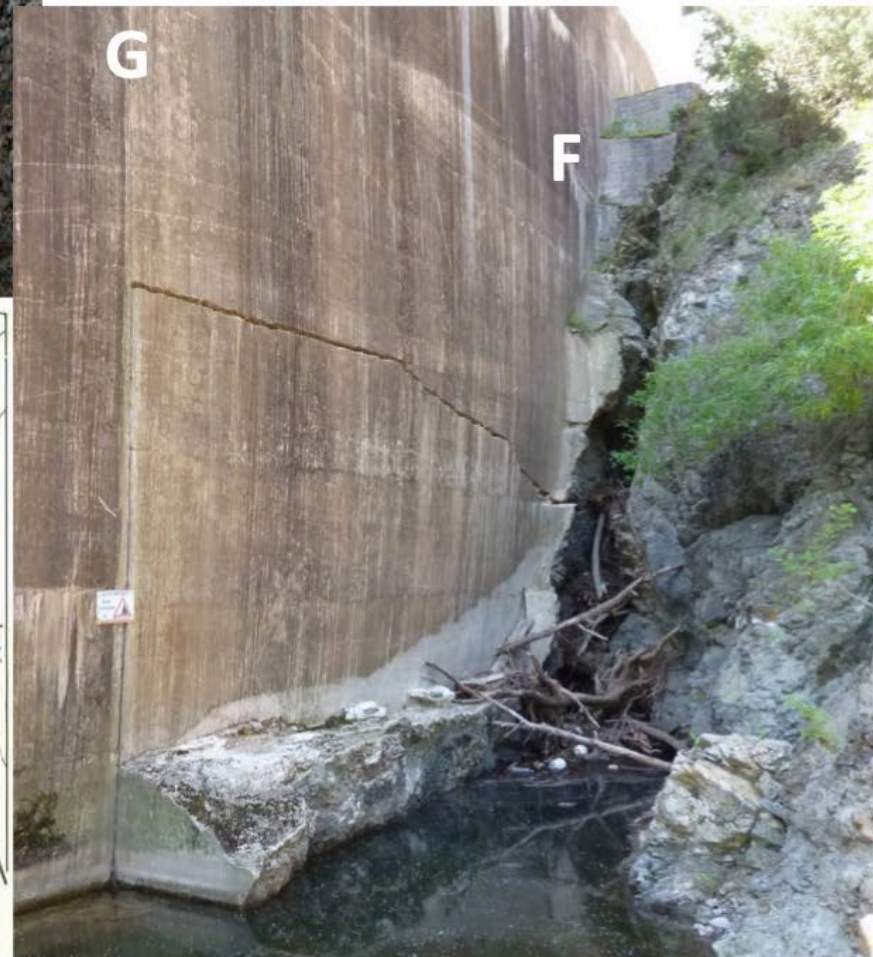
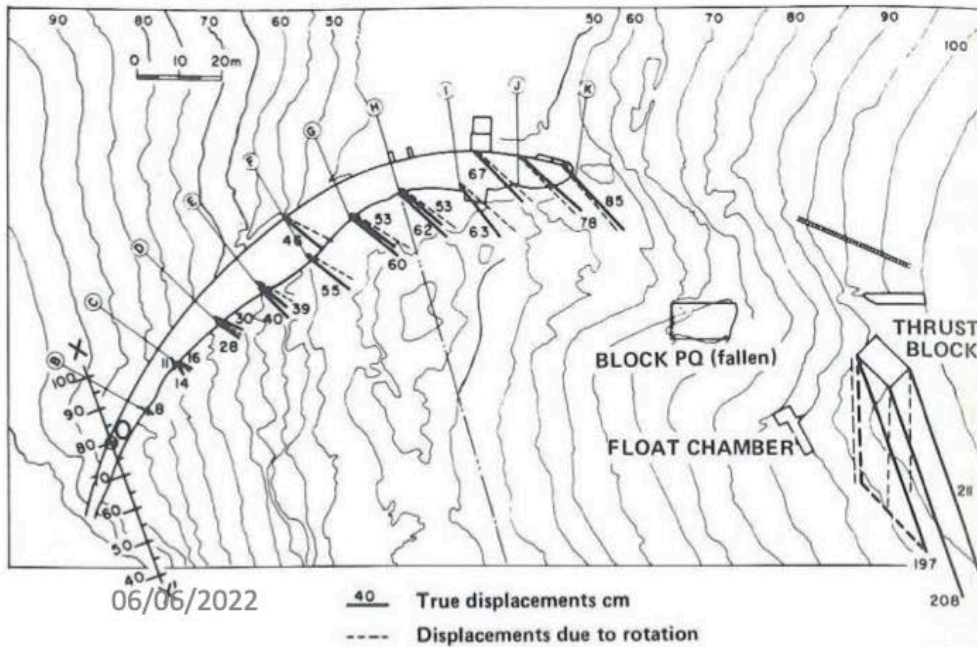
**Right Bank U/S crack**  
**<= 1959**

Fig. 5 : Right Bank upstream side, where a large open vertical crack resulted from the general Rotation, as evidenced by the topographic survey of the remains displacements : rotation like a solid body (+ additional movement of the upper L/B overloaded Thrust Block).

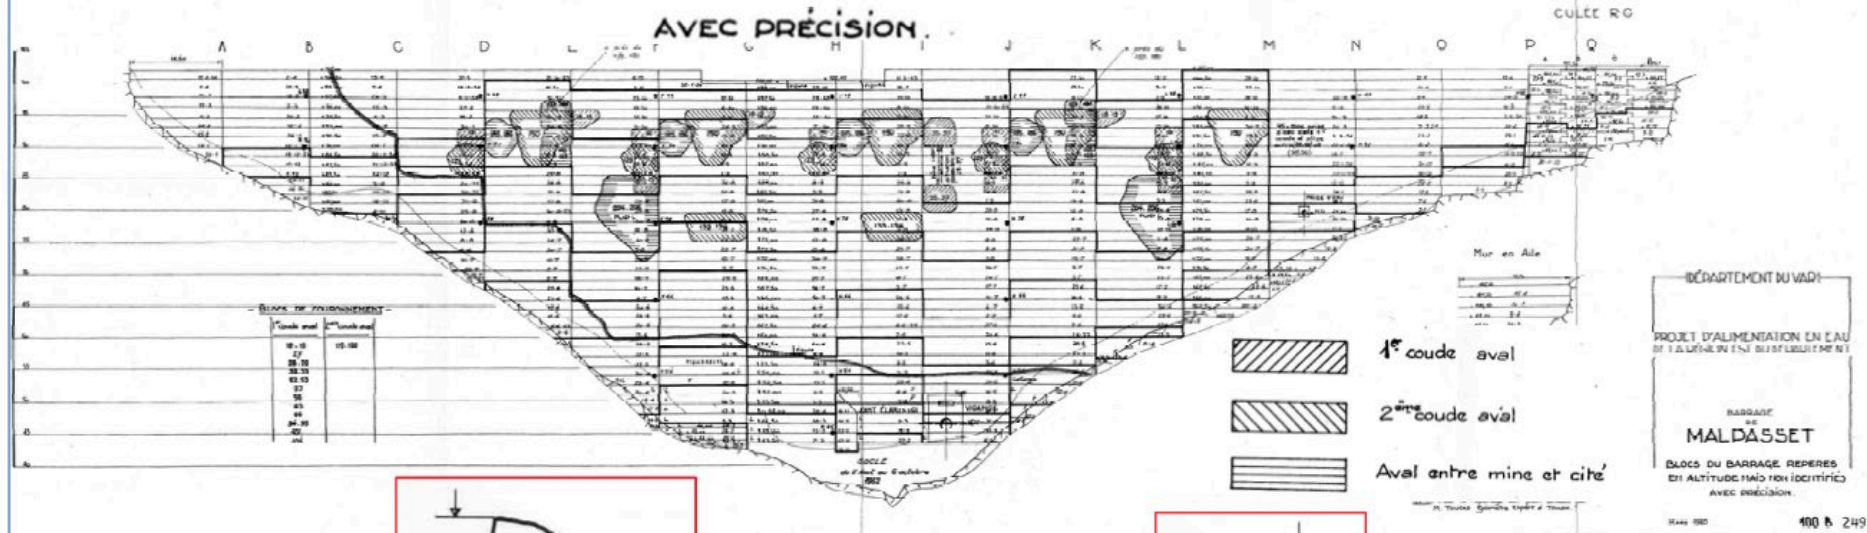
ANNEXE N24

# BLOCS DU BARRAGE REPERES EN ALTITUDE MAIS NON IDENTIFIÉS AVEC PRÉCISION.

Fig. 6 : Blocks found downstream having been identified, in altitude only (upper elevation) or completely located (lower elevation) ; and *typical shapes of cantilever failures*, evidencing a contrast between the L/B side (lower parts of cantilevers KL and LM carried away by the rock wedge movement) and the R/B side (upper parts of cantilevers toppled down).

Fig. 6 : blocs de béton déposés à l'aval ayant été identifiés en altitudes uniquement (en haut), ou dont l'origine a pu être plus complètement située (en bas). Avec profils typiques de ruptures : contraste net entre le bas de l'aile rive gauche (emporté par le coin rocheux qui est parti) et les ruptures des consoles centrales et rive droite, dont la partie supérieure a basculé.

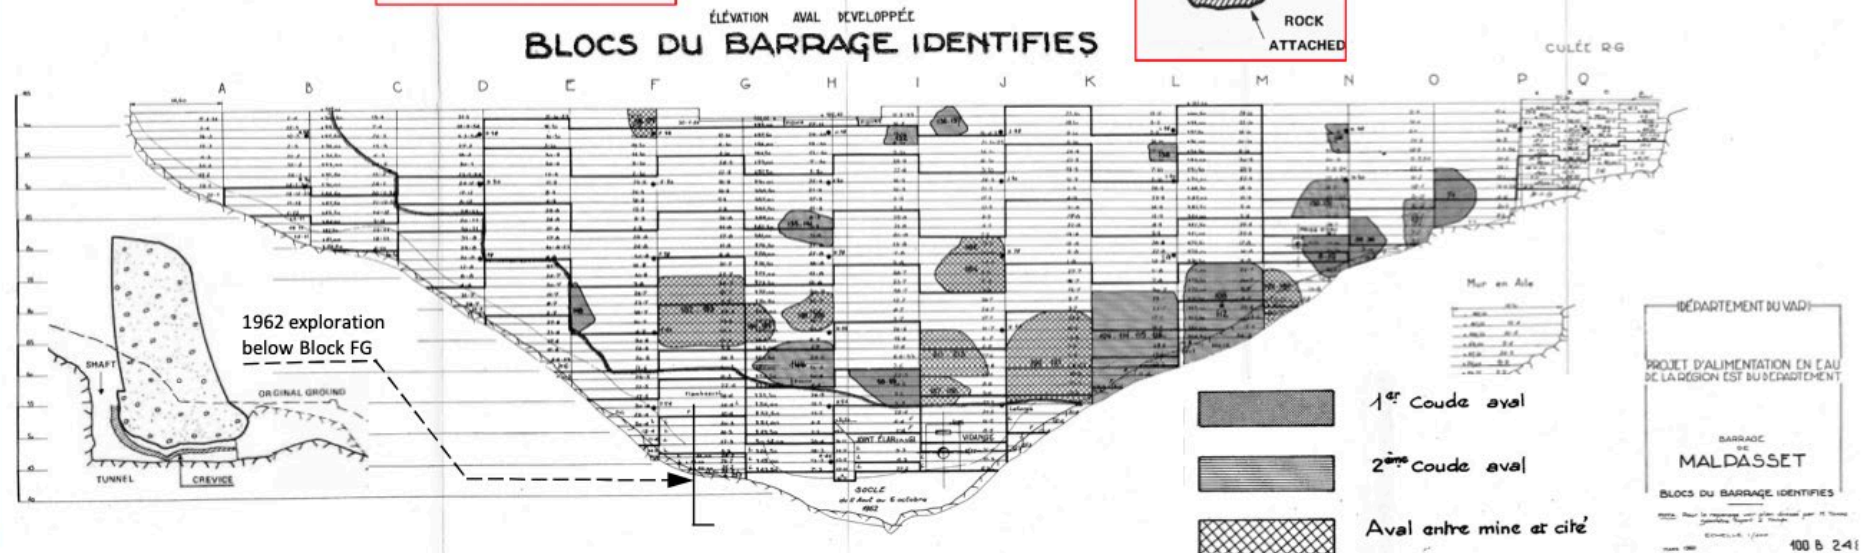
ANNEXE 23

## ÉLEVATION AVAL DÉVELOPPÉE BLOCS DU BARRAGE IDENTIFIÉS

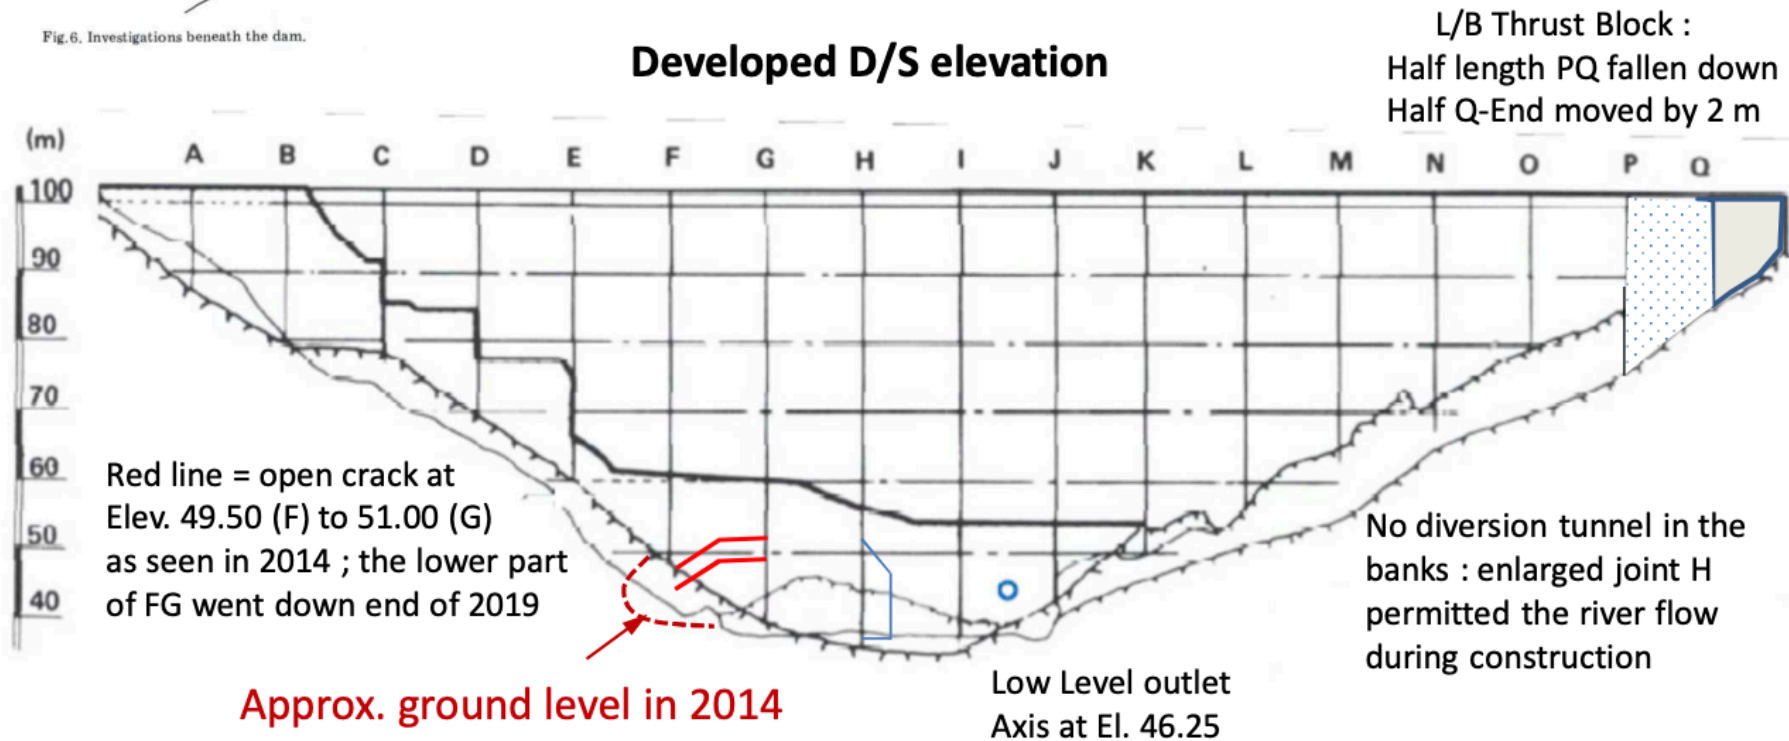
Fig.6. Investigations beneath the dam.

During summer of year **1962**, river being dry, an investigation shaft was excavated in the u/s crack at mid length of Block FG ; and extended below that block for inspecting the sheared cracked open rock. This enlarged the passage for the river, which is transporting sands and gravels and could over the years excavate a larger tunnel : found in 2014 extending over more than one block width. The lower part of FG Block was at that time already 5 cm down. **It felt by 2-3 m end of 2019.**

Fig. 7 : Developed elevation, locating the river passages : no diversion tunnel (a simple temporary opening, at lower enlarged joint K, permitted to pass the river ; before being relayed by the low level outlet). After the failure, the river could flow below block FG ; its course was facilitated by the *1962 investigation Adit* under the block FG, and the abundant sediments (sand and gravels) transport over the years. The lower section of that block, 800 m<sup>3</sup> approx., was seen detached in 2014 by around 5 cm ; it fell down by few meters during a flood on 1st december 2019.

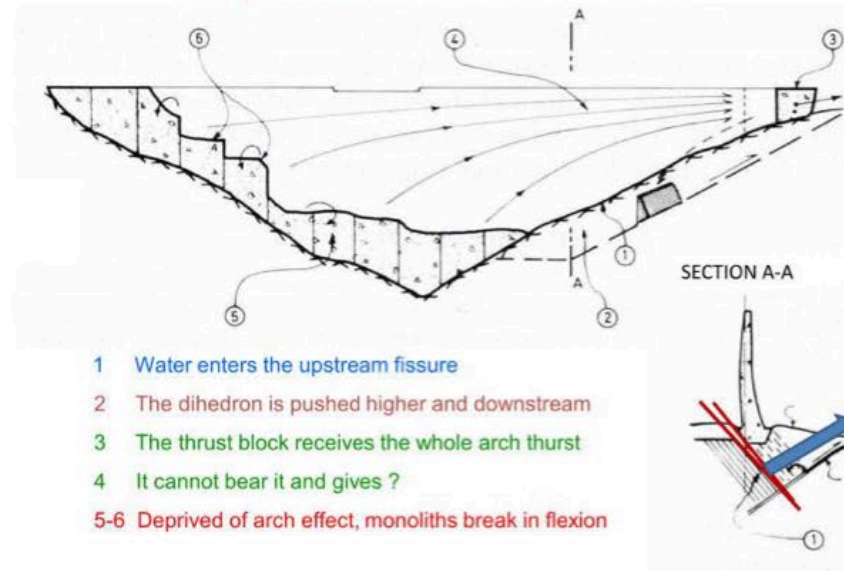
Fig. 8 - Schematic representation of the "explosive" failure phase

- 1 Water enters the upstream fissure
- 2 The dihedron is pushed higher and downstream
- 3 The thrust block receives the whole arch thrust
- 4 It cannot bear it and gives ?
- 5-6 Deprived of arch effect, monoliths break in flexion

**Uplift at depth in the foundation** was a major explanatory factor of Malpasset left abutment failure ; combined with the downstream fault, with the gneiss permeability sensitivity to stress (having created an underground impervious dam, adversely located without any drainage), and with the rock mass excessive deformability (low elasticity modulus).

Fig. 11 : Proposed failure mechanisms, and main lesson : grouting and drainage layout.

Fig. 11 : mécanismes de rupture proposés, et leçons principales : dispositions de l'étanchéité et du drainage.

## MAIN LESSON : grouting and **DRAINAGE** layout
