Partial Blackout of the Balkans 21st of June 2024

June 21, 2024 at approximately 12:20 CET

Blackout in Albania, Montenegro, Bosnia and Herzegovina and parts of Croatia

General cause, voltage collapse following multiple trips

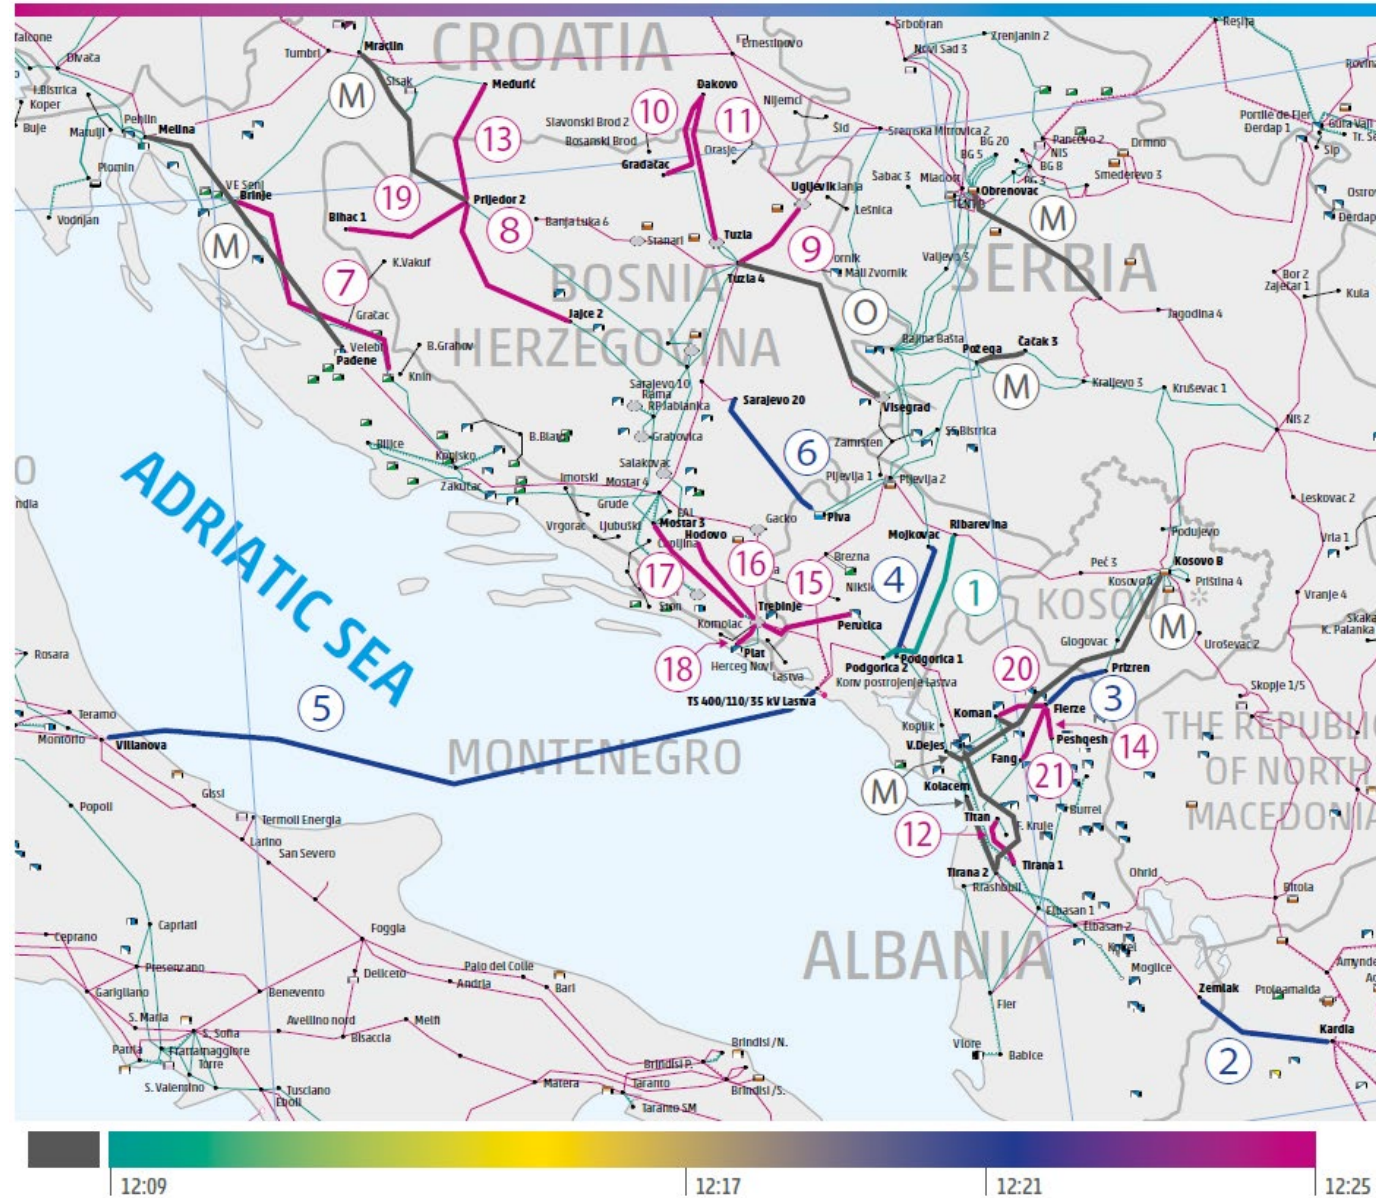
Outage ID	Time (CEST)	Substation A (TSO)	Substation B (TSO)	Voltage Level (kV)	Asset Type	Relay Trigger
1--	12:09:16.213	Ribarevine (CGES)	Podgorica 2 (CGES)	400	OHL	DIFF
2	12:21:33:200	Zemblak (OST)	Kardia (IPTO)	400	OHL-TIE	DIST
3	12:21:44:000	Fierze (OST)	Prizren 2 (KOSTT)	220	OHL-TIE	OC
4	12:21:45.774	Podgorica 1 (CGES)	Mojkovac (CGES)	220	OHL	OC
5	12:21:51:446	Lastva (CGES)	Villanova (Terna)	500	DCC-TIE	UV
6	12:22:06:012	Sarajevo 20 (NOSBiH)	Piva (CGES)	220	OHL-TIE	OC
7	12:24:21:587	Brinje (HOPS)	Pađene (HOPS)	220	OHL	DIST
8	12:24:22:341	Prijedor 2 (NOSBiH)	Jajce 2 (NOSBiH)	220	OHL	OC
9	12:24:22:350	Ugljevik (NOSBiH)	Tuzla 4 (NOSBiH)	400	OHL	OC
10*	12:24:22:959	Đakovo (HOPS)	Gradačac (NOSBiH)	220	OHL-TIE	UV
11*	12:24:22:959	Đakovo (HOPS)	TPP Tuzla (NOSBiH)	220	OHL-TIE	UV
12	12:24:23:000	Titan (OST)	Tirana 1 (OST)	220	OHL	DIST
13	12:24:23:089	Međurić (HOPS)	Prijedor 2 (NOSBiH)	220	OHL-TIE	DIST
14	12:24:24:000	Fierze (OST)	Peshqesh (OST)	220	OHL	MAN

15	12:24:26:558	Trebinje (NOSBiH)	Perucica (CGES)	220	OHL-TIE	UV
16	12:24:26:579	Trebinje (NOSBiH)	Hodovo (NOSBiH)	220	OHL	UV
17	12:24:26:583	Trebinje (NOSBiH)	Mostar 3 (NOSBiH)	220	OHL	UV
18	12:24:26:593	Trebinje (NOSBiH)	Plat (HOPS)	220	OHL-TIE	UV
19	12:24:27:694	Prijedor 2 (NOSBiH)	Bihac 1 (NOSBiH)	220	OHL	DIST
20	12:24:28:000	Fierze (OST)	Koman (OST)	220	OHL	MAN
21	12:24:28:000	Fierze (OST)	Fang (OST)	220	OHL	OC

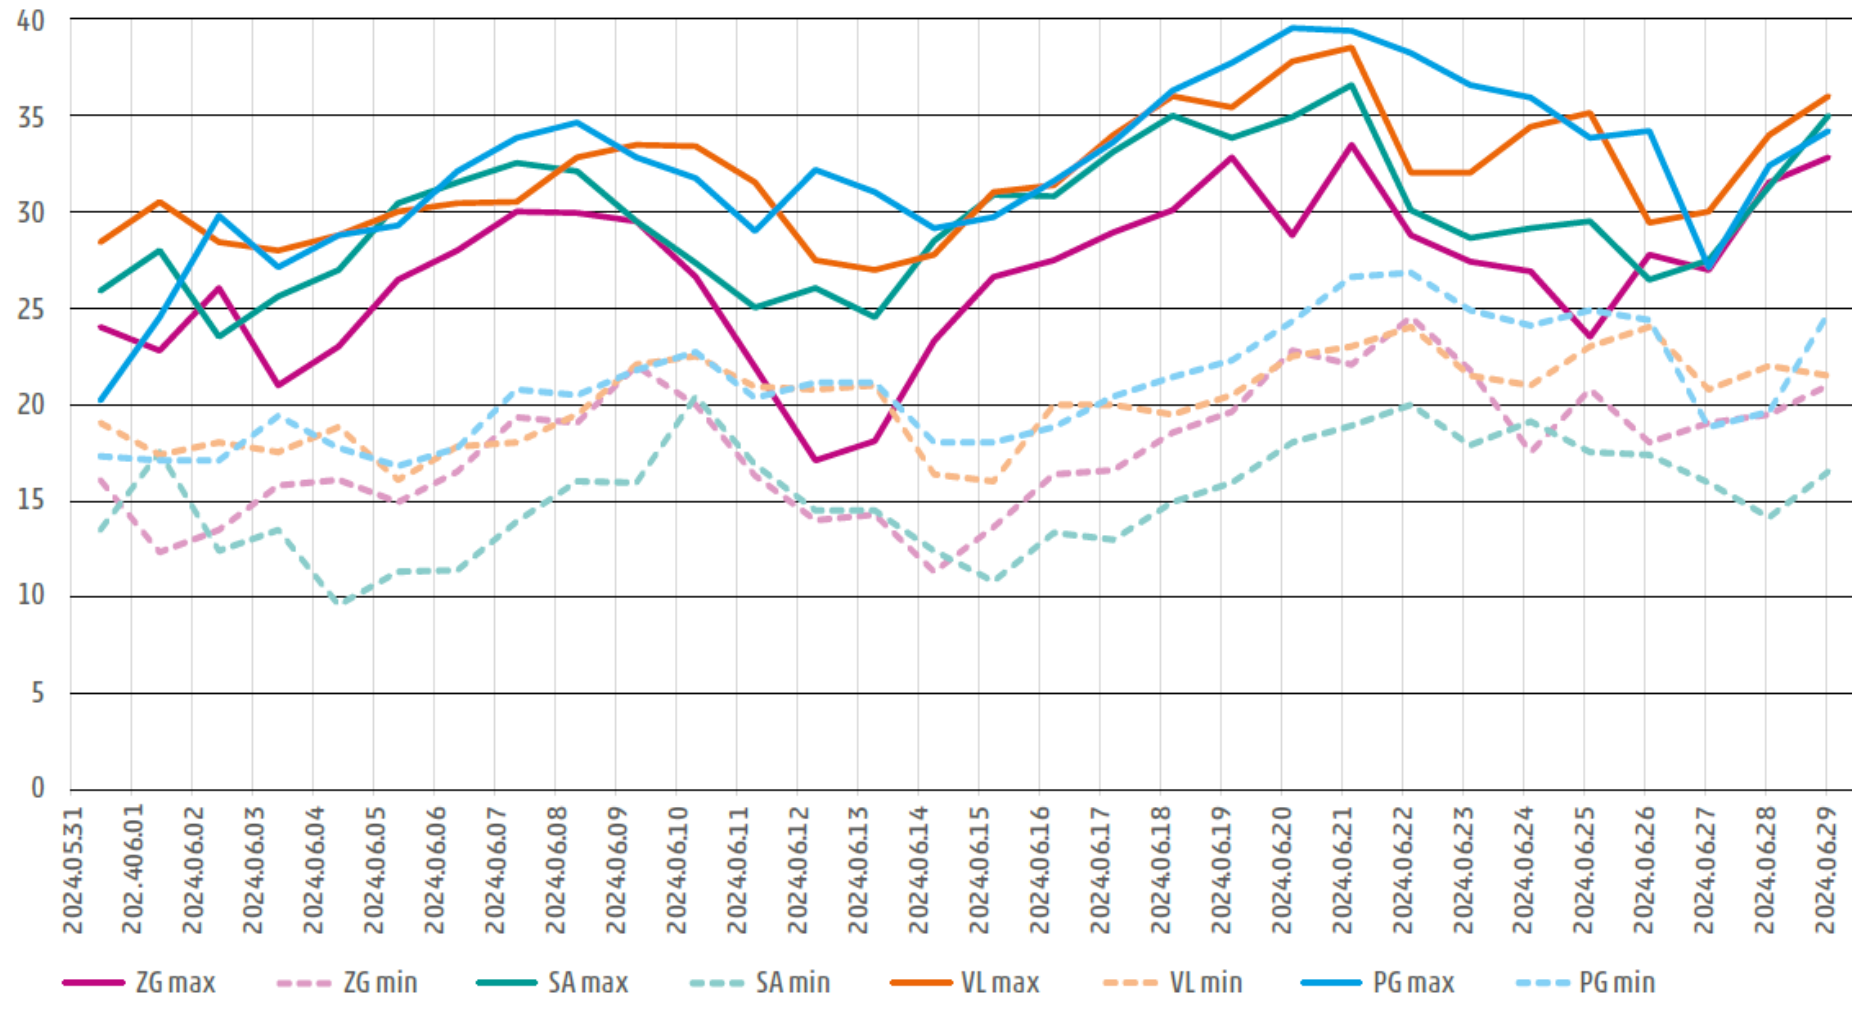
Figure 3: Maximal and minimal daily temperatures during June 2024 in Zagreb (HR), Sarajevo (BA), Podgorica (ME) and Vlore (AL)

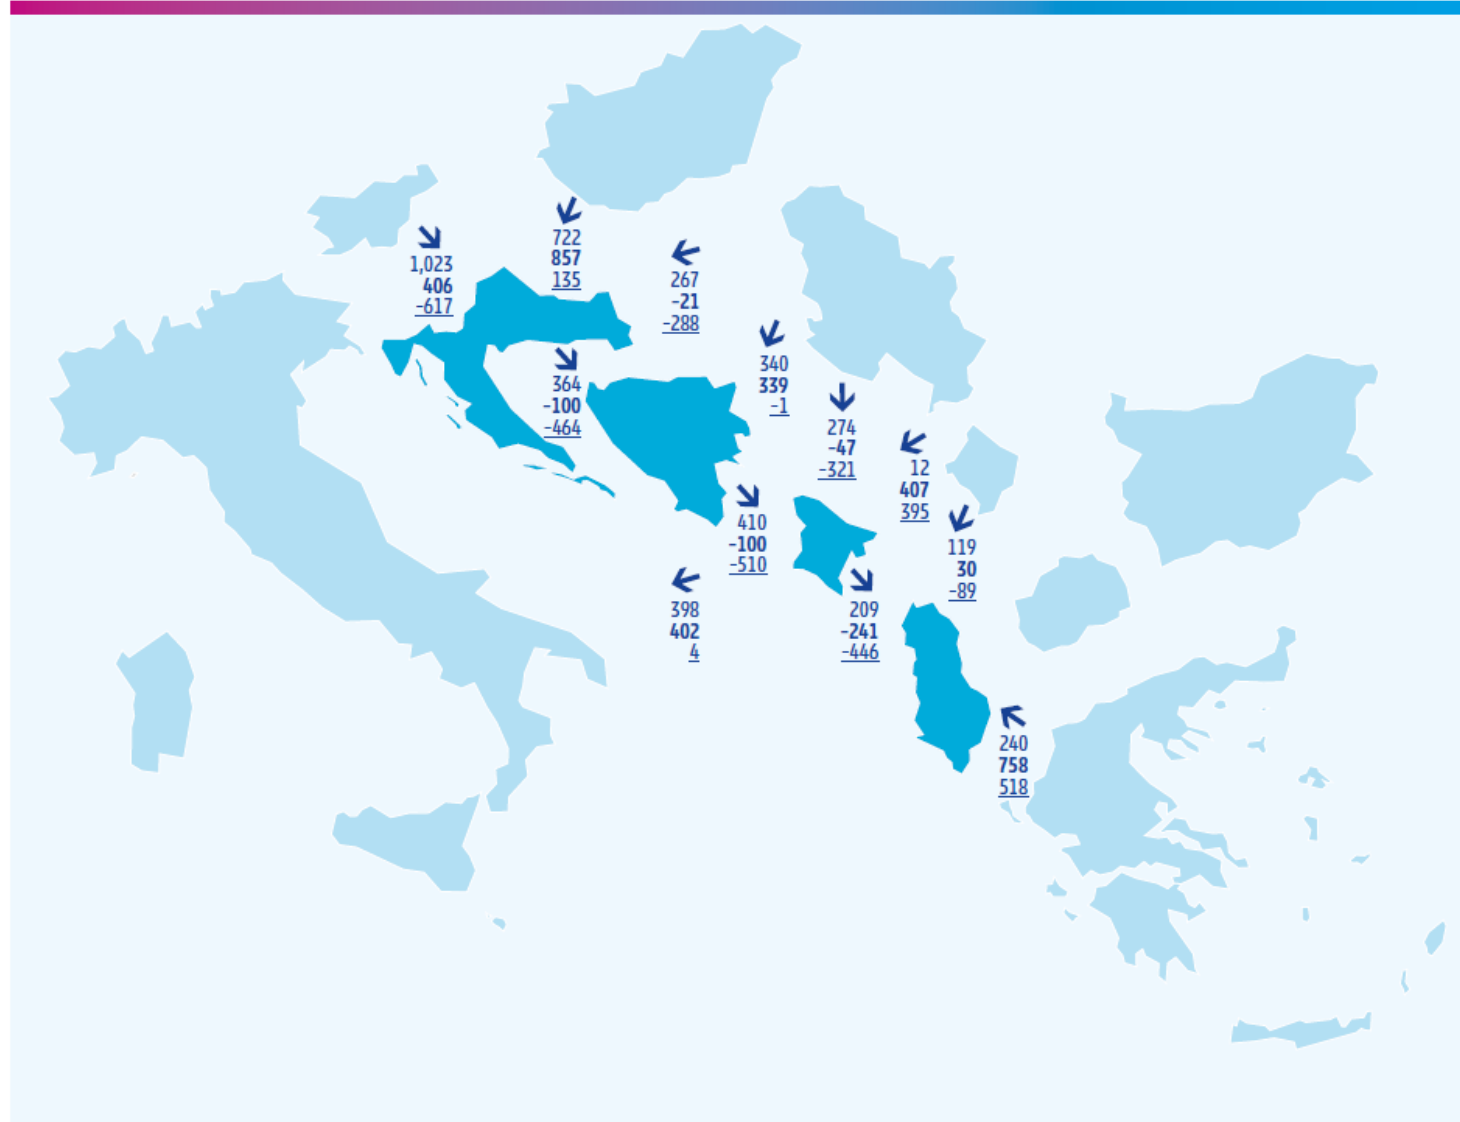
Figure 16: Cross-Border physical flows for 12th hour, 21 June 2024 (bold) and corresponding unscheduled loop-flows (underlined) in MW

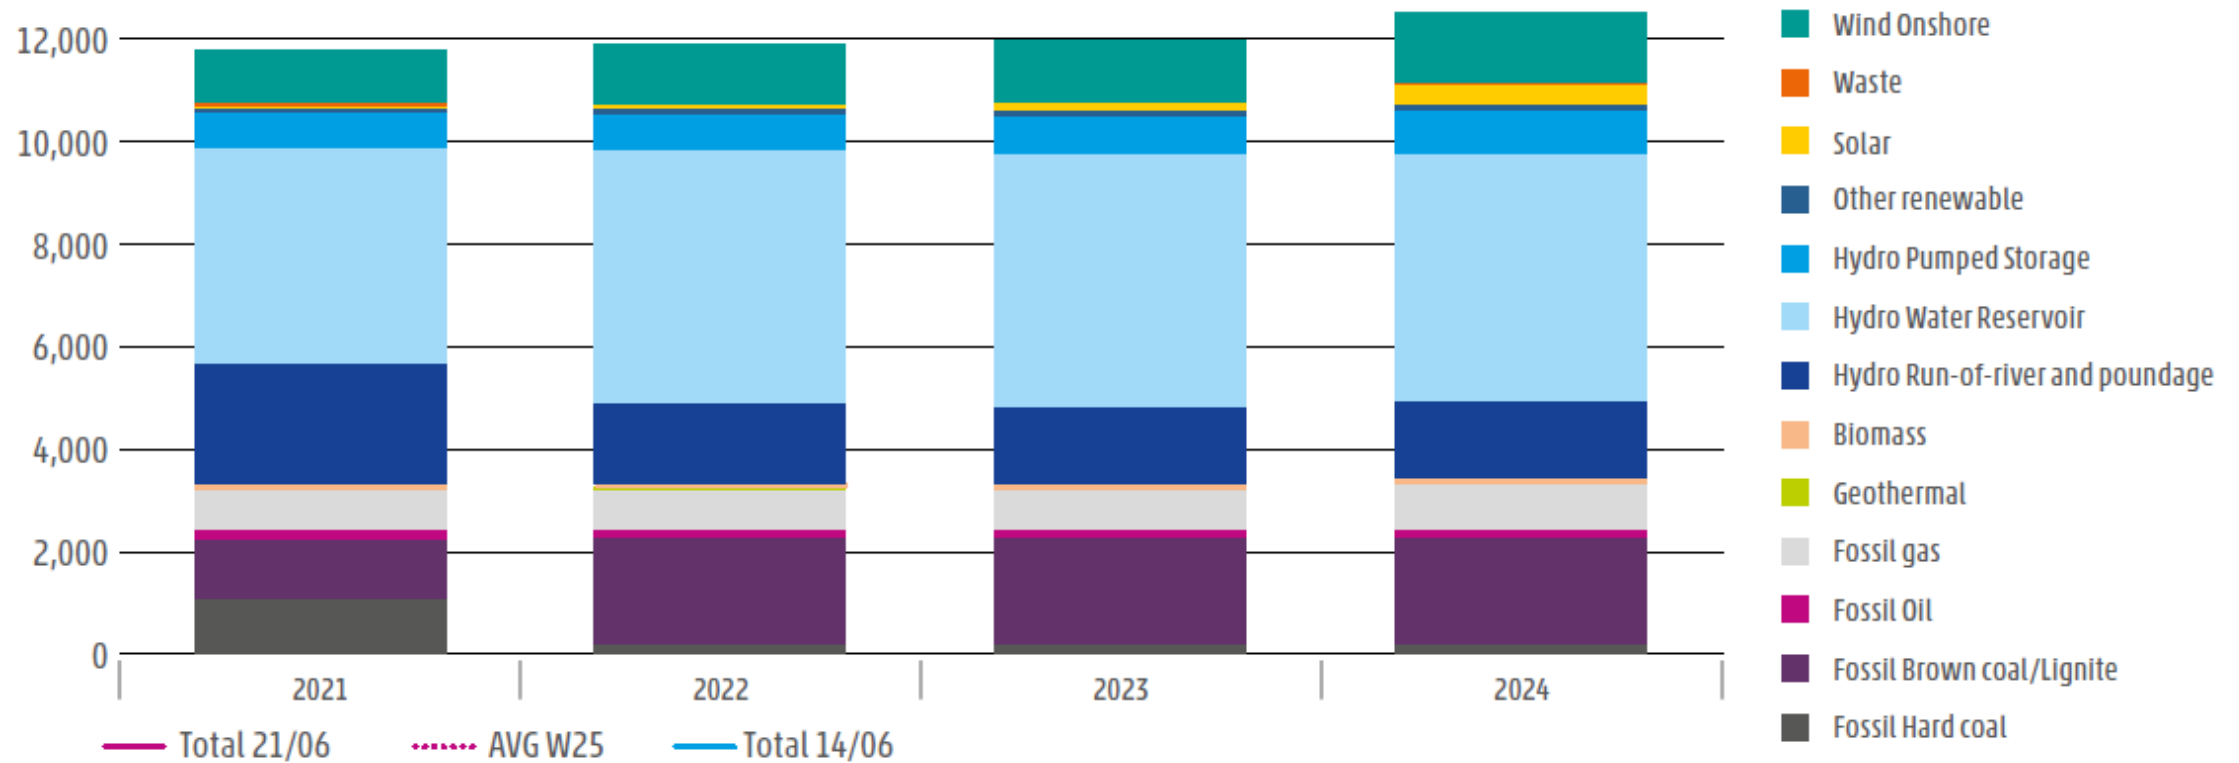
Figure 11: Generation structure of the affected systems during the past years.

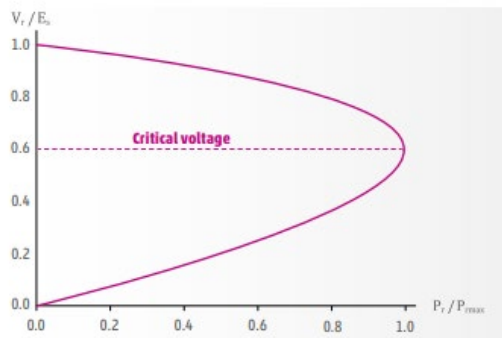
- Each power can be transmitted at a two different voltage levels, one is stable and the other one is unstable.

- This can be depicted by the so-called PV curve
