## Surveillance and monitoring

# Dam Engineering

## Dam Safety and Surveillance

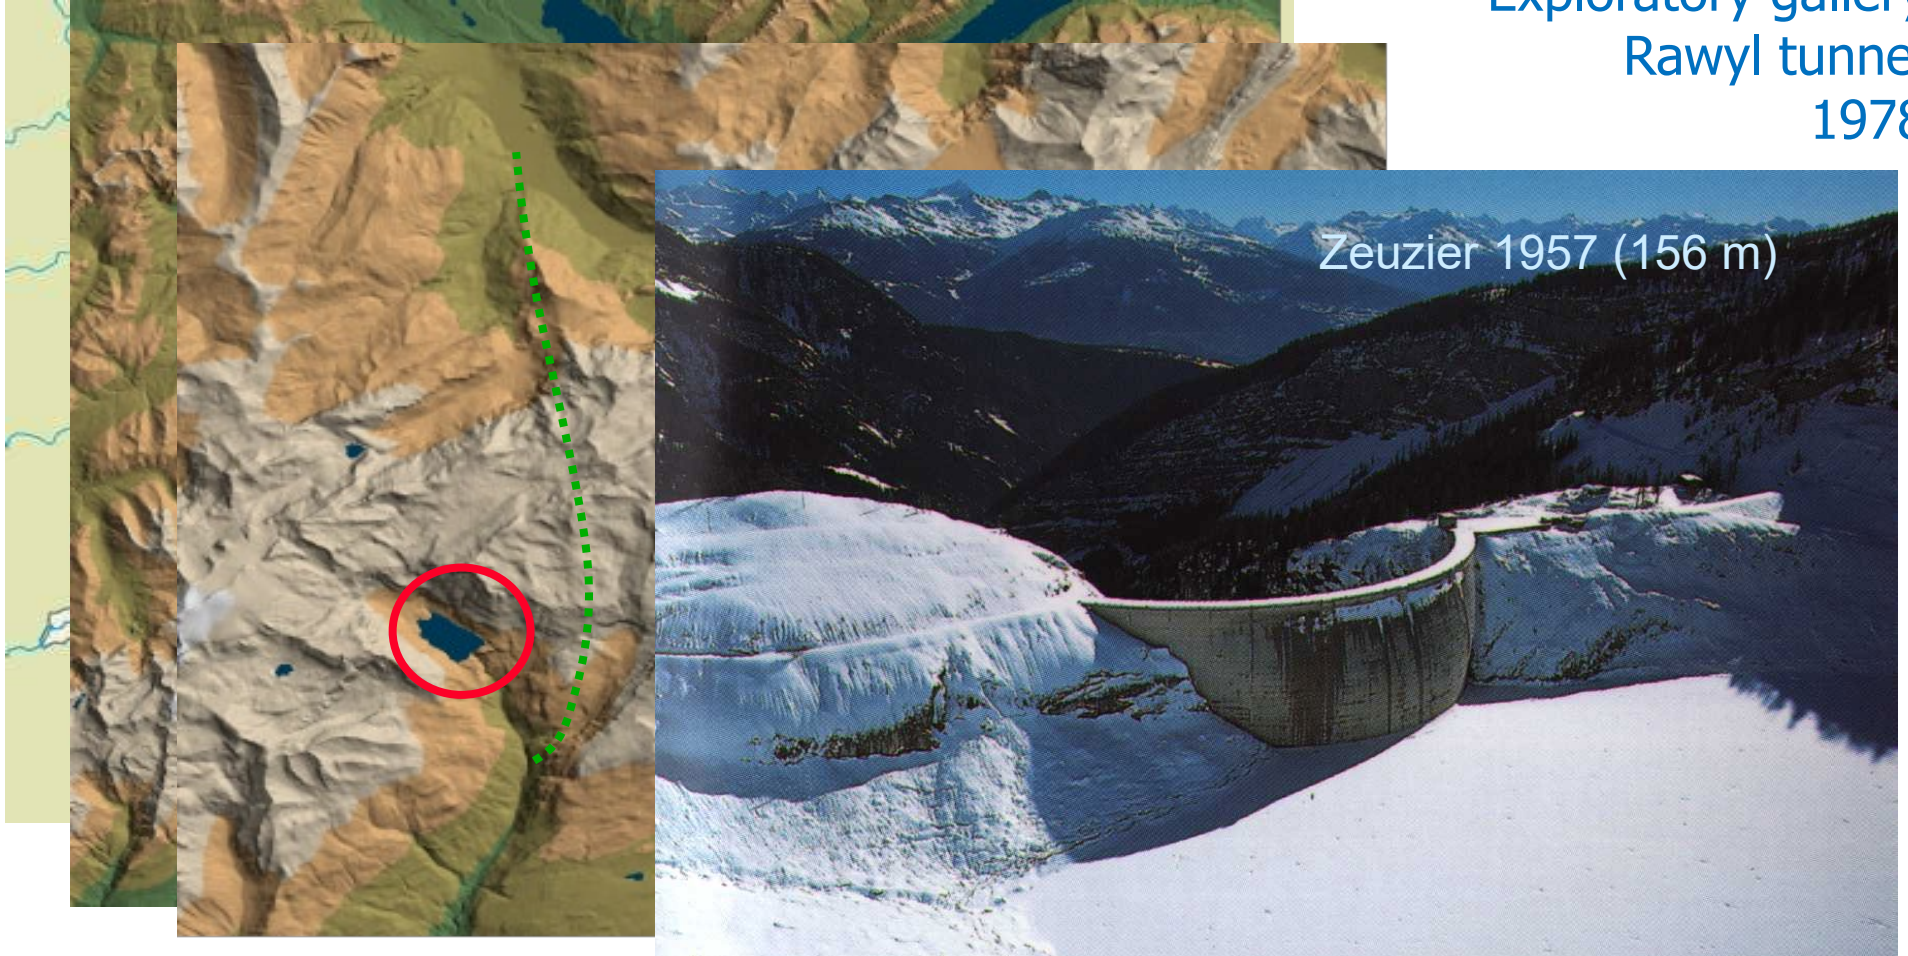
Exploratory gallery  
Rawyl tunnel  
1978

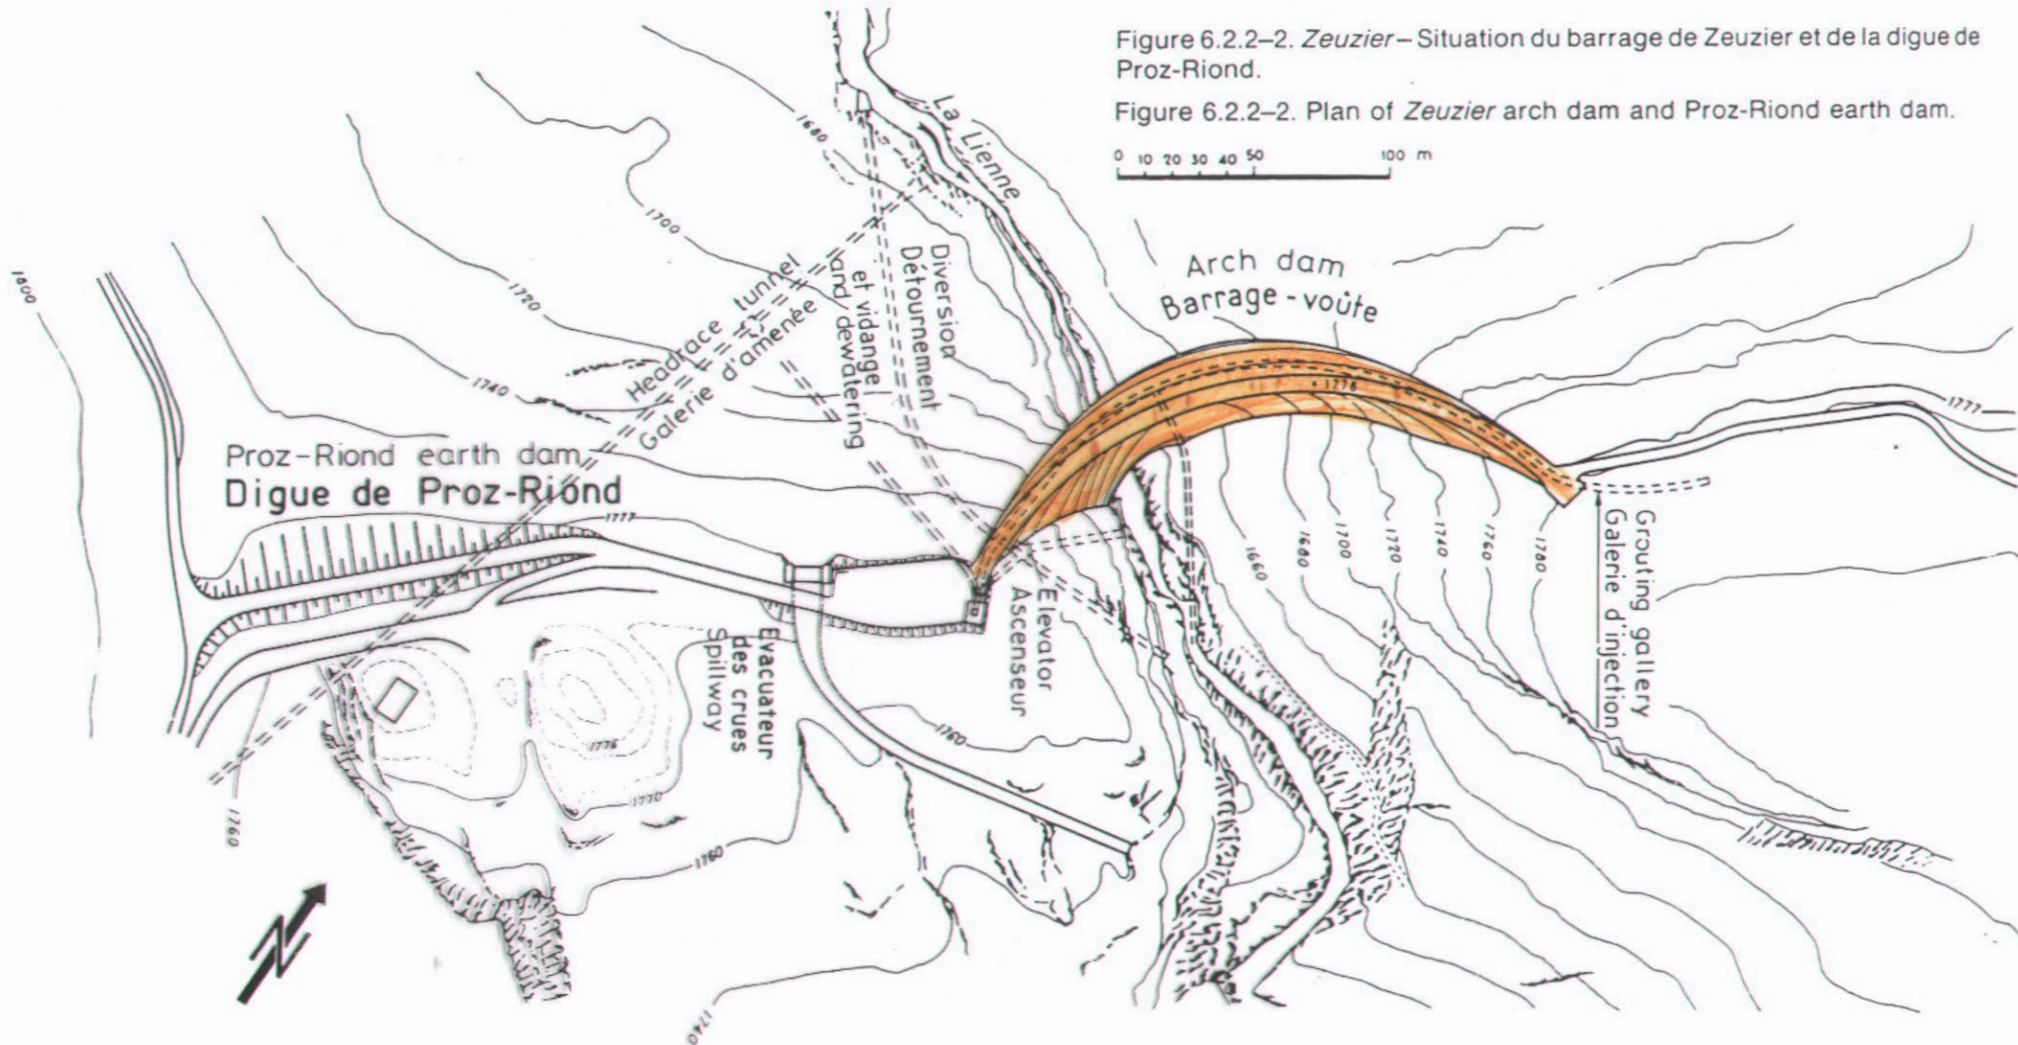
Figure 6.2.2-2. Zeuzier— Situation du barrage de Zeuzier et de la digue de Proz-Riond.

Figure 6.2.2-2. Plan of Zeuzier arch dam and Proz-Riond earth dam.

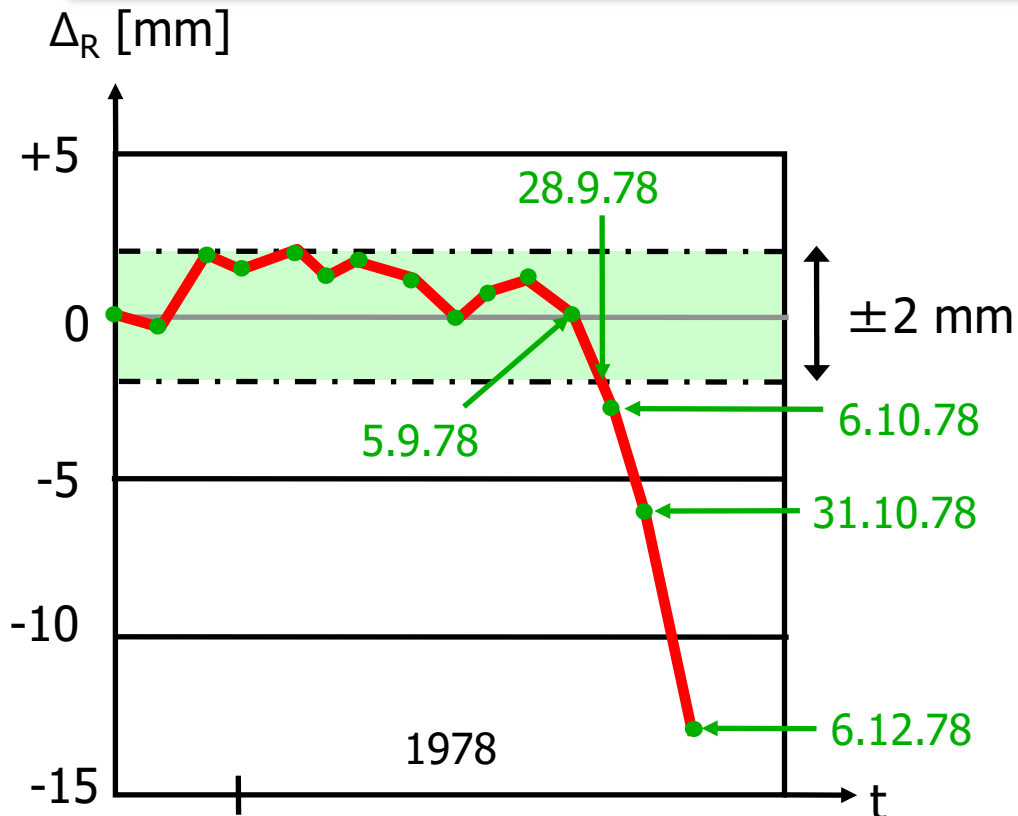
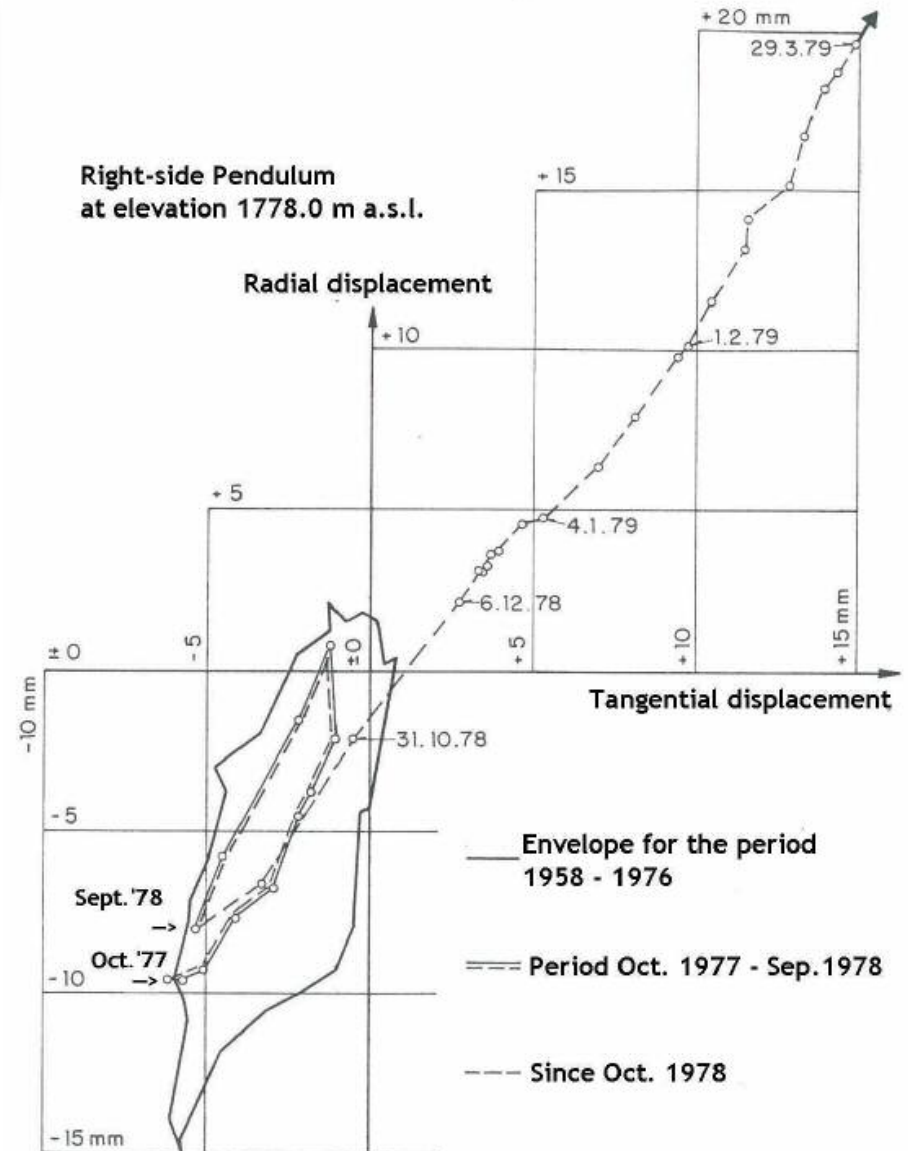
# 1978: movement measured by the pendulum

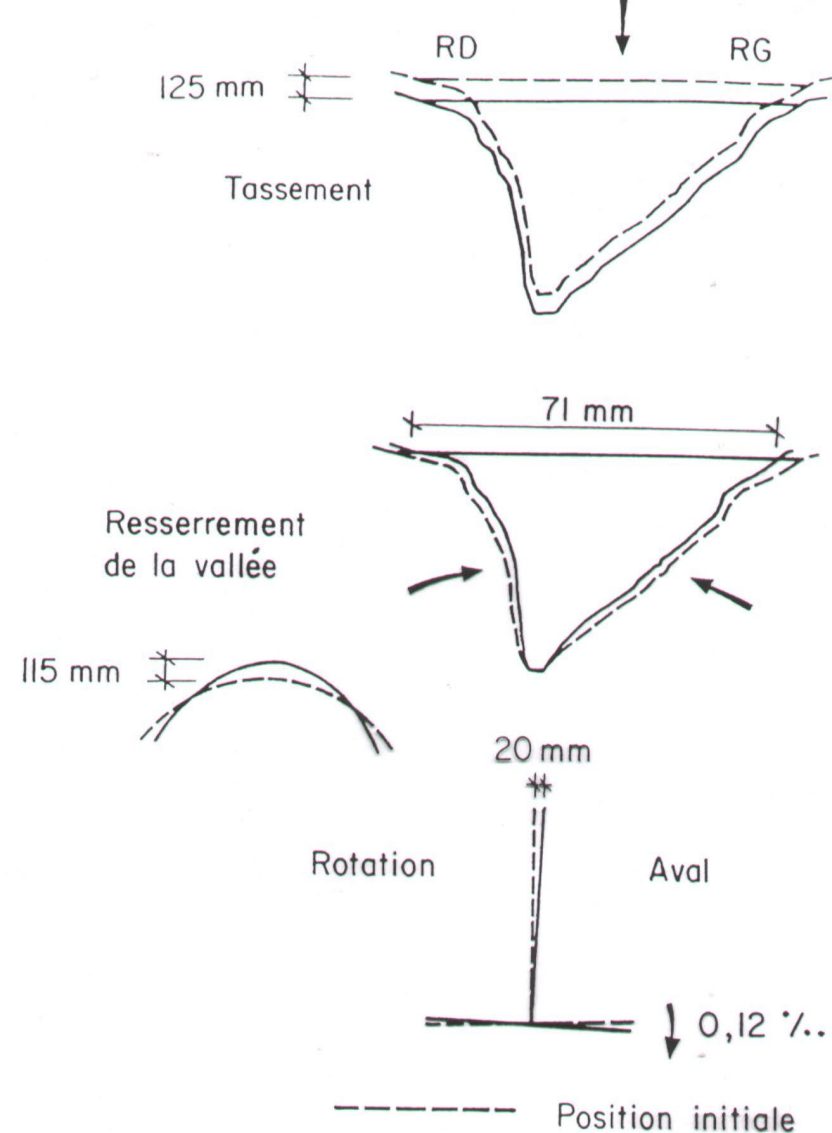
Figure 8, à gauche. Déformations totales observées sur le barrage entre 1978 et 1989.

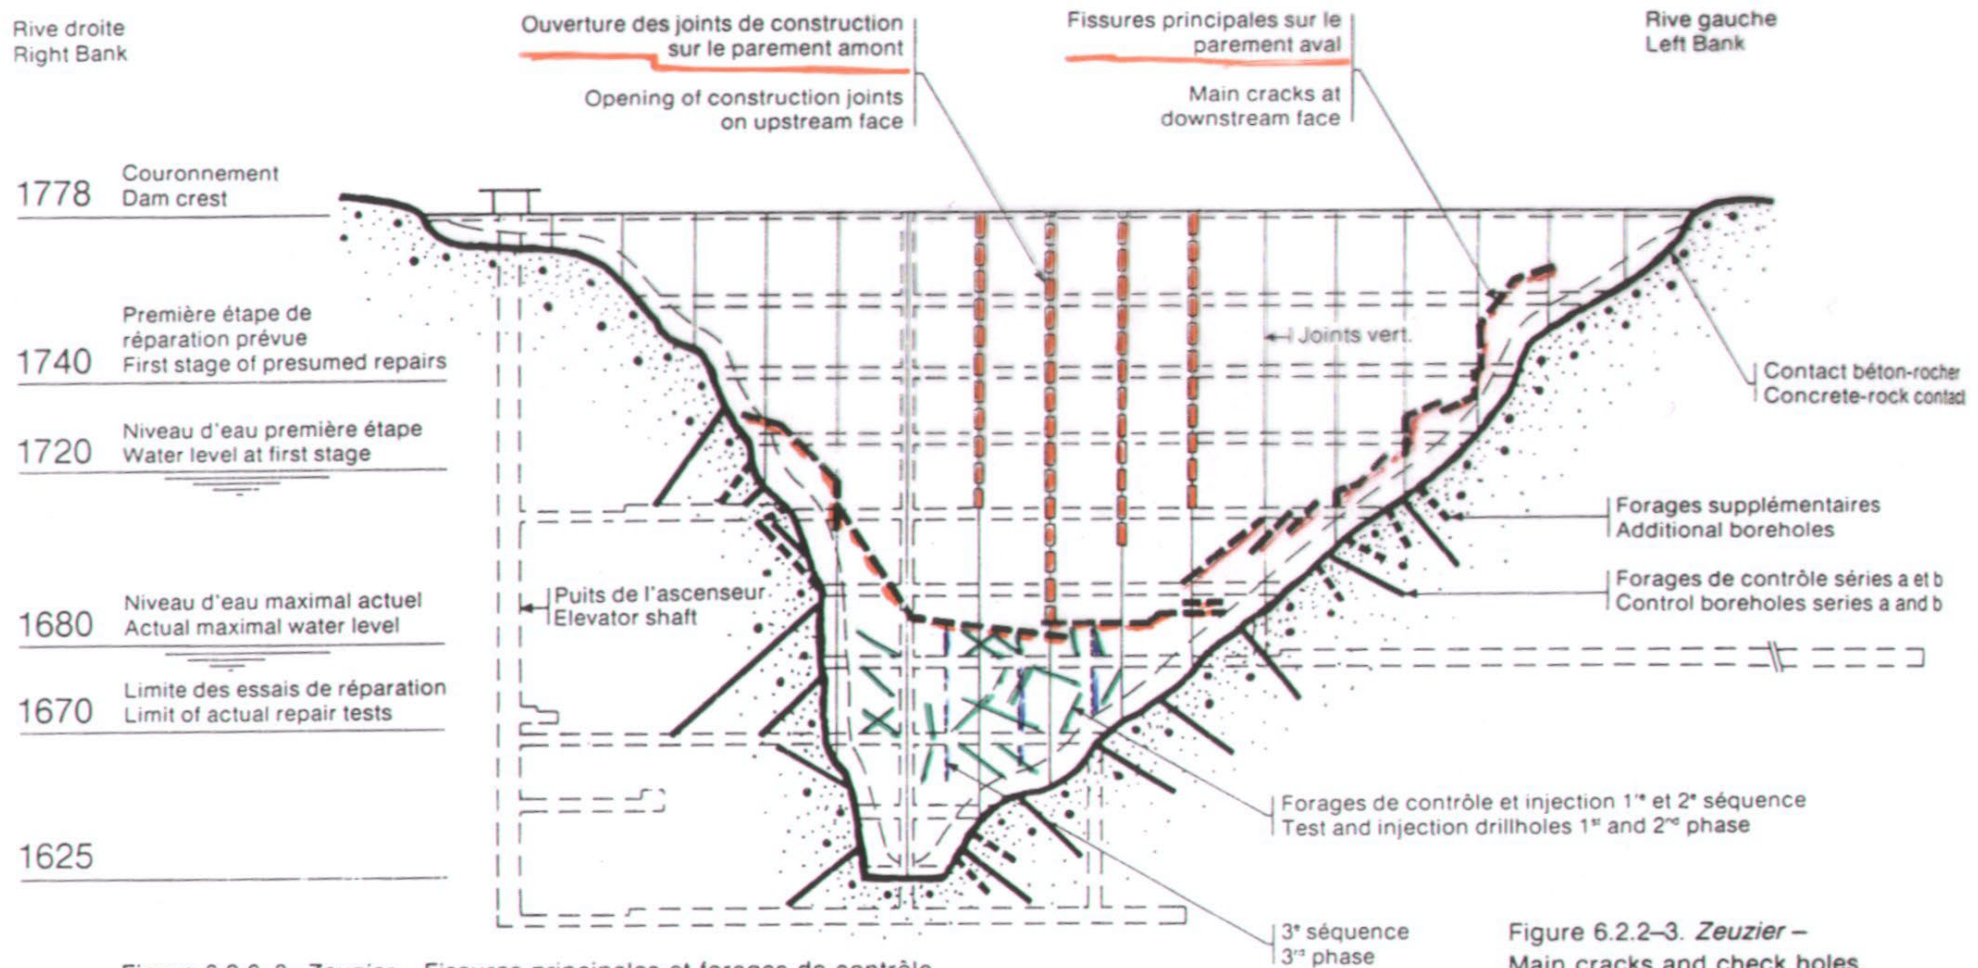
Figure 6.2.2-3. Zeuzier – Fissures principales et forages de contrôle.

Figure 6.2.2-3. Zeuzier – Main cracks and check holes.

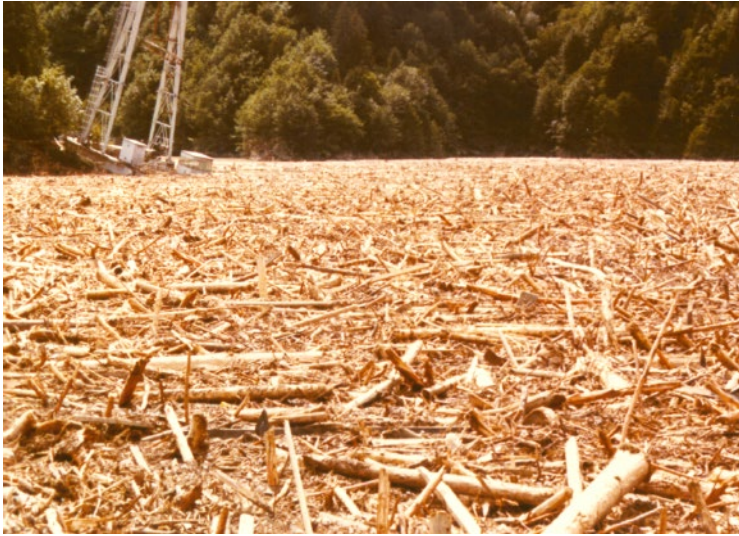
**Palagnedra: 72 m arch dam**

Palagnedra: arch-weight dam  $H=72$  m dam

7th August 1978:

- Heavy rain → flood
- 25,000 tree trunks swept away
- flood spillway blocked
- the bypass gallery remained closed
- spillage and shoreline erosion

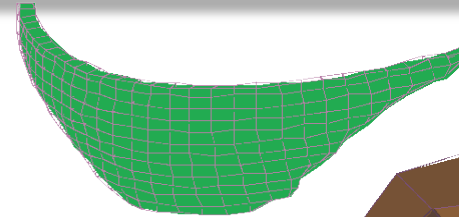
a) Upstream view of dam

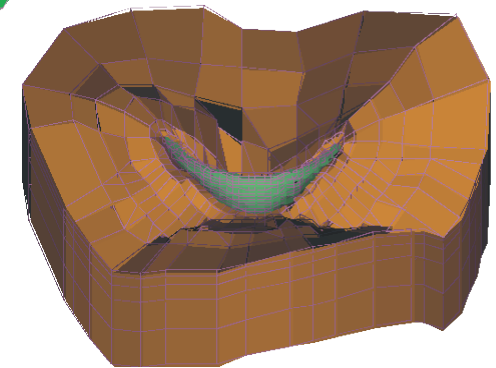
b) Downstream view of dam and foundation

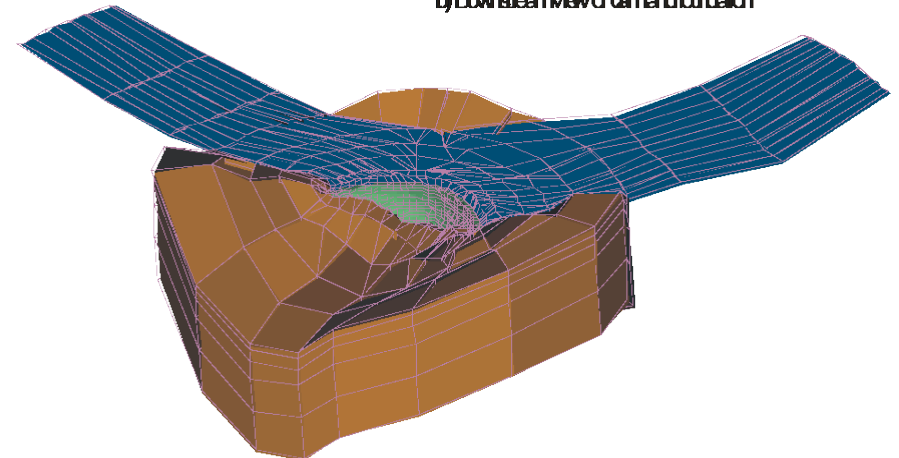
c) Downstream view of dam, foundation, reservoir system

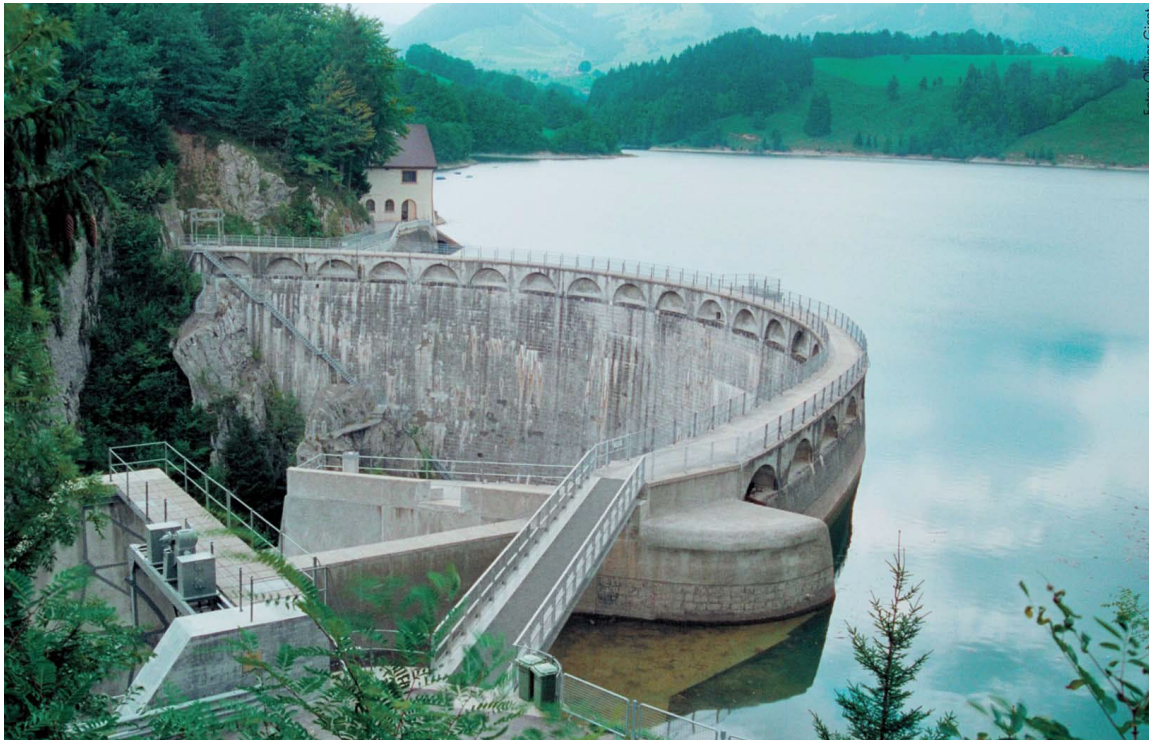
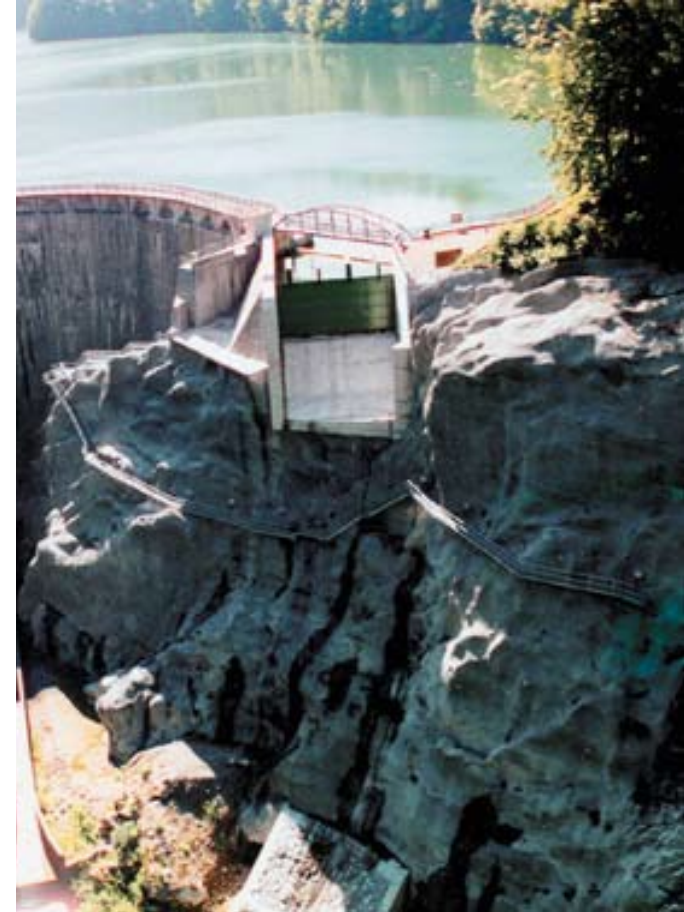
Montsalvens dam  
Arch dam. 52 m, 1920, raised in 1926  
New spillway in 1999

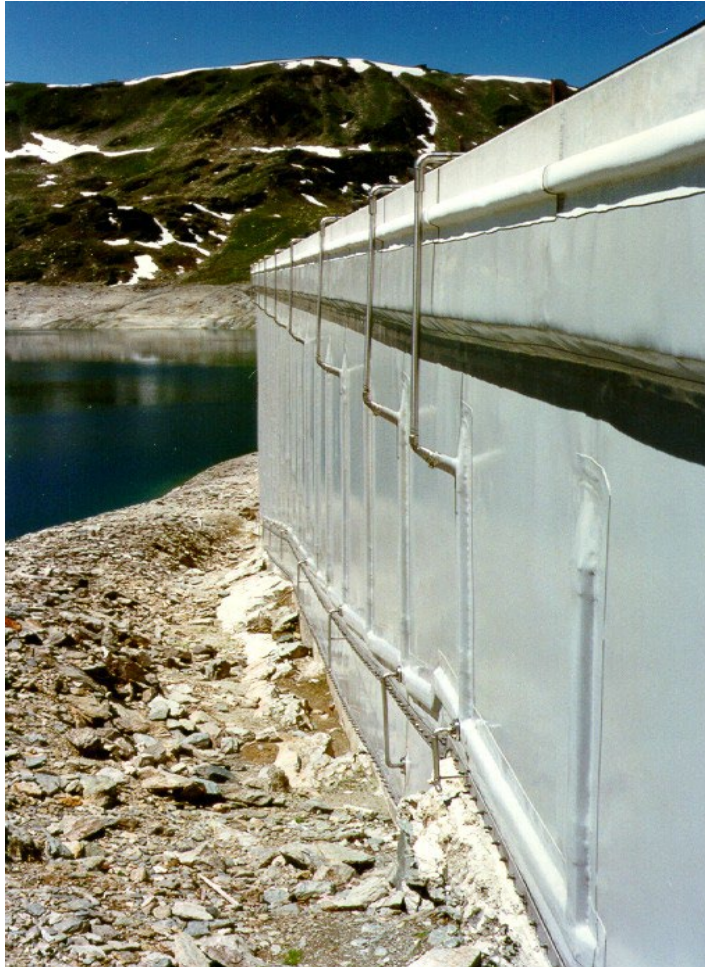
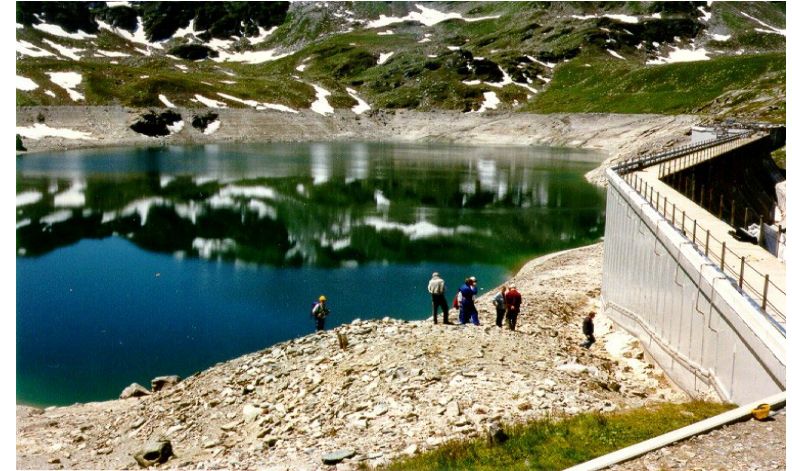
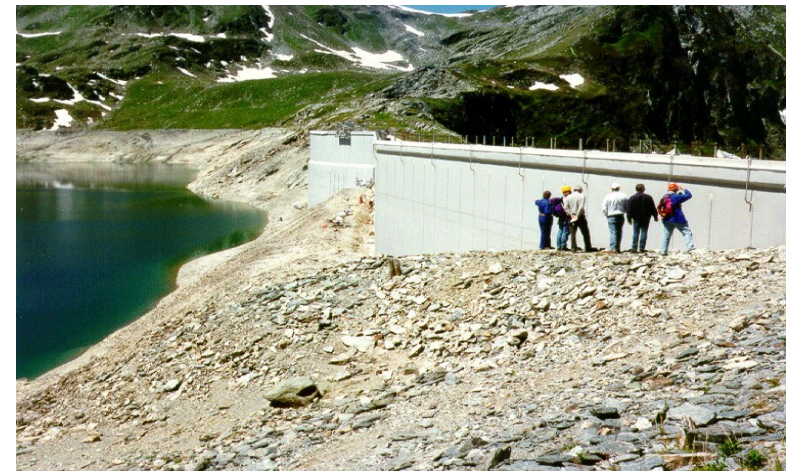
### Lago Bianco dam

Waterproofing  
measures using a  
synthetic  
membrane to  
prevent water  
penetrating the  
concrete

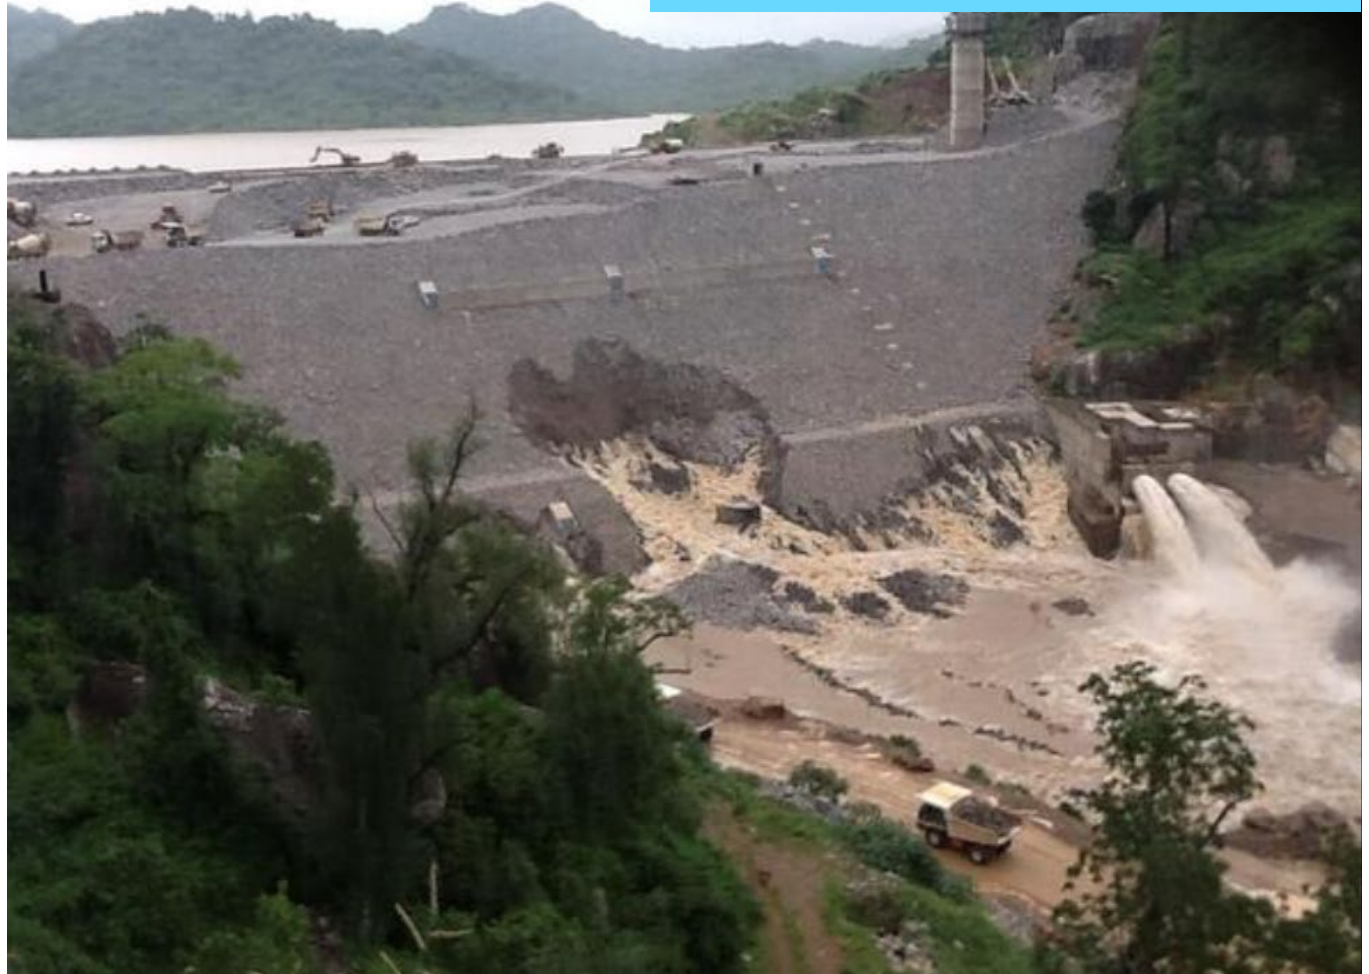
## **TOKWE MUKOSI – Zimbabwe, 2014**

90 m high CFRD  
C = 1.75 billion m<sup>3</sup>

Reservoir filled up  
without upstream  
facing

Cause:  
Diversion tunnel  
undersized

**No failure...**

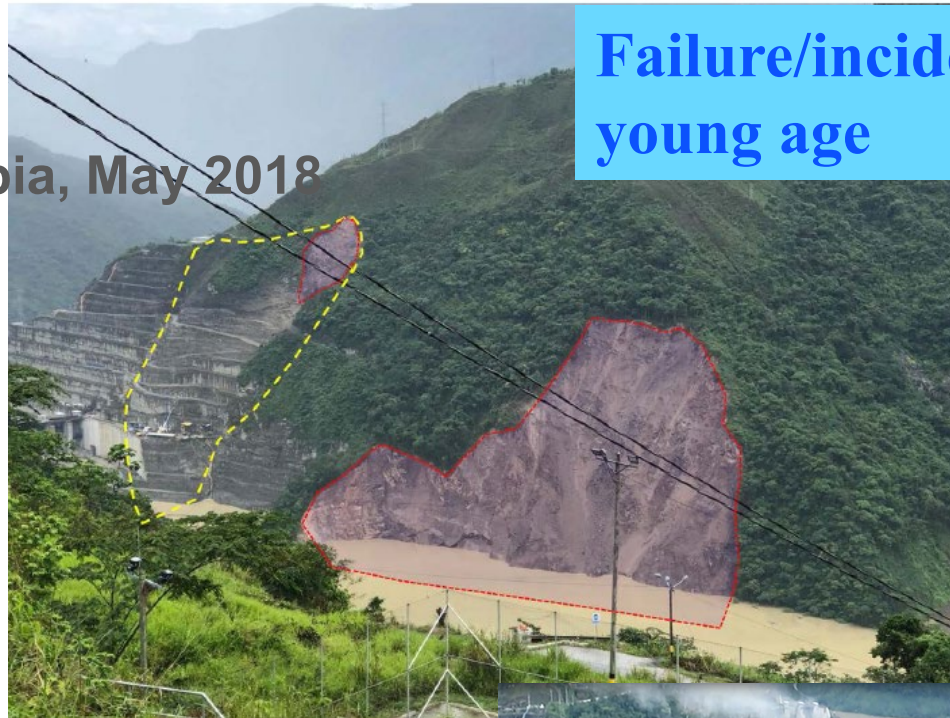
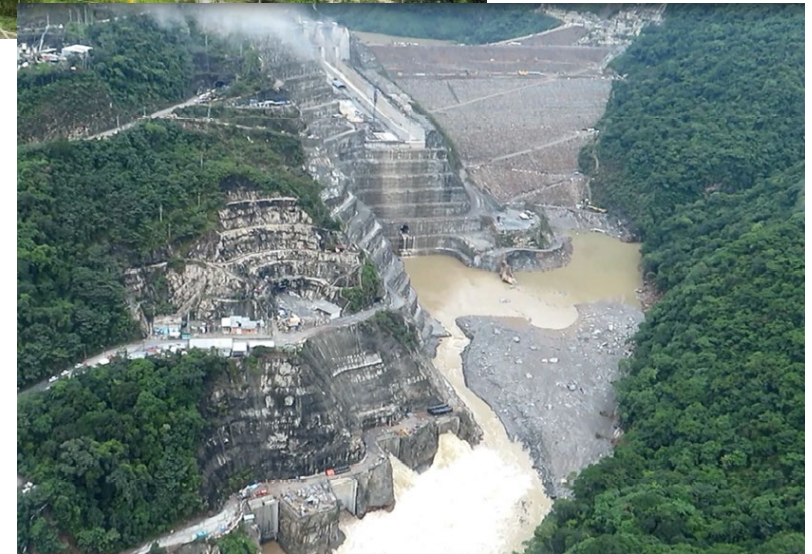
## ITUANGO dam - Colombia, May 2018

Central Clay Core  
Rockfill Dam  
227 m high  
 $C = 2,7 \text{ billions m}^3$

- The diversion tunnel was blocked by a landslide and fontis **near the end of construction.**
- Uncontrolled raising of the reservoir level.

**Discharge by the power plant cavern**  
 **$\approx 1000 \text{ m}^3/\text{s}$  under 200 m head!!!**

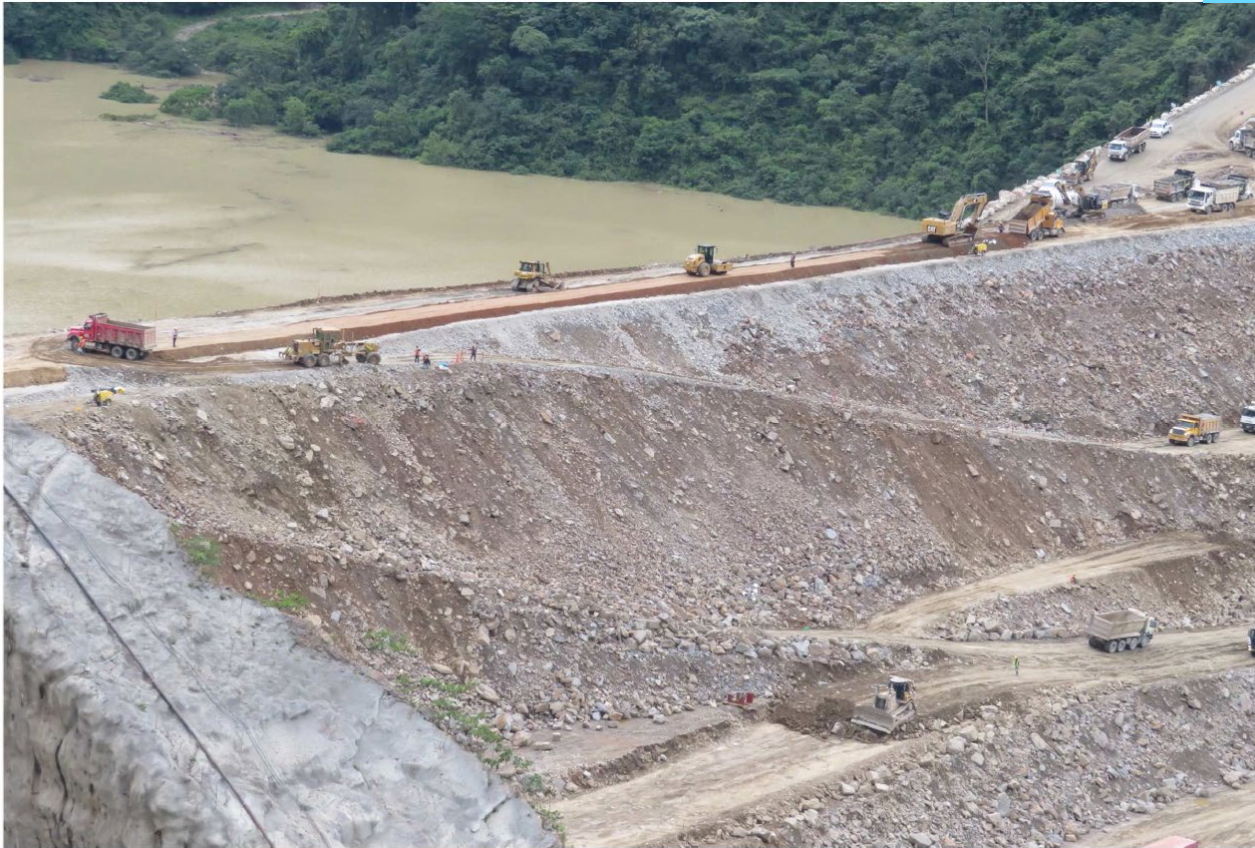
## ITUANGO dam - Colombia, May 2018

Speed race  
between the rise of  
reservoir (100 m in  
a few days) and  
the rise of an  
emergency  
upstream  
emergency  
cofferdam  
**Finally, the dam  
was saved**

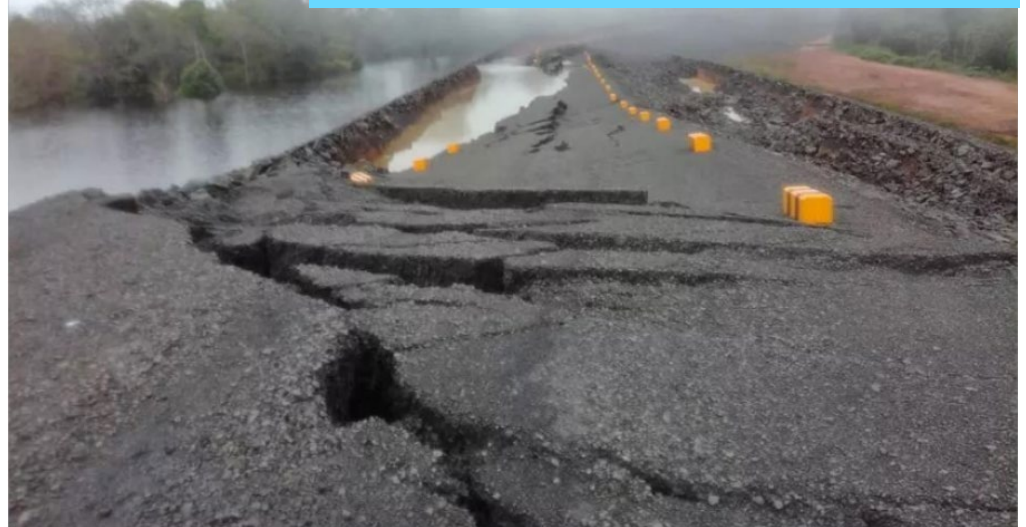
## Xe Pian - Xe Namnoy – Laos, July 2018

Failure of saddle dam  
of a large  
hydroelectric scheme  
**during first filling**

- Homogeneous dike -  $H = 16$  m
- On 16 m deep lateritic foundation
- no foundation treatment

- ✓ Abnormal settlements recorded before failure
- ✓ No overtopping
- **Cause of failure : regressive erosion in the pervious and erodible lateritic foundation**

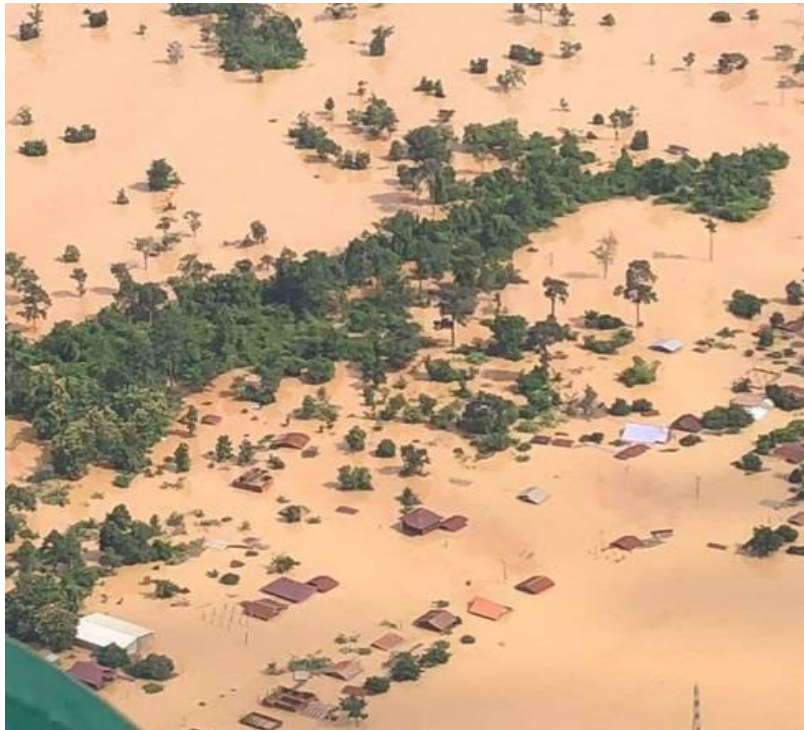
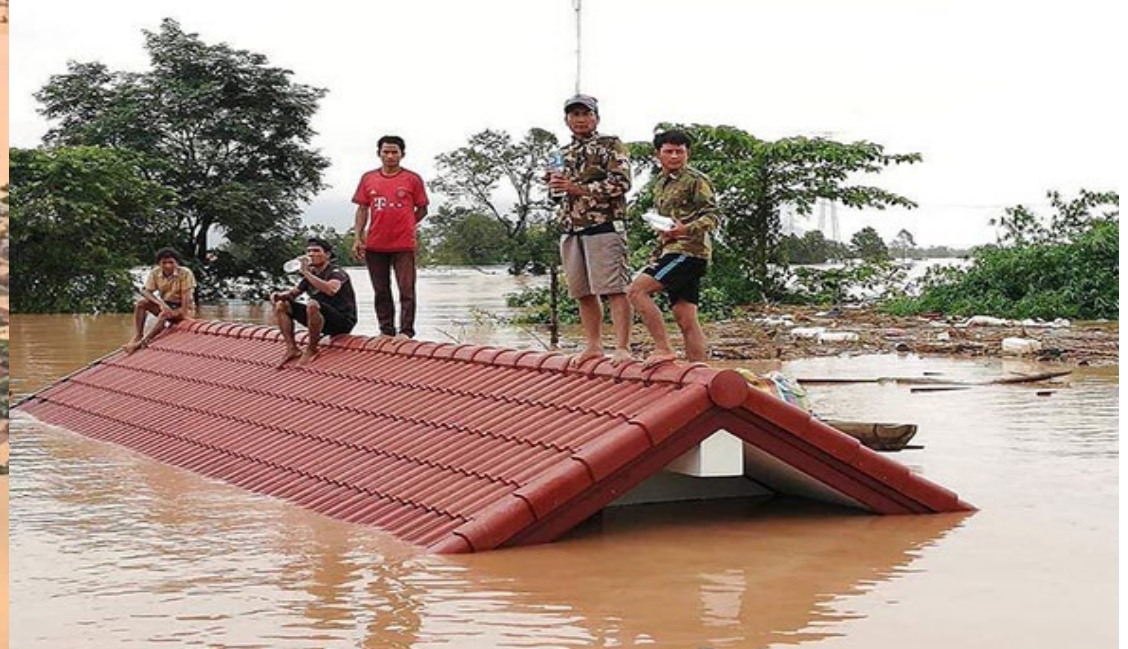
## Xe Pian - Xe Namnoy – Laos, July 2018

- ✓ Total volume of the Xe Namnoy reservoir : 1 billion m<sup>3</sup>
- ✓ Volume released : 0,5 billion m<sup>3</sup>
- ✓ 140 casualties
- ✓ More than 12 000 affected people

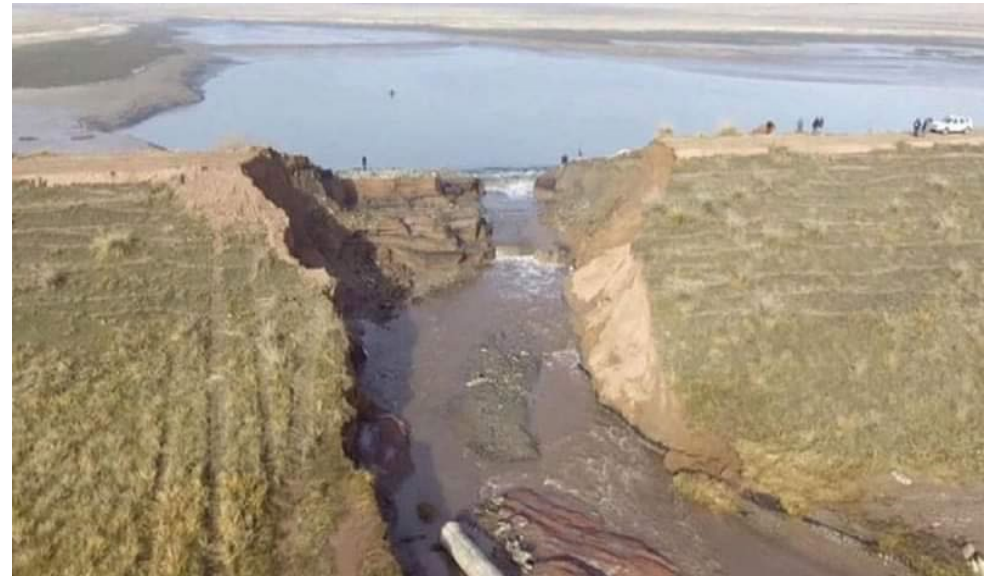
## **SARDOBA dam – Ouzbekistan, May 2020**

Embankment dam

Commissioning : 2017

Height : 29 m

Volume reservoir :  $\approx 922 \text{ Mm}^3$

Failure during flood

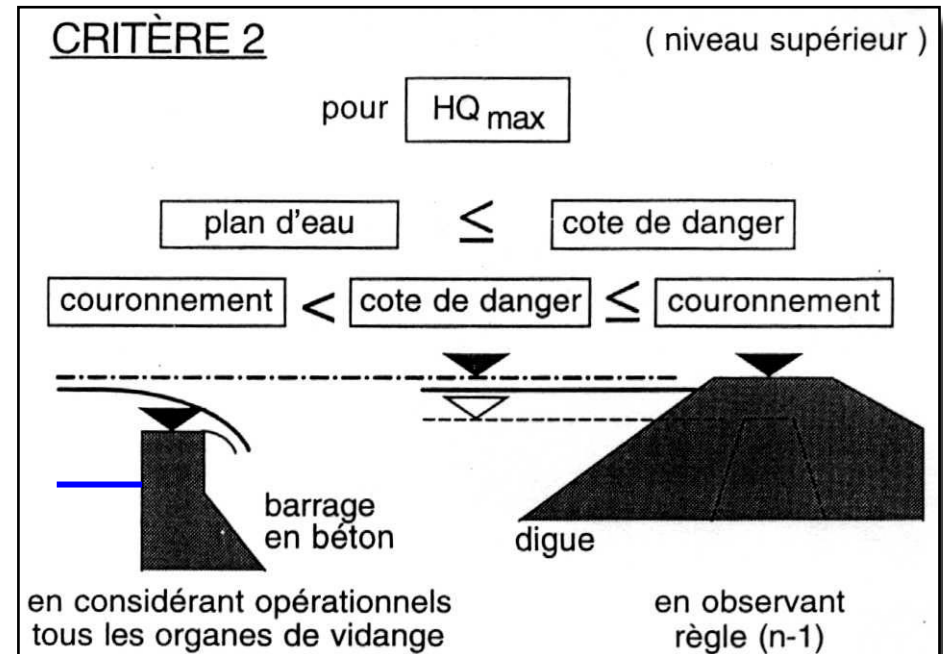
### Minimum Freeboard

Concrete dams: 1 to 2 m

Embankment dams: 2 to 4 m

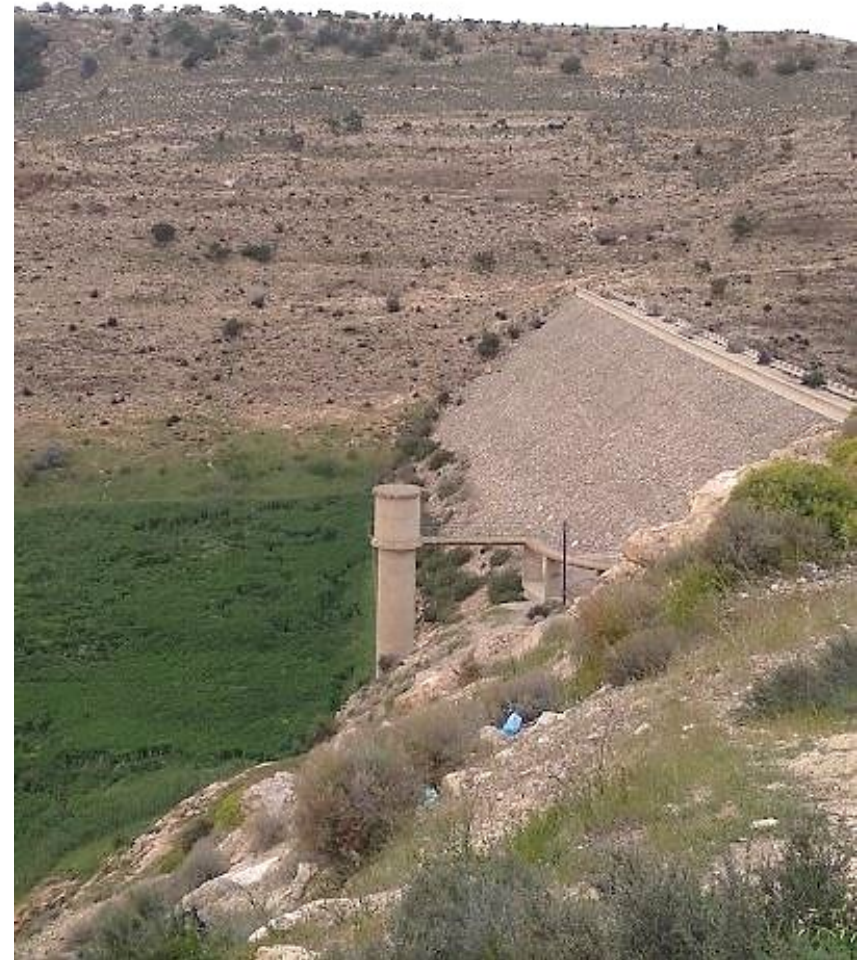
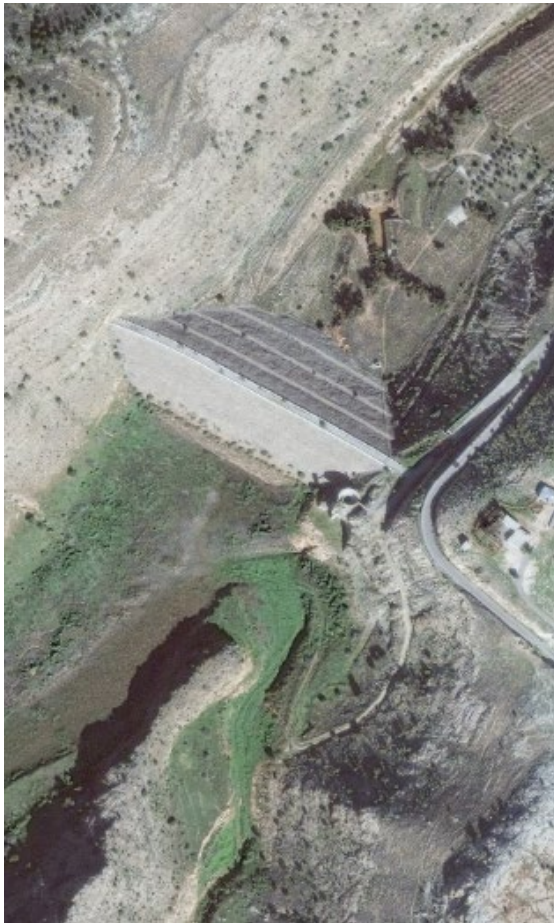
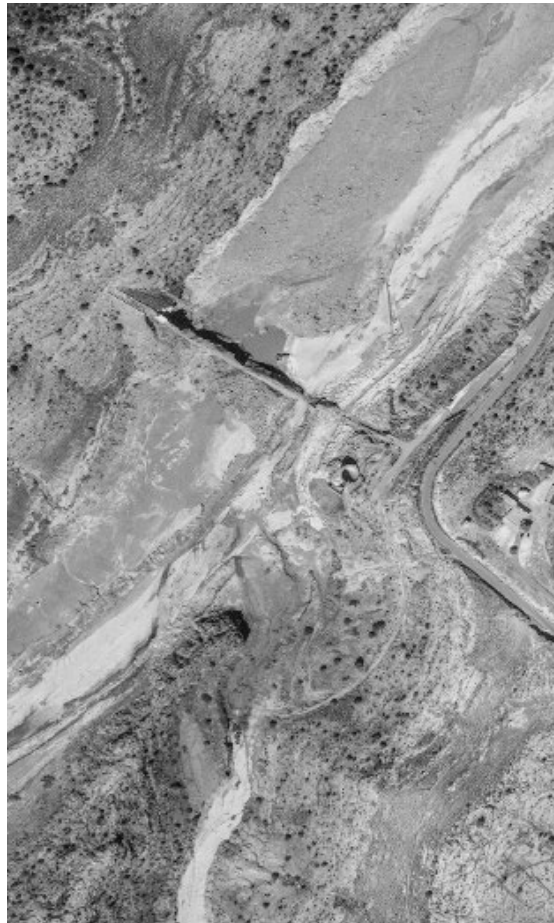
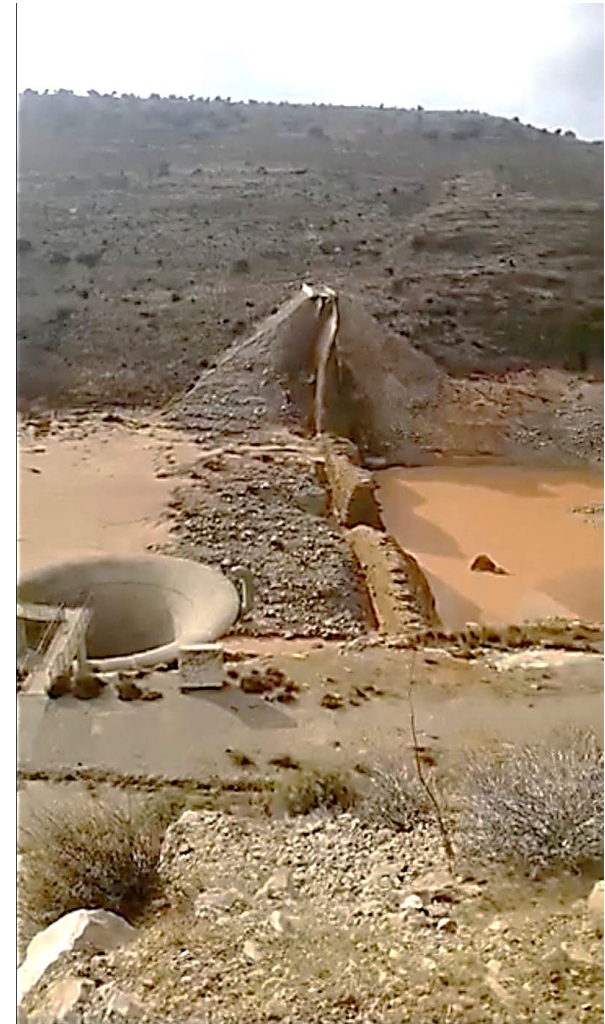
## **Derna & Mansur dams – Libya, September 2023**

Embankment dam with clay core

Commissioning : 1977

Height : 75 m

Volume reservoir :  $\approx 25 \text{ Mm}^3$

Failure during flood

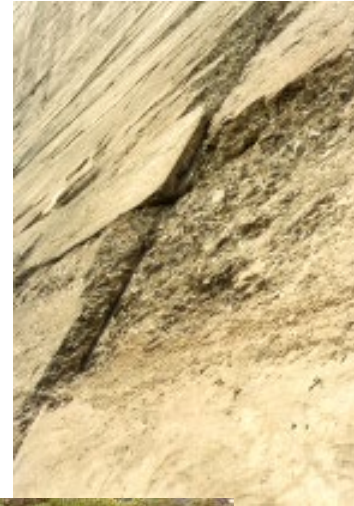
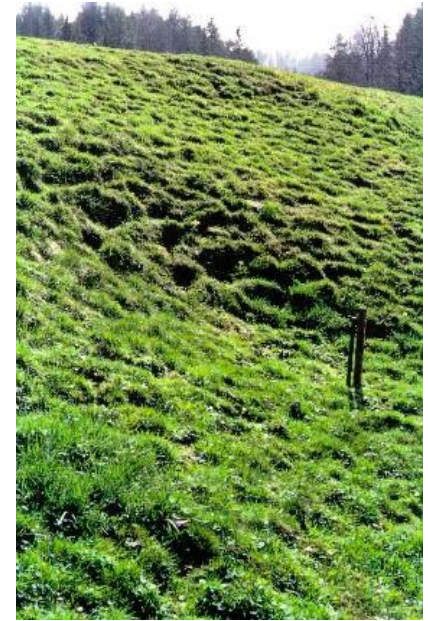
General condition, cracks

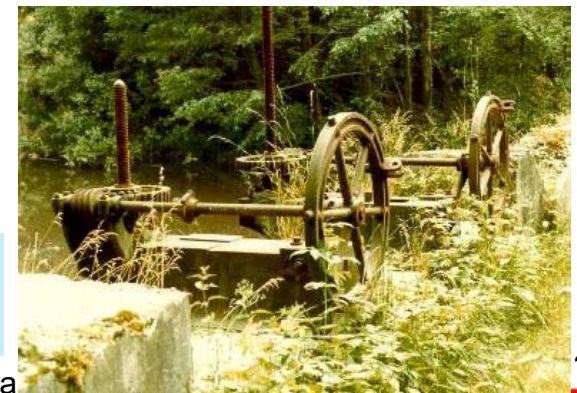
Condition of hydromechanical  
equipment
