## Surveillance and monitoring

# Dam Engineering

## Dam Safety and Surveillance

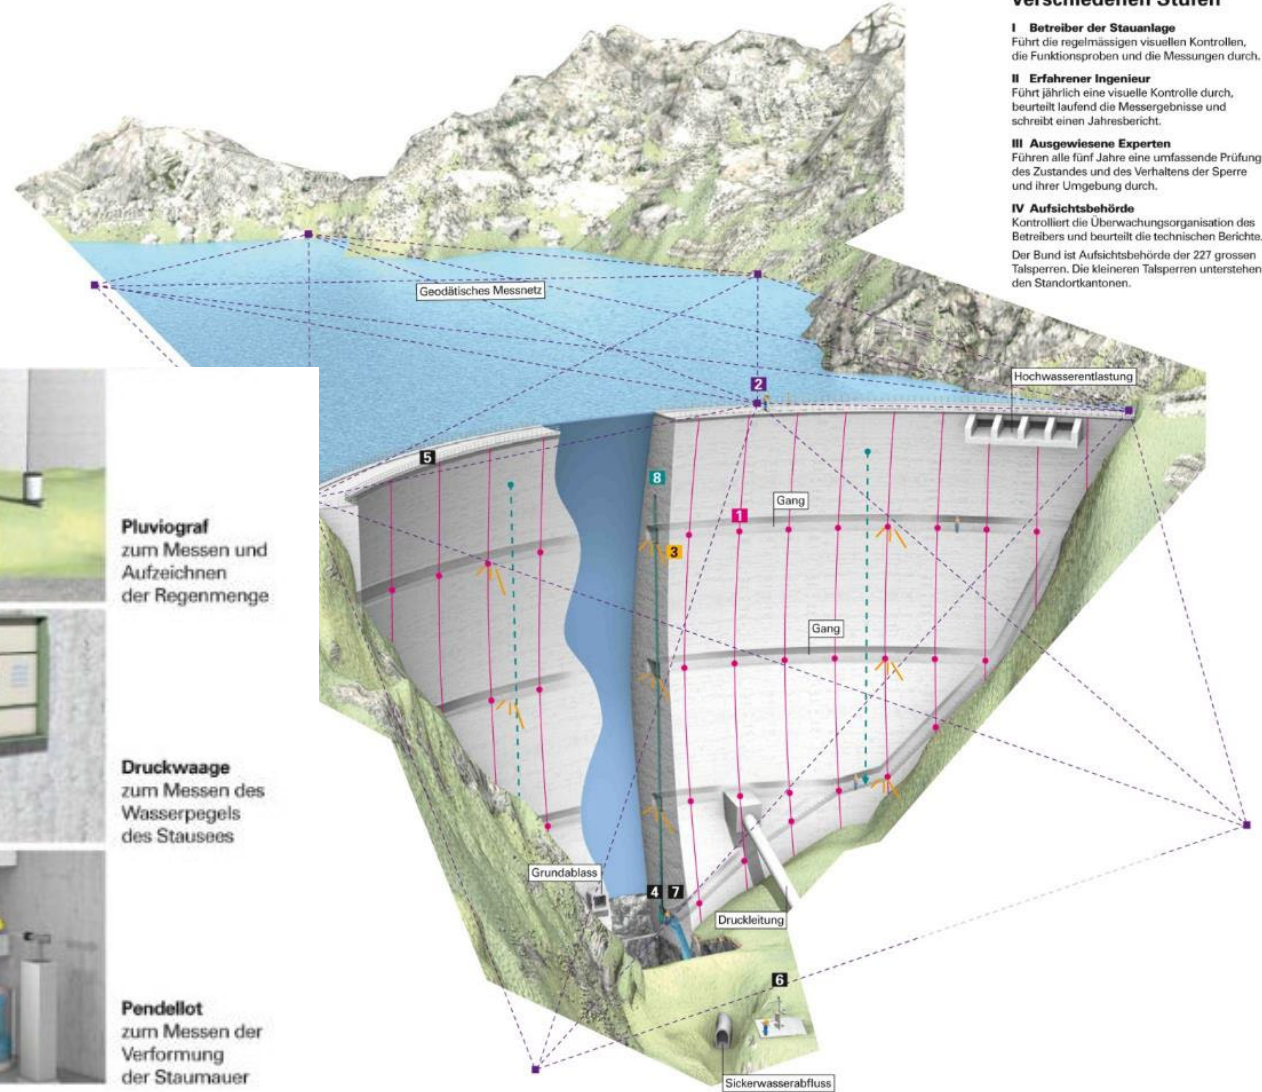
### Monitoring: Instrumentation

**Mikrometer**  
zum Messen der  
Breite von Fugen und  
Rissen (es gibt keine  
Staumauer ohne Risse)

**Theodolit  
(Winkelmesser)**  
zum geodätischen  
Vermessen der  
Verformung der  
Staumauer

**Thermometer**  
zur Messung der  
Wasser- und der  
Betontemperatur

**Stoppuhr und  
Massbecher**  
zum Messen der  
Sickerwassermenge

**Nivelliergerät**  
zum geodätischen  
Vermessen von Höhen-  
unterschieden und  
damit der Verformung  
der Staumauer

**Pluviograf**  
zum Messen und  
Aufzeichnen  
der Regenmenge

**Druckwaage**  
zum Messen des  
Wasserpegels  
des Stausees

**Pendellot**  
zum Messen der  
Verformung  
der Staumauer

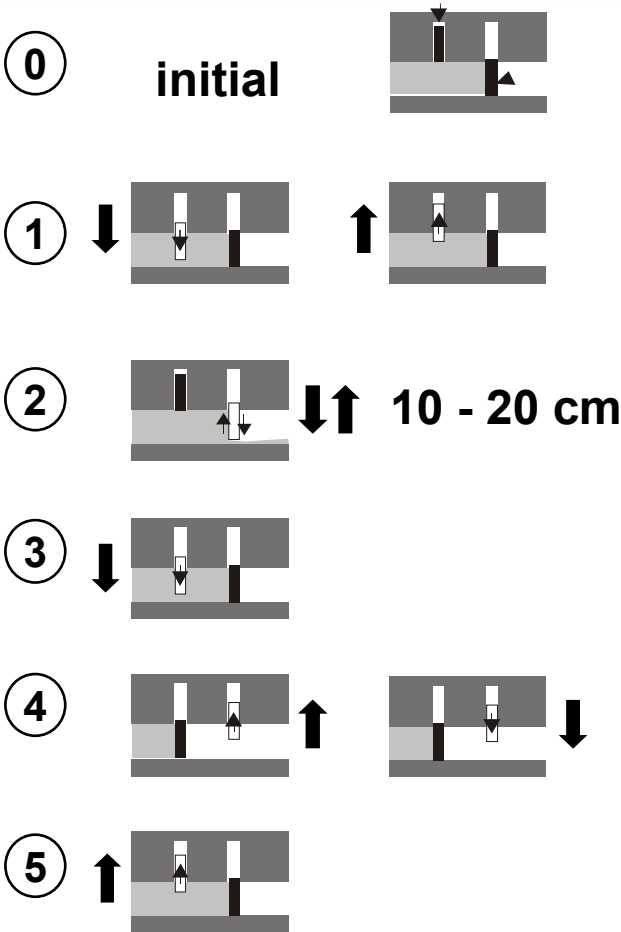
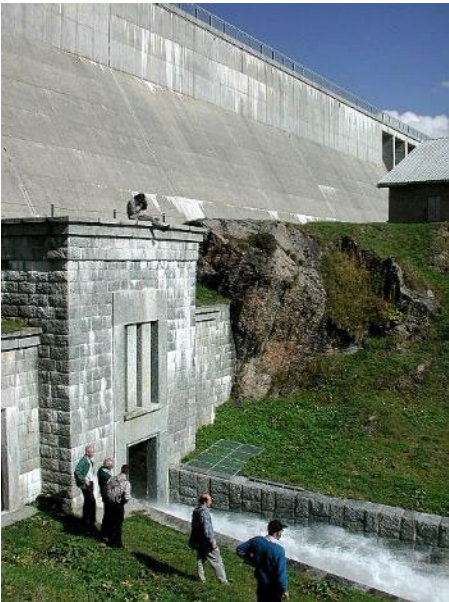
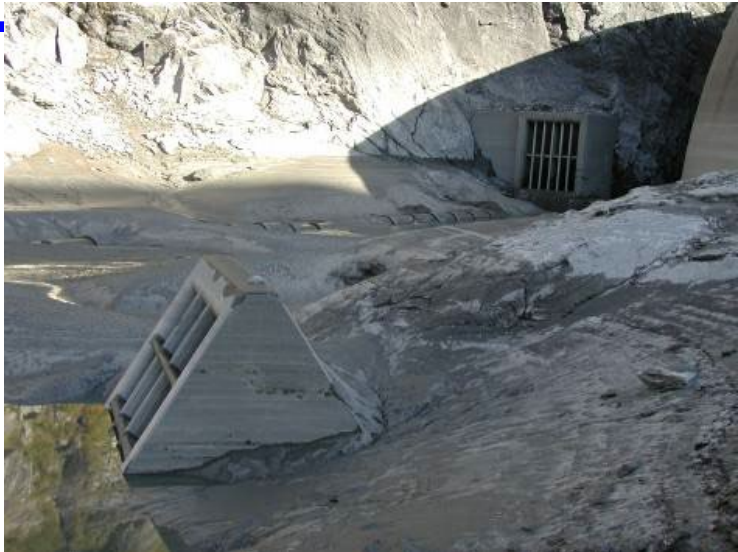
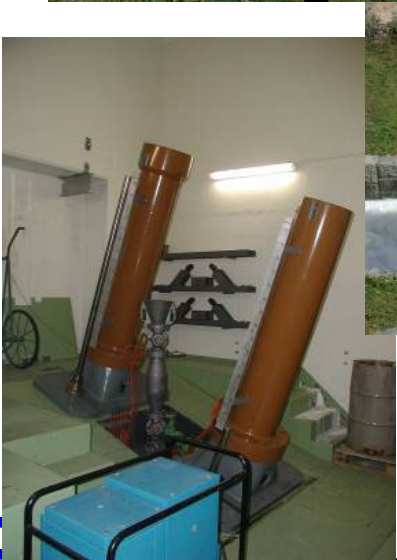
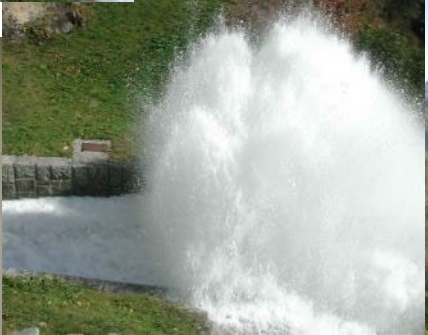
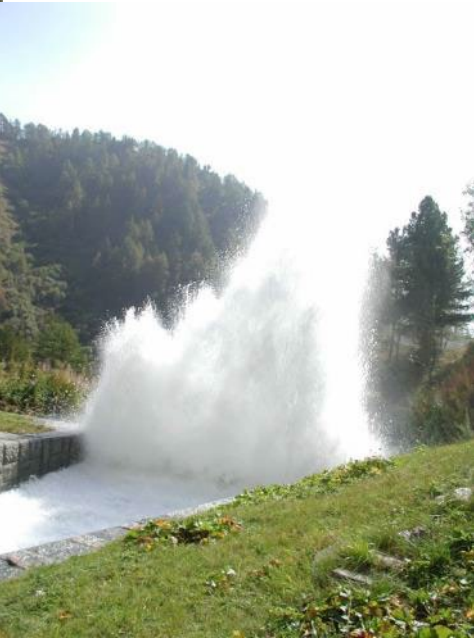
Valve operation tests

- ⇒ Annual inspection;
- ⇒ Each inspection must be carried out with a high water level in the reservoir and must include a discharge test (wet function test) if technically feasible;
- ⇒ The way the inspection is performed and the findings must be recorded in a report.

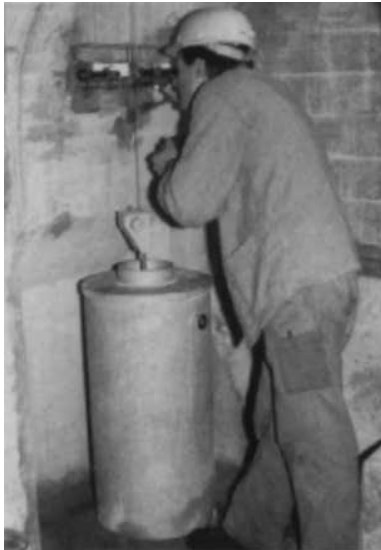
Reference number 2.1000(1), above. Typical example of a modern arrangement of plumb lines. 1 Crest of dam, 2 Plumb line, 3 Point of suspension of plumb line, 4 Inverted plumb line, 5 Anchorage of inverted plumb line.

- ⇒ along vertical lines  
(extension underground)  
Plumblines and inverted plumblines  
geodetic survey (angle and distance measurements)
- ⇒ along horizontal lines  
(extension in abutments)  
wire alignment, levelling, optical alignment, angle and distance measurements, polygons
- ⇒ Rock deformation  
variation in length and deformation along lines in boreholes (extensometer, sliding micrometer, sliding clinometer)
- ⇒ in cracks and joints  
accessible reference points (micrometer, dilatometer, clinometer),  
stress gauges

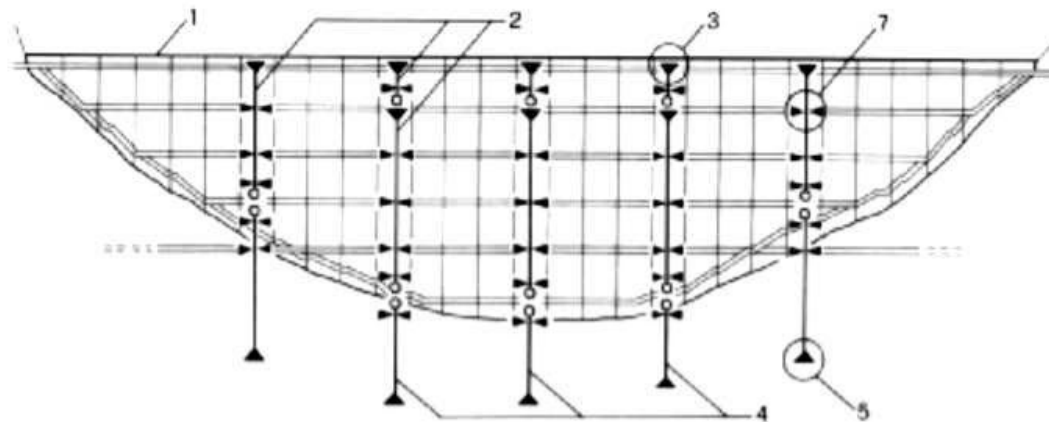
Reference number 2.100(2) at right. Schematic representation of plumb lines. 1 Crest of dam, 2 Plumb line, 3 Point of suspension of plumb line, 4 Inverted plumb line, 5 Anchorage of inverted plumb line, 6 Cement grout, 7 Measuring point, 8 Float/float tank, 9 Damping tank.

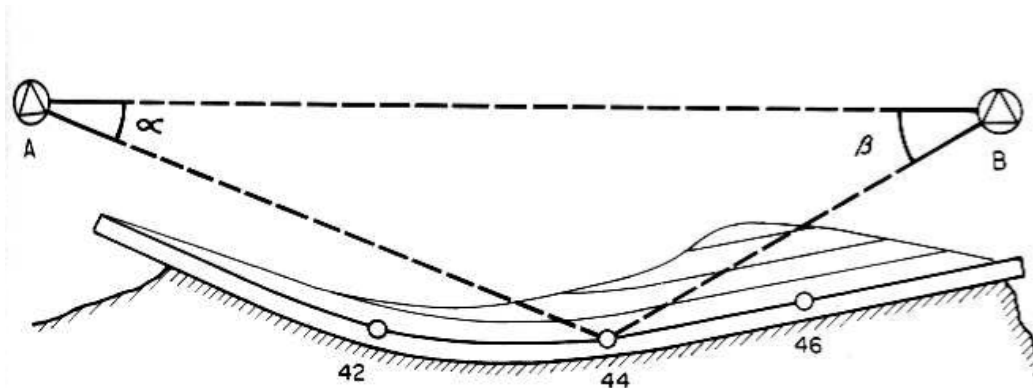
Reference number 2.101(1). Simple measurement of angles used for determining horizontal displacements. The measurement system uses observations with a theodolite from a pillar (reference point A) to the control points on the dam (targets 42, 44, and 46) using reference point (B) as orientation. As a check analogical measurements can be made from the opposite reference point (B).

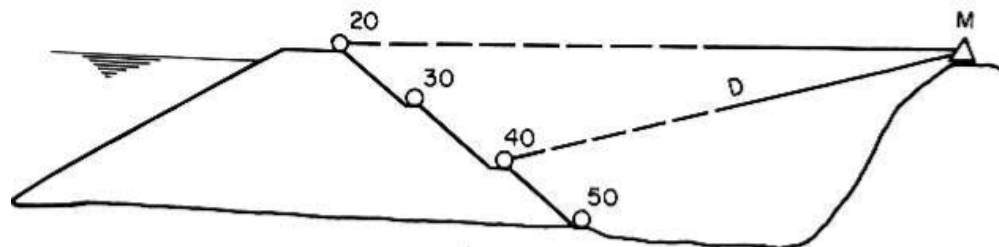
Reference number 2.101(3). Simple measurement of distances between control targets on the dam and fixed reference points downstream displacements of the dam using an electro-optical distance meter. (M) Reference point, (D) Measured distance, 20 to 50 Control targets.

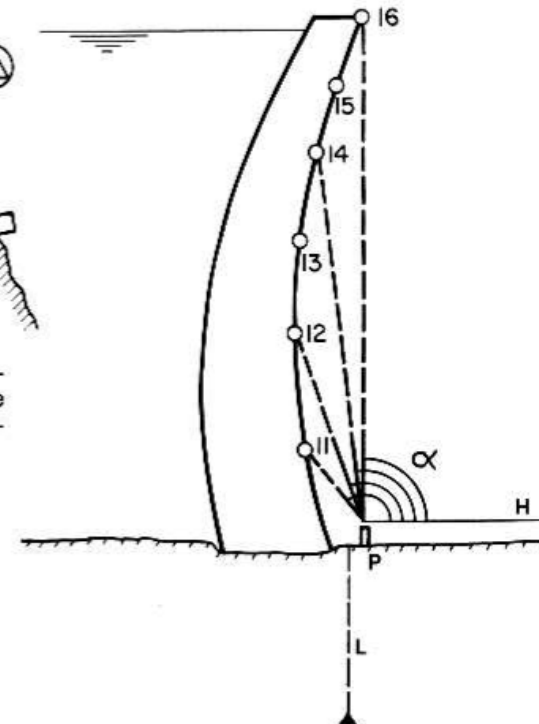
Reference number 2.101(2). Simple measurement of vertical angles used for determining the upstream/downstream displacements of targets located on the downstream face of the dam. (P) Reference point, usually an observation pillar, (H) Horizon, (L) Inverted plumb line, 11 to 16 Control targets.

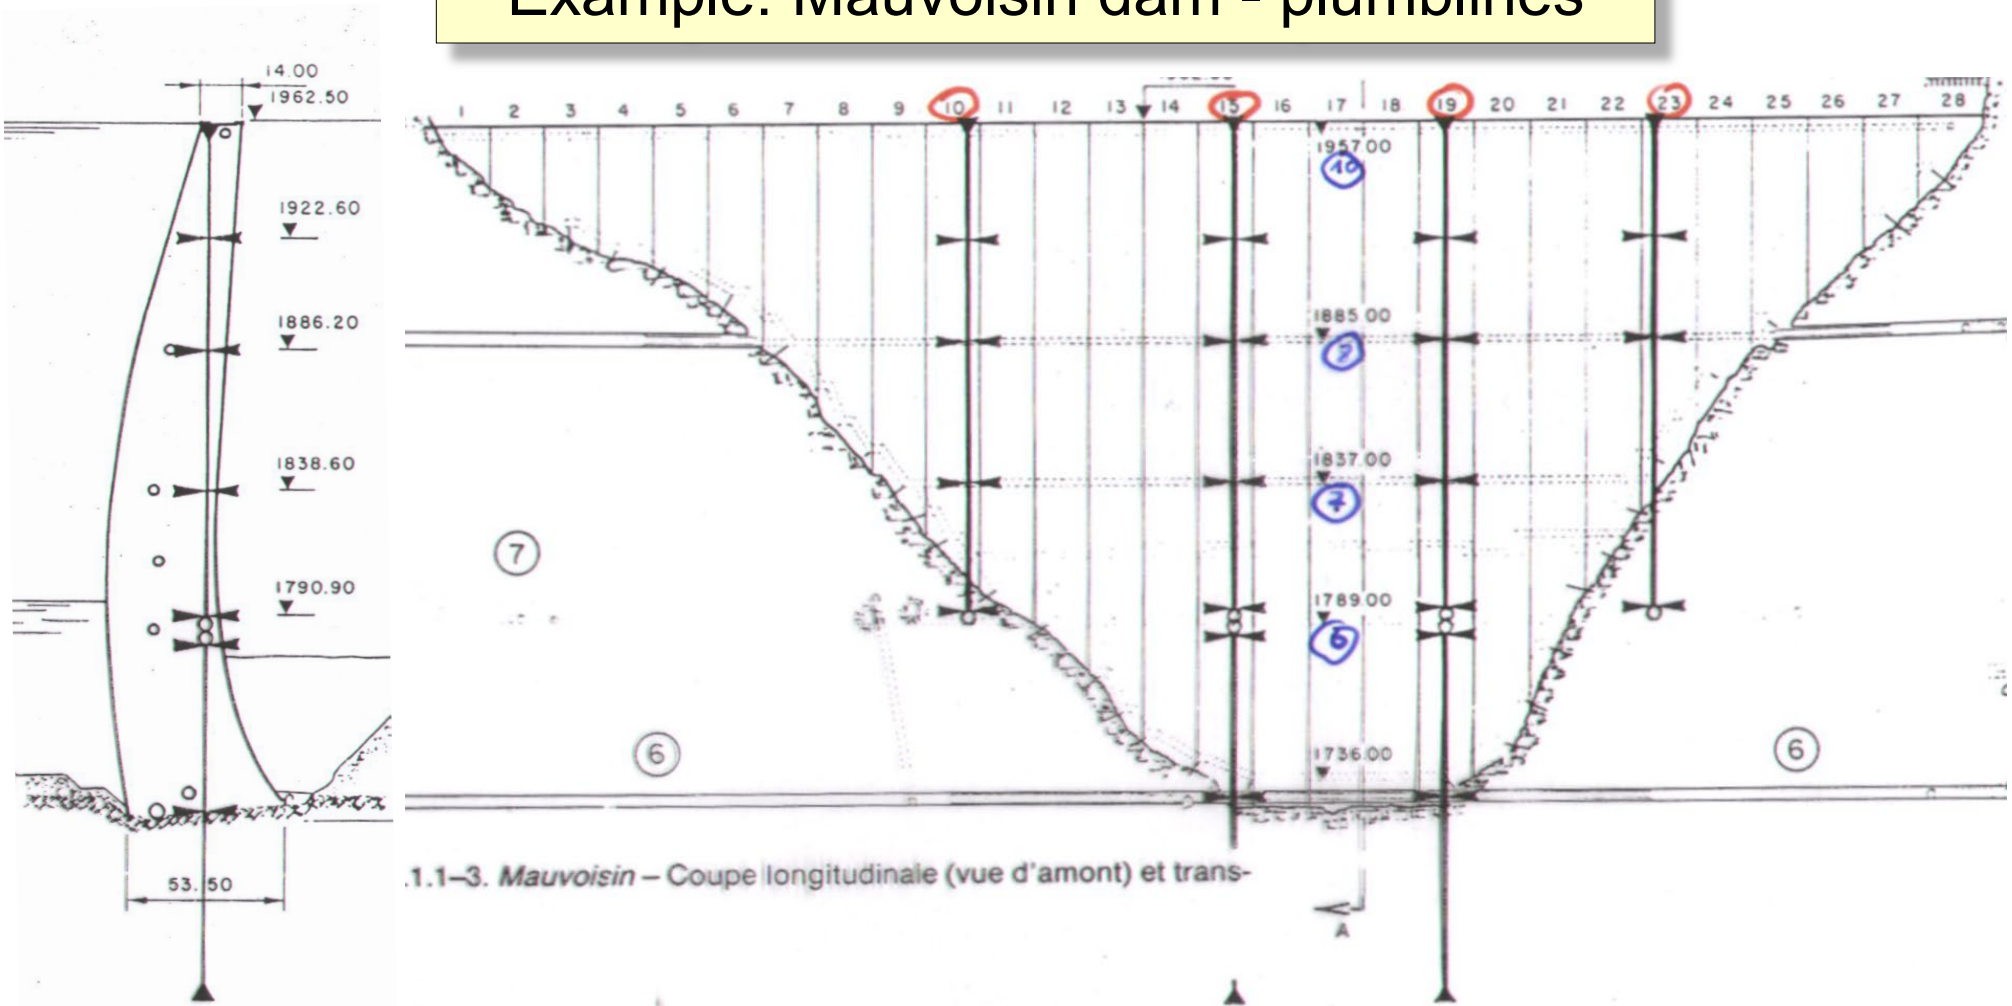
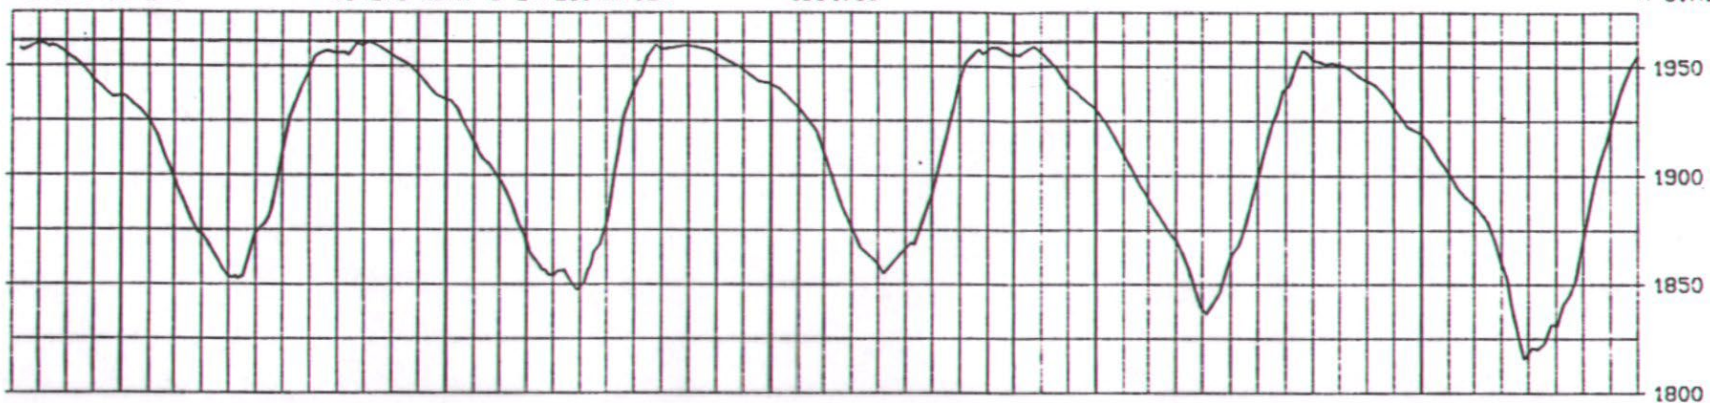
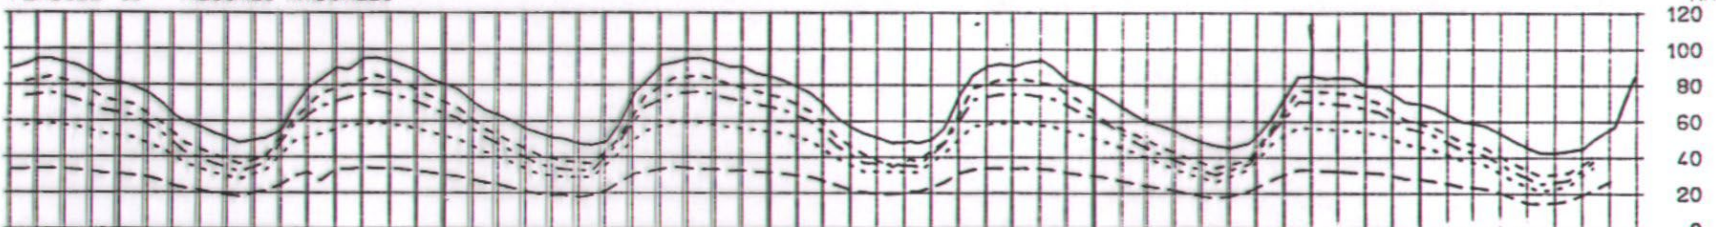
## Example: Mauvoisin dam - plumblines

PENDULE 10 - MESURES RADIALES

PENDULE 15 - MESURES RADIALES

PENDULE 19 - MESURES RADIALES

PENDULE 23 - MESURES RADIALES

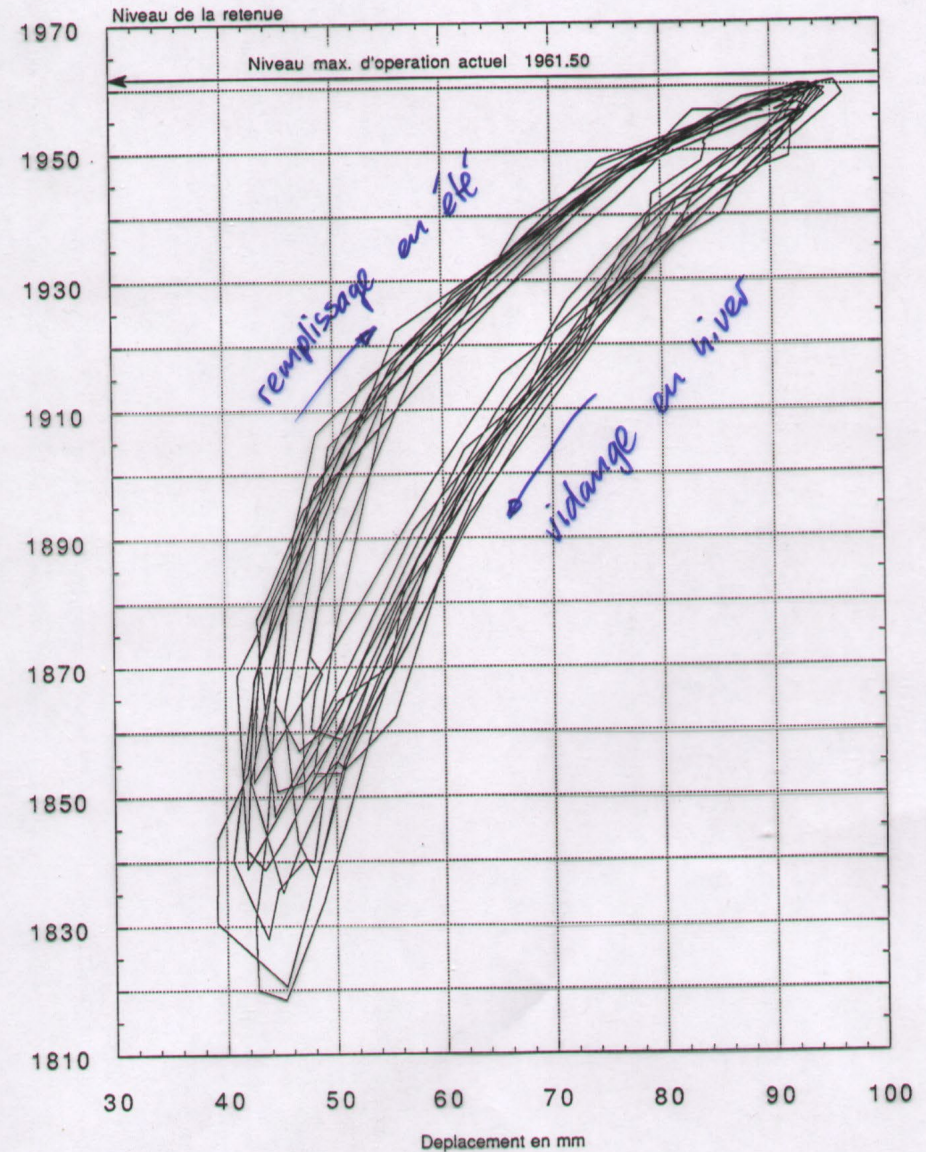
BARRAGE DE MAUVOISIN  
PENDULE 15, STATION S  
Déplacement radial en fonction du niveau d'eau  
Années 1977 - 1990

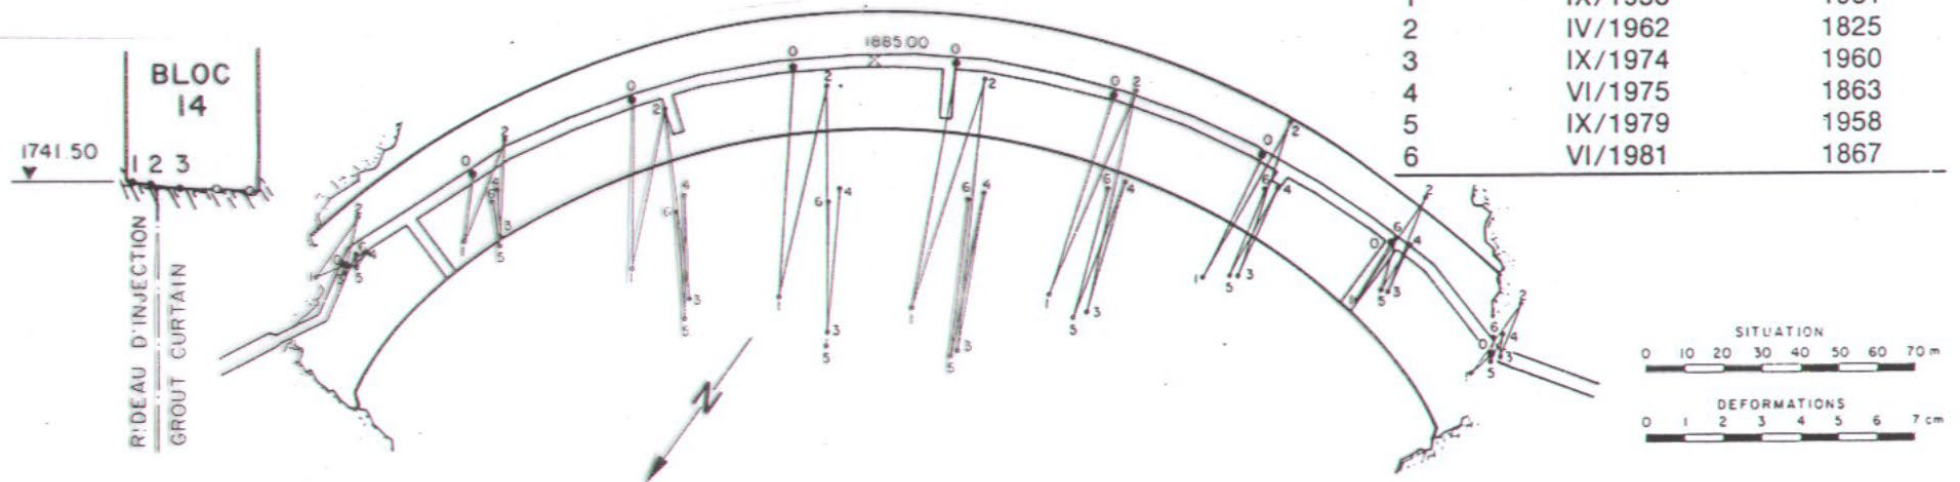
Figure 4.1.1–5. *Mauvoisin* – Déformation horizontale au niveau 1885 (mesures géodésiques).

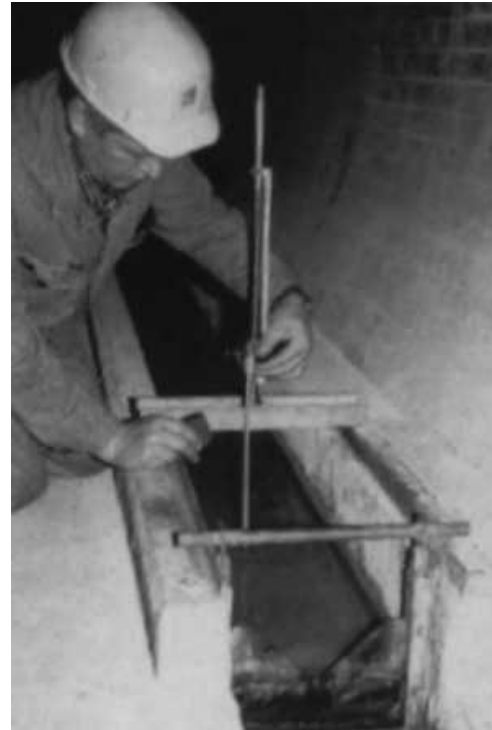
## Monitoring system - Leakage

- Volumetric measurements
- Calibrated weir
- Turbidity measurement

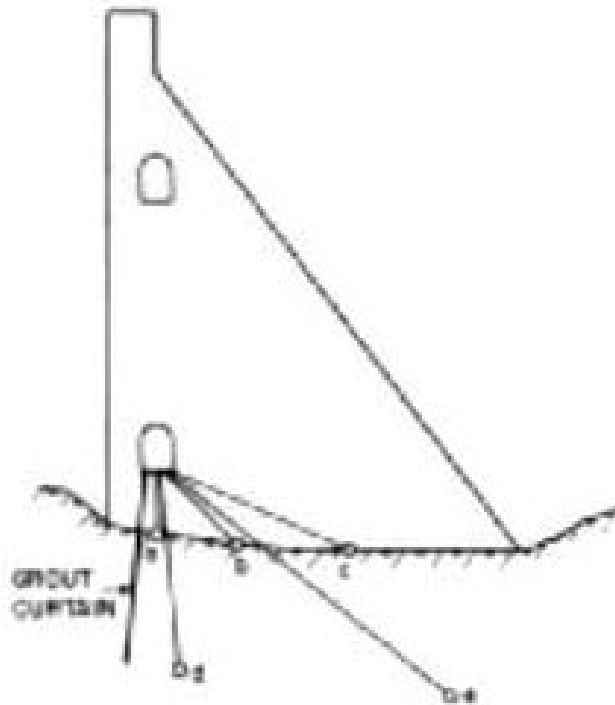
Reference number 2.301-1(2). Typical layout of uplift measurements of type (a).

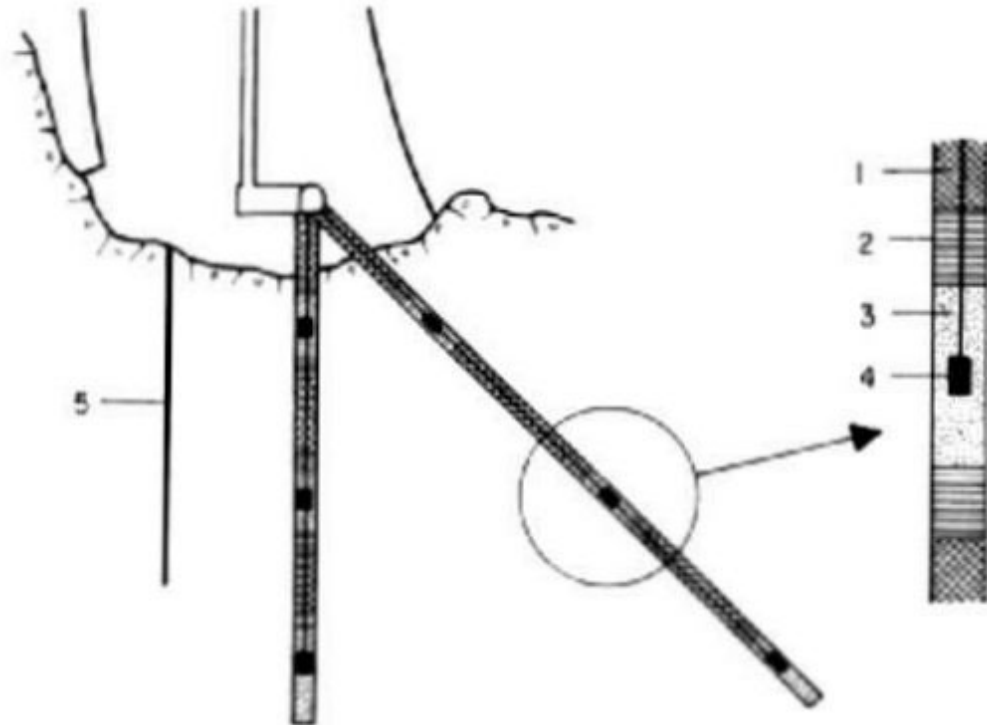
Reference number 2.301-1(6). Possible layout of uplift measurements of types (c) and (d) in the foundation of a dam. 1 Grout, 2 Clay pellets, 3 Quartz sand (grain size 1,5 to 2 mm), 4 Piezometer, 5 Grout curtain.

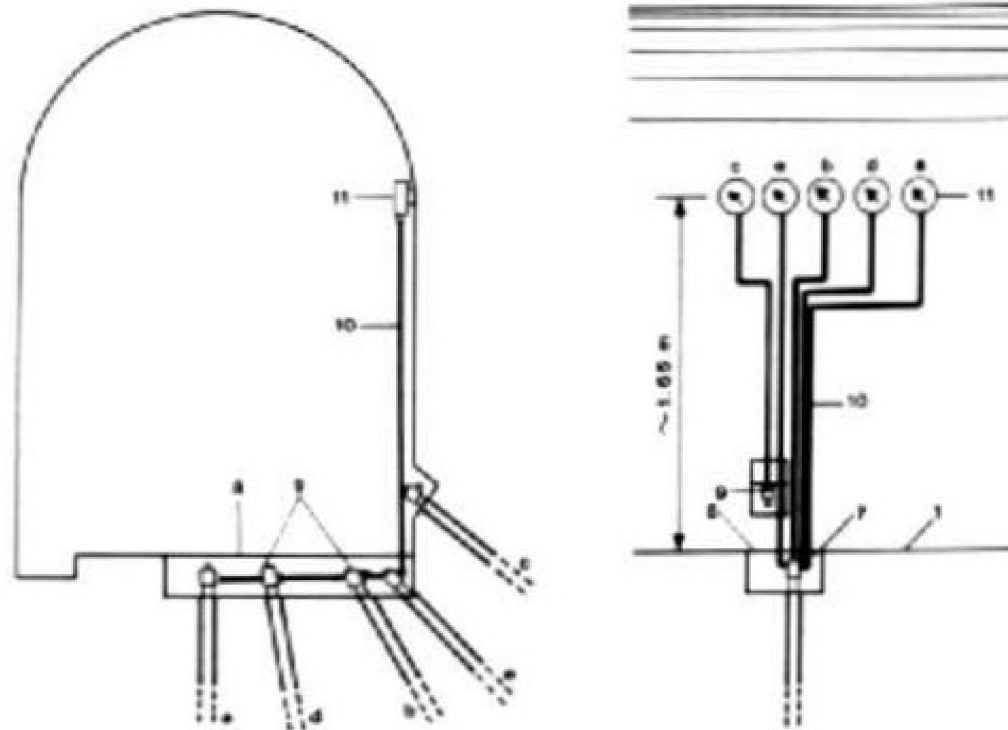
Reference number 2.301-1(3). Connections of pipes to manometers. Floor wall, 2 Grout, 3 Concrete, 4 Rock-concrete interface, 5 Tabled length of borehole, 6 Non-tubed borehole, 7 Ditch, 8 Metal cover, 9 T-piece (e.g. 2" to 2.5") acting as pipe closure and connection to pressure tube, 10 Flexible pressure tube, 11 Manometer.

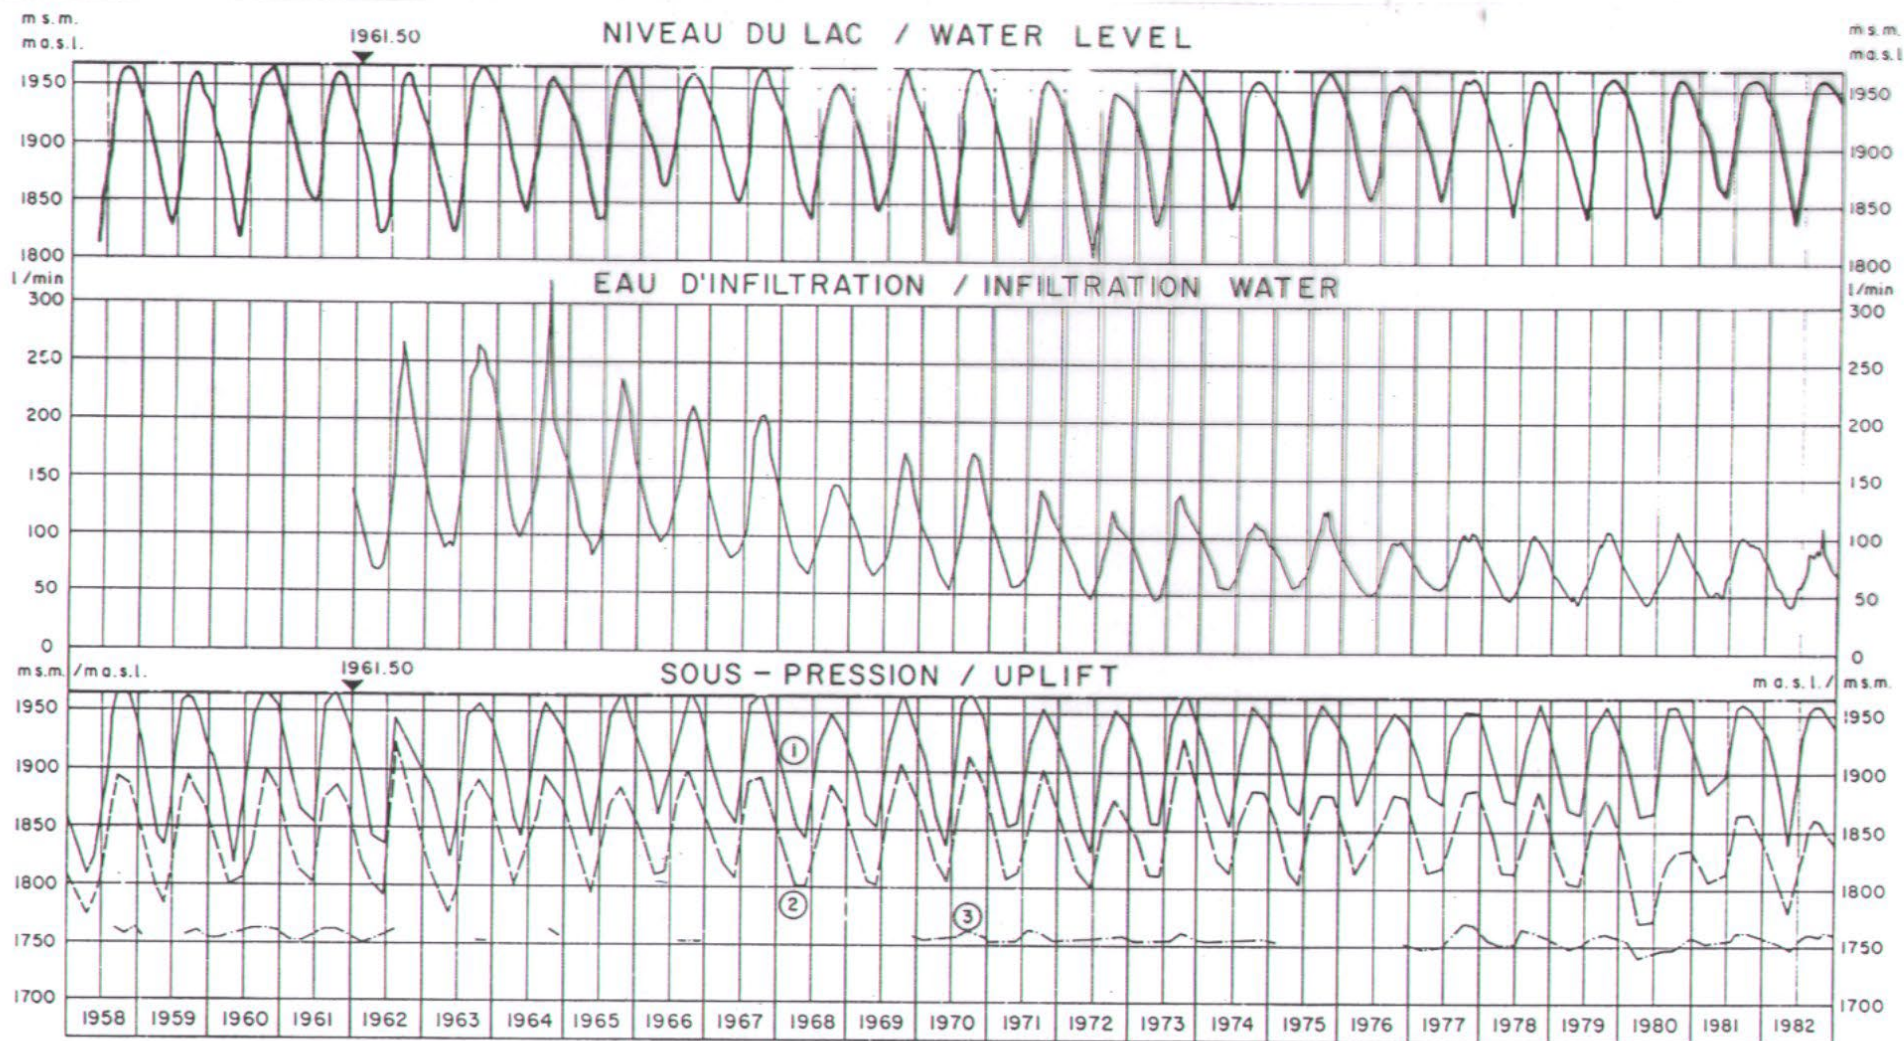
Figure 4.1.1-6. Mauvoisin-Eau d'infiltration et sous-pression.

① ② en amont de la voile d'étanchéité  
 ③ en aval

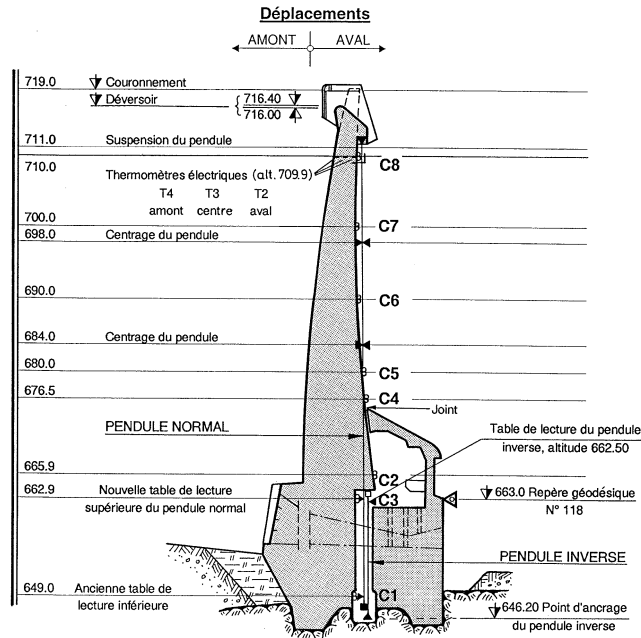
### DISPOSITIFS DE MESURES

( Section centrale du barrage )

- Modernisation et installation de nouveaux appareils de mesure : mai 1987
- Installation de 12 nouveaux capteurs de pression : automne 1995

Anciennes prises installées lors de la construction :  
- 9 prises de pression entre le béton et le rocher, réparties de part et d'autre de la section centrale.

Nouveaux capteurs de pression installés en 1995 :  
- 6 capteurs au niveau du contact rocher - béton  
- 6 capteurs dans le rocher

Remarque : Mesure des débits d'infiltration : Vidange périodique du puits, mesure par compteur.

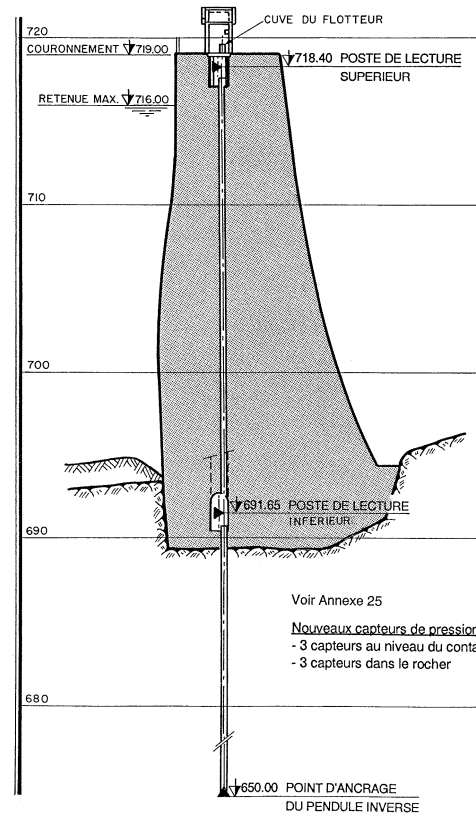
#### Coupe Transversale

### INSTALLATION D'UN PENDULE INVERSE

( Culée Rive Gauche / Bloc22 )

Mesure origine : 22.03.1996 / Niveau du lac 708.39

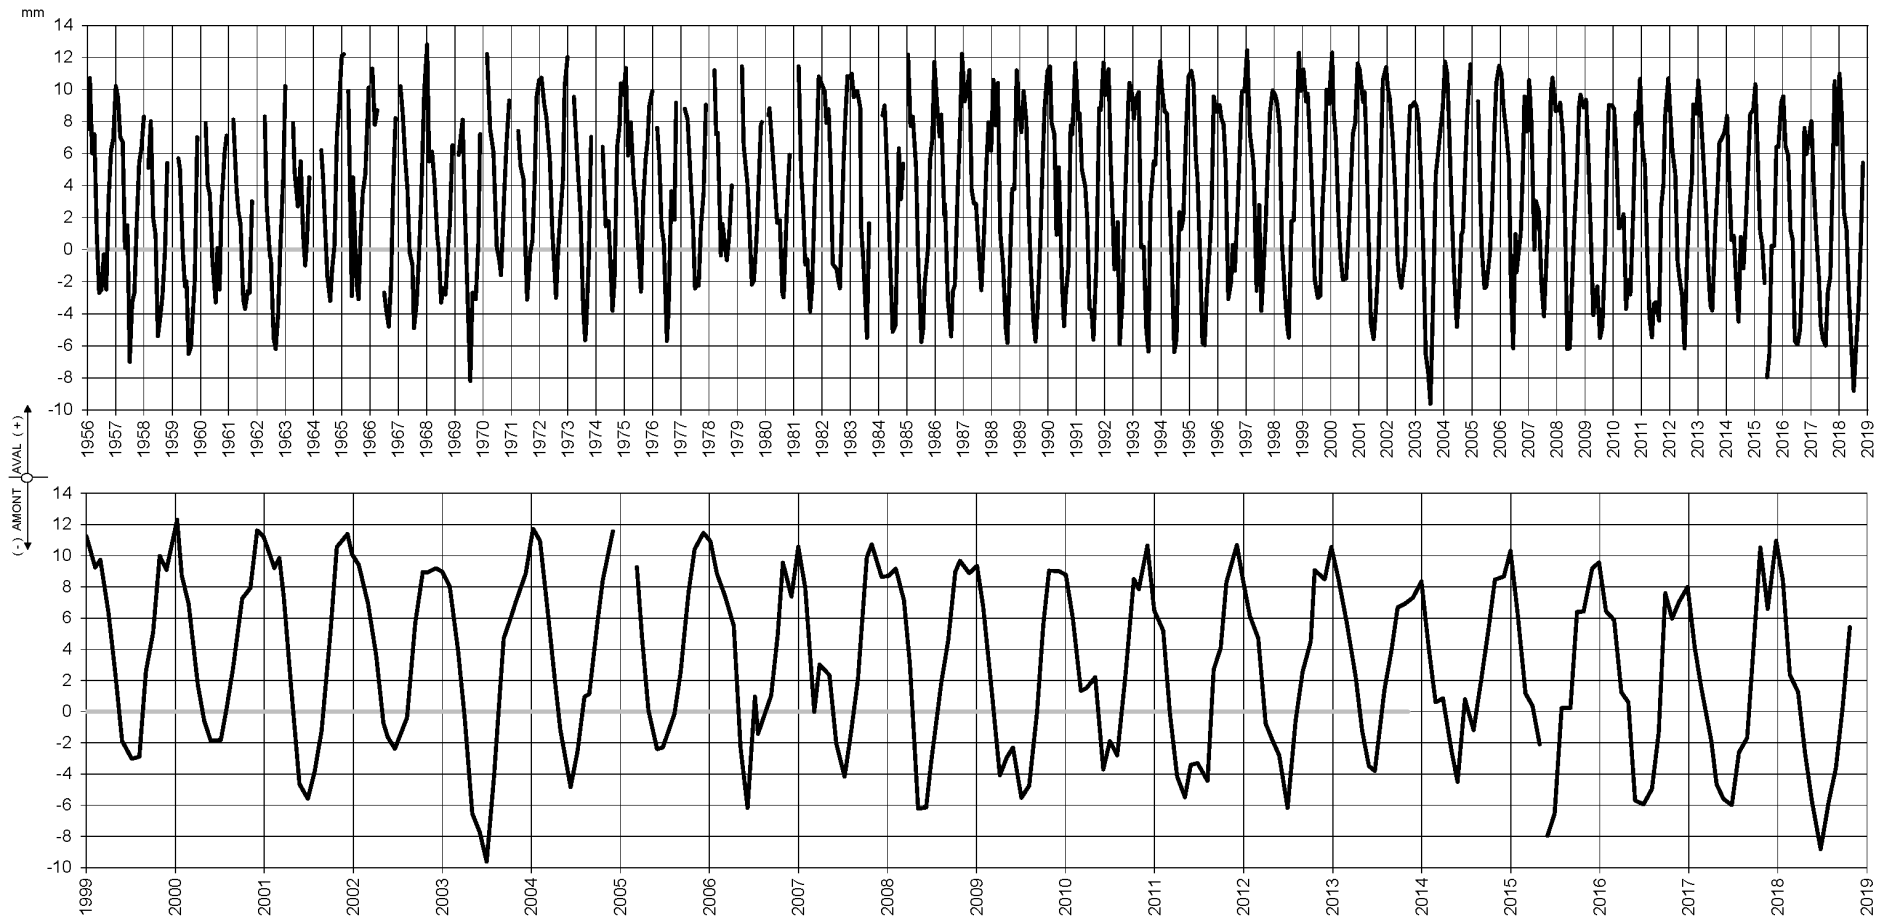
#### Poste de lecture 711

### DEPLACEMENTS MESURES AMONT - AVAL DU POINT ALTITUDE 711.00 M.S.M.

(Pendule normal de la section centrale du barrage)

Mesure d'origine : 15.01.1953 / Niveau du lac : 657.00 m.s.m.

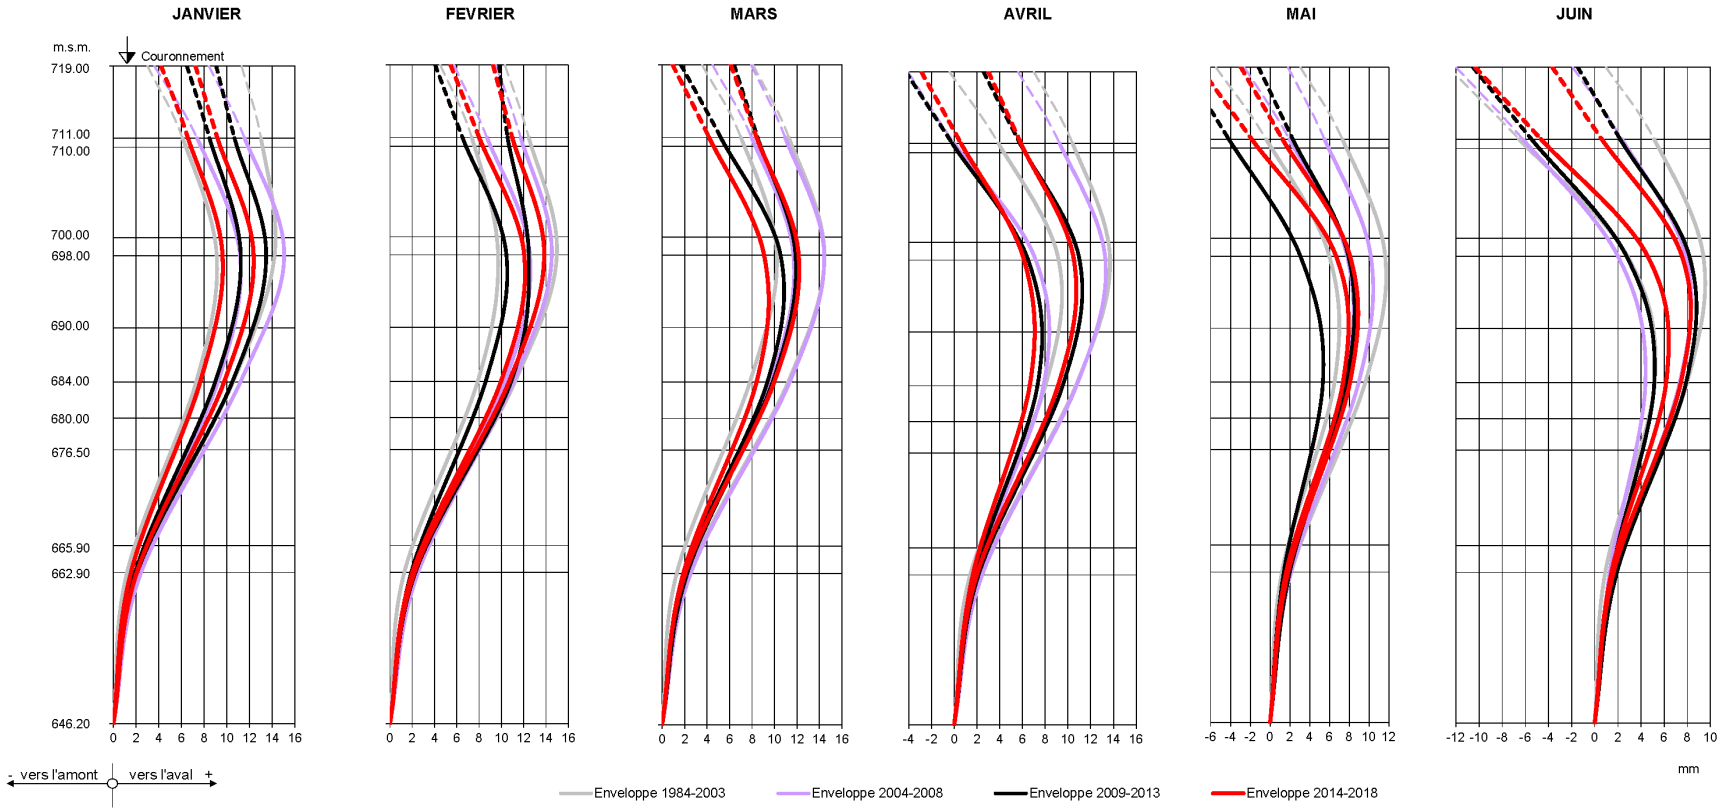
### DEFORMATIONS AMONT - AVAL MESUREES AU MOYEN DES PENDULES (Section centrale du barrage)

Mesure d'origine : 15.01.1953 / Niveau du lac : 657.00 m.s.m.

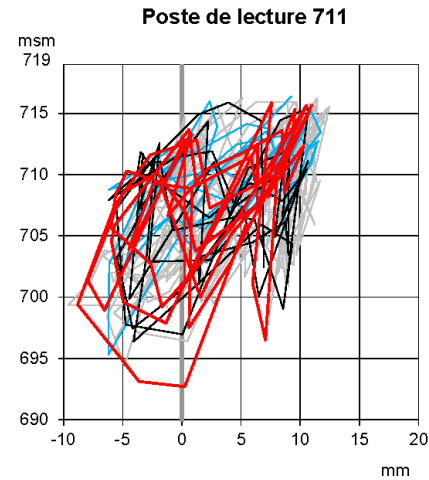
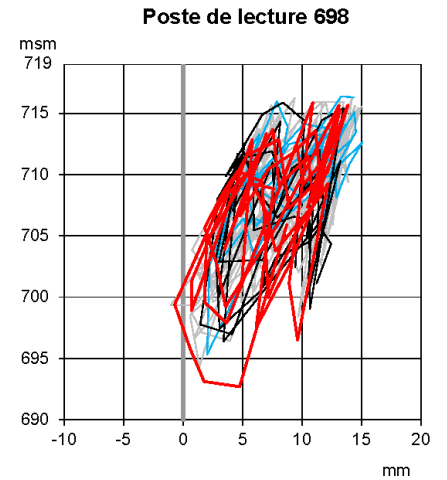
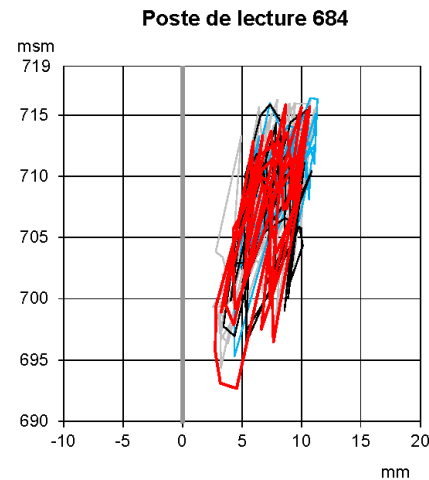
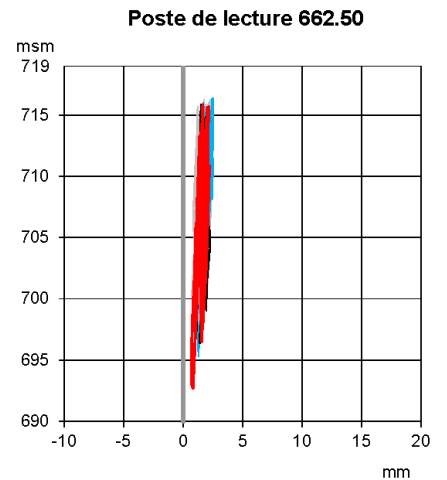
### DEPLACEMENTS AMONT - AVAL MESURES AUX POSTES DE LECTURE DES PENDULES EN FONCTION DU NIVEAU DU LAC (Section centrale du barrage)

Mesure d'origine : 15.01.1953 / Niveau du lac : 657.00 m.s.m.

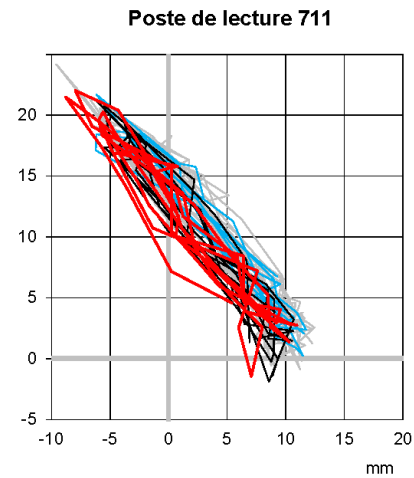
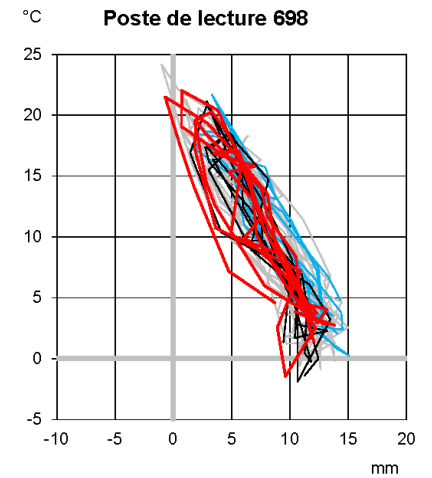
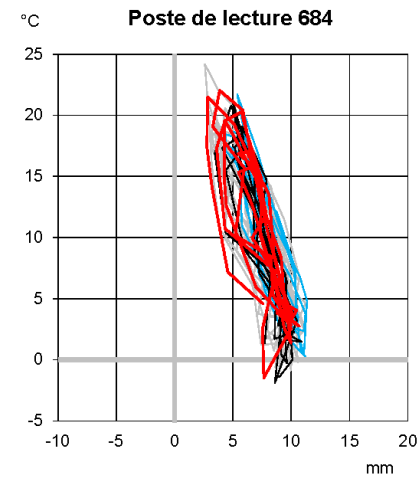
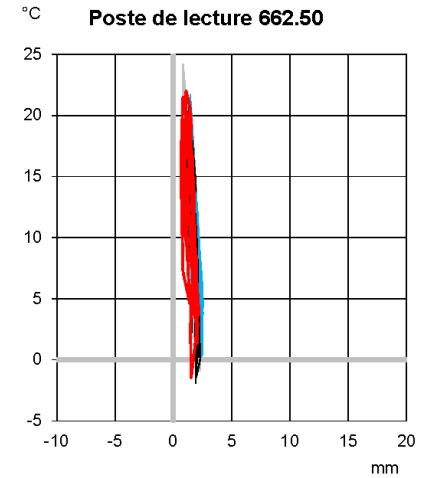
DEPLACEMENTS AMONT - AVAL MESURES AUX POSTES DE LECTURE DES PENDULES  
EN FONCTION DE LA TEMPERATURE DU BETON AU NIVEAU 711.00 M.S.M.  
(Section centrale du barrage)

Mesure d'origine : 15.01.1953 / Niveau du lac : 657.00 m.s.m.

- vers l'amont    0    vers l'aval +
