## Surveillance and monitoring

# Dam Engineering

## Dam Safety and Surveillance

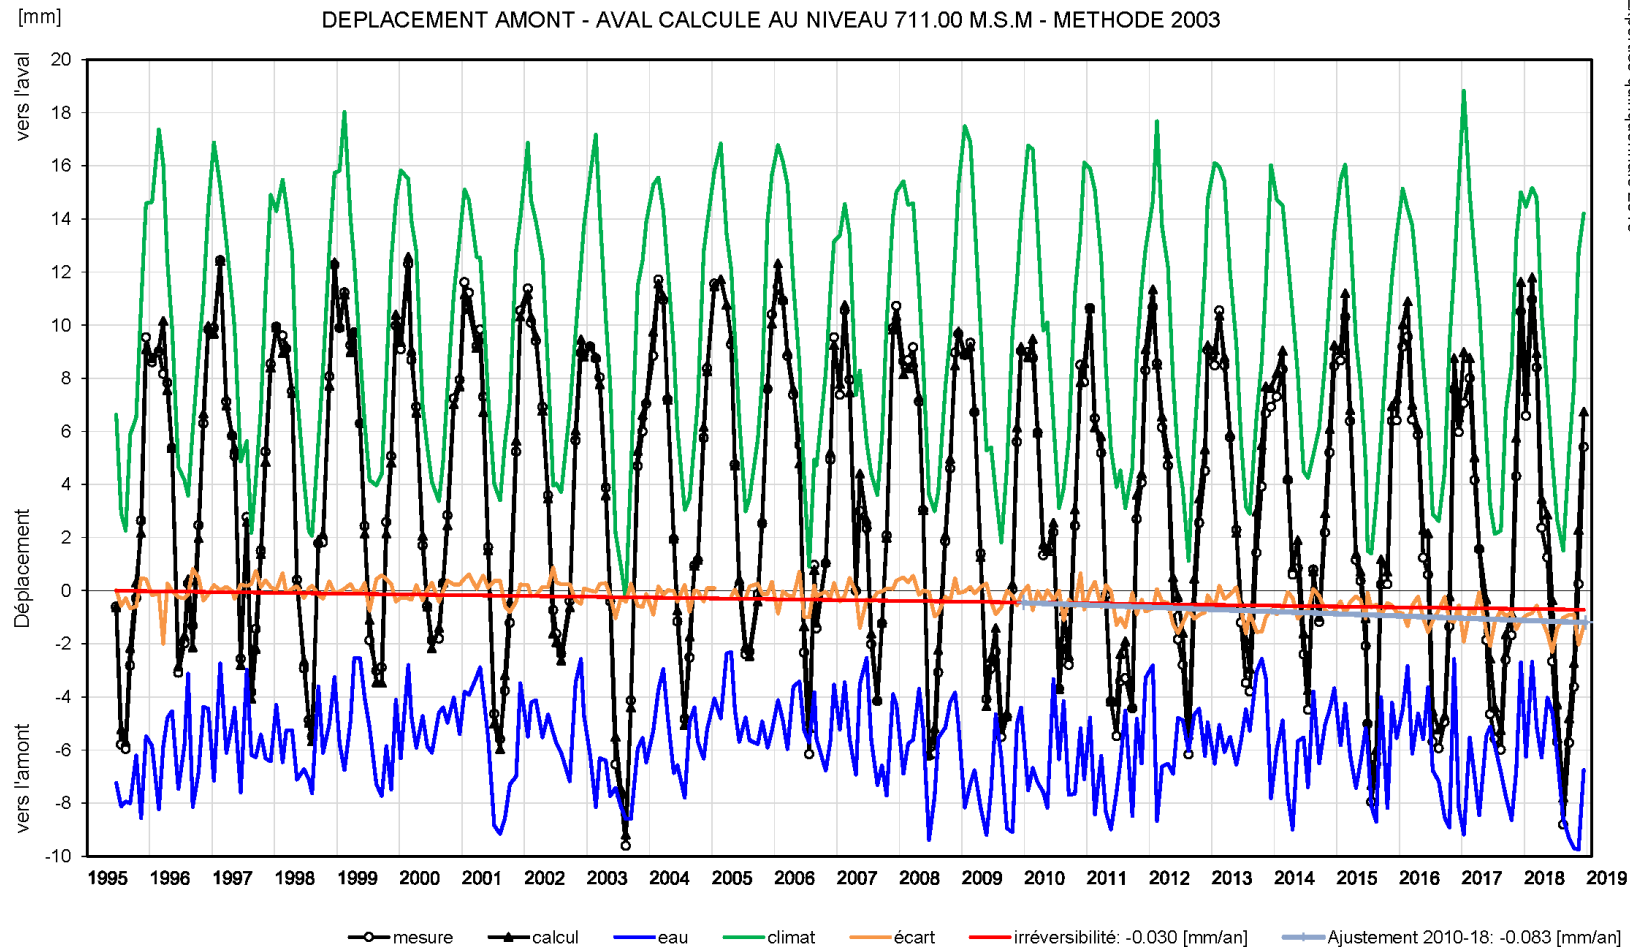
CH09/R01  
Annexe 10.1

| | Période de calage<br>1995 - 2003 | Période de contrôle<br>2004 - 2008 | Période de contrôle<br>2009 - 2013 | Période d'analyse<br>2014 - 2018 |
| Coefficient de détermination: | 0.994 | 0.994 | 0.989 | 0.991 |
| Ecart-type [mm]: | 0.418 | 0.429 | 0.548 | 0.509 |

Barrage du Châtelot  
Expertise quinquennale 2018

Le déplacement calculé  $d_i$  résulte de la superposition des déformations dues à quatre cas de charge :

$$d_i \equiv I_i + W_i + C_i + T_i$$

$I_i$  : Effet des déformations irréversibles (fluage, plasticité, endommagement, etc.)

$W_i$  : Effet du niveau du lac

$C_i$  : Effet du climat (ou période saisonnière)

$T_i$  : Effet de l'état thermique du barrage

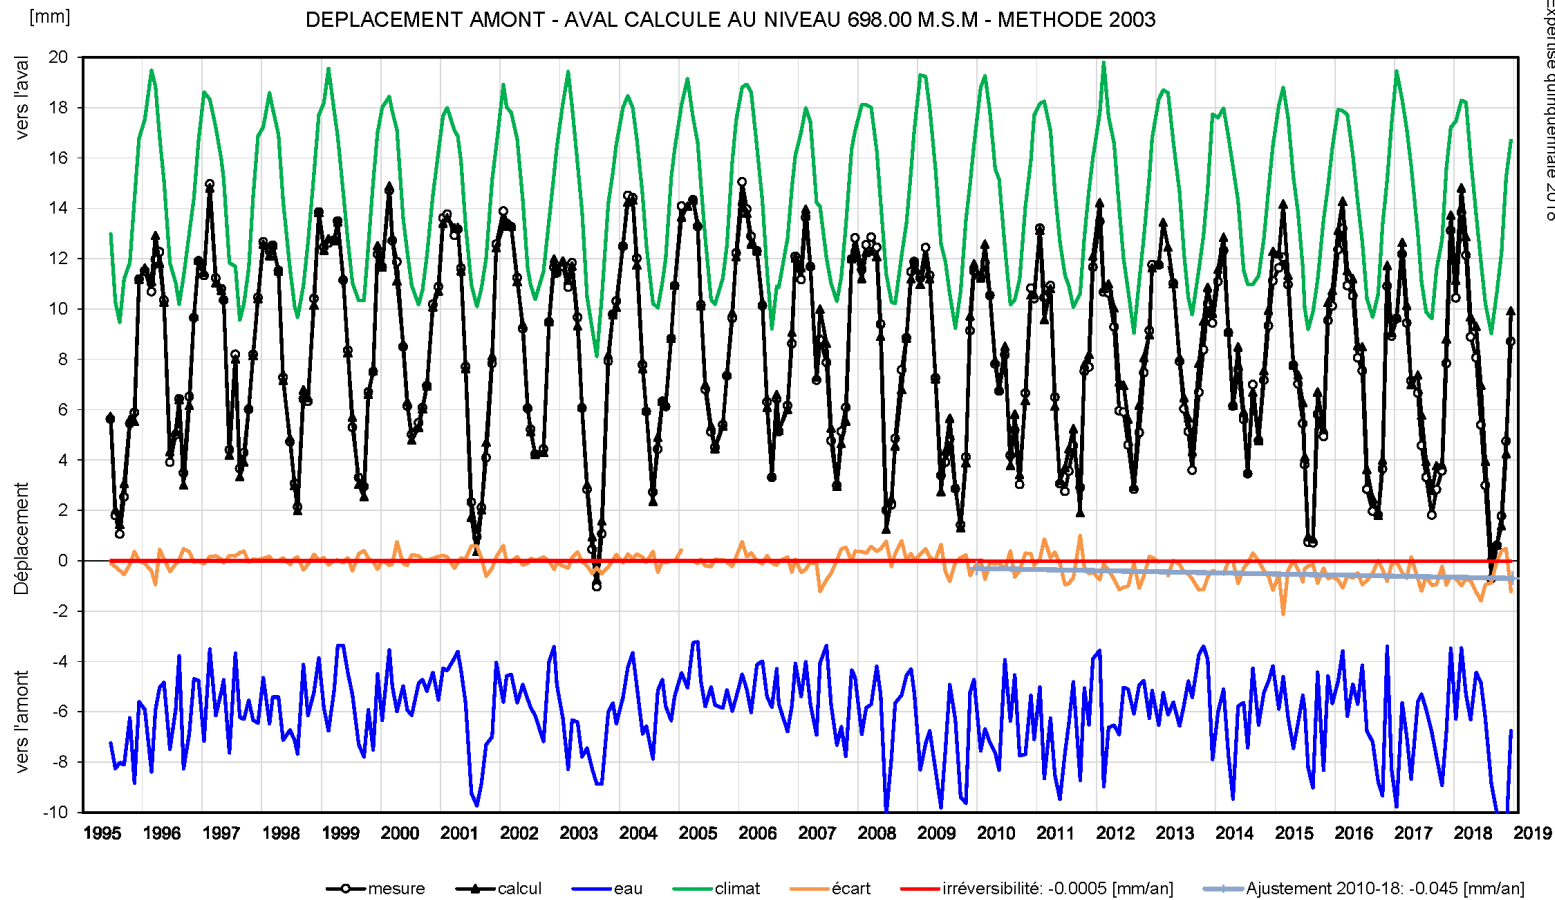
CH09/R01  
Annexe 10.2

Barrage du Châtelet  
Expertise quinquennale 2018

| | Période de calage<br>1995 - 2003 | Période de contrôle<br>2004 - 2008 | Période de contrôle<br>2009 - 2013 | Période d'analyse<br>2014 - 2018 |
| Coefficient de détermination: | 0.995 | 0.991 | 0.977 | 0.987 |
| Ecart-type [mm]: | 0.273 | 0.358 | 0.508 | 0.478 |

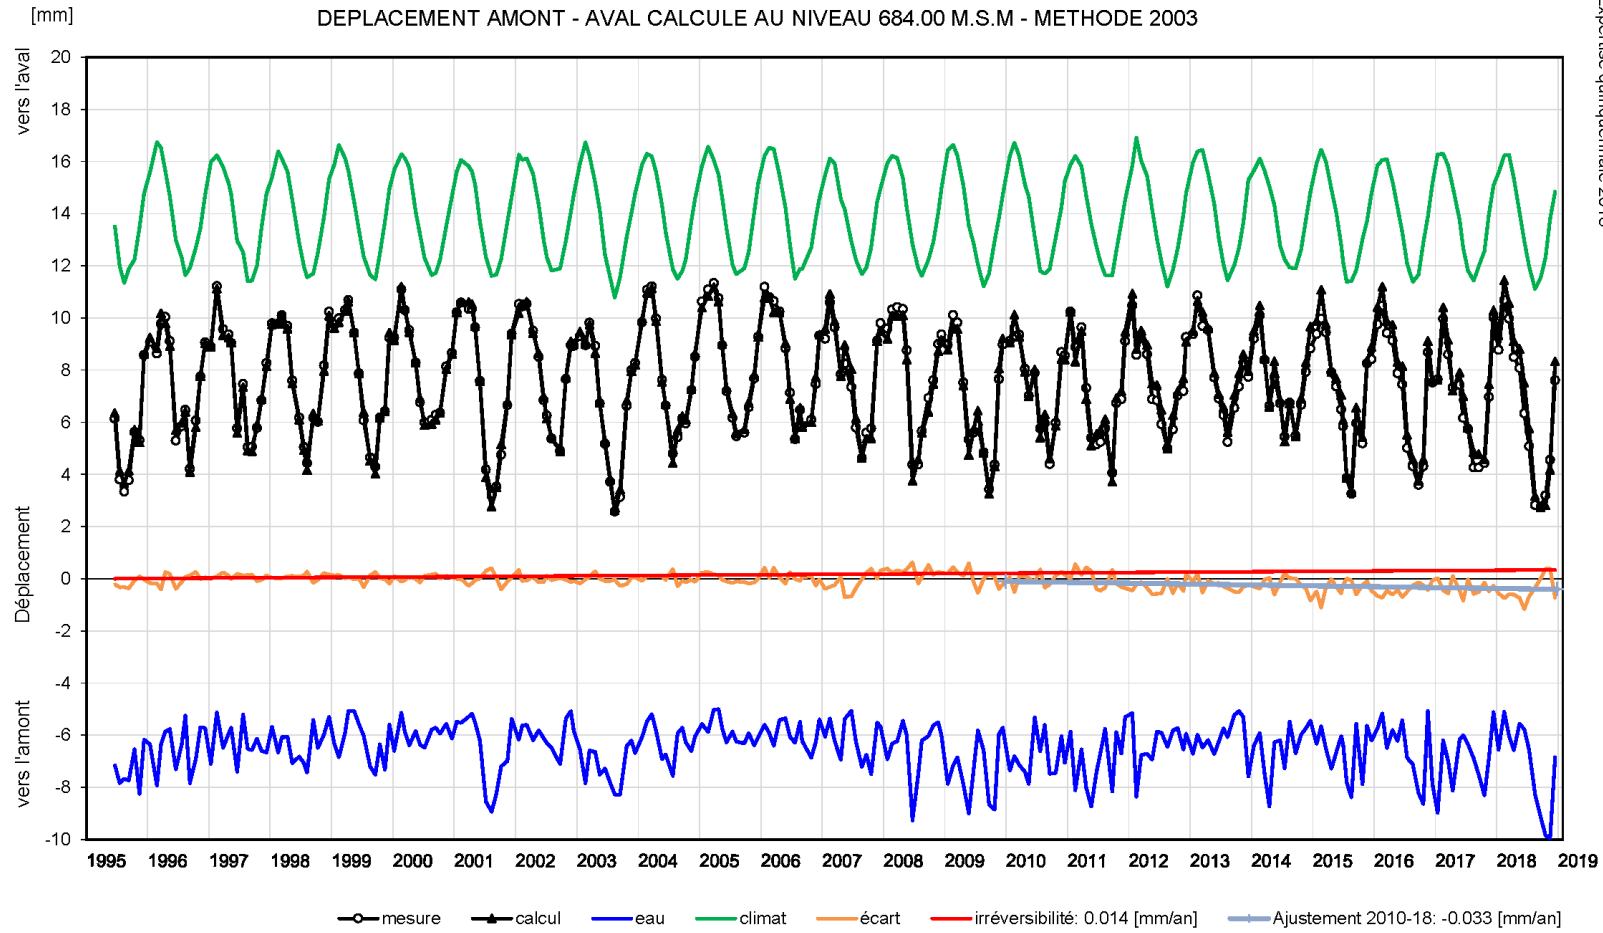
| | Période de calage<br>1995 - 2003 | Période de contrôle<br>2004 - 2008 | Période de contrôle<br>2009 - 2013 | Période d'analyse<br>2014 - 2018 |
| Coefficient de détermination: | 0,995 | 0,984 | 0,971 | 0,984 |
| Ecart-type [mm]: | 0,167 | 0,264 | 0,317 | 0,328 |

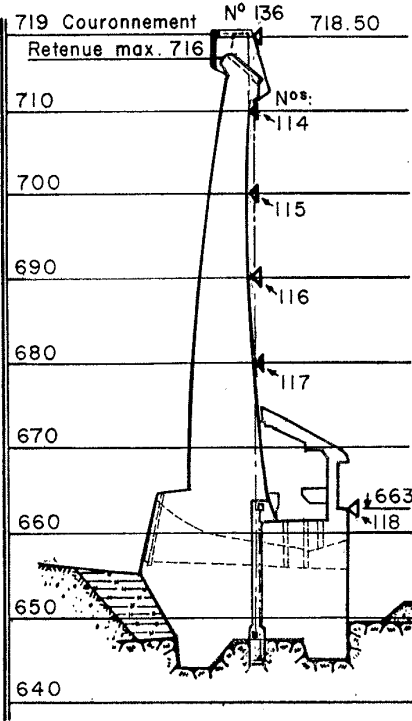
Coupe transversale A-A

1 : 500

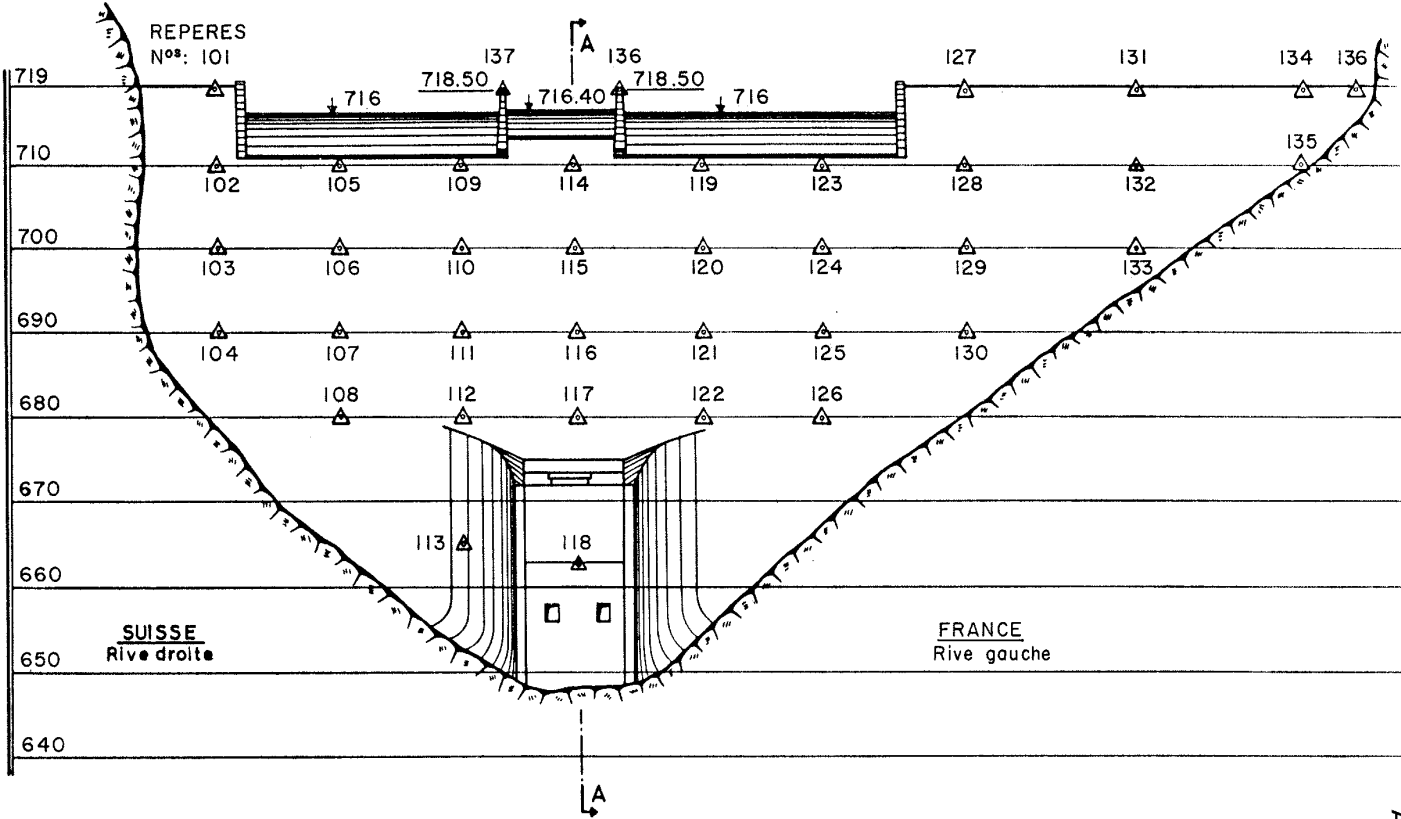
Disposition des repères scellés sur le parement aval

1 : 500

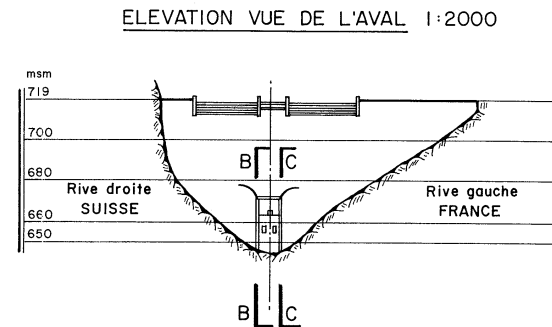
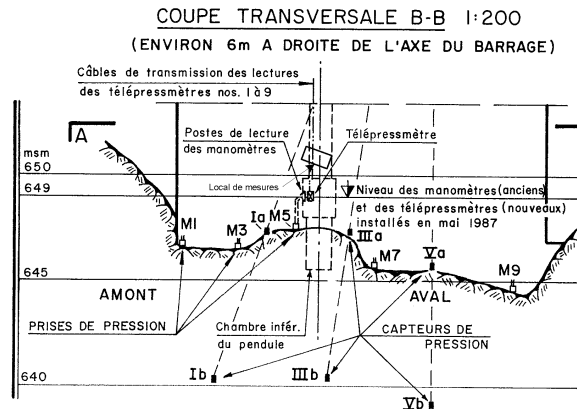
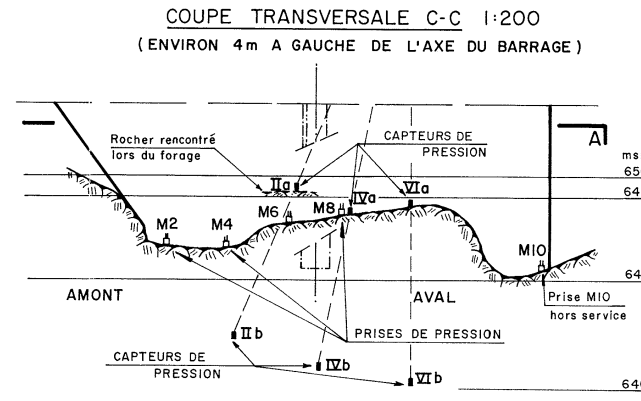
DISPOSITION DES PRISES M1 à M9  
ET DES CAPTEURS DE PRESSION 1a à VIb

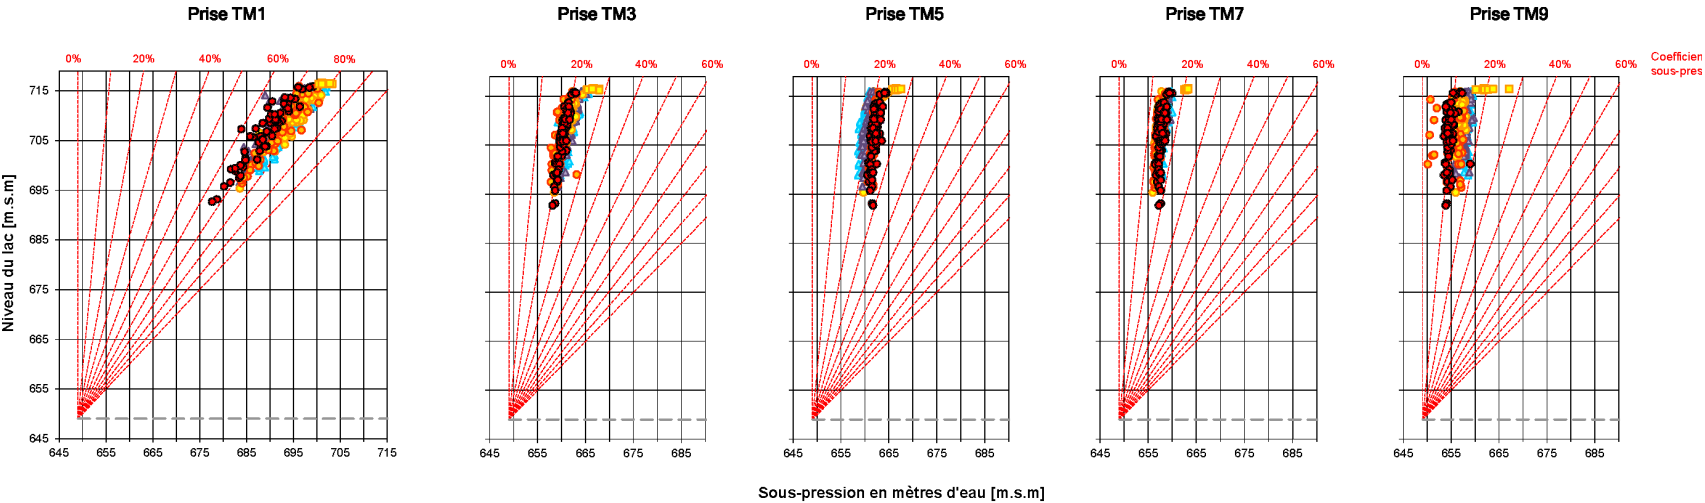
RIVE DROITE : PRISES TM1, TM3, TM5, TM7 et TM9

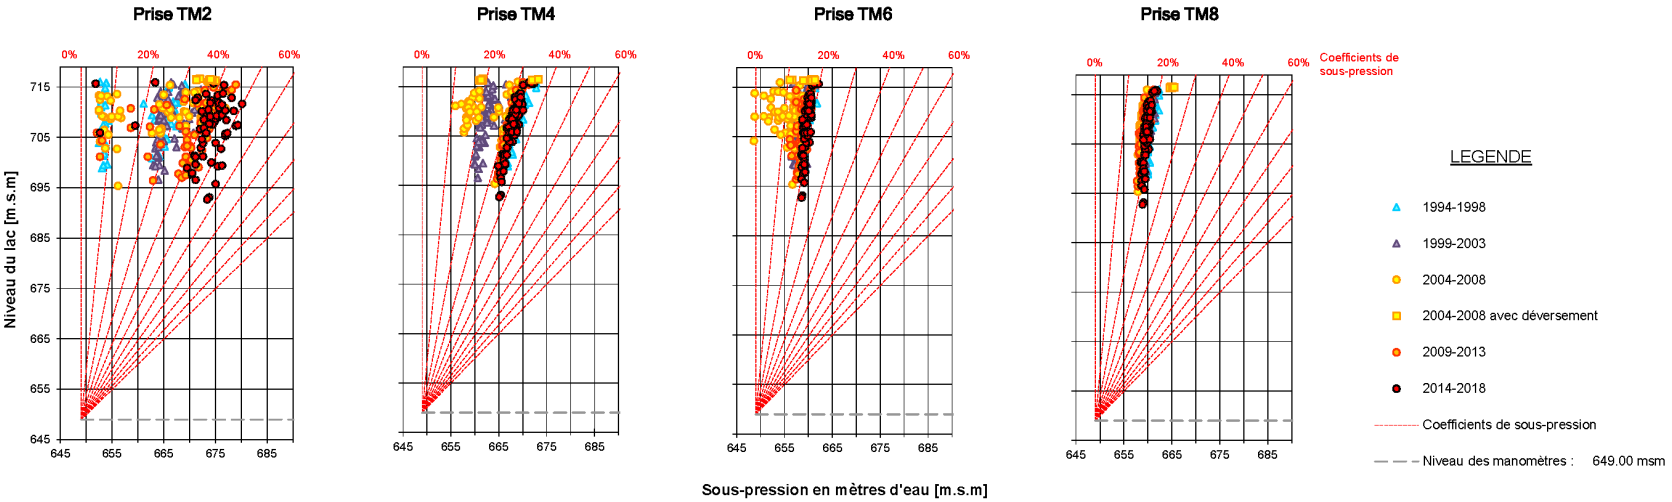
RIVE GAUCHE : PRISES TM2, TM4, TM6 et TM8

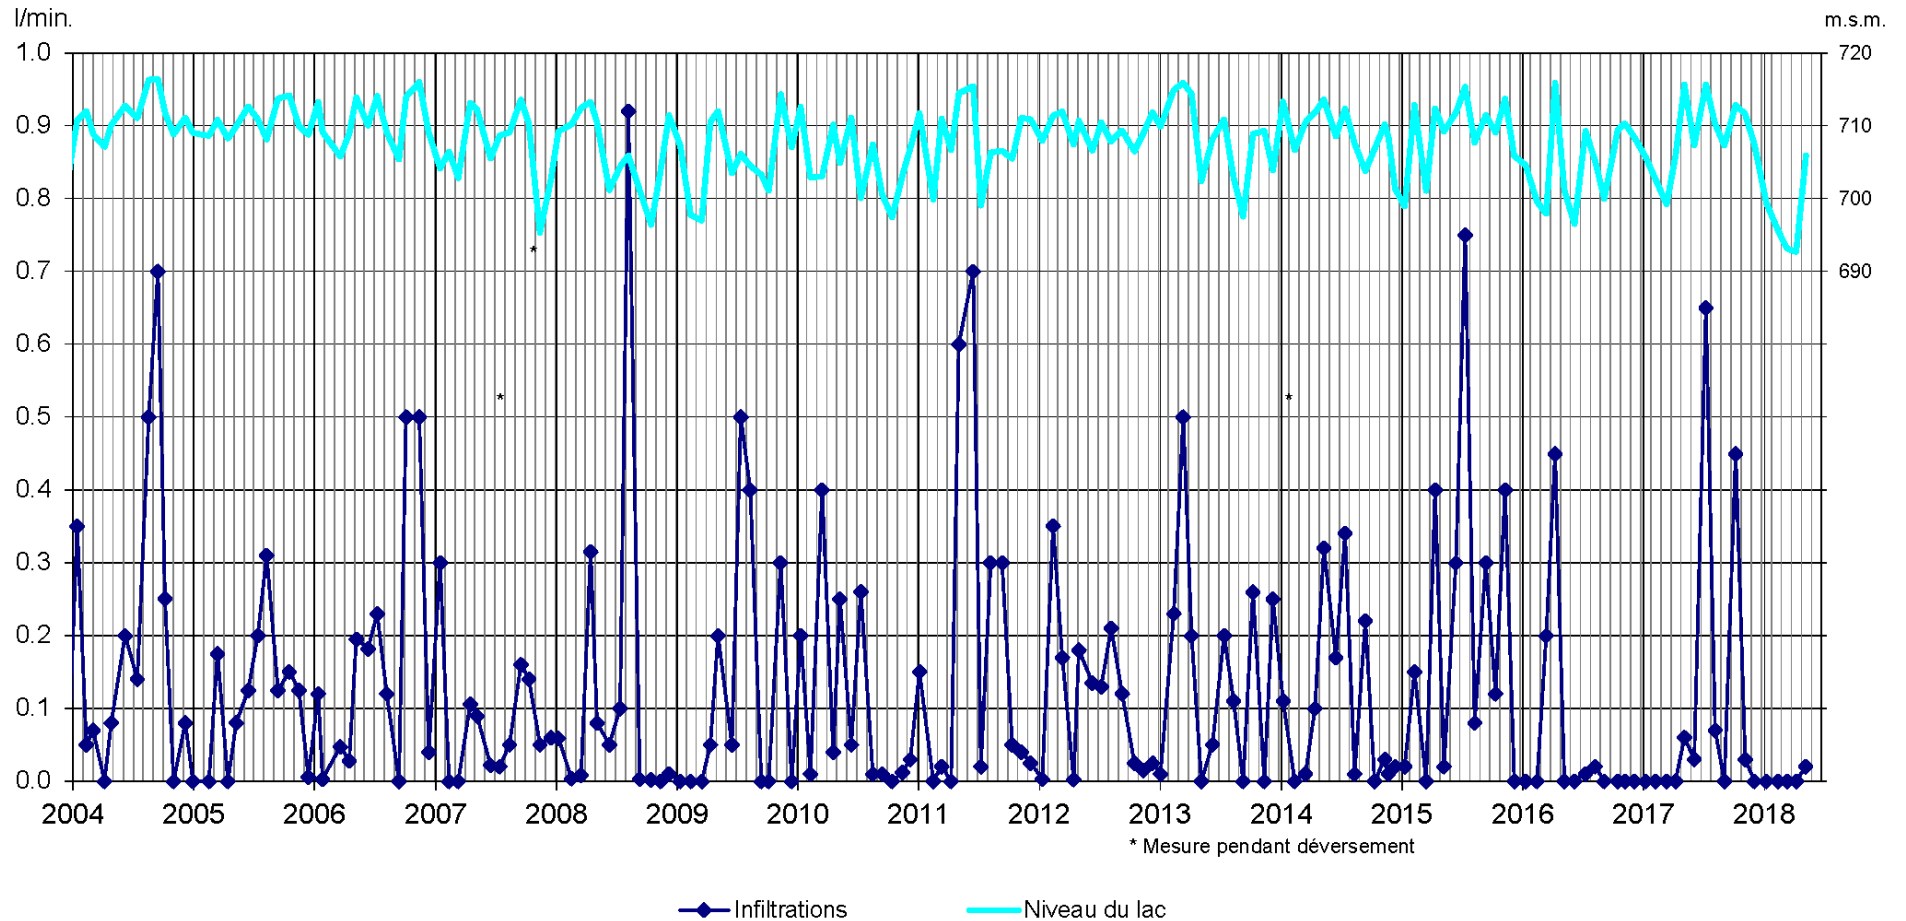
### Débits maximaux d'infiltrations dans la culée, rive gauche

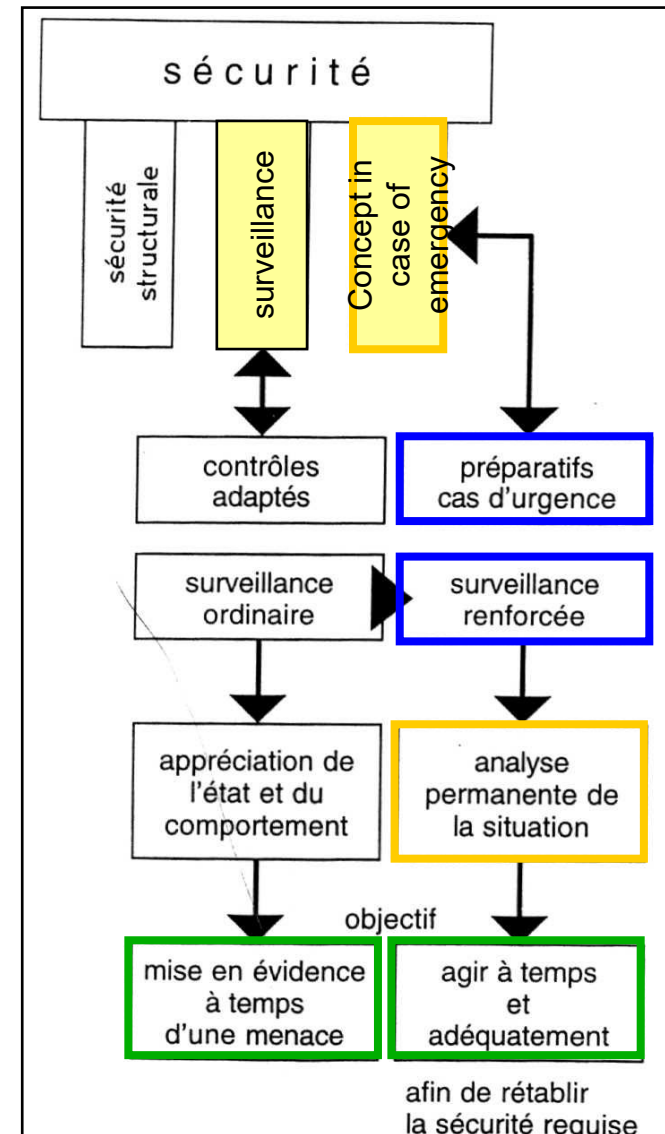
## Correspondence between ordinary surveillance and enhanced surveillance

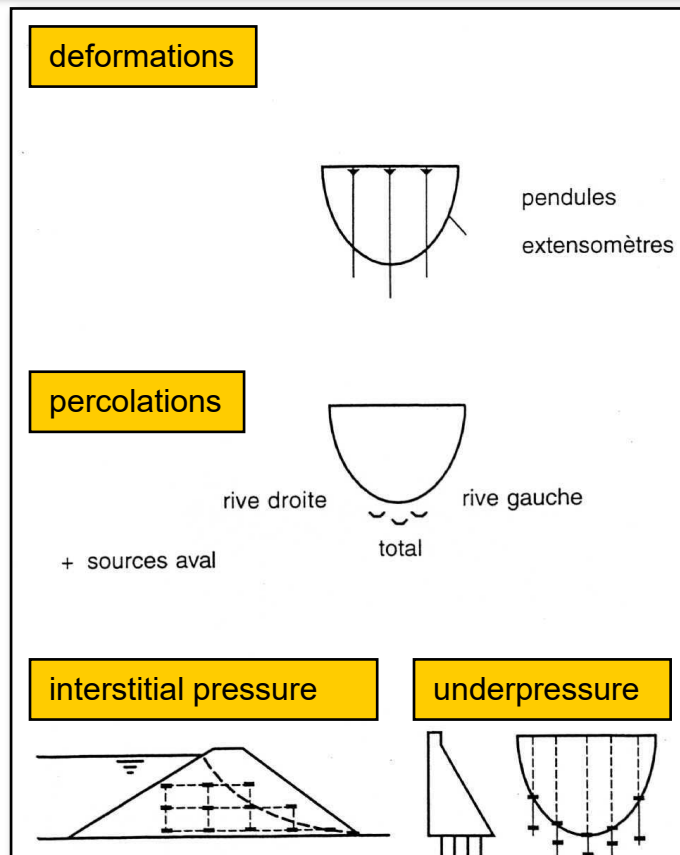
### Ordinary surveillance

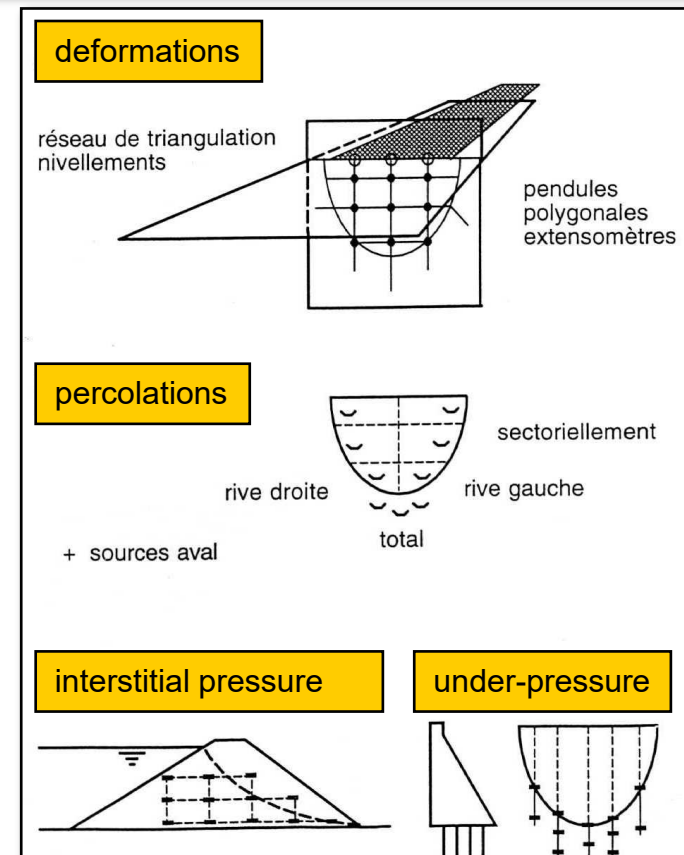
### Enhanced surveillance

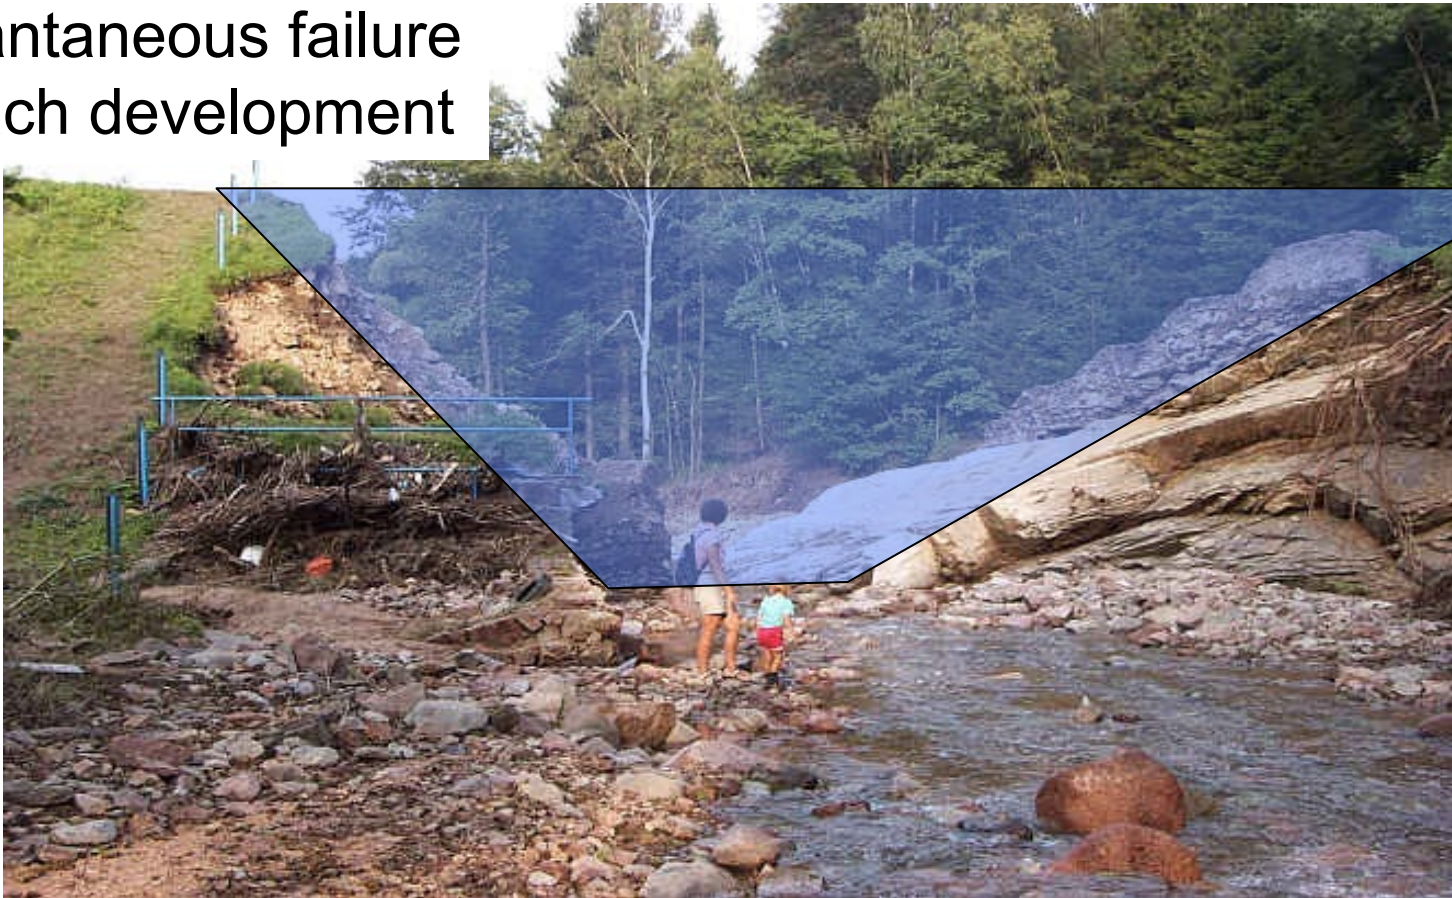
## Flood maps – Failure mode

- Instantaneous failure
- Breach development

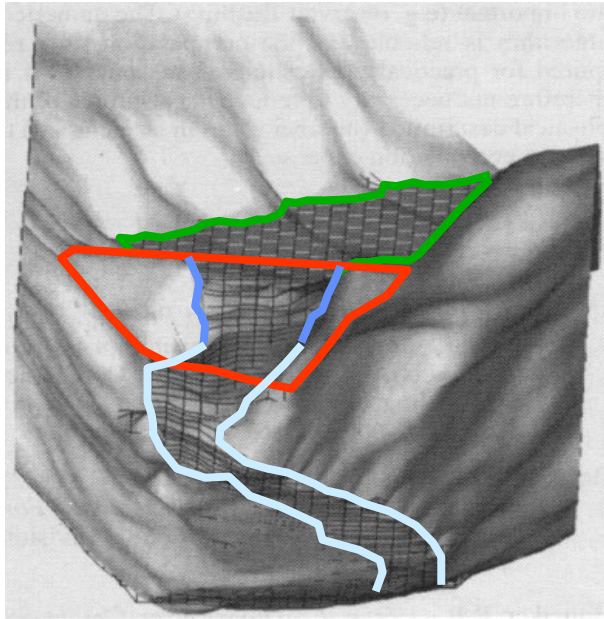
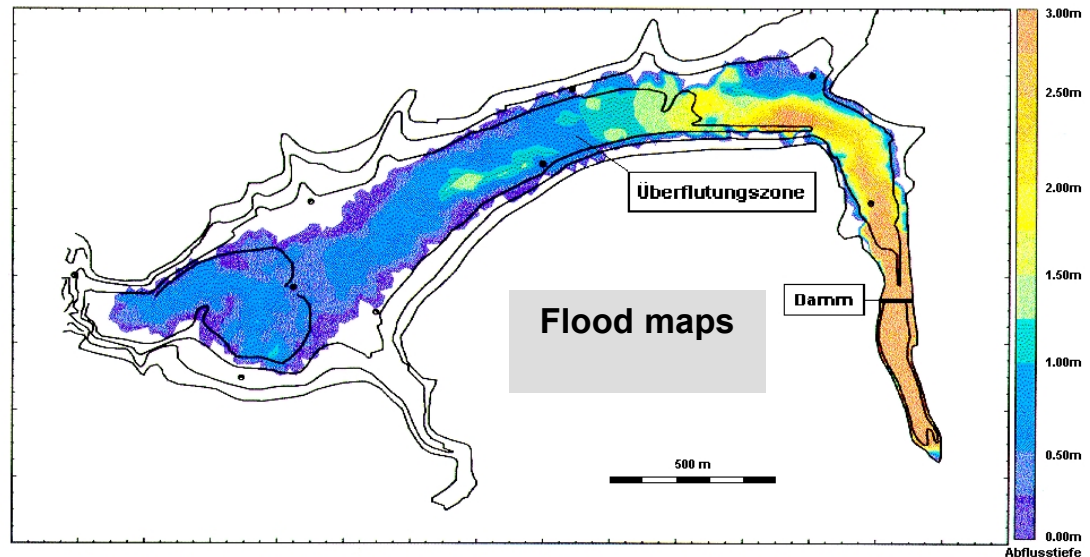
## Flood maps - analysis of the rupture wave

- Water depth and velocity
- Arrival time
