Alkali-Silica Reaction in concrete structures actual knowledge

Cour Master EPFL
L. SOFIA

December 2, 2025

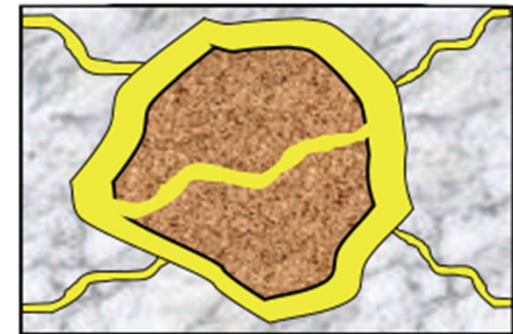
Gel Expansion (hydration)

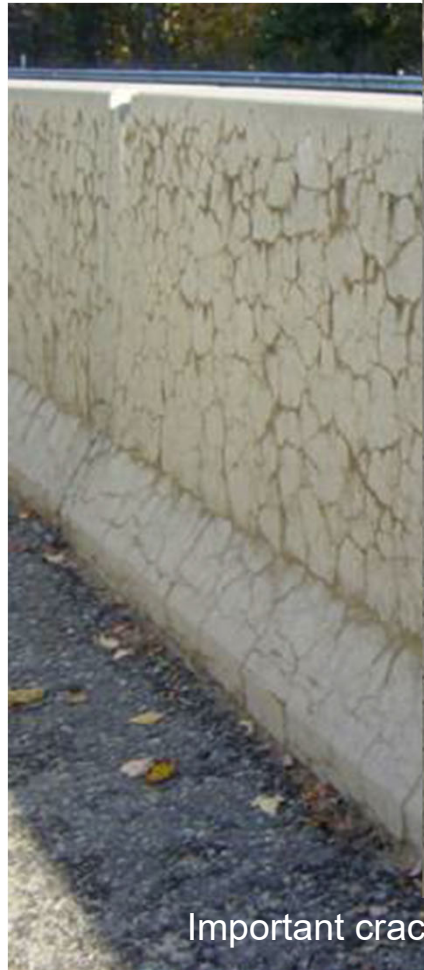
Important cracking on highway barrier wall

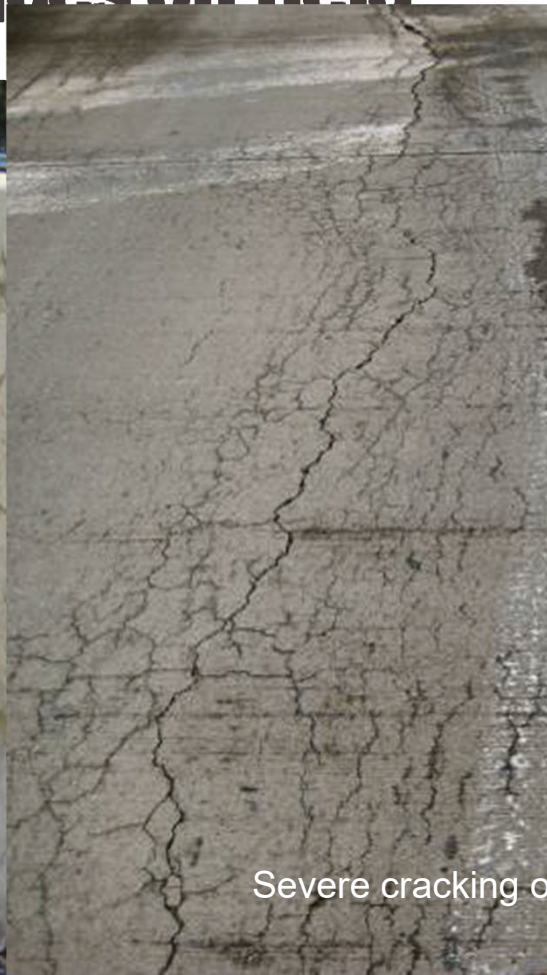
Severe cracking of a concrete pavement

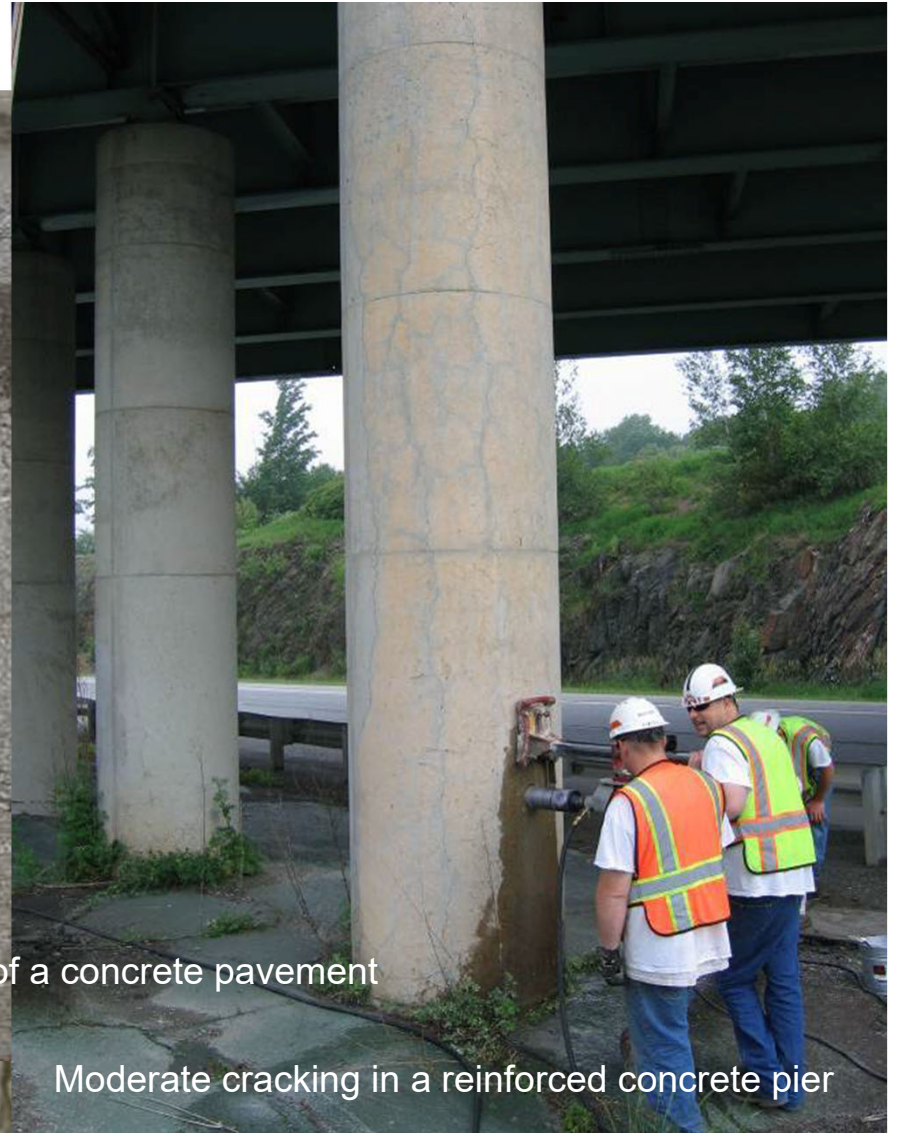
Moderate cracking in a reinforced concrete pier

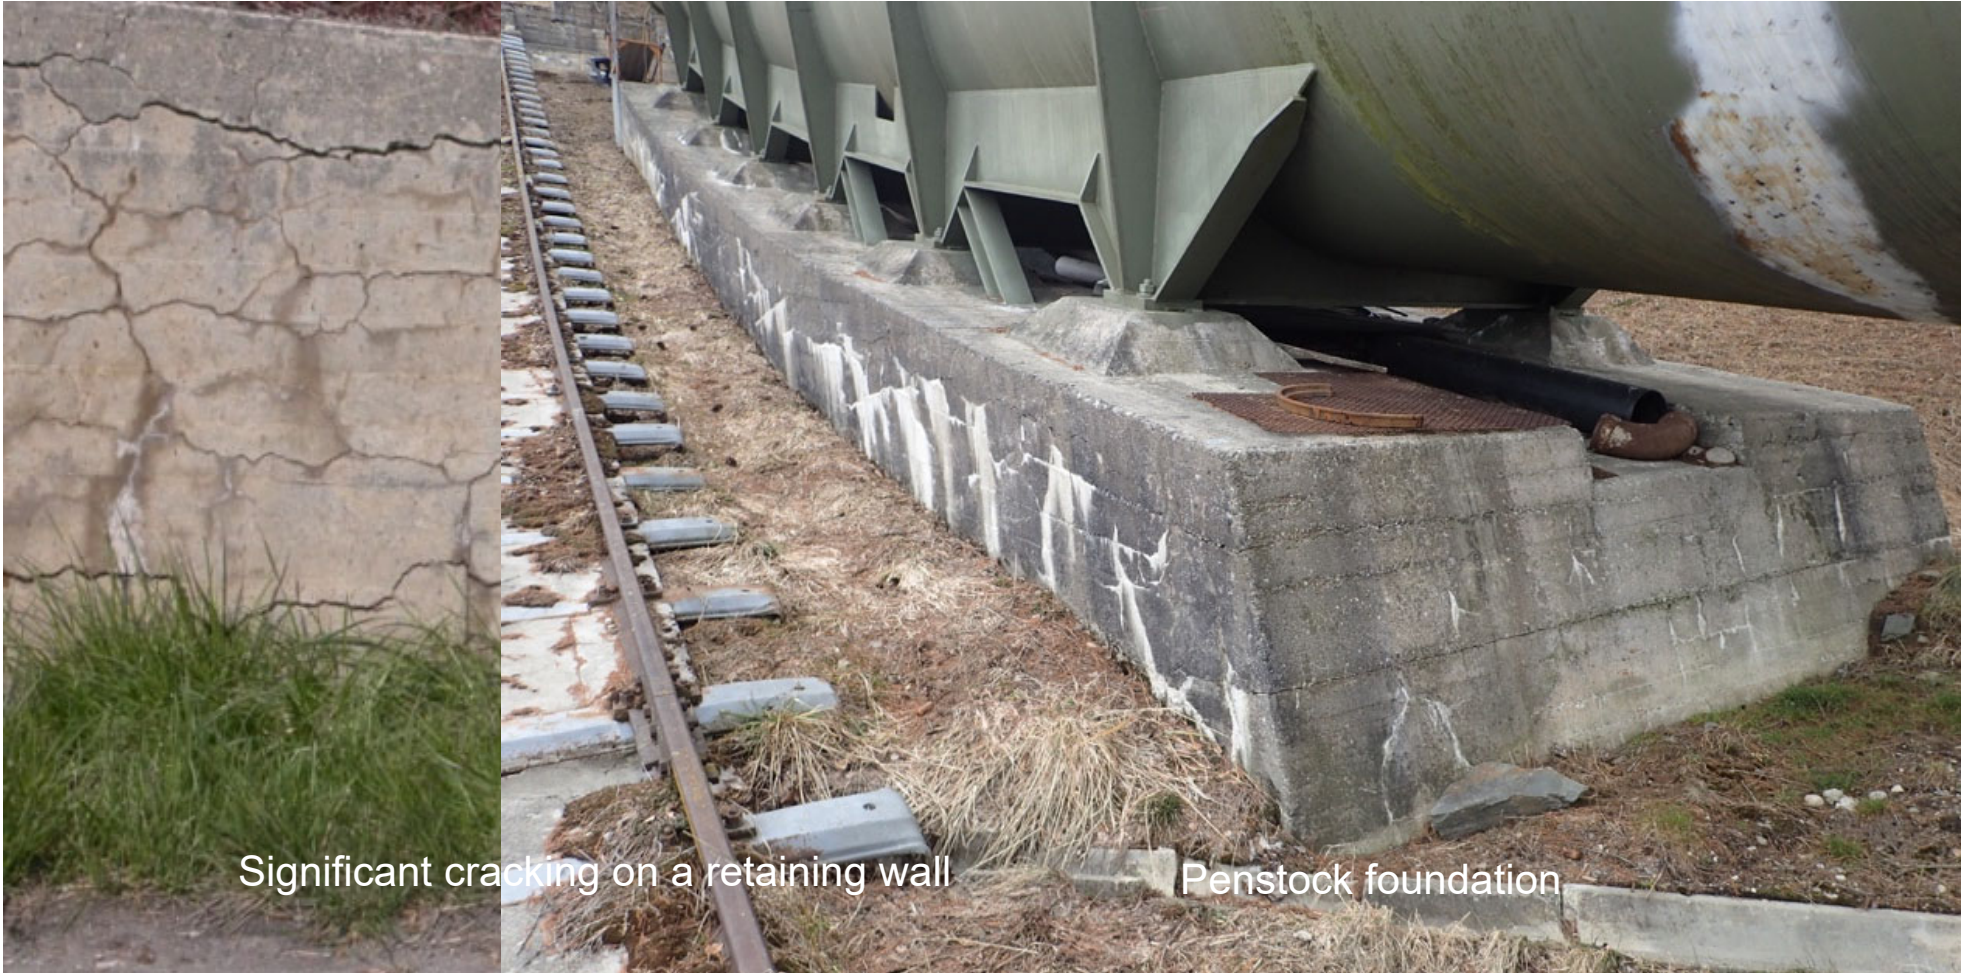
Significant cracking on a retaining wall

Penstock foundation

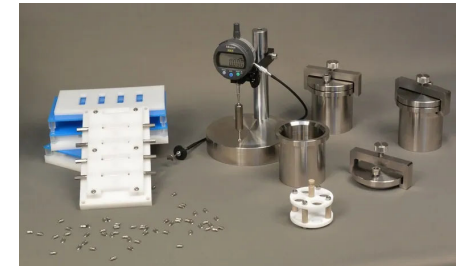
- Casting, unmolde after 24 h and measurement of length
- Steam curing 240 min
- Keep the sample at 20 °C until its temperature reaches 20 °C (approximately 4 to 24 hours)
- Store in a 10% KOH solution in a stainless steel container for 360 minutes at 150°C.
- Store the samples for 1 hour before measuring their length.

- "NR" (Non-Reactive) when the average of the swelling of 3 samples is below 0.11%,
- "PR" (Potentially Peactive) when at least one average value (usually that corresponding to the C/G ratio = 2) is higher than 0.11%.
- "PRP" (Potentially Reactive with Pessim effect) when the average value corresponding to the C/G ratio = 5 is more than 10% > the C/G ratio = 2.

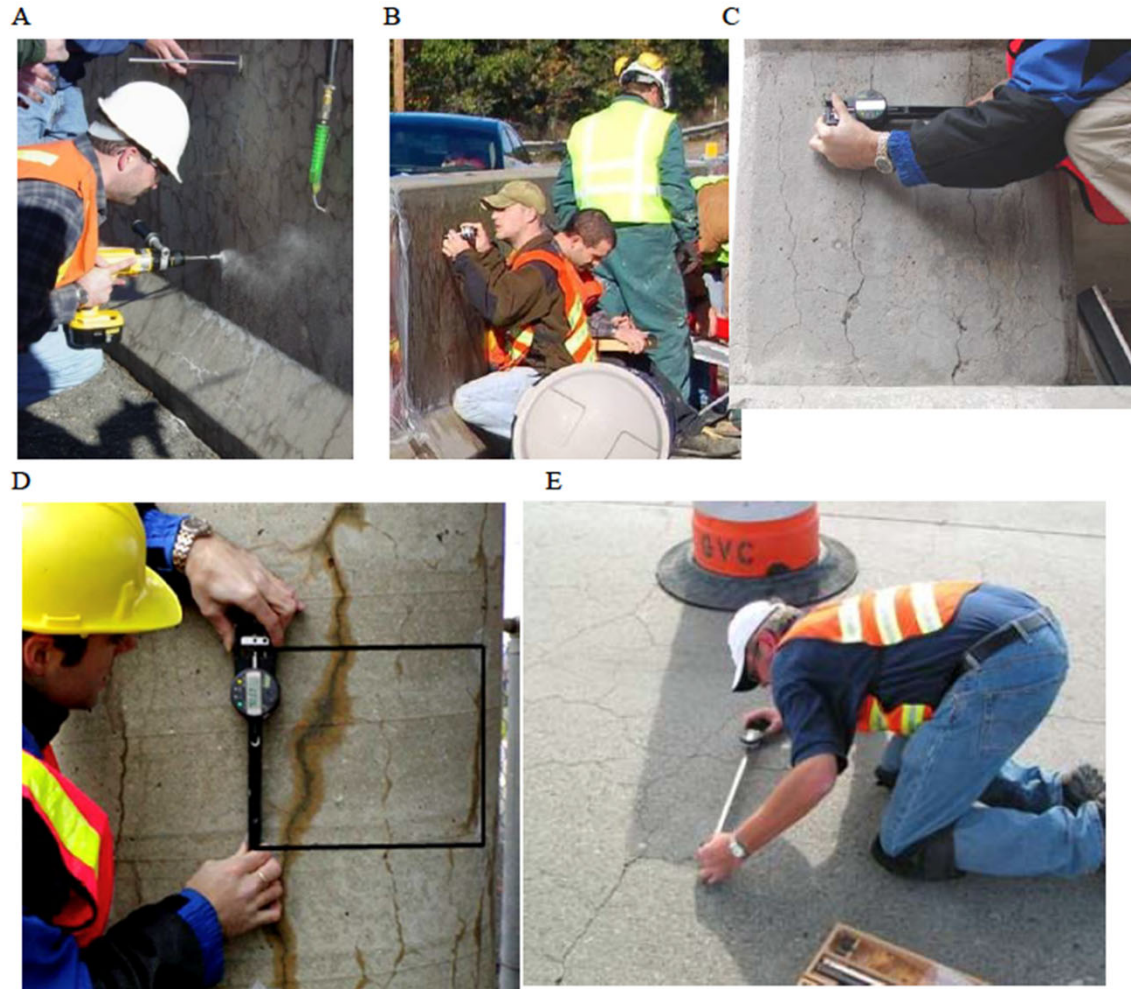
■ In-situ measurements of expansion and deformation in ASR-affected concrete elements. A-E.

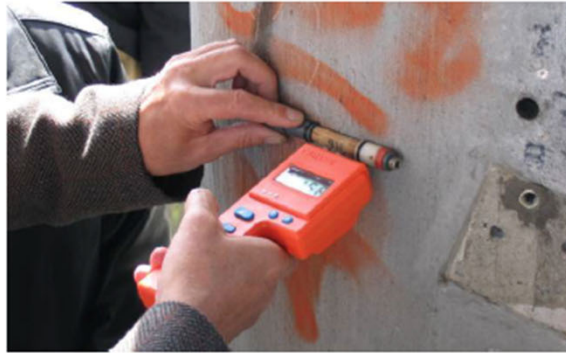
A

A. Wooden-stick method. B-C. Portable humidity probes. D. Automatic in-situ monitoring of temperature, humidity and expansion (vibrating wire) in a bridge deck affected by ASR (Siemes and Gulikers 2000).

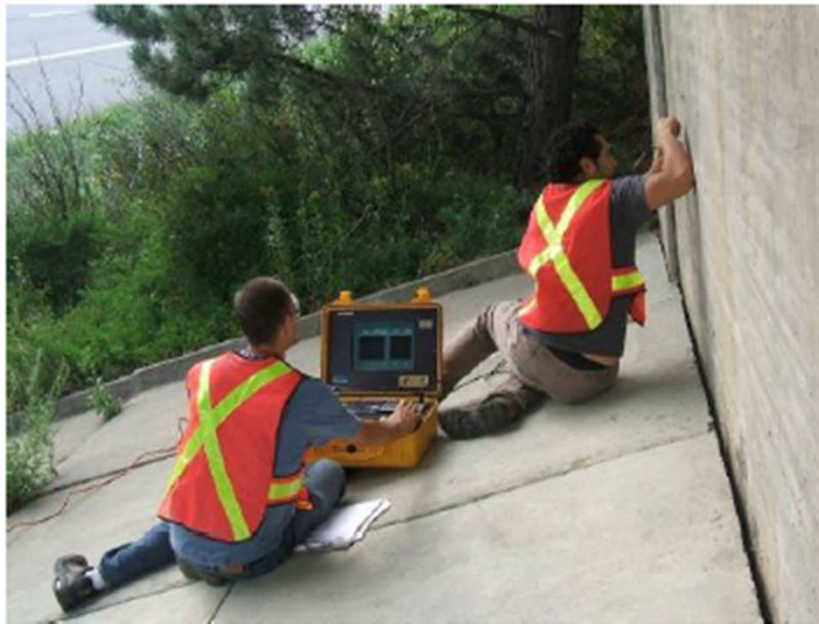
A

A. Impact-echo B. Non-Linear acoustic technique

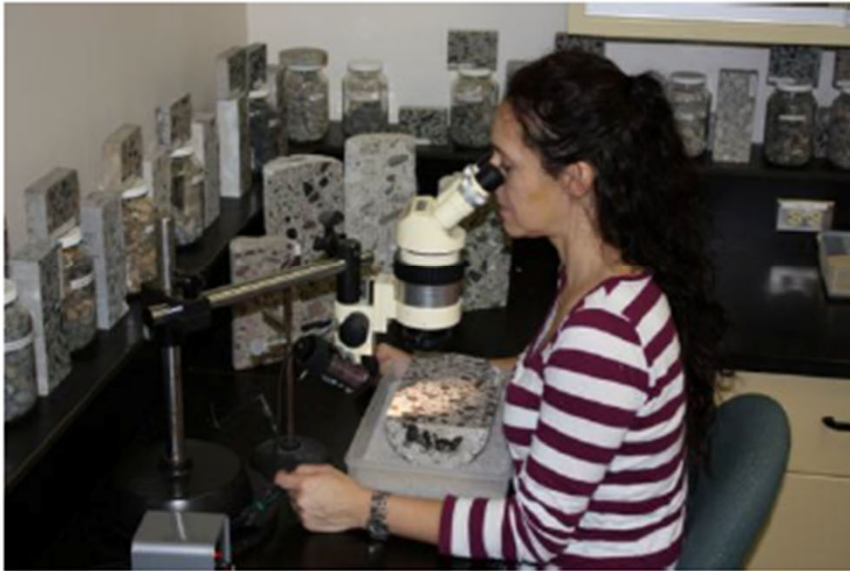
Examination of the polished concrete section under the stereomicroscope for the determination of the **Damage Rating Index**. Petrographic features of deterioration are counted in a **one cm x one cm grid system** drawn at the surface of the polished concrete section.

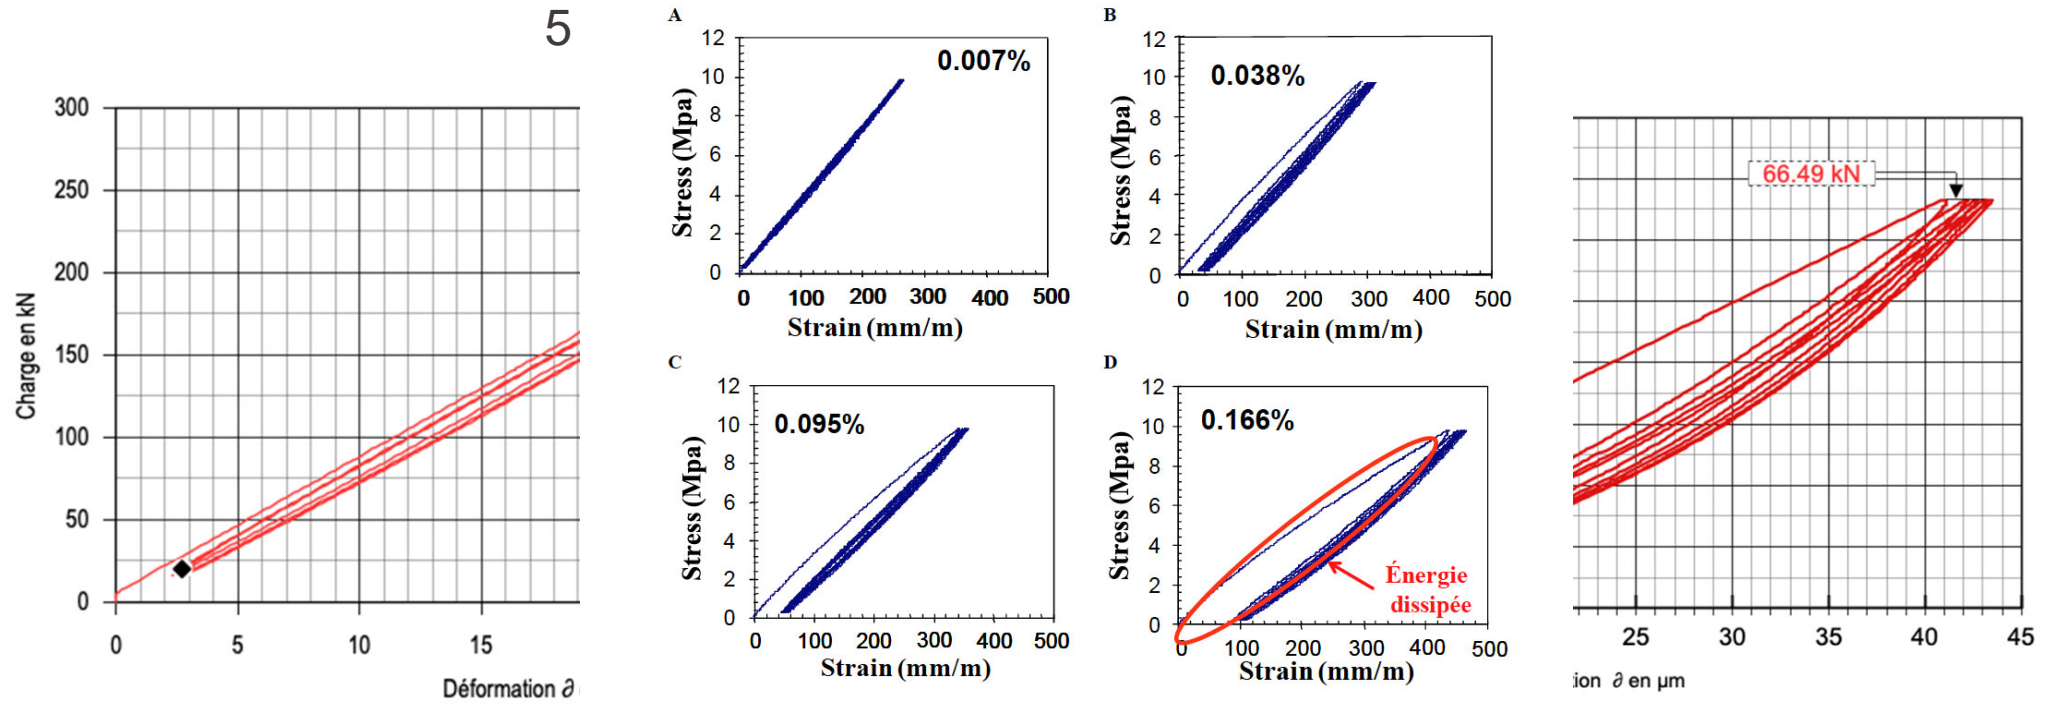
Mechanical tests in laboratory SDT (Stiffness Damage Test)

Figure 2.2 : Courbes typiques *contrainte-déformation* pour des échantillons de béton affectés par la RAS et soumis à 5 cycles de chargement / déchargement lors de l'essai SDT (charge de 10MPa). Les échantillons de béton avaient atteint différents niveaux d'expansion variant entre 0,007% (A) et 0,166% (B) (Smaoui et al. 2004a).

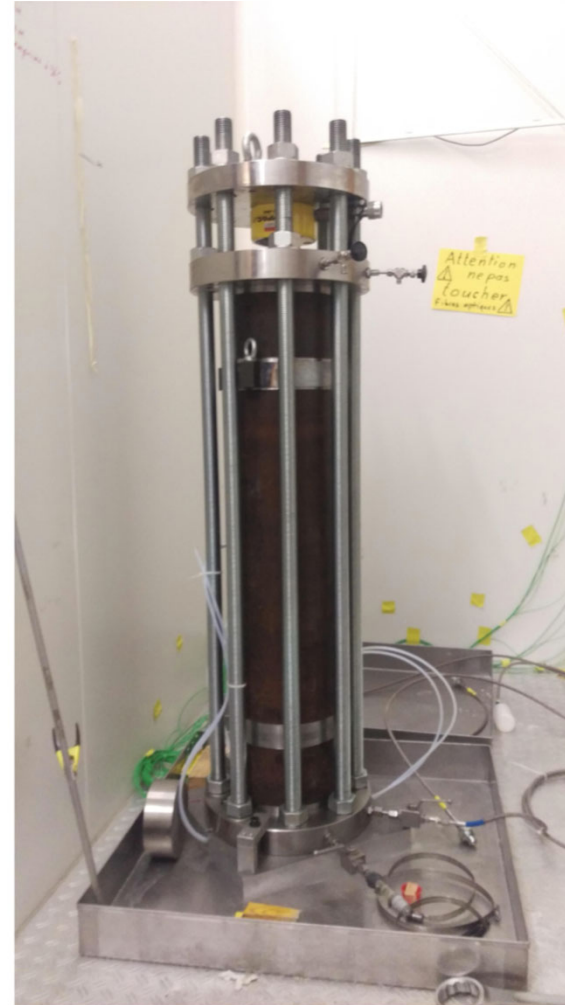
Final test in progress

- Design based on tri-axial cells used for rock mechanics
- Independent axial/lateral load
 - Axial load applied via a hydraulic jack
 - Radial load applied via a pressurised alkali solution
- Alkali solution
 - Promote the reaction
 - Avoid leaching
- Constant temperature (38°C)
