Treatment of imperfections in precast structural elements

State-of-art report
prepared by Task Group 6.8

November 2007

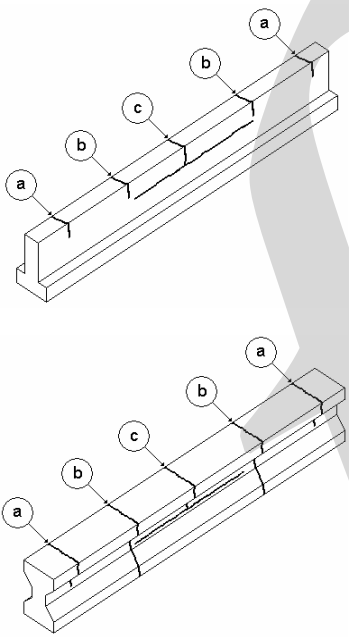
Typical case	Cause	Prevention	Effect	Repair
TRANSVERSE CRACKS AT TOP OF BEAM These cracks are typically perpendicular to the longitudinal axis of the beam and usually extend across the top of the beam and are visible on the sides. In some cases they may extend the full depth of the beam or propagate along the beam near the centroid of the beam.

A) Improper design Prestress uplift at midspan exceeds the top fibre tensile capacity. Cracks 'c' Lack of or inadequate debonding of bottom strands at end of beam. Cracks 'a' Inadequate top reinforcement. Cracks 'b, c'	Reduce midspan prestress and/or provide additional reinforcement to control cracking. Redesign beam with increased strand debonding and/or provide additional reinforcement to control cracking. Redesign beam with increased top reinforcement.	For simply supported beams the effect of cracks type 'b' and 'c' is minimal and they will tend to close with application of load. Crack type 'a' can affect the shear capacity, particularly if the crack occurs in a negative bending moment zone. (this could occur if the beam is incorporated into a continuous structure) In this case the capacity of the beam should be reassessed taking into account the actual crack locations and sizes.	Minor cracks may not need repair unless the beam will be exposed to a corrosive environment. In this case pressure injection with epoxy should be considered. If the cracking results in a structural deficiency the options are to pressure inject with epoxy or in cases of severe cracking to reject the beam.

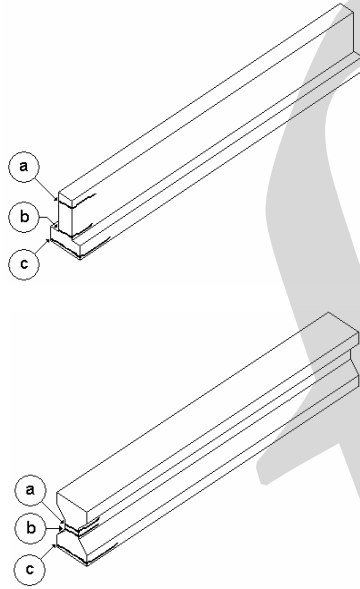
Typical case	Cause	Prevention	Effect	Repair
HORIZONTAL END CRACK IN WEB OR FLANGE These cracks usually begin at the end of the beam and can extend horizontally for a distance up to about one metre. They are frequently located in the horizontal plane of the strands and extend across the full width of the beam.

A) Improper design Excessive prestressing force or uneven distribution of prestressing force. Differential stresses between web and flange. Inadequate confining reinforcement in the end zone. Inappropriate debonded strand configuration in association with lack of confinement reinforcement.	Respace or debond some strands at end of beam to provide more even stress distribution. Provide additional confining reinforcement. Reconfigure or debond strands to provide more even stress distribution. Provide additional confinement reinforcement. Modify debonding configuration and/or provide additional confinement reinforcement.	If the crack does not coincide with prestressing reinforcement the effect is minimal. The end reaction provides a clamping force that will tend to close this type of crack. If the crack coincides with prestressing reinforcement there is a possibility that the strands have lost some or all of their bond. This could reduce the shear and flexural capacity of the beam at the end due to reduced prestressing force.	If the crack does not have structural implications it may be left unless it is an aesthetic issue or if the beam is exposed to a corrosive environment. In these cases epoxy injection or a coating should be considered. If the crack reduces the structural capacity of the beam the situation should be referred to the designer for assessment. Epoxy injection may be an option.

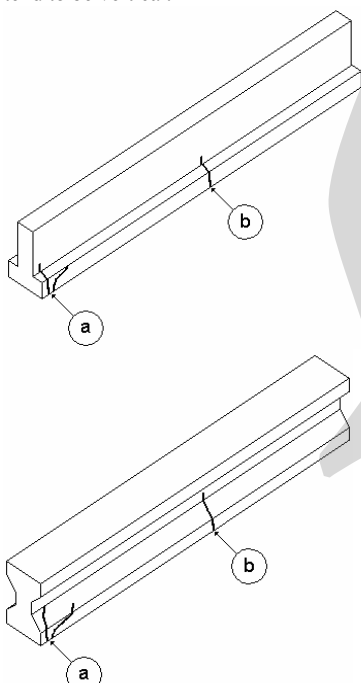
Typical case	Cause	Prevention	Effect	Repair
VERTICAL AND DIAGONAL CRACKS AT THE BOTTOM OF THE BEAM These cracks start at the bottom of the beam and extend upward. If at the end of the beam they can tend to slope diagonally upward towards the centre. If they are in the centre section of the beam they will tend to be vertical.

A) Improper design Insufficient flexural or shear capacity to carry loads. Prestress losses underestimated. Excessive debonding of strands at end of beam.	Check design calculations for possible errors. Ensure that correct reinforcement configuration is used. Reassess losses and modify stressing to suit. Ensure that sufficient strands are bonded to control cracking in this area.	Cracks crossing strands near the end of the member can result in failure by a loss of bond between the end of the member and the crack. Transfer length is also increased. This can result in a reduction in shear capacity and failure unless sufficient shear and confinement reinforcement is provided. If no bond failure has occurred at the ends the flexural capacity is not affected.	Epoxy injection can be used to restore shear capacity if there is still sufficient bonded reinforcement. Epoxy injection will not restore loss of bond or be an appropriate repair method where there is insufficient reinforcement.

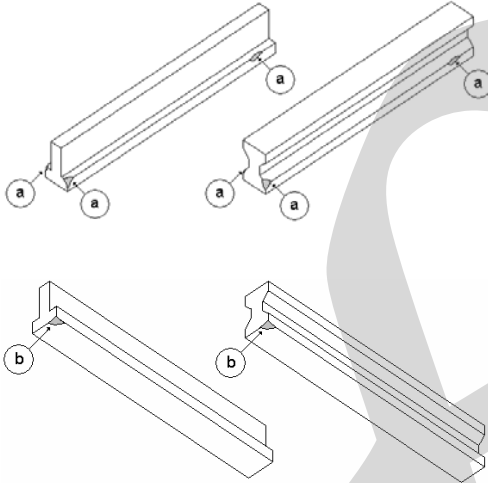
Typical case	Cause	Prevention	Effect	Repair
LEDGE CORNER CRACKS Diagonal cracks at the edge of the flange. Crack 'a' can be located anywhere along the length of the beam. Crack 'b' is usually located at the ends.

A) Improper production Binding on form during stripping. Inserts fixed to form during stripping. Bearing plates not flush with formwork. Improperly debonded strands. Improper release Improper detensioning sequence. Binding on form during release.	Keep forms clean and in good repair. Use good quality release agent. Ensure that fixings for inserts are removed before stripping. Place bearing plates flush with forms and fixed in place during pouring. Modify debonding to ensure that beam does not crack. Modify release procedures. Adopt a method that allows slow release of strands. Modify form to eliminate offsets and restraint points.	Provided there is no member bearing on the ledge in the vicinity the crack is simply a cosmetic problem. Where members bear there will be a reduction in capacity particularly if reinforcement is missing or misplaced. Cracks in the bottom of the flange can reduce the bearing area or expose reinforcement but generally have little effect on capacity.	Minor cracks in non-bearing areas require only cosmetic patching. In bearing areas with adequate reinforcement the bearing area should be restored with epoxy injection or by removing loose material and patching with a propriety repair mortar. Any spalled areas should be patched to provide reinforcement cover. Where reinforcement is inadequate an auxiliary support such as a steel-bearing bracket may be required.

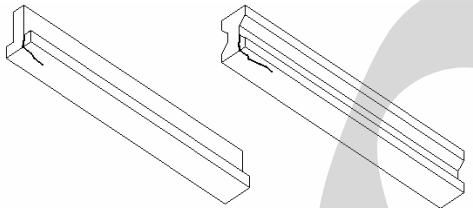
Typical case	Cause	Prevention	Effect	Repair
<p>LEDGE CRACKS</p> <p>Cracks generally originate at the intersection of the web and flange and extend towards the bottom of the beam. Typically such cracks are located at the end of the beams.</p>

<p>A) Improper production.</p> <p>Incorrect reinforcement design.</p> <p>Incorrect placement of reinforcement.</p> <p>Inappropriate debonding of strands.</p> <p>Improper detensioning sequence.</p> <p>Binding on form during stripping.</p>	<p>Verify the reinforcement design.</p> <p>Ensure that reinforcement is correctly placed.</p> <p>Review design of debonded strands and ensure that strands are debonded in accordance with design.</p> <p>Modify detensioning sequence to ensure that prestressing force is balanced during release. Adopt a method that allows slow release of strands.</p> <p>Eliminate offsets and restraint points in formwork. Provide greater 'draw' on formwork and/or use improved form release agent.</p>	<p>The load carrying capacity of the ledge can be significantly reduced and the effective bearing area of the beam can be affected. If reinforcement is misplaced or missing the beam capacity must be reviewed by the designer.</p>	<p>Where there is little load on the ledge or where there is sufficient reinforcement perpendicular to the crack epoxy injection may be used as a repair method.</p> <p>Where the ledge is required to support load and there is insufficient reinforcement across the crack then an auxiliary support such as a steel bracket may be used.</p>

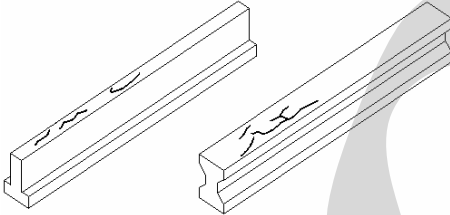
Typical case	Cause	Prevention	Effect	Repair
<p>MISCELLANEOUS CRACKS</p> <p>Fine shallow cracks in the top surface of the beam occurring at random or coinciding with reinforcement.</p>

<p>A) Improper production</p> <p>Surface shrinkage</p> <p>Rapid moisture loss.</p> <p>Excess water in concrete.</p> <p>Heat applied too early in curing cycle.</p> <p>Excessive curing temperatures.</p> <p>Settlement of concrete around top reinforcement.</p>	<p>Proper mix and curing.</p> <p>Cover concrete completely as soon as possible after pouring. Spray with curing compound or water mist before covering.</p> <p>Modify concrete mix design and use water reducing agents if necessary.</p> <p>Adjust heating cycle to slow down rate of temperature rise.</p> <p>Reduce curing temperatures.</p> <p>Allow time for initial settlement of concrete and revibrate.</p>	<p>Generally minor but can be serious in a corrosive environment.</p> <p>It there is prestressing in the top of the beam the potential for loss of bond should be assessed.</p>	<p>If repair is required inject cracks with epoxy or patch with a flowable grout.</p>

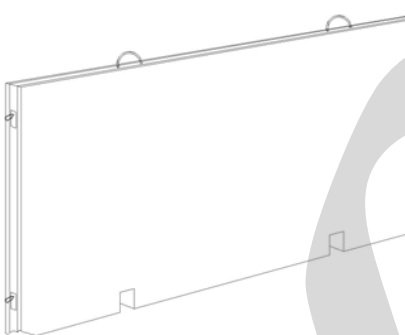
Typical case	Cause	Prevention	Effect	Repair
Missing dowell bars or broken corners

A) Improper production a) Missing dowell bars or connectors failure of manufacture. b) Broken corners failure at demould, storage or transportation.	Better quality assurance. More careful handling.	Limitations in structural performance. Lack of connectors can prohibit the assembly. Aesthetic error. In some cases may need modification of support surfaces.	Check of structural capability. Install of new dowel bars or new welded connectors. If repair not possible, the unit should be rejected. Filling with grout or screeding.
Uneven support surfaces or failures at concrete surfaces

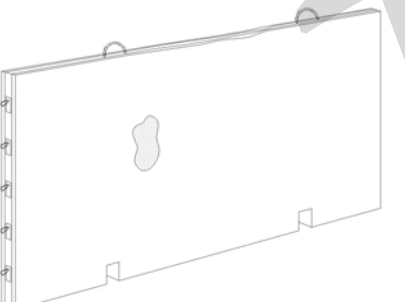
B) Improper production a) Uneven support surfaces pour finishing of the surface. b) Failures at concrete surfaces see before.	Better finishing. Change vibration or mixture. Even mould surface.	Risk of failure at assembly. No structural effect, some additional costs possible.	Levelling of support surfaces with concrete of the same strength, possibly before assembly of upper structures. Plaster or screeding layer before painting.

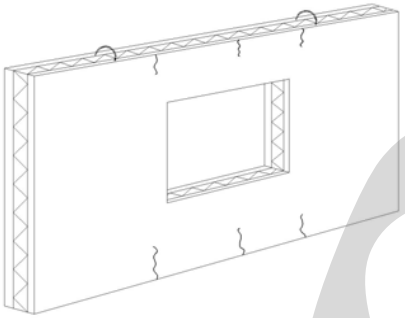
Typical case	Cause	Prevention	Effect	Repair
Cracking at panel sides

A) Improper production Plastic shrinkage. Lack of edge reinforcement.	Better curing. Edge reinforcement in outer layer. Less shrinkage in concrete.	Aesthetic inconvenience, if crack width less than 0,1- 0,2 mm. Steel corrosion, if cracks wider.	Larger cracks can be injected with grout or epoxy. Surface treatment can be changed into painting or plaster.
Cracking at opening corners or lifting devices

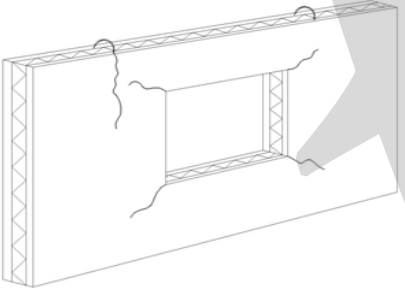
A) Improper production Cracks at openings - Quick shrinkage. - Lack of reinforcement. B) Improper handling Cracks at lifting devices - Too fresh concrete during handling of the unit. - False lifting device. - Too thin concrete layer.	Better curing. Less shrinkable concrete. Additional reinforcement. Concrete strength over 60% at demoulding. Tilting table moulds. Strengthening of outer layer at lifting point.	Aesthetic inconvenience, if crack width less than 0,1- 0,2 mm. Steel corrosion, if cracks wider. Concrete can be broken during lifting, if cracks wider.	Larger cracks can be injected with grout or epoxy. Surface treatment can be changed into painting or plaster. Careful erection may be possible or otherwise the unit should be rejected.

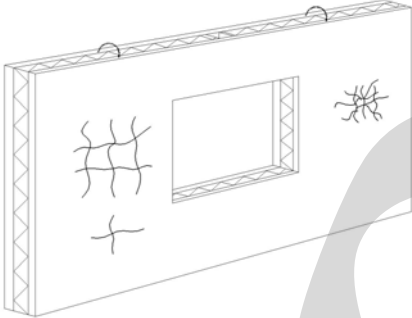
Typical case	Cause	Prevention	Effect	Repair
Surface cracking

A) Improper production <p>a) Systematic cross- ruled cracks</p> <ul style="list-style-type: none"> - Separated mixture. - Too fast concrete drying. - Too small aggregate size. - Too small concrete cover of reinforcement. <p>b) Non- systematic net- cracking</p> <ul style="list-style-type: none"> - Too much cement paste. - Separated mixture. - Trowel failed. - Too high temperature gradient. 	<p>Improved cast and curing. Larger aggregate size. Check of concrete cover.</p> <p>Check of proportion. More exact trowel timing. Better curing.</p>	<p>Aesthetic inconvenience, if crack width less than 0,2 mm. Steel corrosion, if cracks wider.</p>	<p>Normally does not influence to other durability than frost and chemical resistance of the surface. Larger cracks can be injected with grout or epoxy. Surface treatment can be changed into painting or plaster.</p>

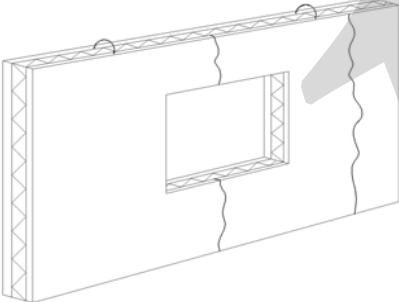
Structural cracks

A) Improper production <p>a) Occurs at the age of over 1 week</p> <ul style="list-style-type: none"> - Too fast heat curing. - Shrinkage of long panel prohibited (moulds for openings, steel connectors etc.). - Demoulding too early. <p>b) Thermal deformations in the whole skeleton. This may occur during the 1st year eg. at ground or roof level.</p>	<p>Less heat curing and outer layer temperature less than 45°C. Check of mould and tie bars. Demoulding strength of concrete at least 60 %. More flexible connectors between wall panels and the skeleton.</p>	<p>Aesthetic inconvenience, if crack width less than 0,1- 0,2 mm. Steel corrosion, if cracks wider. Whole panel can be broken at lifting, if cracks are protruding.</p>	<p>If cracks protrude the panel, they should be injected or the panel should be rejected.</p>

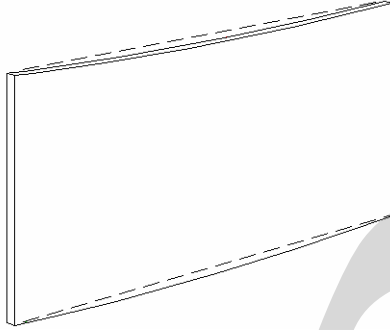
Typical case	Cause	Prevention	Effect	Repair
Bowing and other dimensional tolerances

A) Improper production <p>a) Bowing</p> <ul style="list-style-type: none"> - Variations at density and shrinkage of panel layers. - Sunshine and creep at stockyard. - Long storage time. - Too long panels. <p>b) Other dimensional tolerances</p> <ul style="list-style-type: none"> - Insufficient production measures and quality control. - Long- term deformations not taken into account in design. 	<p>Avoid long storage times and sunshine for dark surfaces or long panels.</p> <p>Careful mixing, vibration and curing.</p> <p>Good measuring systems and quality control.</p>	<p>Influences at the visual appearance both individually and when all panels viewed together.</p> <p>Can limit architectural or structural performance or can make erection work impossible.</p>	<p>Very often panels can be drawn straight with normal or additional connectors.</p> <p>Panels exceeding allowed tolerances may still be acceptable, if the total erected assembly can be modified to meet structural and architectural requirements.</p>

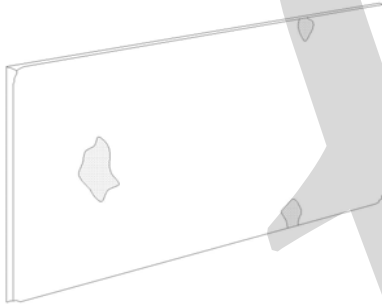
Surface failures and dirtyness

A) Improper production <p>a) Separation of aggregate</p> <p>b) Variations in colour or darkness</p> <p>c) Lime at surfaces</p> B) Improper handling <p>Dirt at surfaces (oil, rust,...)</p>	<p>Change vibration or mixture.</p> <p>Even mould surface, no variations at pigment amount or vibration, the same aggregate and curing all through the delivery.</p> <p>Careful curing and no free water on the young concrete surface.</p> <p>Careful production, storage and transportation.</p>	<p>Aesthetic problem.</p>	<p>a) Surface repair or rejection</p> <p>b) Small variations accepted. If they are larger, the panel should be rejected</p> <p>c) Washing with salt- phosphor- or acetic acid and water</p> <p>d) Washing or other cleaning</p>

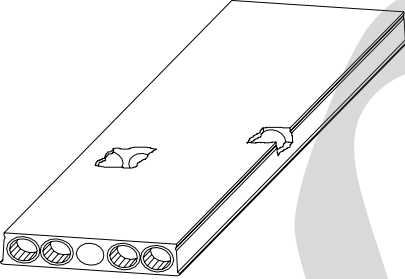
Typical case	Cause	Prevention	Effect	Repair
Imperfections in holes, recesses or lifting devices

A) Improper design or production <p>Lack of digged holes or recesses.</p> <p>Lack of lifting hooks.</p> <p>Lack of intermediate webs or other strengthening for lifting.</p> <p>Lack of drilled water holes in lower flange.</p> <p>Lack of plugs or other filling material for core ends.</p>	<p>Improved data transfer at stage of design and manufacture and improved quality control of production.</p>	<p>Joints cannot be finished and installations of piping cannot be done.</p> <p>Lifting difficult or dangerous.</p> <p>Rainwater can gather into the cores during construction.</p> <p>Additional use of joint cast. Deadweight of slab increases.</p>	<p>Recess shall be made carefully on site. Small holes are drilled and big holes cutted on site.</p> <p>Lifting are made with special equipment.</p> <p>Lifting are made with special equipment.</p> <p>Water holes are drilled on site.</p> <p>Cores are plugged or ends filled with other methods before the joint cast.</p>

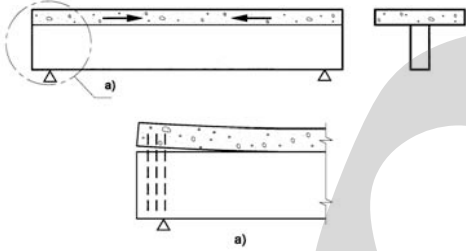
Typical case	Cause	Prevention	Effect	Repair
CRACKS OF HYDRAULIC SHRINKAGE BETWEEN IN SITU CONCRETE AND PRECAST ELEMENT

A) Improper design Lack of transversal reinforcement.	Adequate transversal reinforcement.	Difficult to see in many cases. The shear capacity can be reduced.	Inject with epoxy or put mechanical connection reinforcement.
	B) Improper construction Excess of differential shrinkage of in situ concrete.	Adequate curing of in situ concrete.

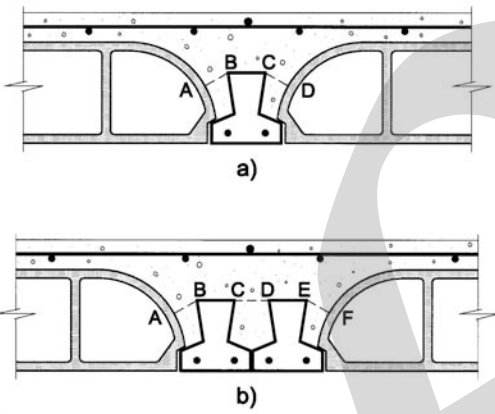
Typical case	Cause	Prevention	Effect	Repair
<p>CRACKS DUE TO THE SHEAR AT THE INTERFACE BETWEEN IN SITU CONCRETE AND PRECAST ELEMENT</p>

<p>a)</p> <p>b)</p>	<p>A) Improper construction</p> <p>Poor quality of in situ concrete.</p> <p>Low slump of in situ concrete.</p> <p>Smooth contact surface.</p> <p>Lack of cleaning in the prefabricated concrete surface element.</p> <p>Defects of striking during early age.</p>	<p>Better concrete quality.</p> <p>Use adequate concrete slump.</p> <p>Make rough or indented surface in the precast element.</p> <p>Clean the surface before concreting.</p> <p>Prevent settlements of props.</p>	<p>No visible defect.</p> <p>The rupture surface follows the line ABCD or ABCDEF.</p>	<p>Normally requires strengthening.</p>

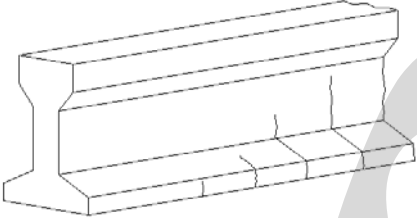
Typical case	Cause	Prevention	Effect	Repair
CRACKS IN THE BOTTOM FLANGE AT SERVICE LOAD

A) Improper design Larger prestressing losses than calculated.	Adequate estimation of prestressing losses.	Higher in the middle of the span. Normally appear at service load, and the crack width is less than 0.4 mm. Possible steel corrosion.	If the crack is not acceptable, inject or protect to prevent the corrosion.
	B) Improper production Stresses due to the prestressing lower than nominal value. Errors in the prestressing reinforcement position. Early transfer.	Calibrate jacks of prestressing and elongation control of steel. Position of reinforcement. Make the transfer at the correct time.

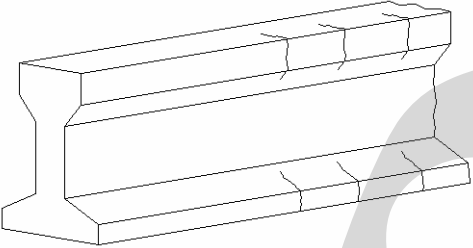
Typical case	Cause	Prevention	Effect	Repair
CRACKS IN ONE SIDE OF THE JOIST

A) Improper production Non symmetrical position of reinforcement. Errors in the transfer.	Position of reinforcement. Revise the procedure of transfer.	Cracks in only one side of the precast element. Irregular distribution. They appear immediately after the transfer.	Revise the load capacity of the element. Inject or protect against steel corrosion.

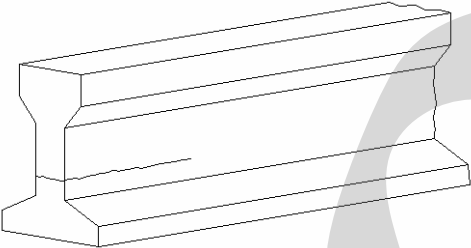
Typical case	Cause	Prevention	Effect	Repair
HORIZONTAL CRACKS AT THE ENDS OF THE PRECAST ELEMENT

A) Improper design Excessive prestressing force in the bottom, or bad distribution of prestressing force.	Replace or change wire distribution.	If the crack does not coincide with prestressing, the affect is minimal. The end reaction tends to close this crack. If the crack coincides with prestressing reinforcement, possibility of steel corrosion.	Inject, if necessary, for protection. If the crack reduces the structural capacity, study the safety of the general slab.

B) Improper production Poor quality of concrete at transfer. Excess of bond between steel reinforcement and concrete.	Improve concrete quality. Use wires with smoother surface. Attention: Not possible to use transversal reinforcement to prevent the defect or to debond wires.	Lack of bond and reduction in flexural and shear capacity.
