### Toxic Chemical Release at the DuPont La Porte Chemical Facility

## Investigation Report

Published: June 2019

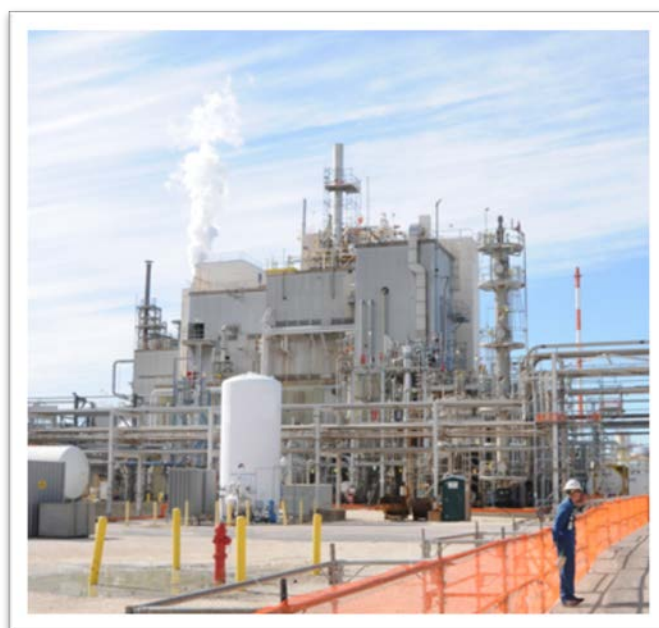
**Figure 1.** The Lannate<sup>®</sup> Manufacturing Building. The methyl mercaptan release occurred in the manufacturing building. Source: CSB.

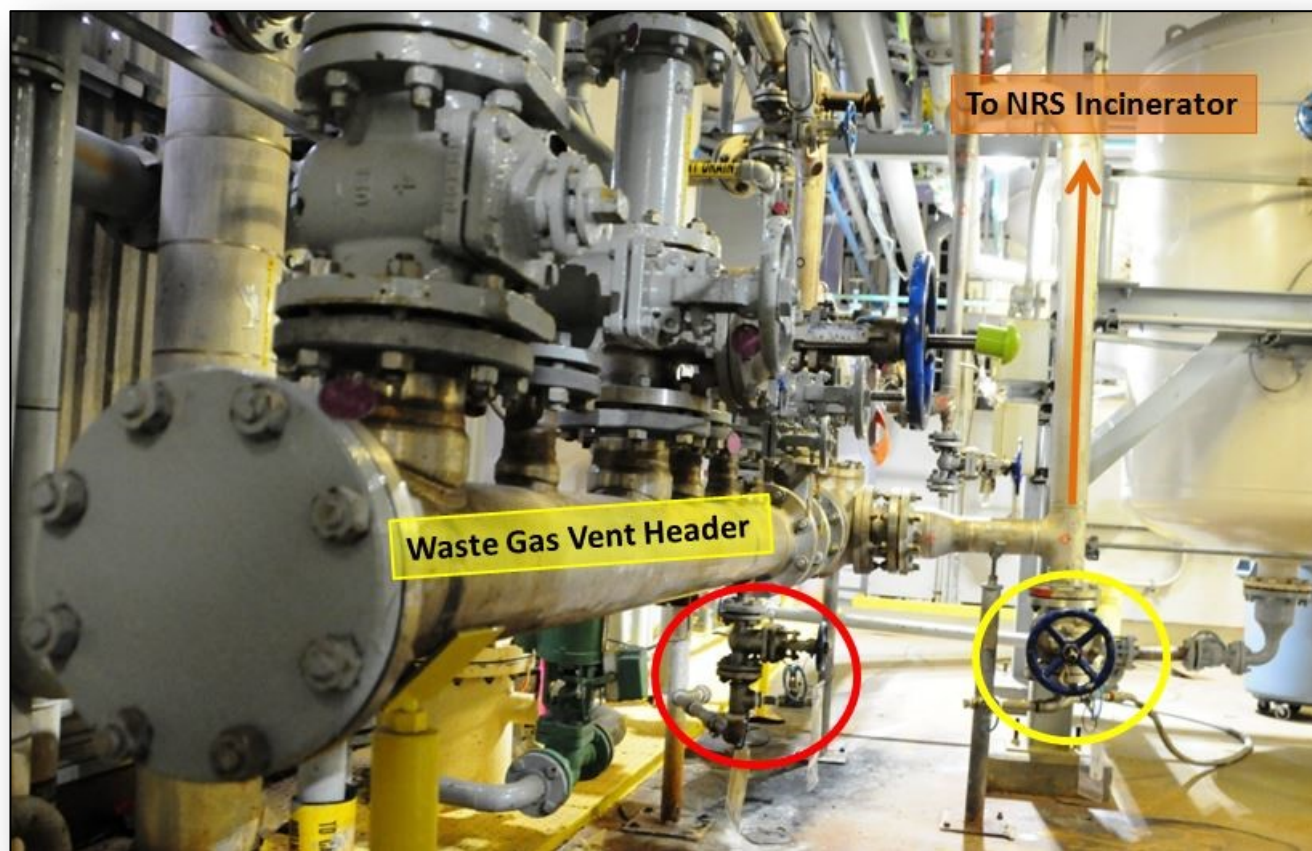
**Figure 2.** Waste Gas Vent Header Piping on the Third Floor of the Manufacturing Building. This portion, where several waste gas sources come together, is referred to as the *waste gas vent header*. Waste gas from this portion of the vent header traveled up to reach the NRS incinerator, a piping configuration that created a low spot where liquid accumulated. To remove the liquid during waste gas vent header piping high-pressure events, operators were instructed to open valves (yellow circle) and drain the system through a hose routed to a floor drain located near a safety shower. The floor drain is connected an open trench-type sump on the first floor. At the time of the incident, a second set of drain valves (red circle) were also opened directly to the floor inside the manufacturing building. Source: CSB.

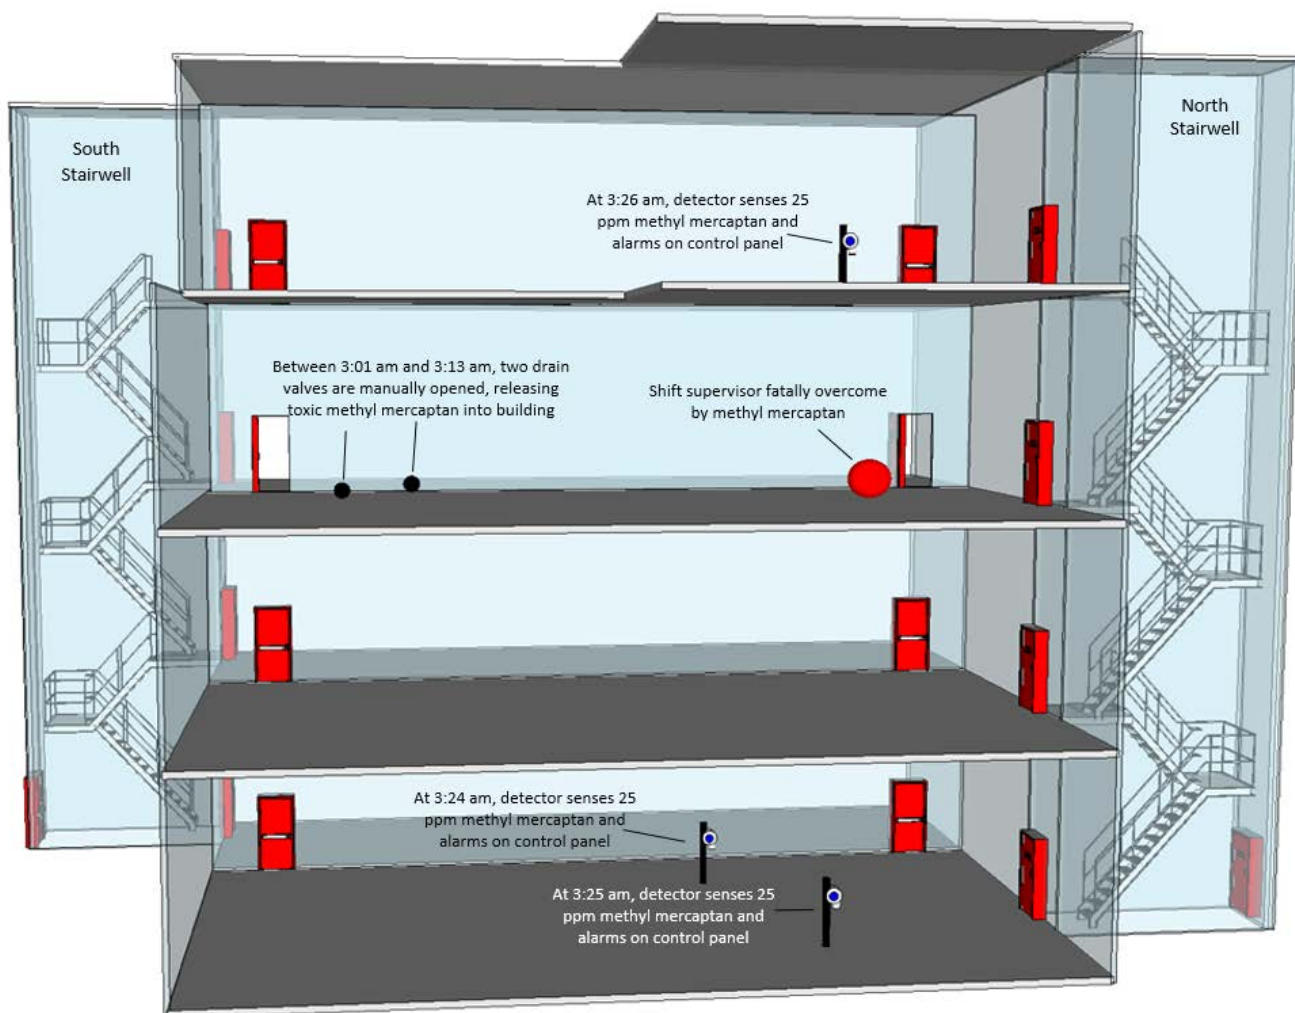
**Figure 3.** Depiction Showing Where Drain Valves Were Opened. These drain valves released toxic methyl mercaptan into the manufacturing building. Methyl mercaptan detectors on the first and fourth floors detected high concentrations of methyl mercaptan shortly after the release began. This depiction is a simplified graphic of the manufacturing building (see Section 4.5) and does not show the location of Operator 1. Source: CSB.

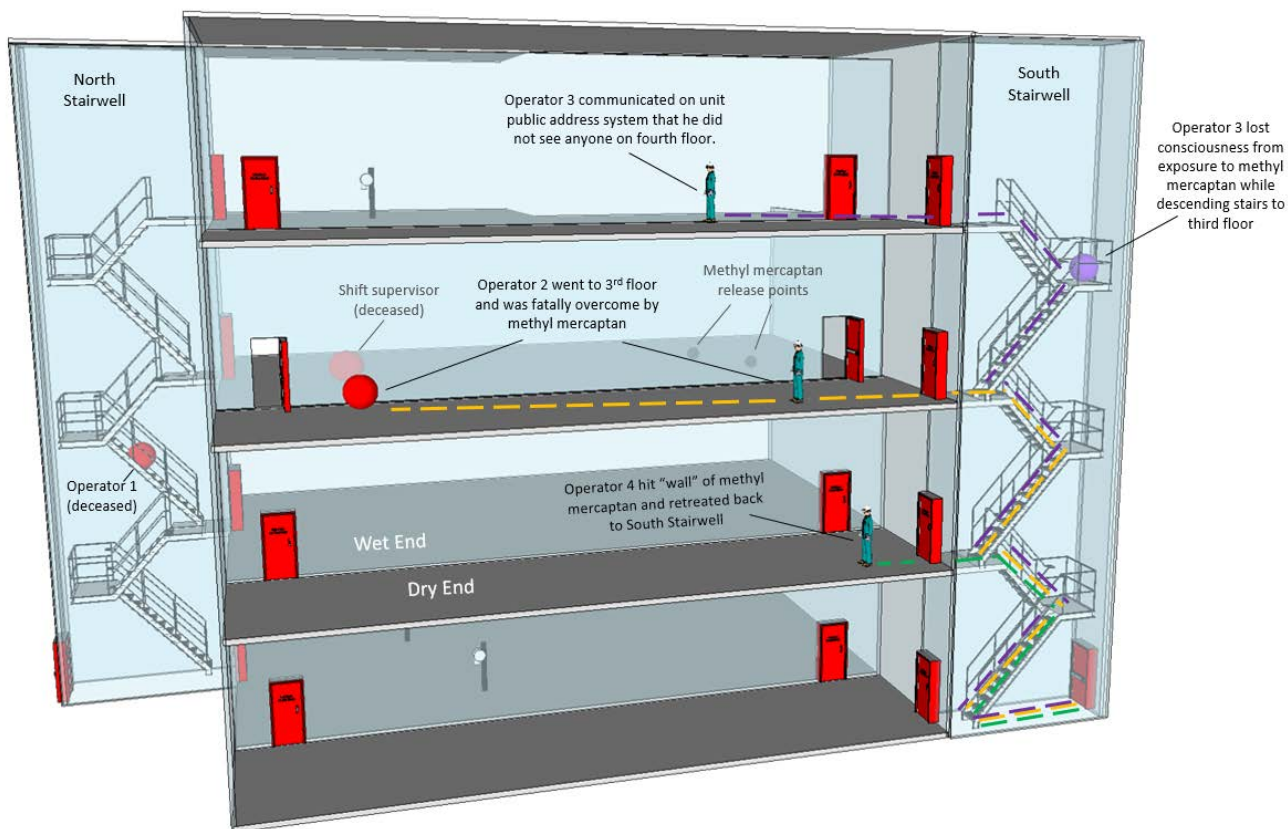
Operator 2, Operator 3, and Operator 4 each entered the south stairway and took different a route inside the manufacturing building to try to find Operator 1 (Figure 4). Operator 2 went to the third floor, where he was fatally overcome by methyl mercaptan [1, p. 29]. Operator 4 went to the second floor. He walked about 10 feet and hit what he later described as a "wall" of methyl mercaptan, but he managed to retreat to the stairwell [1, p. 29]. Operator 3 went to the fourth floor but did not find anyone. He then announced on the Lannate<sup>®</sup> Unit's public-address system that he did not see anyone on the fourth floor. The Board Operator responded that the Shift Supervisor and Operator 1 may be on the third floor [1, p. 29]. Operator 3 then began to feel light-headed. He made his way to the stairwell and lost consciousness while descending from the fourth floor [1, p. 29].

**Figure 4.** Depiction of Paths Taken by Operator 2, Operator 3, and Operator 4 When They Responded to Operator 1's Distress Call. Locations of the deceased Shift Supervisor and Operator 1 are also shown. Operator 2 was killed by methyl mercaptan exposure, and Operator 3 and Operator 4 were exposed to high concentrations of methyl mercaptan. This figure shows the opposite side of the manufacturing building from the view in Figure 3. Source: CSB.

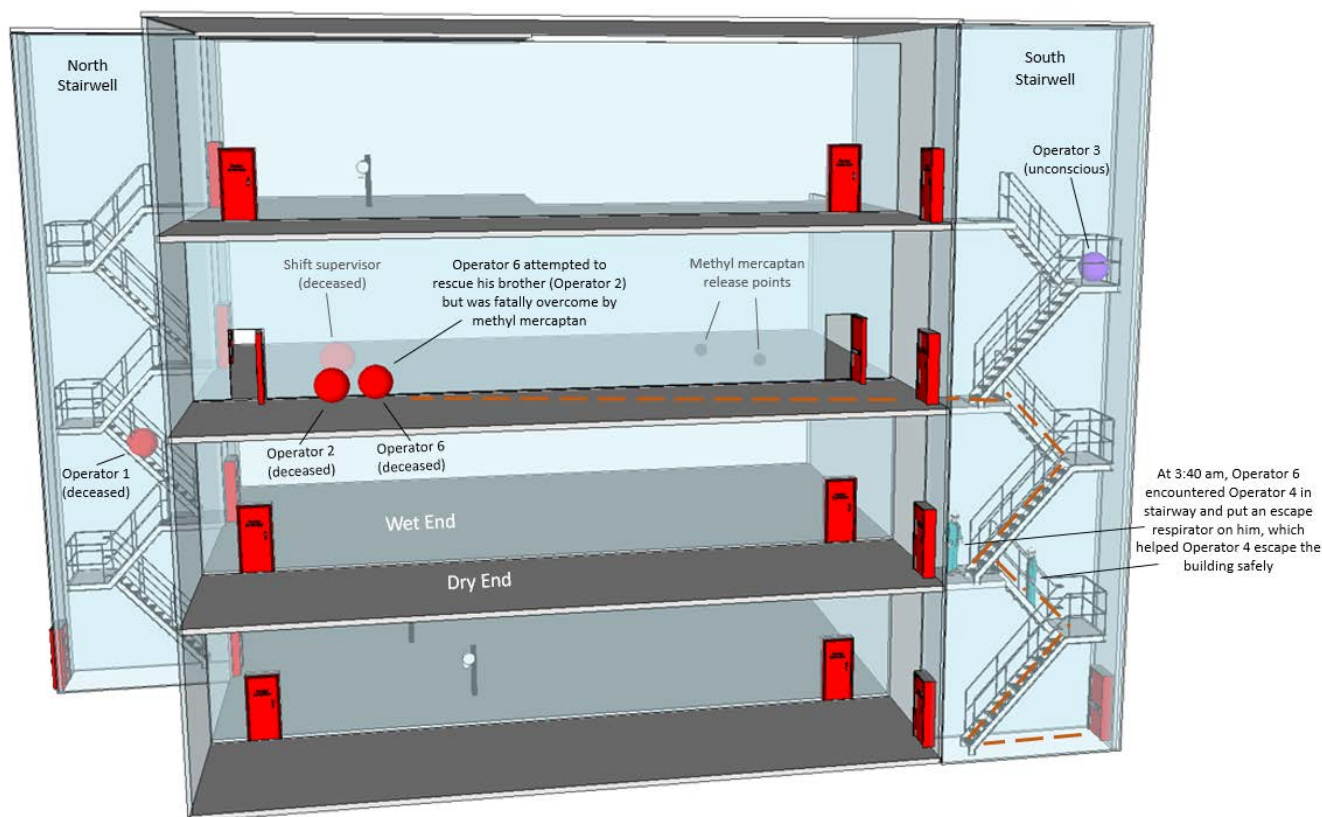
**Figure 5.** Depiction of the Path Taken by Operator 6 Inside the Manufacturing Building. Operator 6 helped Operator 4 escape by providing him with a respirator. Operator 6 was fatally overcome by methyl mercaptan when trying to rescue his brother, Operator 2, on the third floor. Source: CSB.

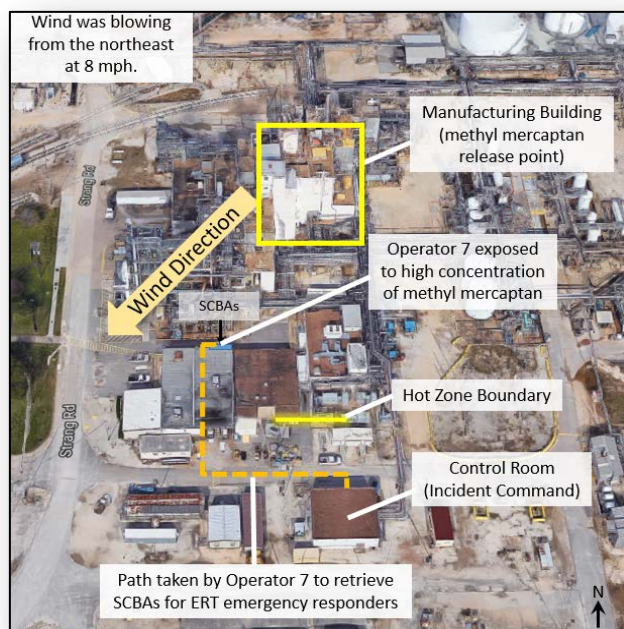
**Figure 6.** Depiction of Path Taken by Operator 7 to Retrieve SCBAs for ERT When the Mini Pumper Truck Would Not Start. The hot zone was not controlled adequately to ensure that personnel did not enter a hazardous area. Source: Google Earth, with annotations by CSB.

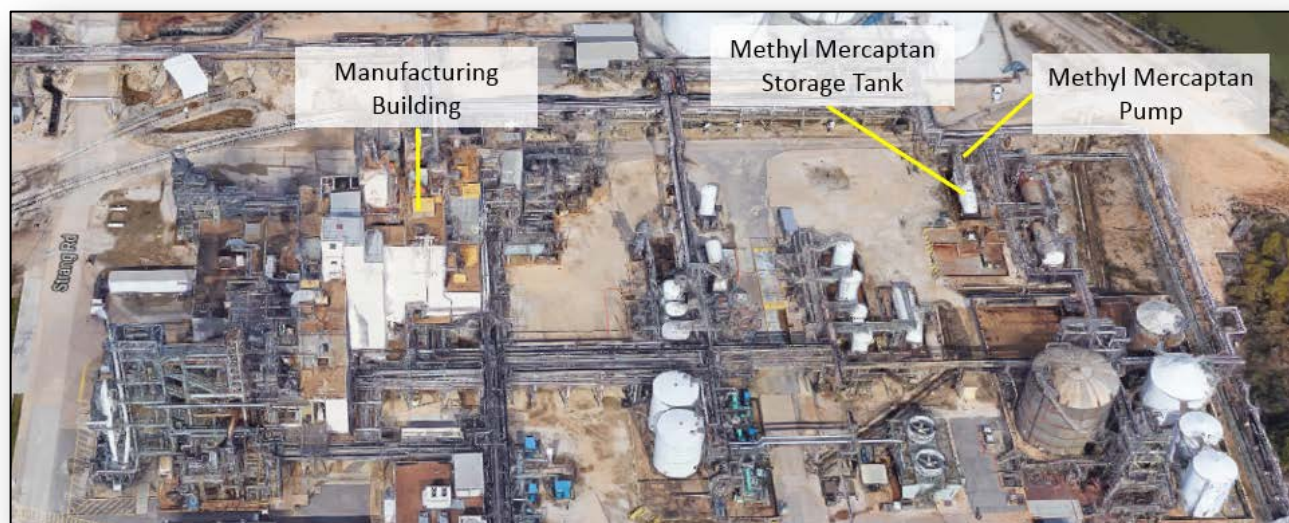
At 6:02 am, approximately three hours after the release started, DuPont La Porte personnel turned off the methyl mercaptan storage tank pump, which had been operating since the last startup attempt, before the release began (Figure 7). Shutting off this pump significantly slowed the methyl mercaptan release rate (Section 4.6).<sup>a</sup>

**Figure 7.** Location of Methyl Mercaptan Pump. The pump was turned off nearly three hours after the release began. Source: Google Earth, with annotations by CSB.

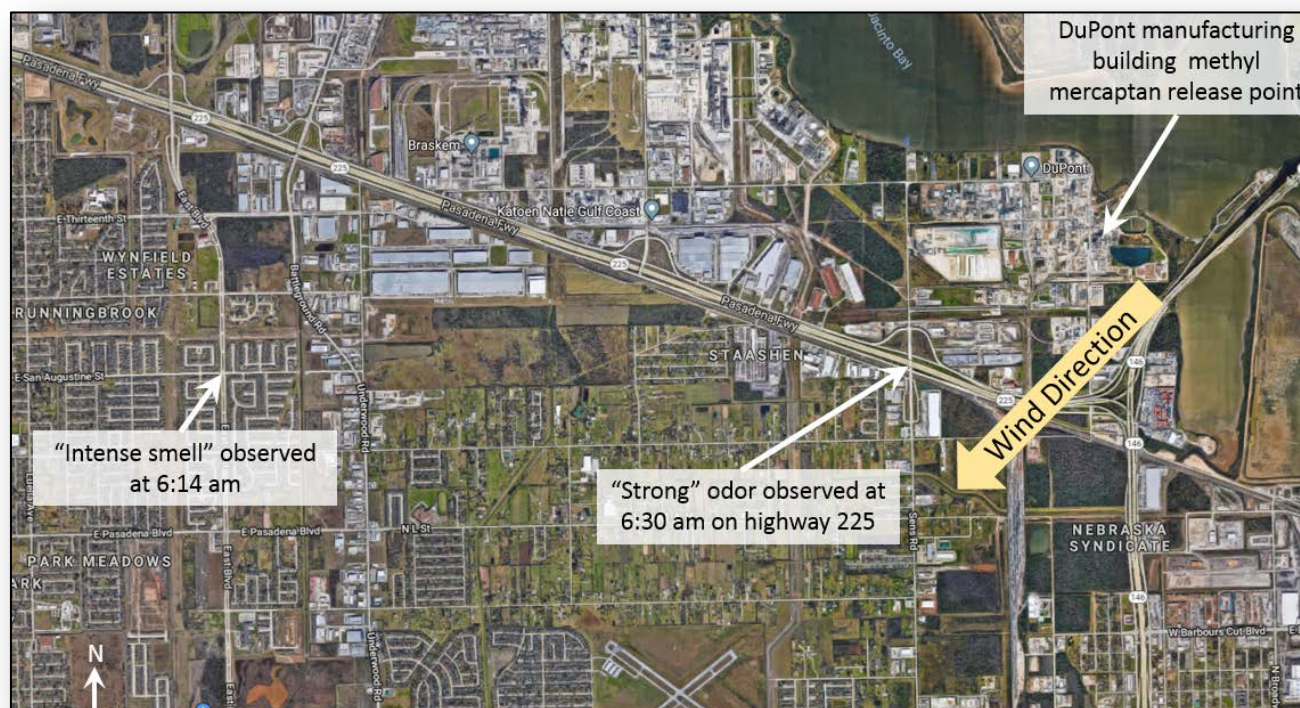
**Figure 8.** Locations Where a Sheriff's Sergeant Reported Strong Methyl Mercaptan Odor During the Incident. Source: Google Earth, with annotations by CSB.

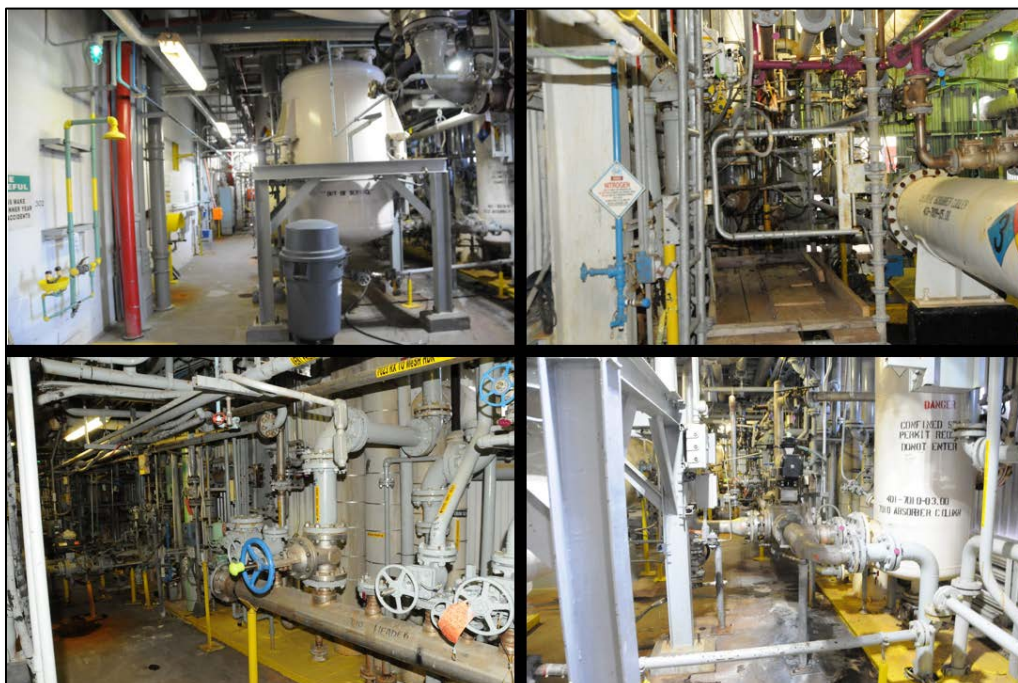
Many of the emergency responders searching the manufacturing building worked at the La Porte site as operators in other units or for other companies located there. Some of these responders, therefore, were unfamiliar with the manufacturing building—a four-story building containing a large amount of piping and process equipment, dividing walls, multiple stairwells, and an elevator. Figure 11 shows photos taken inside the manufacturing building, illustrating the complexity of the layout inside the building.

Figure 11. Photos of the Interior of the Lannate® Manufacturing Building. Source: CSB.

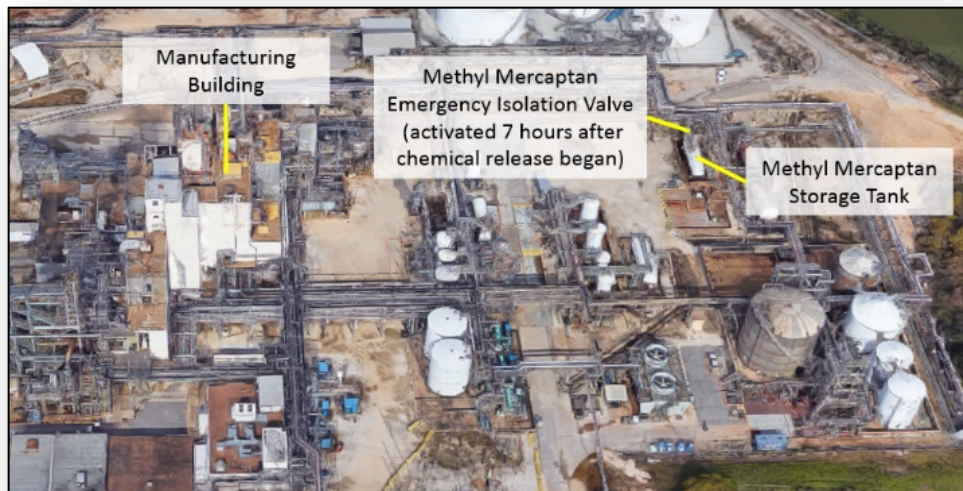
**Figure 13.** Location of Methyl Mercaptan Emergency Isolation Valve Relative to Manufacturing Building Where Leak Occurred. The emergency isolation valve was not activated until seven hours after the release began. Source: Google Earth, with annotations by CSB.

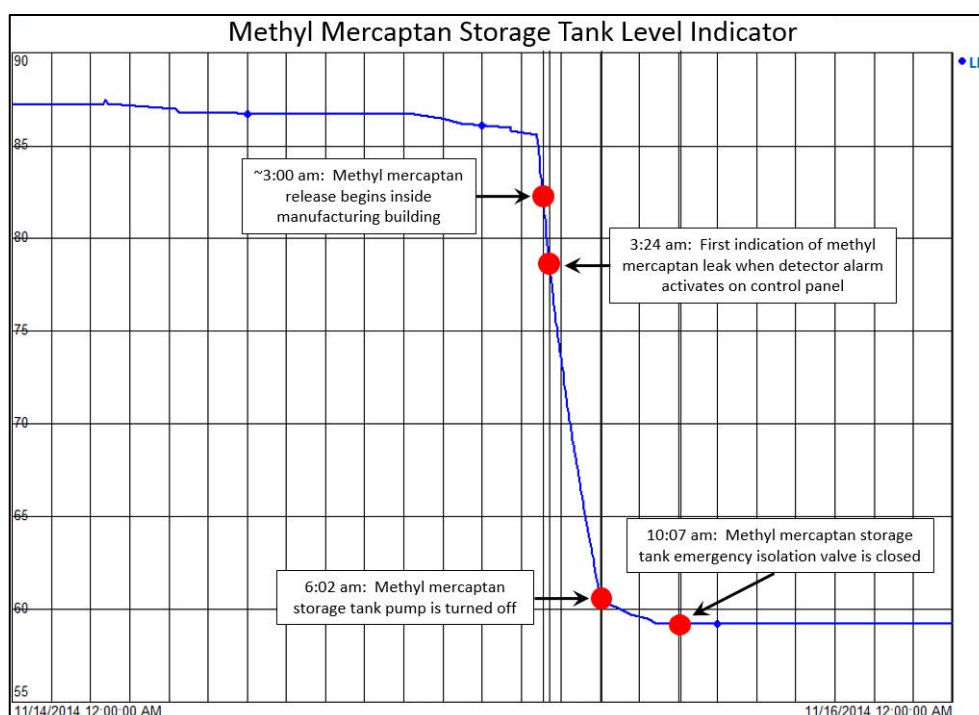
1. Personnel did not recognize the need to close the methyl mercaptan storage tank isolation valve when they determined that methyl mercaptan was the chemical being released inside the manufacturing building.
2. No one evaluated process data to determine what was causing the release until hours into the response efforts. Had personnel looked at the process data earlier during the release, it should have been clear that methyl mercaptan was flowing from the methyl mercaptan storage tank, requiring closure of the emergency isolation valve (Figure 14).

**Figure 14.** Process Data from November 15, 2014. Data shows that methyl mercaptan was abnormally flowing from the methyl mercaptan storage tank. No one analyzed these data during the first hours of the incident. Source: CSB graph based on DuPont data.

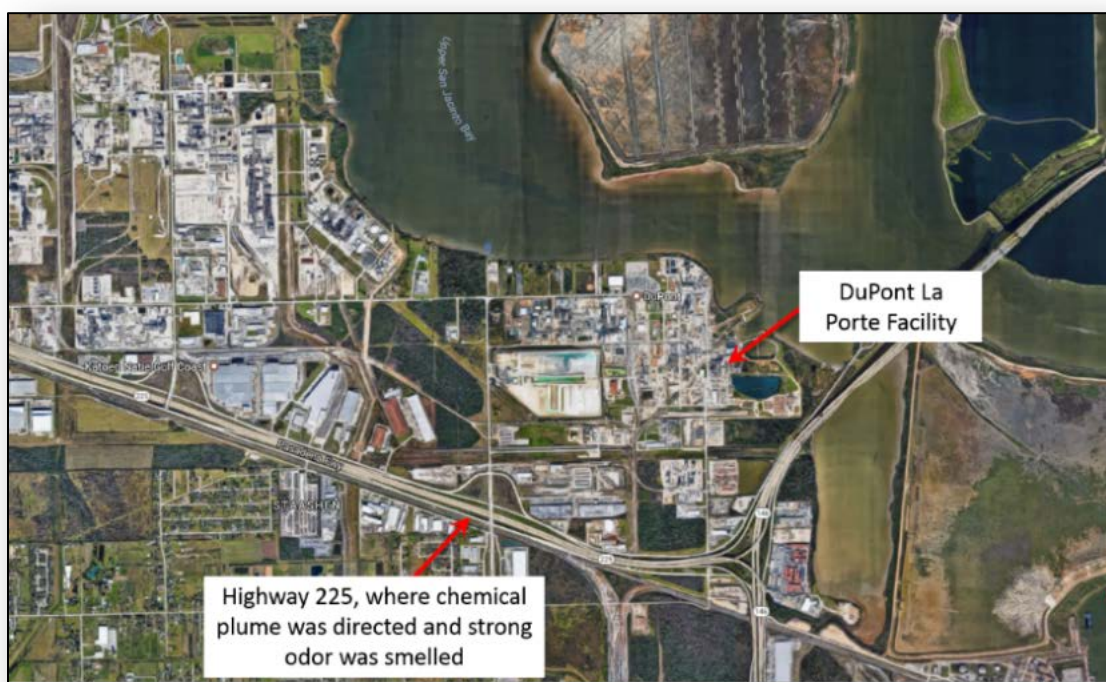
**Figure 16.** Overhead Image of DuPont La Porte Facility. A plume of methyl mercaptan left the DuPont property in a southeasterly direction toward a major highway and residential area. Source: Google Earth, with annotations by CSB.

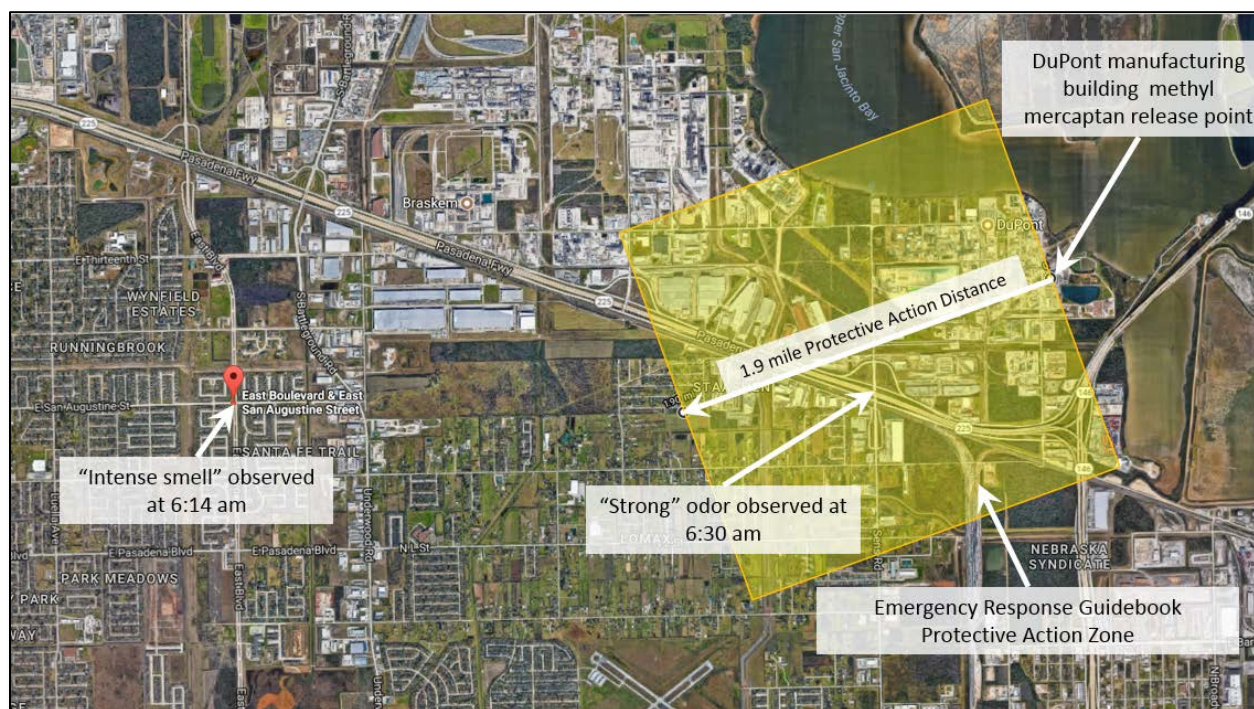
**Figure 17.** Overhead Image of DuPont La Porte Facility with Recommended Downwind Protection Zone (Shown in Yellow) Based on the 2016 Emergency Response Guidebook [12, p. 297]. Downwind sections of Highway 225 and residential areas were within the area recommended for public protection from a methyl mercaptan chemical leak. Source: Google Earth, with annotations by CSB.

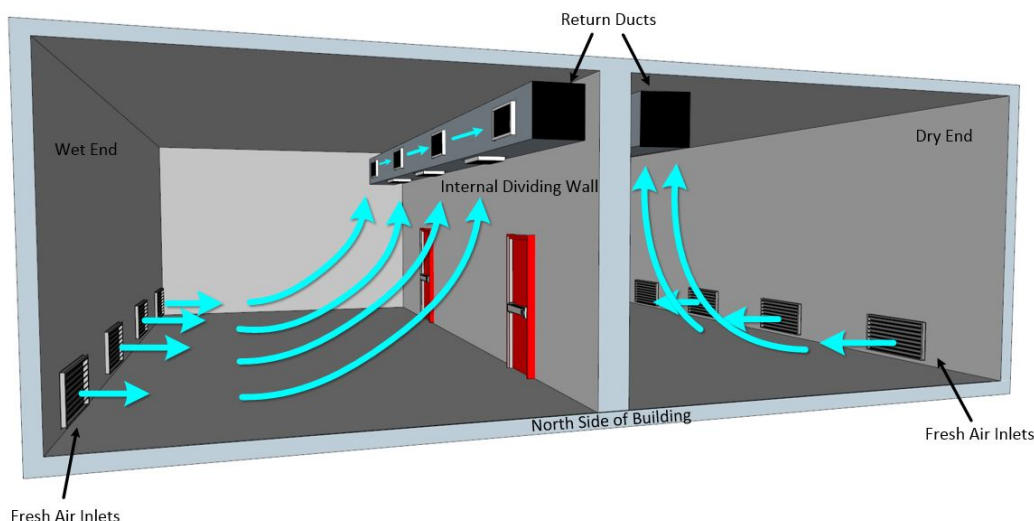
**Figure 27.** Simplified Graphical Representation of a Typical Floor of the Manufacturing Building. It shows how fresh air was pulled in from the outside walls, swept across the floor, and entered the exhaust return air ducts on each side. Source: CSB.

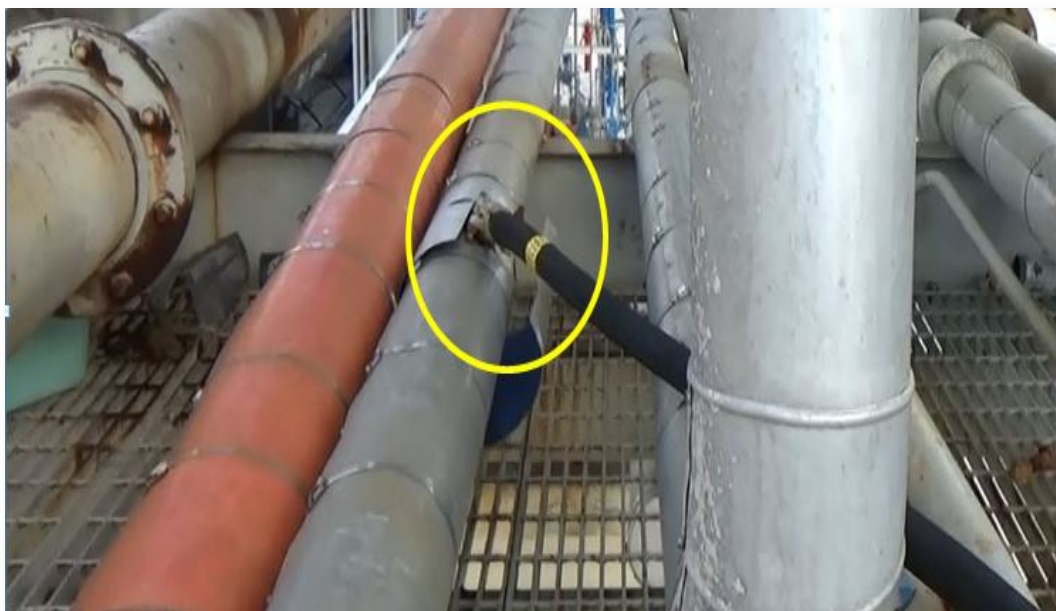
**Figure 30.** Hot Water Hose Positioned on the Liquid Methyl Mercaptan Feed Piping. Hot water flowed between the piping and the insulation to heat the piping and dissociate the solid hydrate that had formed after water inadvertently entered the methyl mercaptan storage tank. Source: CSB.

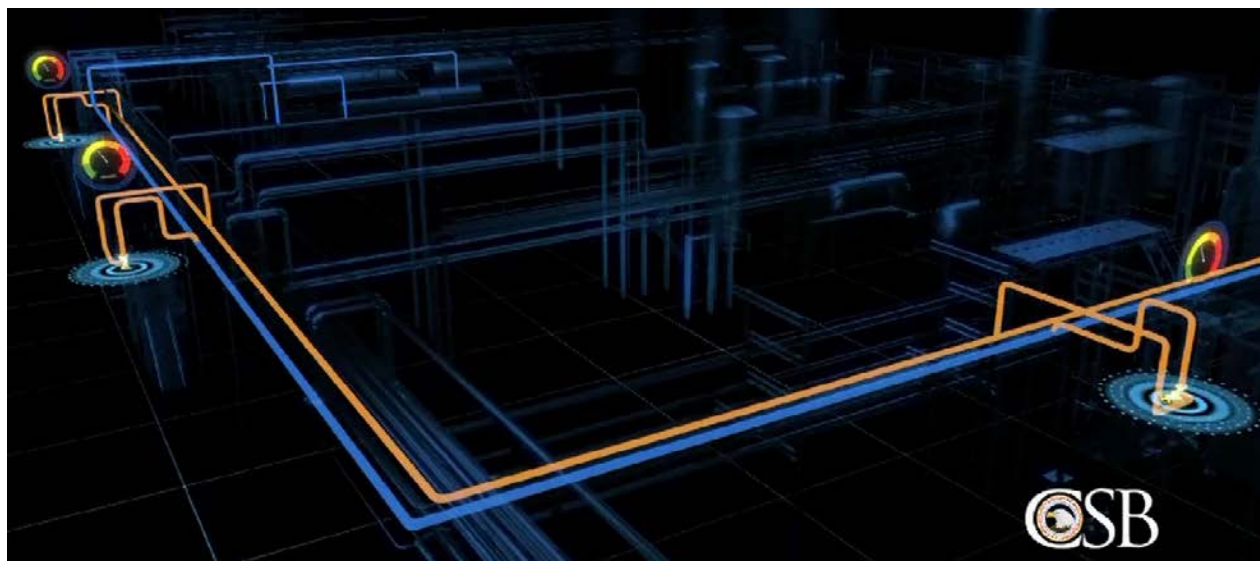
**Figure 31.** Excerpt from CSB Animation. It depicts the three locations where valves connected the methyl mercaptan feed piping (blue) to the waste gas vent header piping (orange). Workers used the pressure gauges shown at these locations to monitor the progress of clearing the hydrate blockage inside the methyl mercaptan feed piping. Source: CSB.

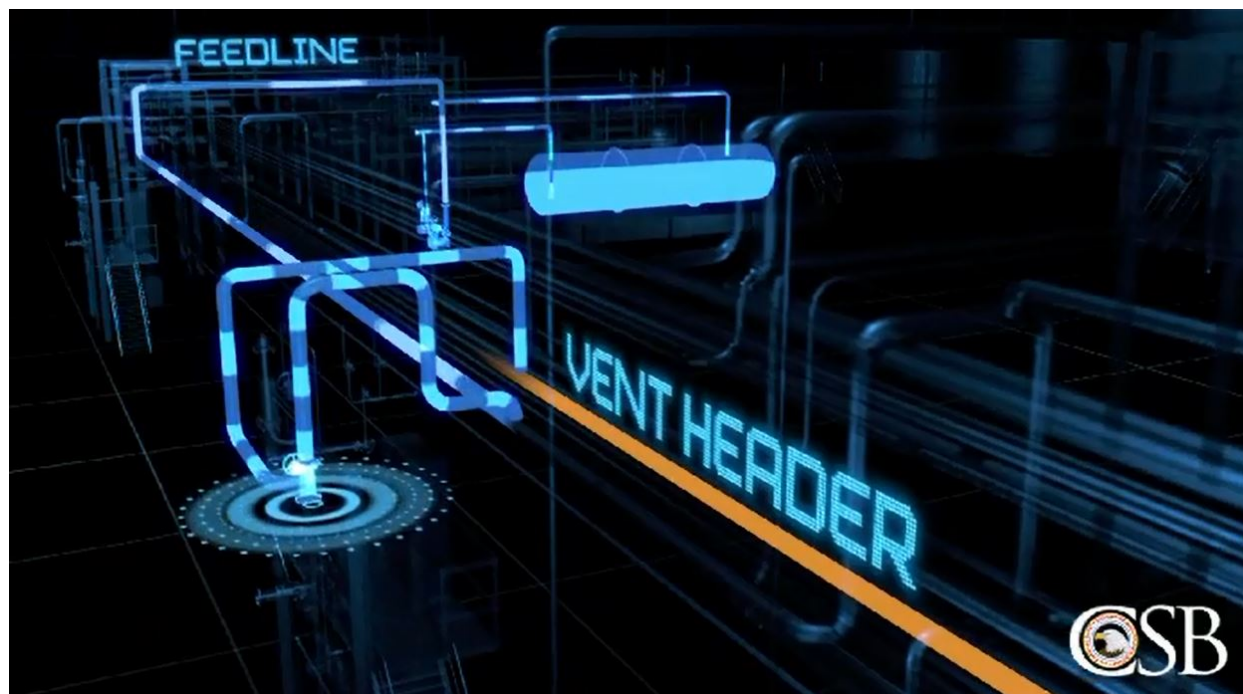
**Figure 32.** Excerpt from CSB Animation. It depicts the piping arrangement that allowed liquid methyl mercaptan from the feed line (blue) to flow into the waste gas vent header piping (orange). Source: CSB.

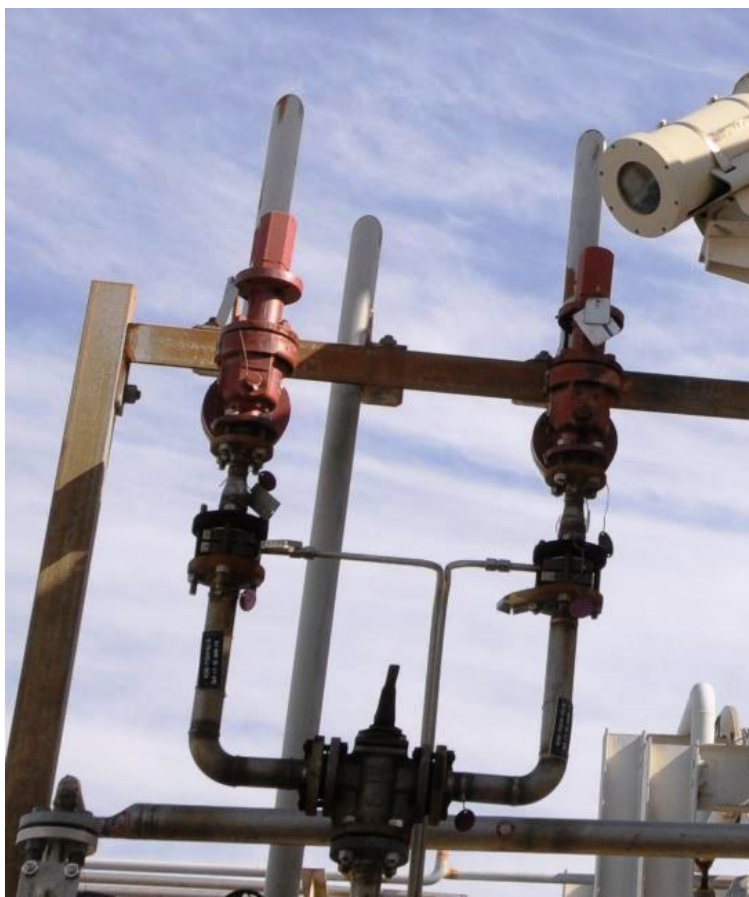
**Figure 33.** Nitrogen Relief Valves at One of the Two Methyl Mercaptan Railcar Unloading Stations. DuPont PHAs and relief valve design documents never considered the possibility of lining up the methyl mercaptan storage tank pumps to these relief valves—as they were at the time of the incident. As a result, liquid methyl mercaptan was discharged from a system designed for nitrogen vapor. Source: CSB.

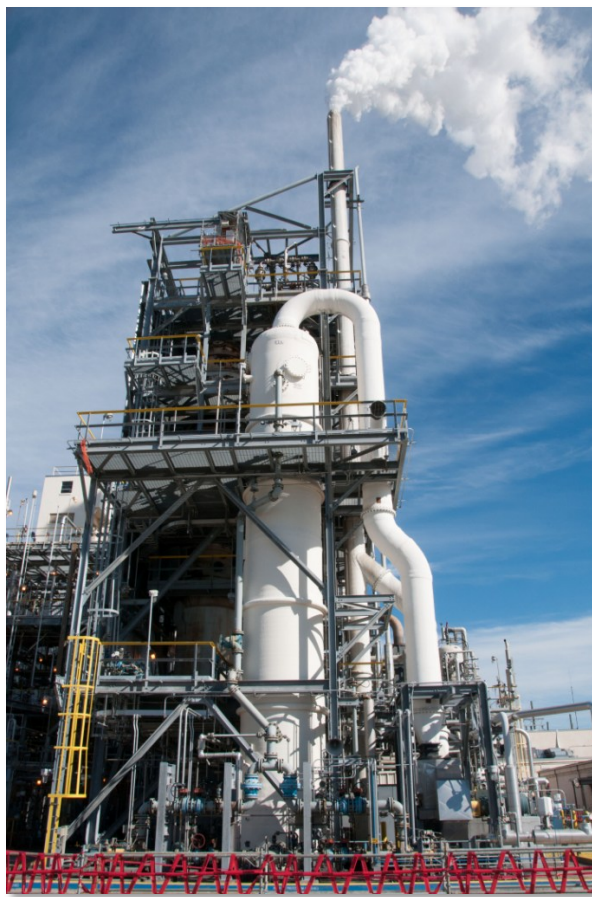
**Figure 34.** NRS Incinerator. NRS was installed in 2011 to reduce emissions and allow increased production at the DuPont La Porte facility. Source: CSB.

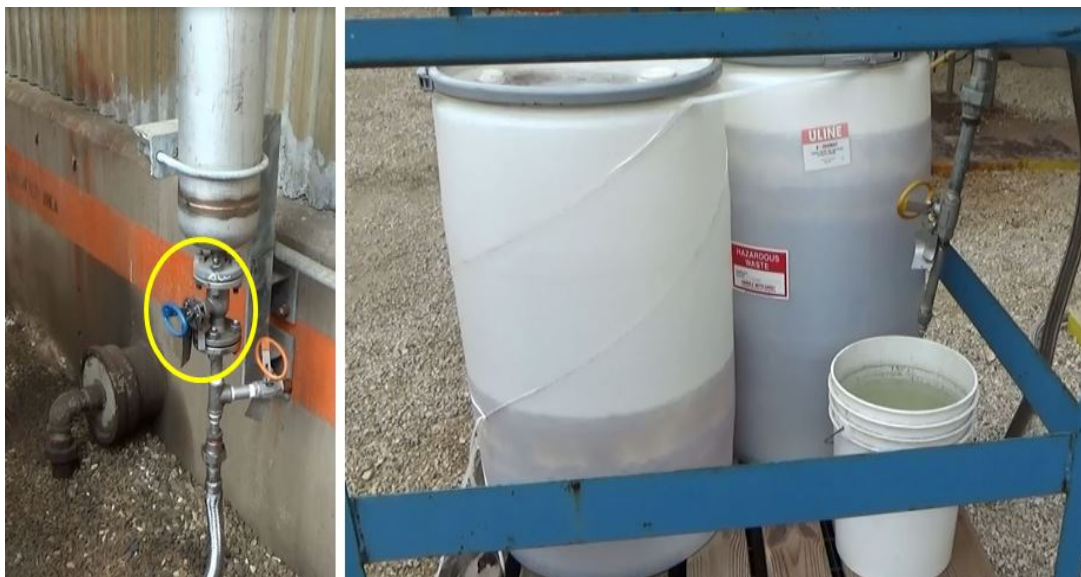
**Figure 37.** Photo Showing Another Line Break. Operators drained liquid accumulation in another vent header without using line-breaking procedures. Source: CSB.

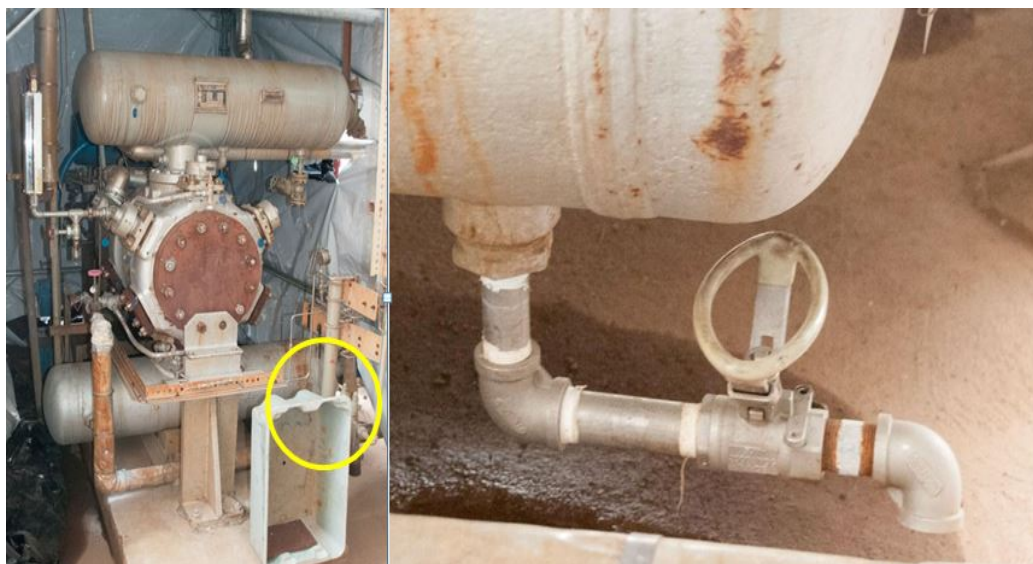
**Figure 38.** Methylene Chloride<sup>a</sup> Compressor. Photo shows where operators routinely drained liquid accumulation from a methylene chloride compressor without using line-breaking procedures. Source: CSB.

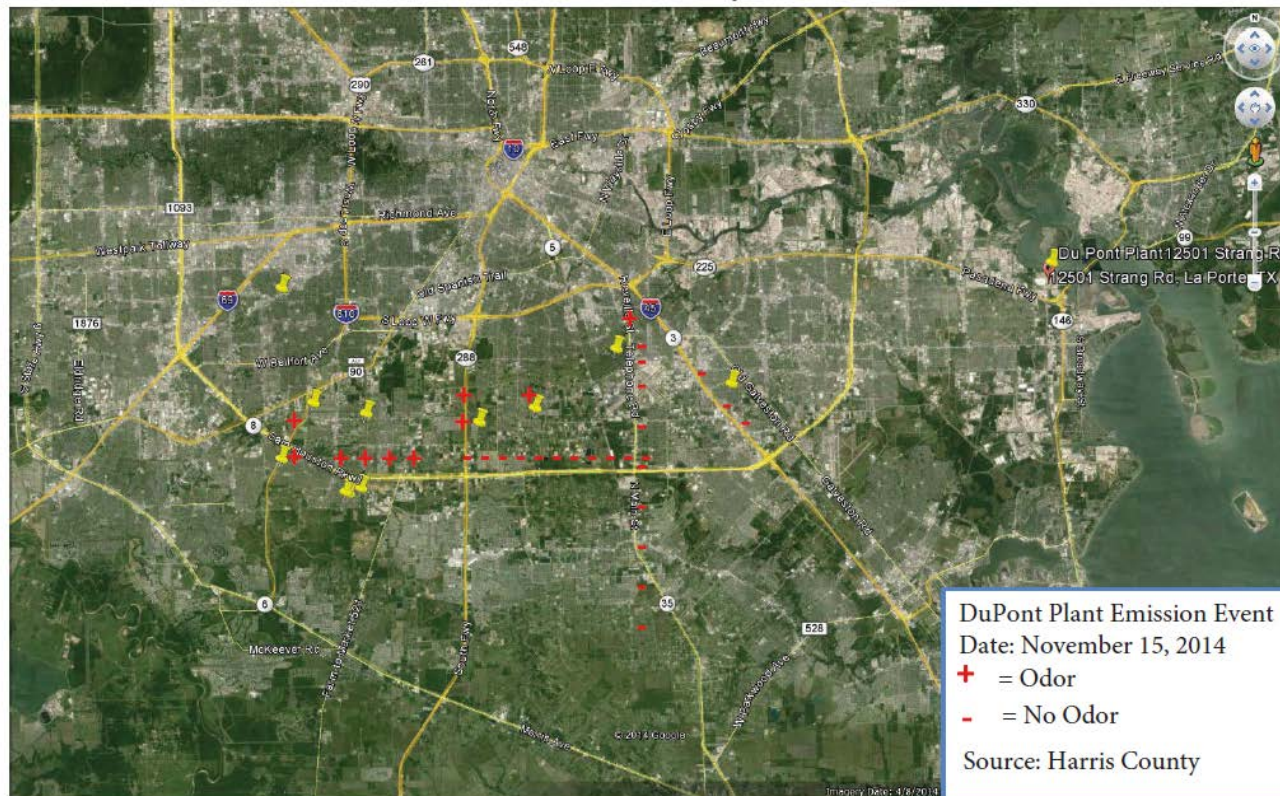
**Figure 40.** Map of the Odor Complaints (Yellow Pins) from the November 15, 2014 Incident. Source: Harris County, Texas.
